Analysing a mechanism of failure in retrieved magnetically controlled spinal rods

Abstract

Purpose We aim to describe a mechanism of failure in magnetically controlled growth rods which are used for the correction of the early onset scoliosis.

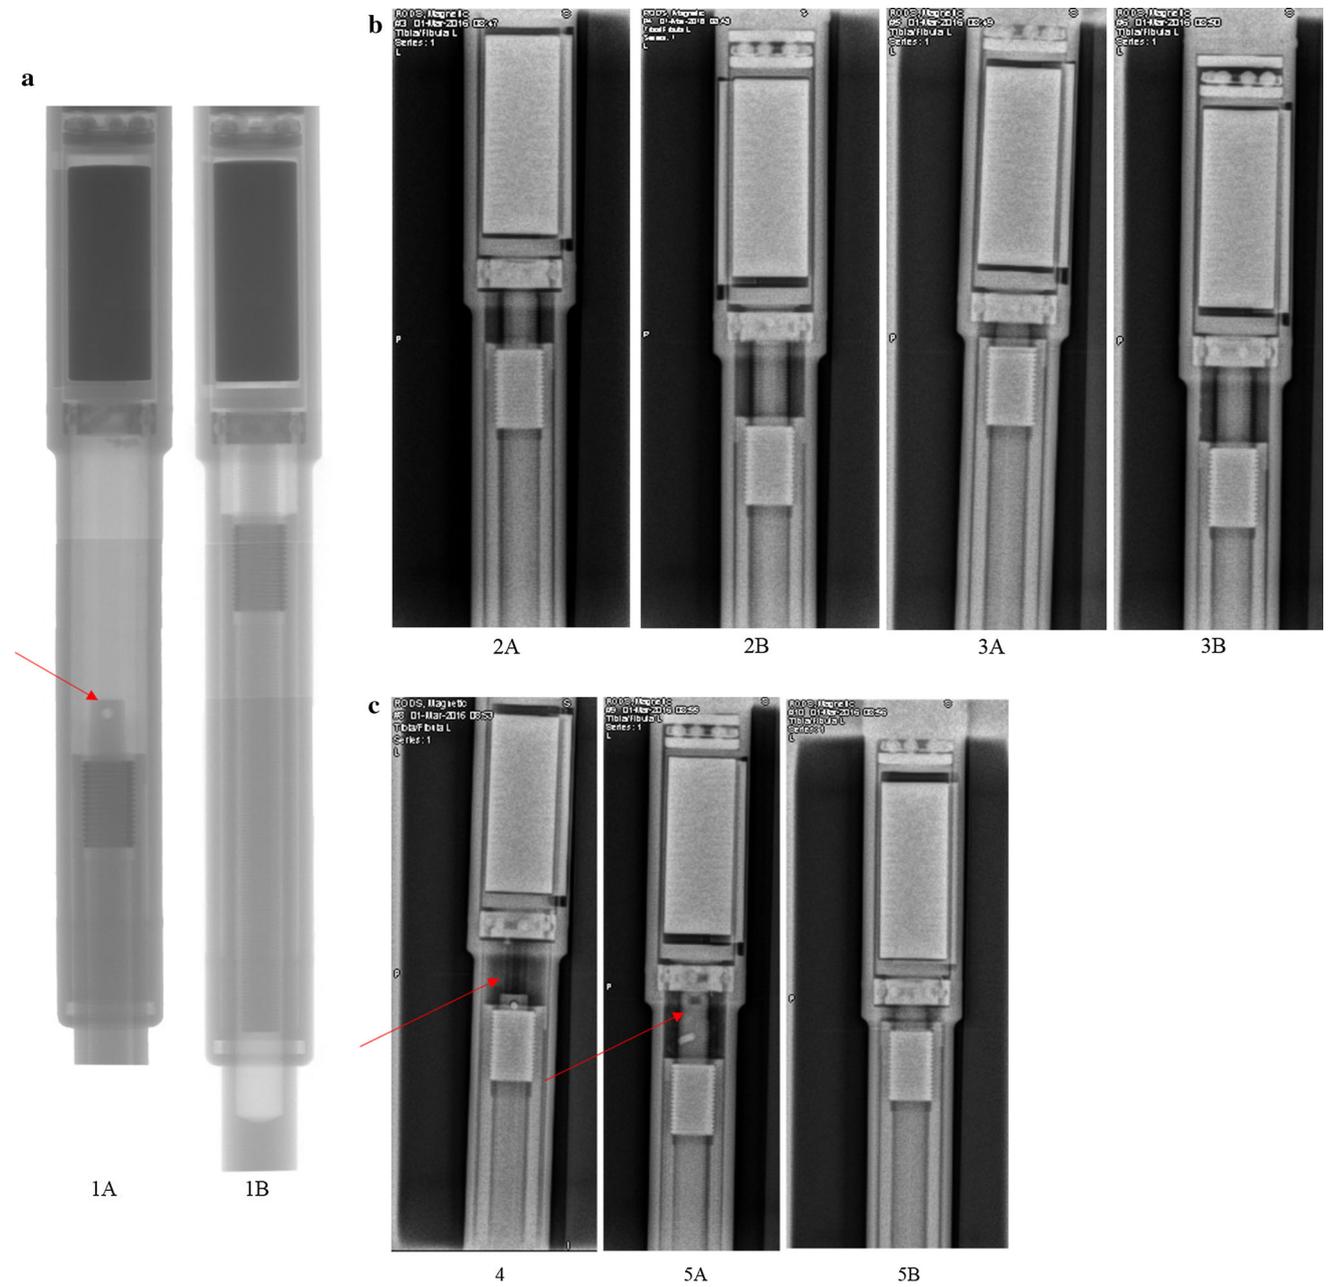
Fig. 2 a High power radiographs of two retrieved MCGRs. In rod 1A, the internal mechanism is no longer in place (indicated by the *red arrow*), while rod 1B appears intact. **b** Plain radiographs of four

retrieved rods, all of them appear intact. **c** Plain radiographs of three retrieved rods, two of them having a fractured mechanism as indicated by the *red arrows*, while the rest remains intact

Plain radiographs showed evidence of dislocation of the thread mechanism of the telescopic components in three cases.

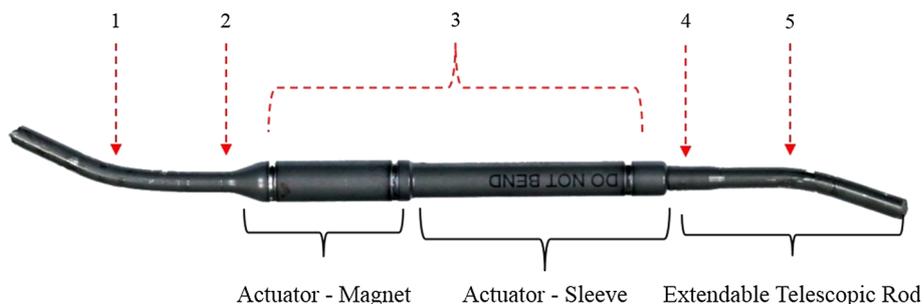
Fig. 3 Image of an explanted MCGR, with labelling of the main parts of the rod (actuator and extendable telescopic rod) and with referencing of the five areas of interest used for comparison of surface damage findings for each rod

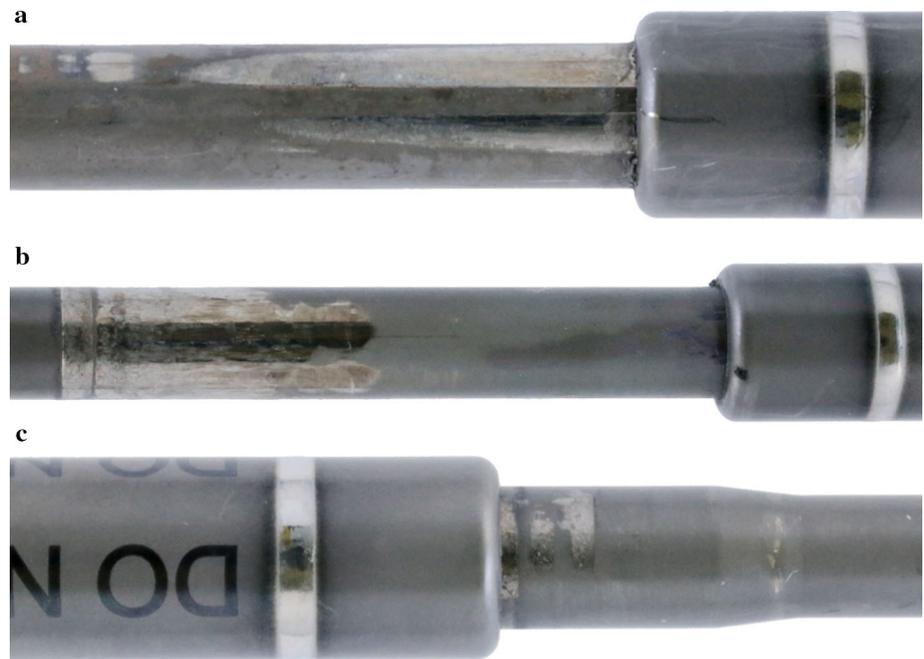
Fig. 4 Images showing the patterns seen of surface wear and removal on the extendable telescopic rod. **a, b** Show the pattern of surface wear on the same rod at different orientation, while **c** shows a different pattern of surface degradation on another rod

All retrieved implants showed signs of surface degradation on the extendable telescopic rod on regions that had been extended during the lengthening procedure and showed surface damage in two predominant patterns (see Fig. 4a–c). All implants showed some evidence of scratches attributed to surgical tools used during implantation and revision surgery. The results of grading the areas of interest in terms of surface damage are shown in Table 3. Table 4 presents the findings from the macroscopic inspection (type of pattern at the junction) with the results from the radiographs (fractured or not mechanism). All rods with fractured pins had the same wear pattern at the junction, removing a larger area of the surface layer than the MCGRs with an intact internal mechanism.

MCGRs with fractured pins. The regularity of the distribution of scratches in MCGRs with intact pins (Fig. 4c) likely reflects the number of distraction therapies. In contrast, the irregular patterns of surface damage (Fig. 4a, b) were only seen in cases with fracture of the pin. The surface damage seems to be linked to the bending moment.

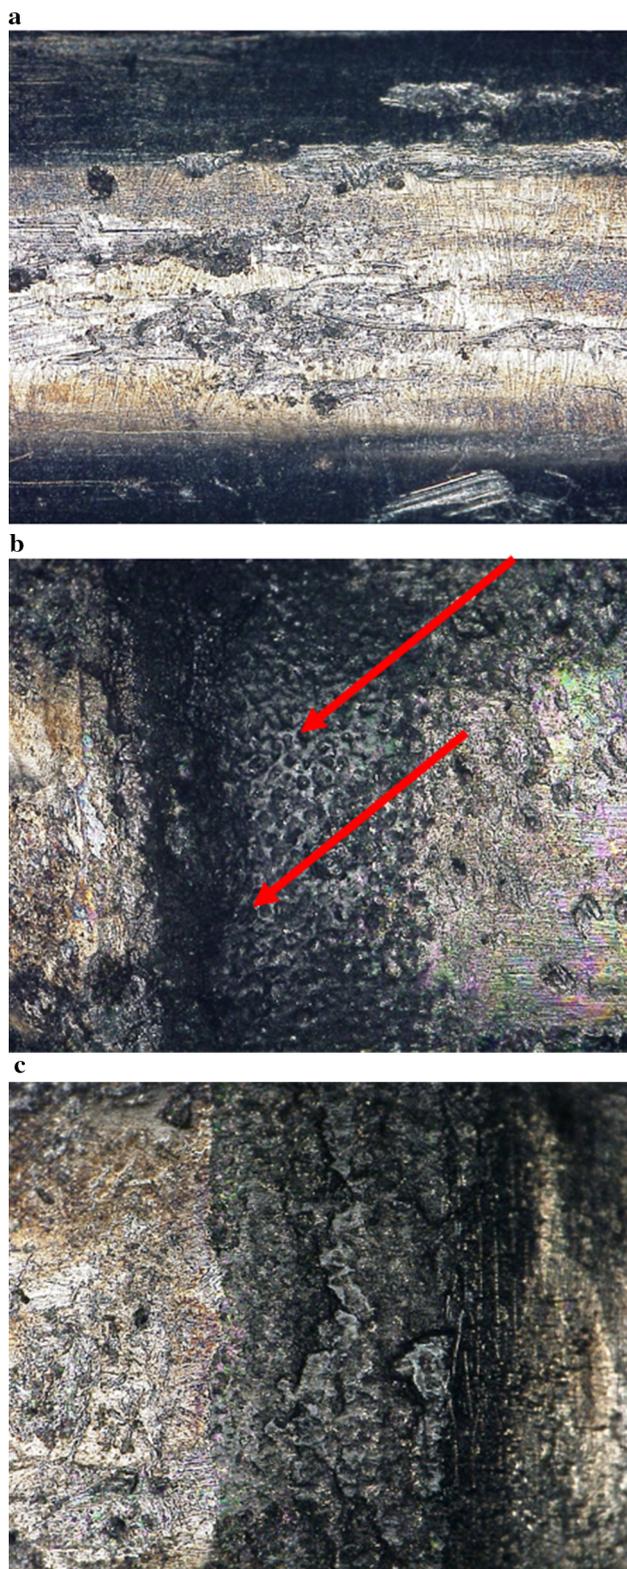
All implants showed signs of pitting and fretting on areas of the rod exposed during distraction, Fig. 5a–c.

Fig. 5 **a** Microscopic picture of the damaged surface near the junction at $\times 200$ magnification. **b** Microscopic picture of the damaged surface near the junction at $\times 200$ magnification, with *red arrows* showing the pitting. **c** Microscopic picture of the damaged surface near the junction at $\times 200$ magnification

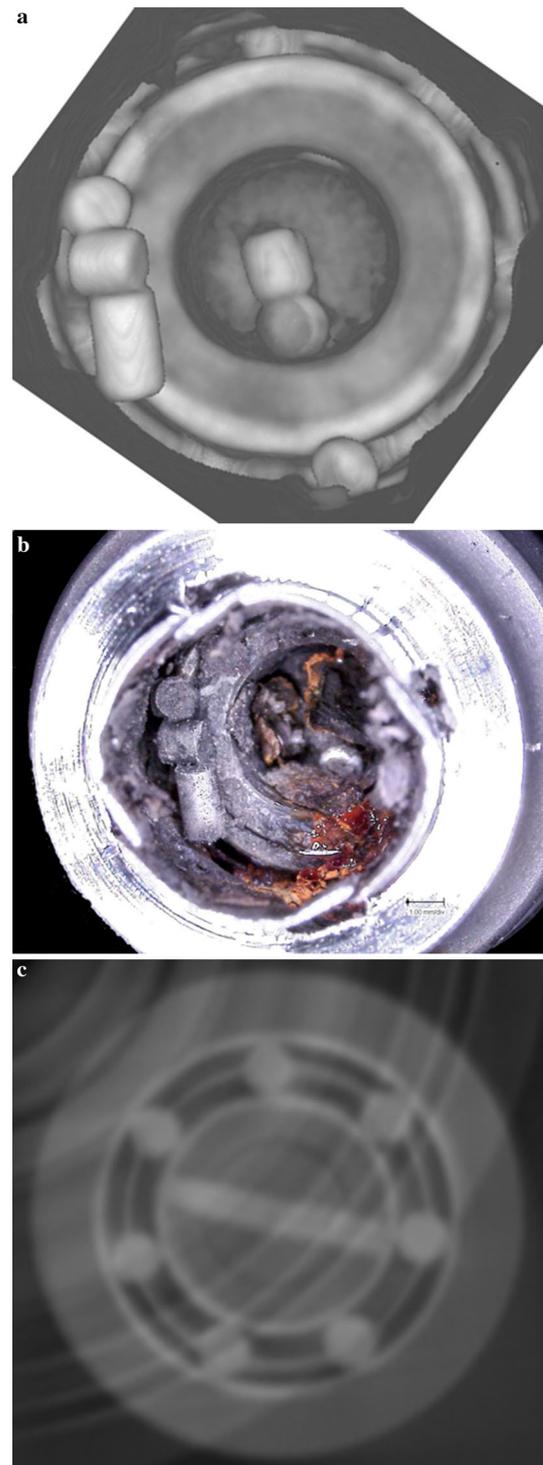
MCGR with fractured pin—mCT of the MCGR showed the drive shaft had become disengaged from the magnet, Fig. 6. Fragments of the pin were located around the ball bearing and had fractured into two pieces. Two of the fragments were located within the plain ball bearing with the remaining four on top, Fig. 6a. **MCGR with intact pin**—mCT confirmed that the magnet and the drive shaft were still engaged, with the pin in place, Fig. 6c.

Fig. 6 **a** Micro-CT image of the fractured pin in and atop of the ball bearing. **b** Image of sectioned rod showing the fractured pin in and atop of the ball bearing **c** Micro-CT image of the intact pin

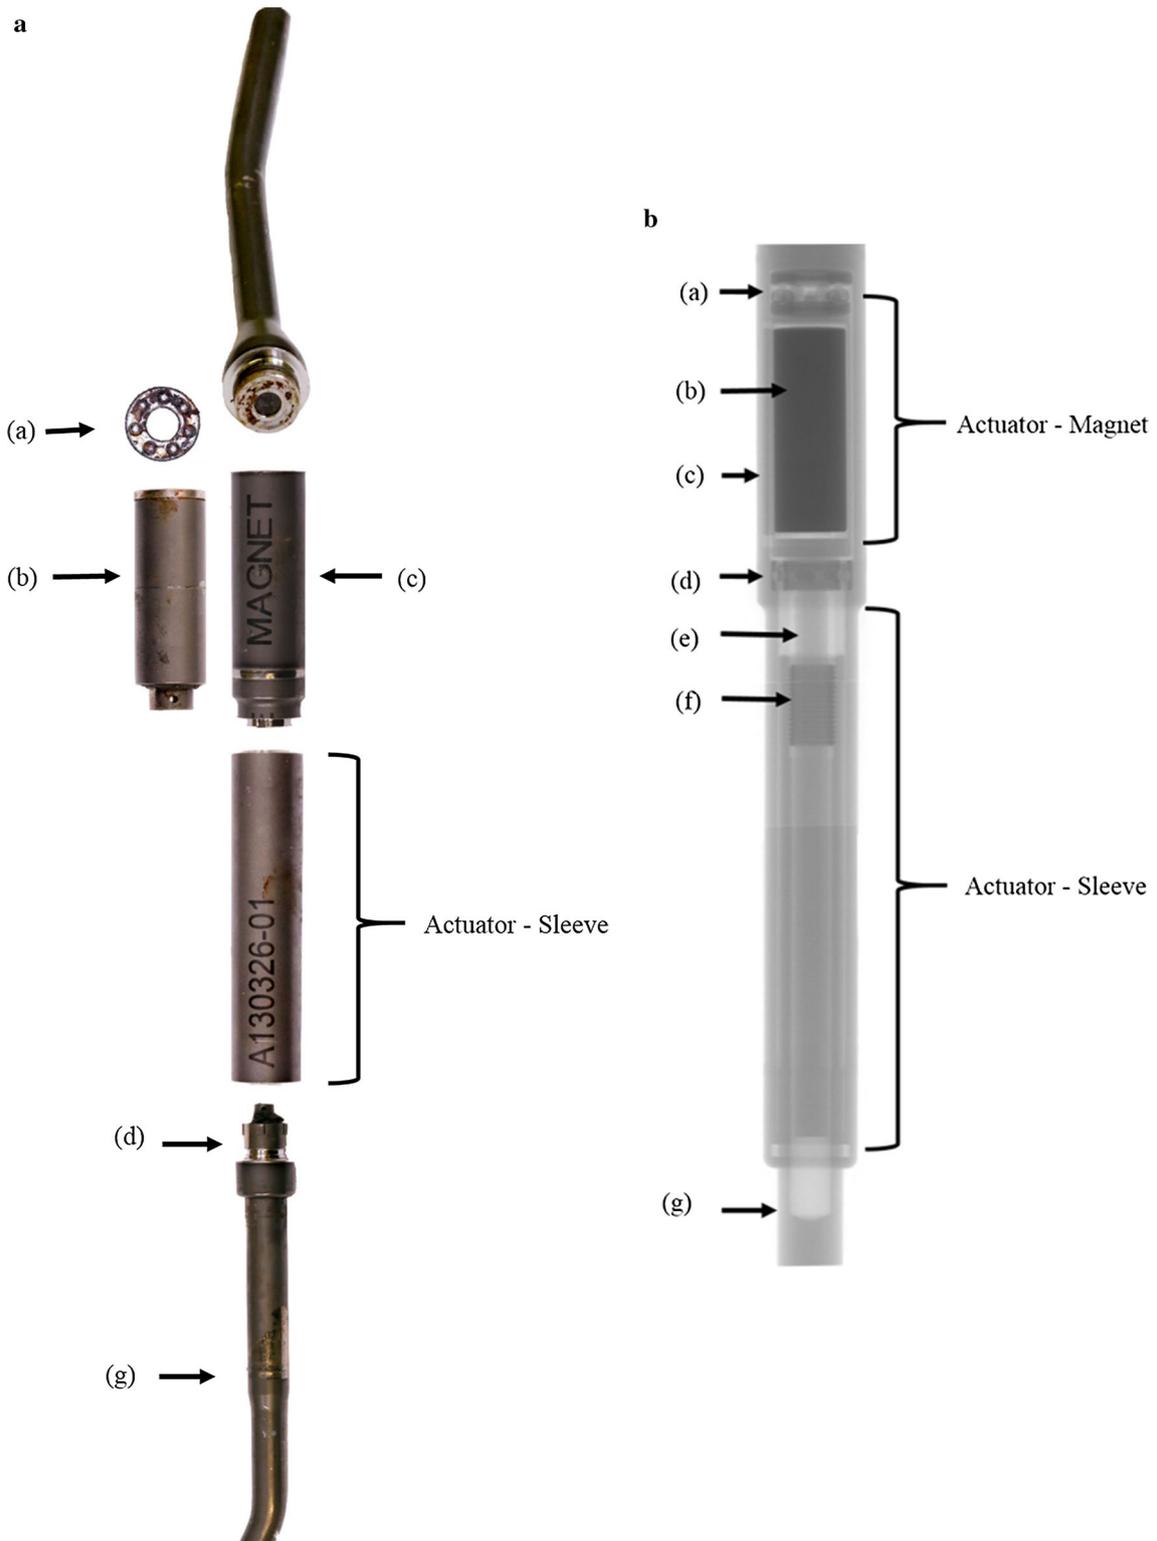
The MCGR with the fractured pin was sectioned in two areas: (1) one to allow access to the site of the fractured pin and (2) the other to access the thrust ball bearing and magnet within the sleeve, Fig. 7a, b. We found that the pin was fractured into six pieces, and once sectioned, the pieces were located in the same region, Fig. 6a, b.

Fig. 7 a Image of all parts of the fractured rod after sectioning. (a) Thrust bearing (b) magnet (c) keeper plate (d) ball bearing (e) drive train screw (f) fixed nut (g) extendable telescopic rod.

b Radiograph showing the construct of an intact spinal rod. (a) Thrust bearing (b) magnet (c) keeper plate (d) ball bearing (e) drive train screw (f) fixed nut (g) extendable telescopic rod

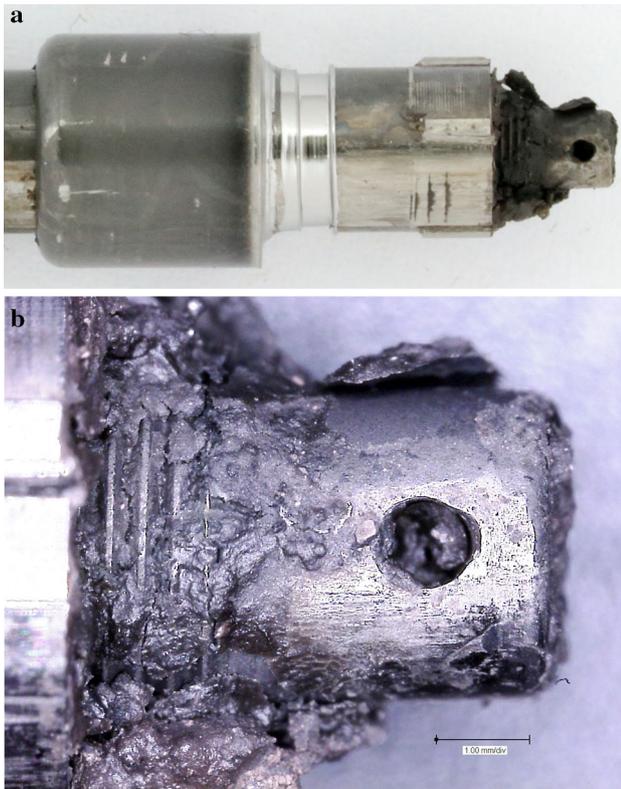
Visual and microscopic inspection showed debris and deposits on the bearings (see Fig. 8a–d). The lengthening component of the rod was inseparable from the caudal part of the implant, unable to move due to large build up of debris, Fig. 9.

Fig. 9 **a** Image showing drive train pin hole and debris. **b** Microscopic image showing drive train pin hole and debris ($\times 30$ magnification)

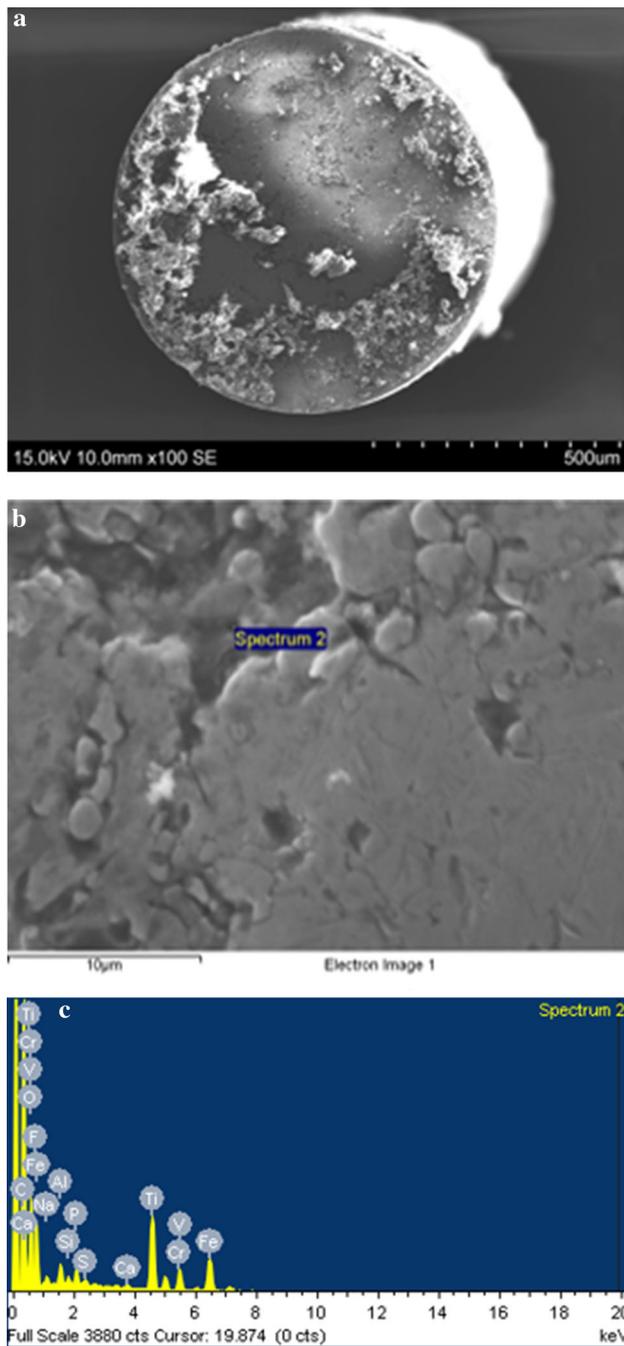
SEM confirmed the presence of debris on the pin, on the train drive mechanism and on the exterior lengthening rod. The fractured surfaces of the actuator pin were rough with

no clear indication of the exact location of fracture initiation. The rough morphology of the fractured areas did not account for any fatigue-related cracking. EDX analysis suggested that the pin was made of ferritic stainless steel, but was highly corroded (Fig. 11–c); we found traces of sulphur (0.2%), calcium (0.12%) and titanium (Fig. 11c). Specifically, oxygen amount was more than double on the corroded regions of the actuator pin compared to the original areas (60 versus 30%). On the corroded region, we noticed a tenfold decrease of the amount of iron and a fivefold reduction of the chromium content compared to non-corroded areas. The presence of titanium (5%), aluminium (0.4%), and vanadium (0.4%) suggested transfer of metal debris from mechanical wear of the rod to the actuator pin. We confirmed that the rod (Fig. 12a, b) and the drive mechanism (Fig. 13a–c) were made of titanium

Fig. 11 **a** SEM image on the internal pin. **b** SEM image on the internal pin. **c** EDX analysis of debris on the internal pin

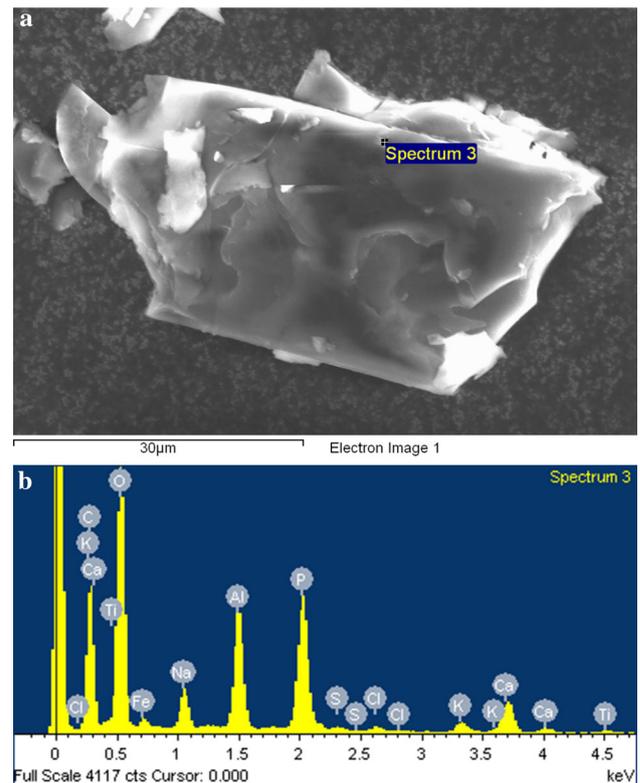
Fig. 12 **a** SEM image of debris on the external damaged surface of the rod on a carbon coated tab. **b** EDX analysis of the debris on the external damaged surface of the rod

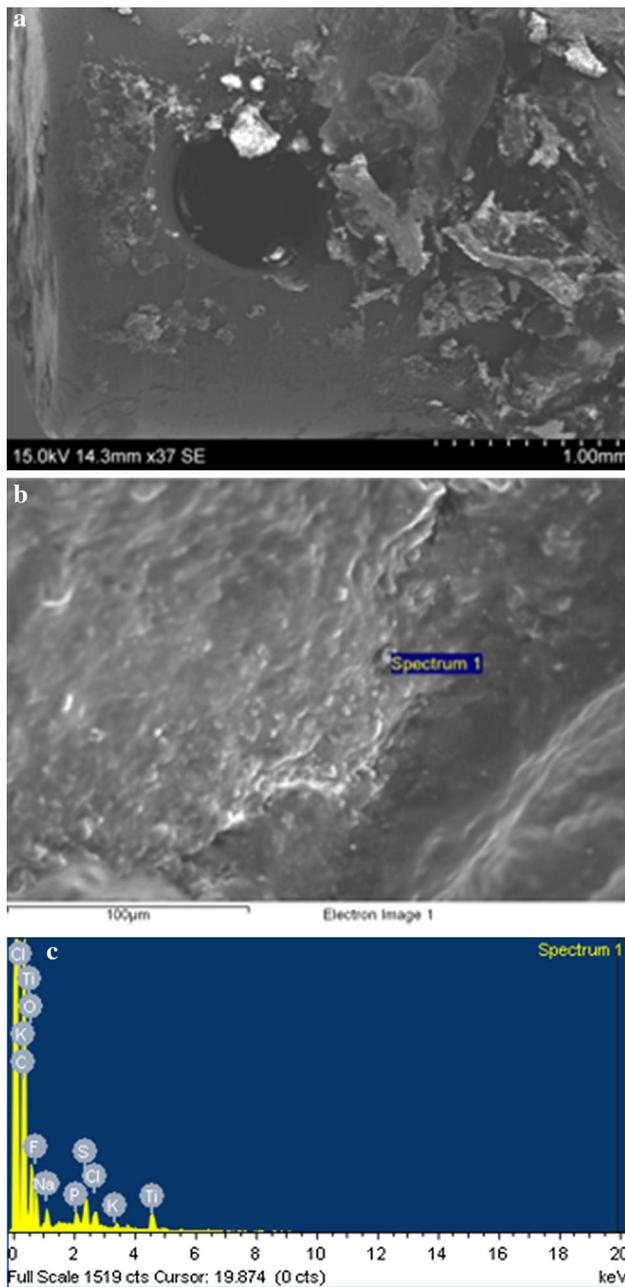
alloys and that both had evidence of corrosive products containing sulphur (0.15 and 0.6%, respectively), iron (1% in the case of the rod), phosphorus (6 and 0.4%, respectively), and calcium (Figs. 12b, 13c). EDX analysis of the debris on the drive mechanism revealed the presence of sodium (0.6%), potassium (0.2%), and chlorine (0.4%), confirming the presence of body fluids inside the magnetic rod.

Fig. 13 **a** SEM picture of debris on the drive mechanisms of the fractured rod. **b** SEM picture of debris on the drive mechanisms of the fractured rod. **c** EDX analysis of debris (*graph on the right*) on the drive mechanism of the fracture rod
