Reconnaissance report and preliminary ground motion simulation of the 12 May 2008 Wenchuan earthquake

Louise Wedderkopp Bjerrum · Kuvvet Atakan ·
Mathilde Böttger Sørensen

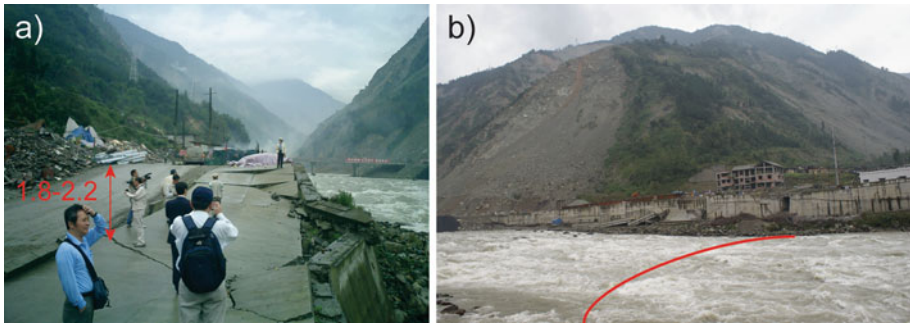
The fault scarp in Yingxiu is located at (31.065°N; 103.490°E). The displacement observed was pure thrust with a vertical displacement of 1.8–2.2 m (Fig. 3). The fault has

Fig. 3 Fault scarp, Yingxiu. **a** Surface rupture crossing and deforming the main road, which was flat prior to the earthquake. **b** Fault scarp continuing across the river. The approximate location of the surface rupture is shown by a *red stippled line*. A landslide scarp is visible on the hill side in the background

a strike of $240\text{--}250^\circ$ and a dip of $30\text{--}50^\circ$ at this location, crossing and deforming the main road (Fig. 3a). Eyewitnesses confirmed that the earthquake created a 2 m vertical scarp on the river bed, resulting in a small waterfall, which had gradually eroded away before our visit. In the background of Fig. 3b scarps after landslides are visible.

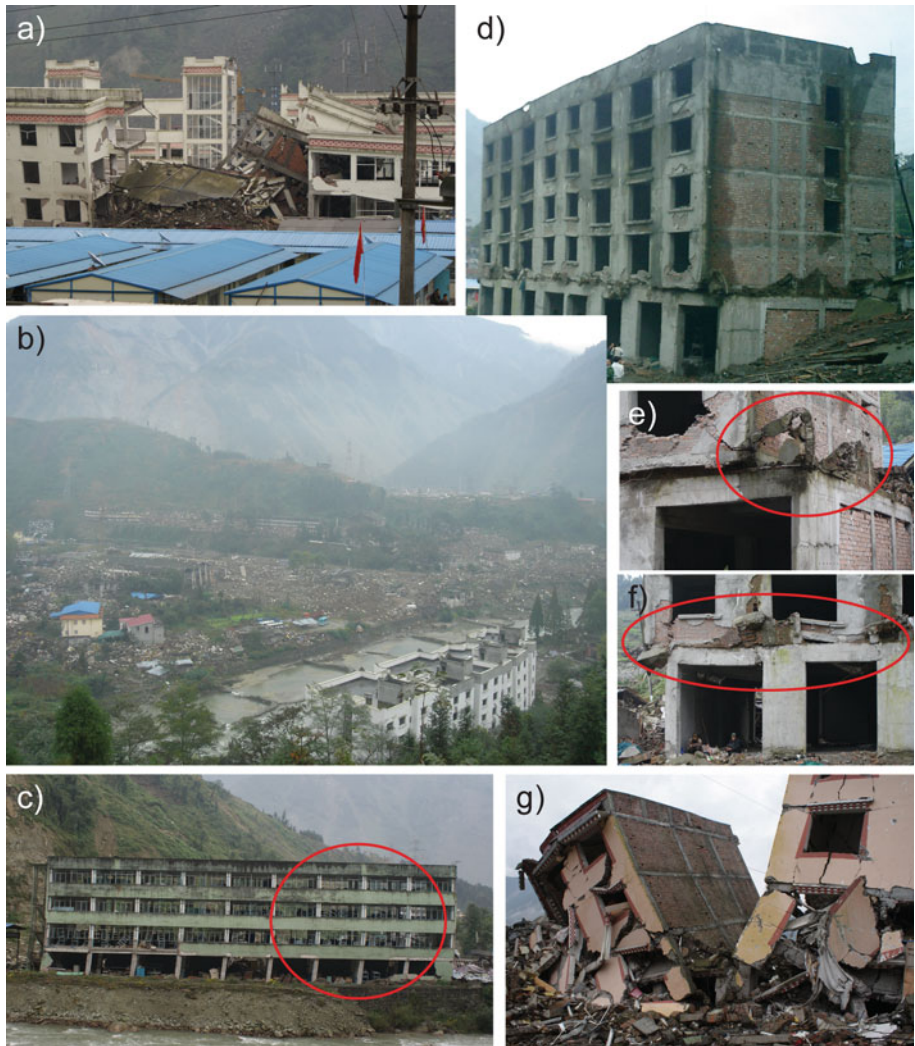
In Fig. 4, various types of building damage in Yingxiu are shown. Approximately 80% of the buildings in central Yingxiu collapsed during the earthquake, and it is planned that parts of the destroyed city will be preserved as a memorial museum. The massive destruction in Yingxiu is consistent with the short distance to the rupture initiation point from city and the thrust mechanism of the displacement. The high level of ground shaking experienced in the area was a consequence of proximity to the asperity with the largest displacement across the fault plane, estimated by waveform inversion (e.g. Ji and Hayes 2008; Nishimura and Yagi 2008; Zhao et al. 2010), as well as large displacements at the surface and is expressed through the damage to buildings and infrastructure (Fig. 4b). The buildings in the area were predominantly of reinforced concrete (RC) with brick infill (see Fig. 4a, the Xuankou Middle School, built in 2005 as an example). The damage observed varies from non-structural damage to total collapse of buildings. For further information on the damaged school buildings, see Zhao et al. (2009). Strong ground shaking is verified in Fig. 4c, where a factory building is clearly tilted and has been close to a collapse of the ground floor. The structures still standing had suffered heavy structural damage, ranging from soft storey collapse due to failure of columns (Fig. 4d–f) to partial collapse (Fig. 4g).

Fig. 4 Building damage at Yingxiu Town of Wenchuan County. **a** Xuankou Middle School, shelter buildings are visible in the foreground. **b** Overview of Yingxiu where ca. 80% of the city's buildings collapsed during the earthquake. **c** Factory building with clearly tilted columns. **d–f** Six-story RC-brick infill building which suffered a single story collapse of the second floor. **g** Partial collapse of residential buildings

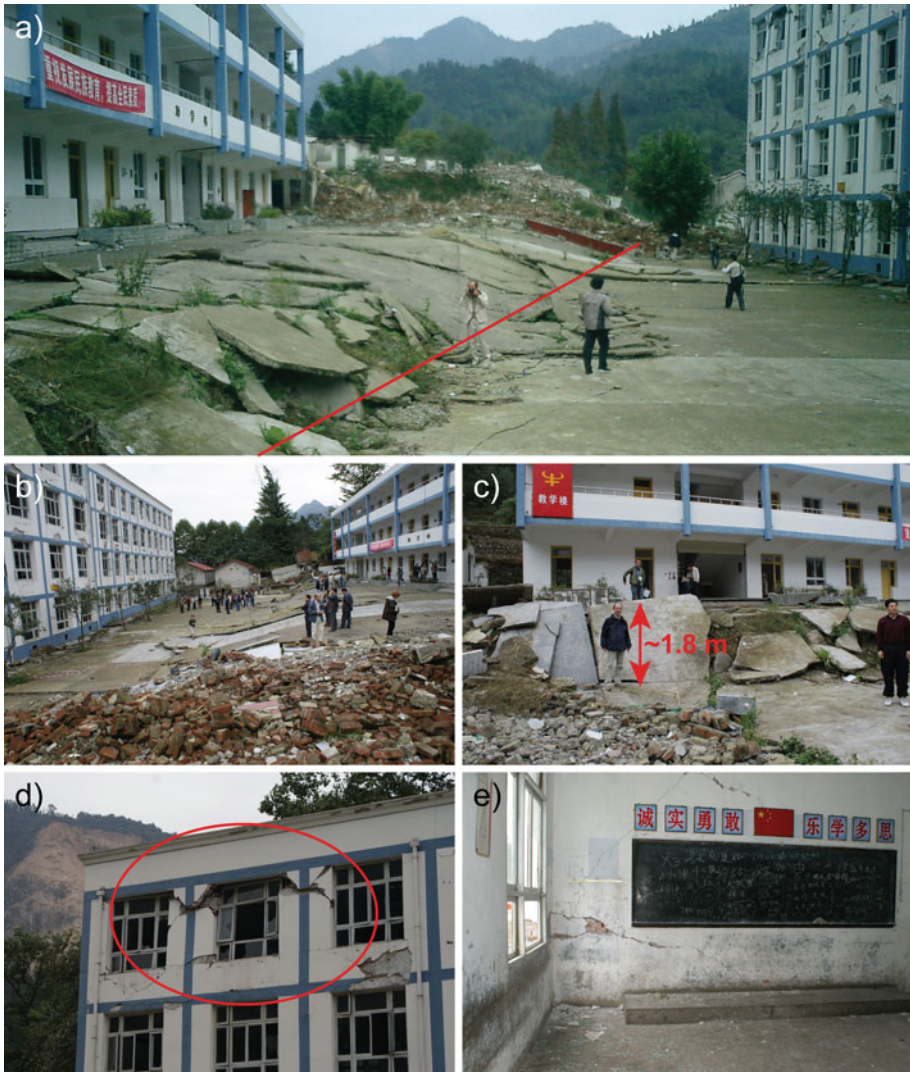
In the city of Bailu, we visited the Bailu Middle School where the ruptured fault lies between two large school buildings (Fig. 5a,b, pictures are taken towards NE and SW, respectively). Here, the fault scarp has a minimum displacement of 1.5–2 m with a small dextral component (0.2 m). The strike of the fault is approximately 230° with a dip of approximately $30\text{--}50^\circ$ at the position 31.211°N ; 103.913°E . The two school buildings were not constructed at the same time. The building located on the hanging wall block (left in Fig. 5a) is from 2005, whereas the other one is older. Piles of rubble at each end of the school yard indicate total collapse of other smaller buildings that were located on top of the fault rupture. Studying details of the school buildings reveals that the large ground motions caused little or no damage to the new school building (Fig. 5c), whereas the older building has suffered non-structural

damage in the infill walls as shear cracks, but also severe damage was observed as is evident by beam and column failure (Fig. 5d,e).

Fig. 5 Damage of Bailu Middle School buildings and fault scarp in Bailu. **a–b** School yard, taken towards northeast and southwest, respectively. **c** Newer school building on the hanging wall block with no visible damage. Vertical uplift of approximately 1.8 m is visible. **d** Structural failure of cross diagonal fractures on the older school building. **e** View from inside the older school building, where wall cracks are visible

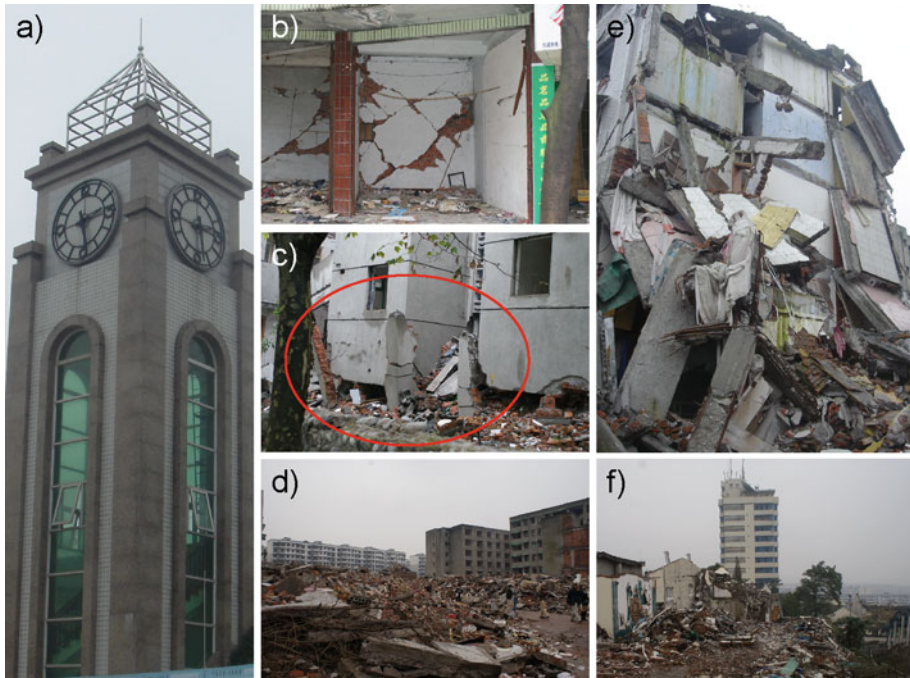
The clock tower shown in Fig. 7a has become a symbol of the Wenchuan earthquake, since it stopped at the time of the earthquake (14:28 local time). There was no apparent damage to this structure. The photographs in Fig. 7b–e are from the most heavily damaged area in the central part of the town. Non-structural shear cracks were observed in several buildings where the joints between the columns and beams seemed intact (Fig. 7b). Many residential buildings of 4–5 stories suffered substantial damage in the area. An example of a soft storey collapse, of an apartment building is illustrated in Fig. 7c. In this residential building complex, the staircases between the apartment blocks also collapsed, leaving no exit for survivors.

Fig. 7 Building damage in Hanwang. **a** City clock tower of Hanwang with no apparent damage. The clock stopped at the time of the earthquake, 14.28 (local time). **b** View inside a building, with visible non-structural damage. **c** Single story collapse of apartment building. **d–e** Widespread damage of poorly constructed buildings, whereas modern buildings sustained the ground shaking. **f** Main building of Dong Fang Steam Factory with no apparent damage. In the foreground widespread damage and collapse of poorly constructed buildings is visible

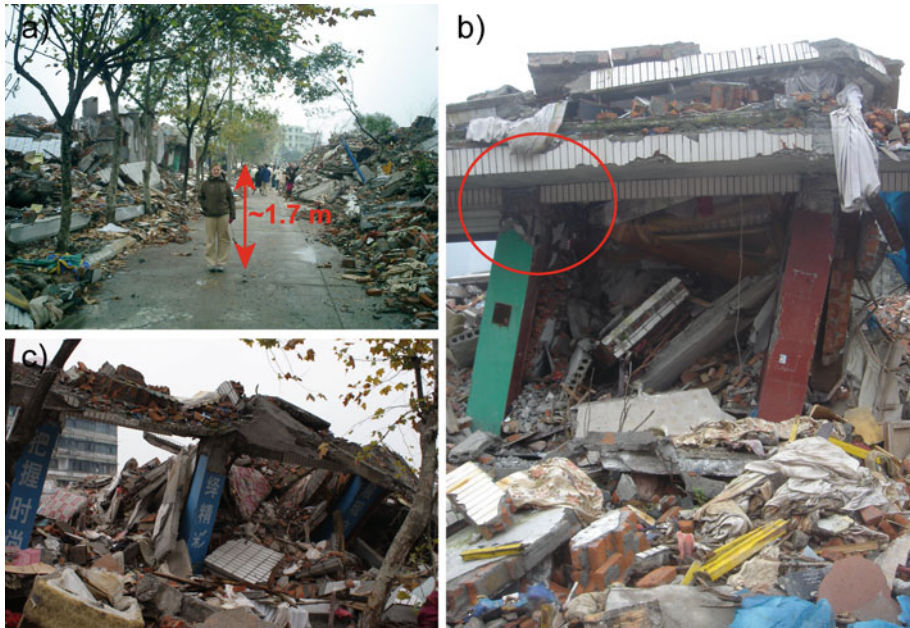
This area of Hanwang also includes the old market area. Most structures here were simple two-storey reinforced concrete buildings with a flat roof, where the ceiling height of the ground floor was larger than the ceiling height of the second floor. These buildings suffered severe damage due to failure of beam and column joints. As a result, there were significant volumes of rubble and construction material (piles up to 2 m high) in the streets (Fig. 8).

Fig. 8 Typical market buildings with shops on the ground floor and apartments on the second floor, Hanwang. **a** View through the main street of the market area. **b** Close-up of the structural damage of the beam-column joints in a market building. **c** Front of market building is partial collapsed while the rest of the building is totally destroyed

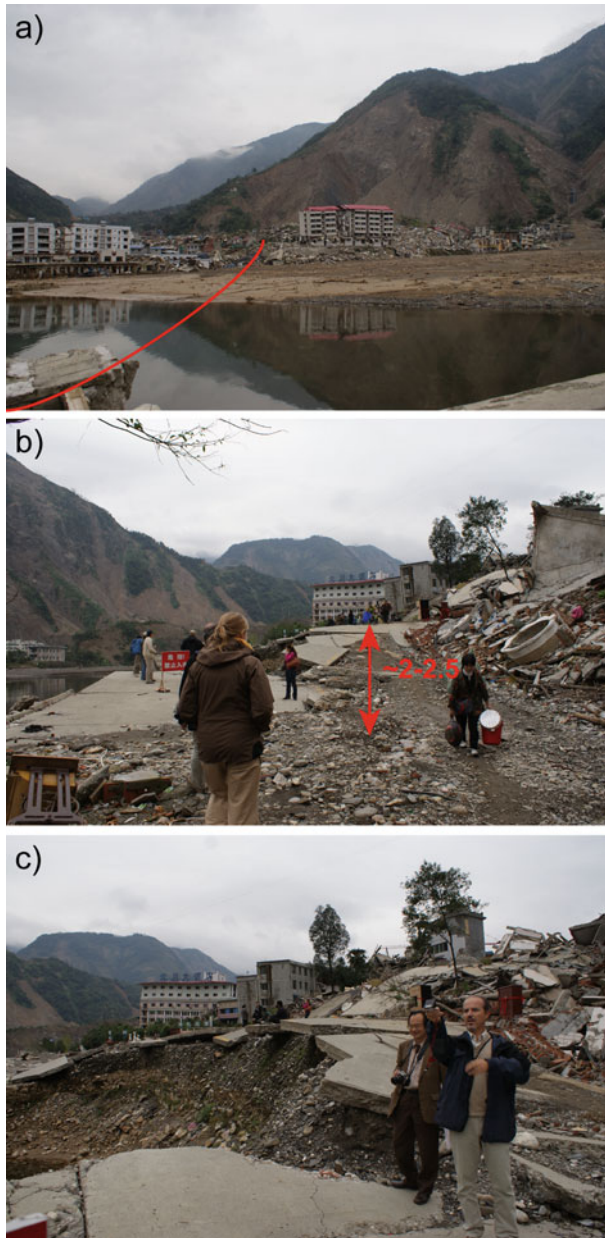
The ground motions in Beichuan exceeded 350 cm/s^2 during the earthquake, with the largest ground motions on the vertical component (Li et al. 2008b). The fault scarp runs through the city in the area between the old and the new part of town (31.829°N ; 104.457°E , Fig. 9). The strike of the fault is found to be $230\text{--}240^\circ$, and the vertical displacement was 2–2.5 m. Scarps due to the extensive landslides covered the mountain sides, and part of the

Fig. 9 Fault scarp in Beichuan, crossing the river with a 2.5 m uplift. **a** View towards SW, the old part of Beichuan with alluvial material in the foreground, the *red line* marks the continuation of the fault across the valley. **b** Surface rupture in Beichuan. The picture is taken towards the new part of town to the NE, at the same location as (a). Vertical uplift of 2–2.5 m was measured in Beichuan, as indicated with the *red arrow*. **c** Close-up of the fault scarp, where deformed concrete road blocks and rubble from collapsed buildings are visible

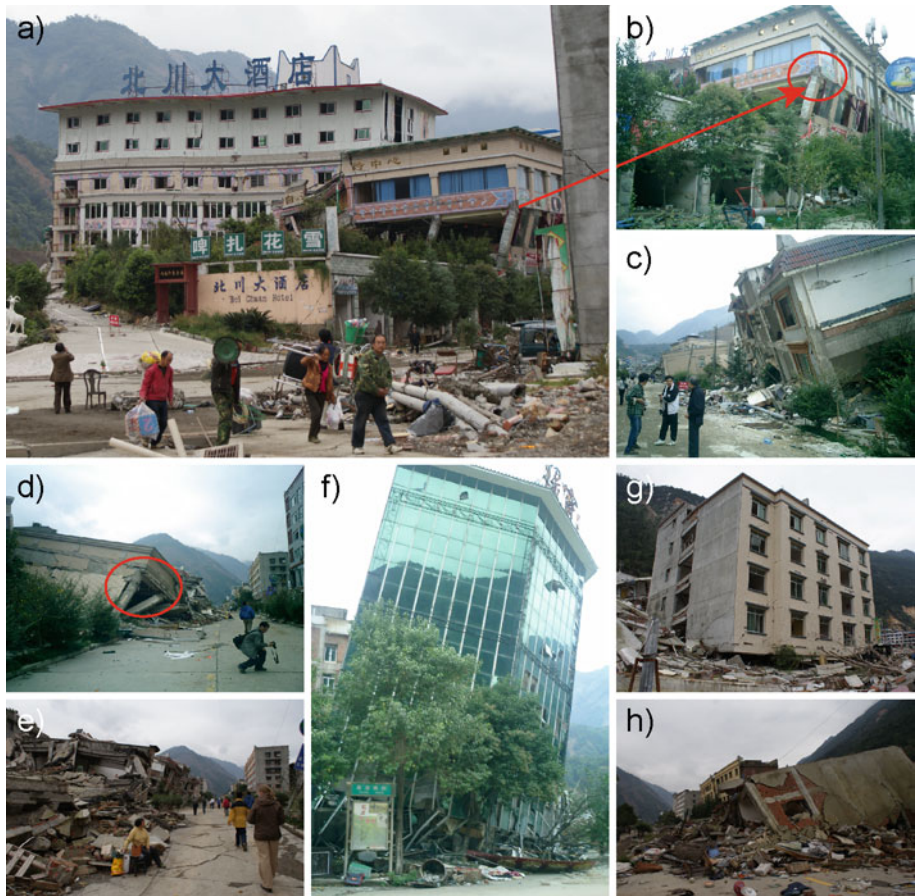
Various types of building damage are observed in Beichuan, ranging from non-structural damage to total or partial collapse (Fig. 10). The Bei Chuan Hotel sustained the strong ground shaking and did not collapse. However, failures at the column beam joints are visible and the hotel is no longer habitable (Fig. 10a, b). In the main street of the new part of Beichuan (Fig. 10c–e), weak structures, with partly open-ground storey, have partially or totally collapsed due to column failure, whereas the more resistant apartment blocks, without open-ground storey, have no apparent structural damage. The building in Fig. 10f, located in the main street, suffered from soft-story collapse. Note that the glass façade of the building is almost intact. Other examples of damage to structures in Beichuan are collapse of soft stories as well as tilting and toppling of apartment blocks indicating ground failure (Fig. 10g,h). Throughout the city, survivors were still trying to recover their belongings from the damaged buildings and rubble at the time of our visit (Fig. 10a, e).

Fig. 10 Building damage in Beichuan County Town. **a–b** Bei Chuan Hotel suffered severe damage, as failure of the column beam joints, but sustained the ground shaking. The main building of the hotel is clearly tilted (**a**). **c–e** Main street of the newer part of Beichuan, with collapse of weak structures due to column failure. **f–g** Buildings suffering single story collapse of the first floor. **h** Toppled building due to ground failure

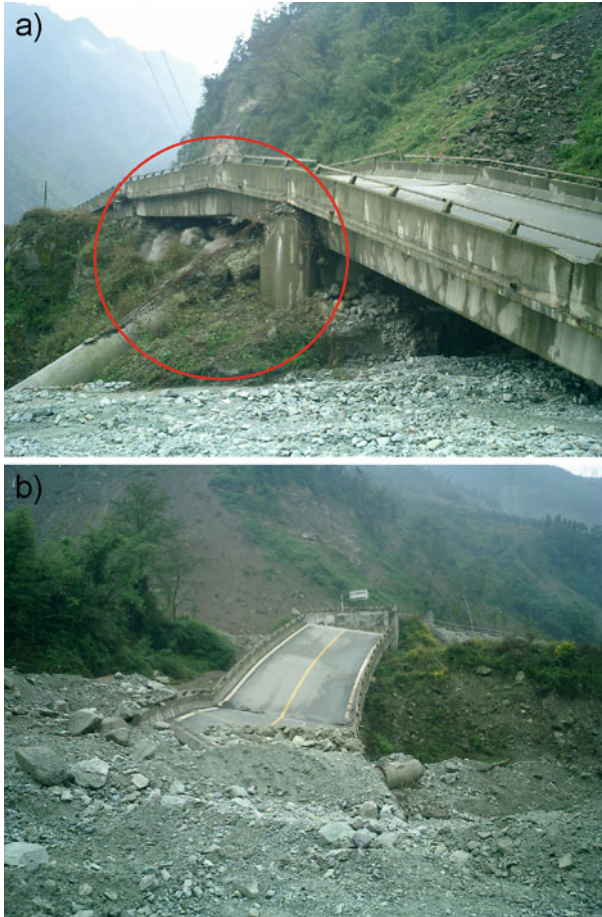
On the road from Chengdu to Yingxiu, the Baihua Bridge (“Hundreds of Flower” Bridge) collapsed at the entrance to Yingxiu (31.045°N; 103.474°E) due to failure of the bearing

columns (Fig. 11). The failure of the bridge further complicated the access to the area, hindering emergency rescue efforts.

Fig. 11 Structural damage to the highway between Chengdu and Yingxiu. **a** View towards Chengdu. A collapsed column is visible in the lower left corner. **b** View towards Yingxiu, where the road section in the foreground is dislocated and separated from the section in the background

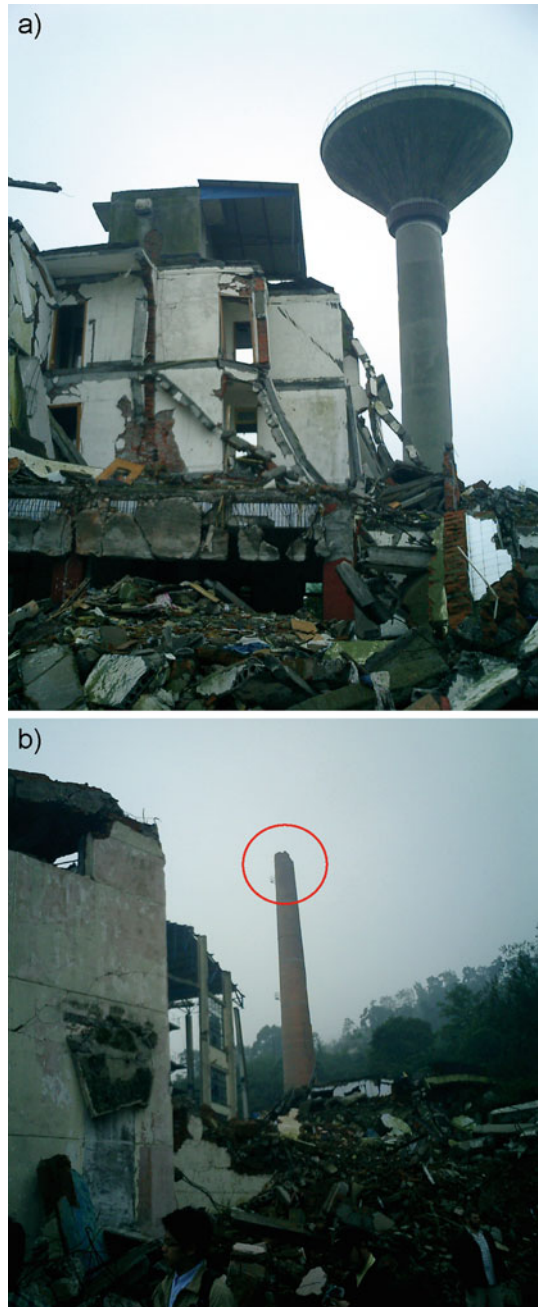
High-rise structures suffered varying degrees of damage. As an example, the water tower of the Shifang Cement Plant (located in Hanwang), approximately 15–20 m high and with a large mass on top (Fig. 13a), is intact after the earthquake, although nearby buildings were severely damaged. Figure 13b, on the other hand, shows another factory in Hanwang where the chimney has been damaged near the top. The nearby factory buildings have been heavily damaged, with partial collapse of some walls. Also long-span structures, such as bridges and dams, experienced varying levels of damage. Damage to bridges varies from total

Fig. 13 High-rise structures. **a** Water tower of Shifang Cement Plant in Hanwang. **b** Slightly damaged factory chimney in Hanwang

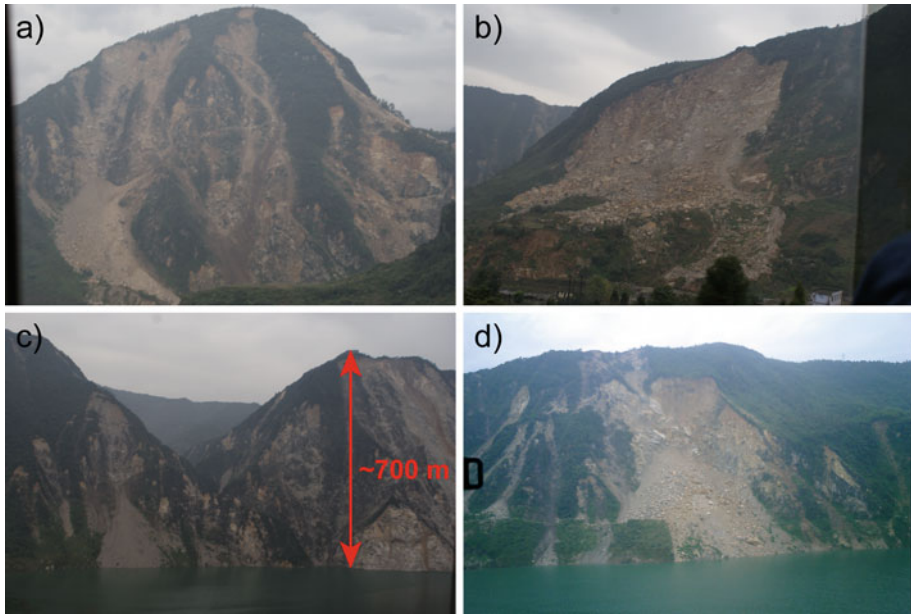
The steep slopes of the mountains in the entire earthquake affected region (the mountain front rises about 4,500 m over a horizontal distance of 100 km across the Longmenshan Mountains), combined with the likely amplification of strong ground motion in the mountain topography, are important factors for the large amount of triggered landslides following the Wenchuan earthquake. In the area near Yingxiu and the water reservoir for the Zipingpu Dam, the large

Fig. 16 Landslide scarps near Yingxiu. The vertical distance from the water level to the top of the mountain is in these pictures roughly estimated to be 700 m. **a–b** Landslide scarps visible from the road towards Yingxiu. **c–d** Landslide scarps at the hills surrounding the water reservoir of Zipingpu Dam

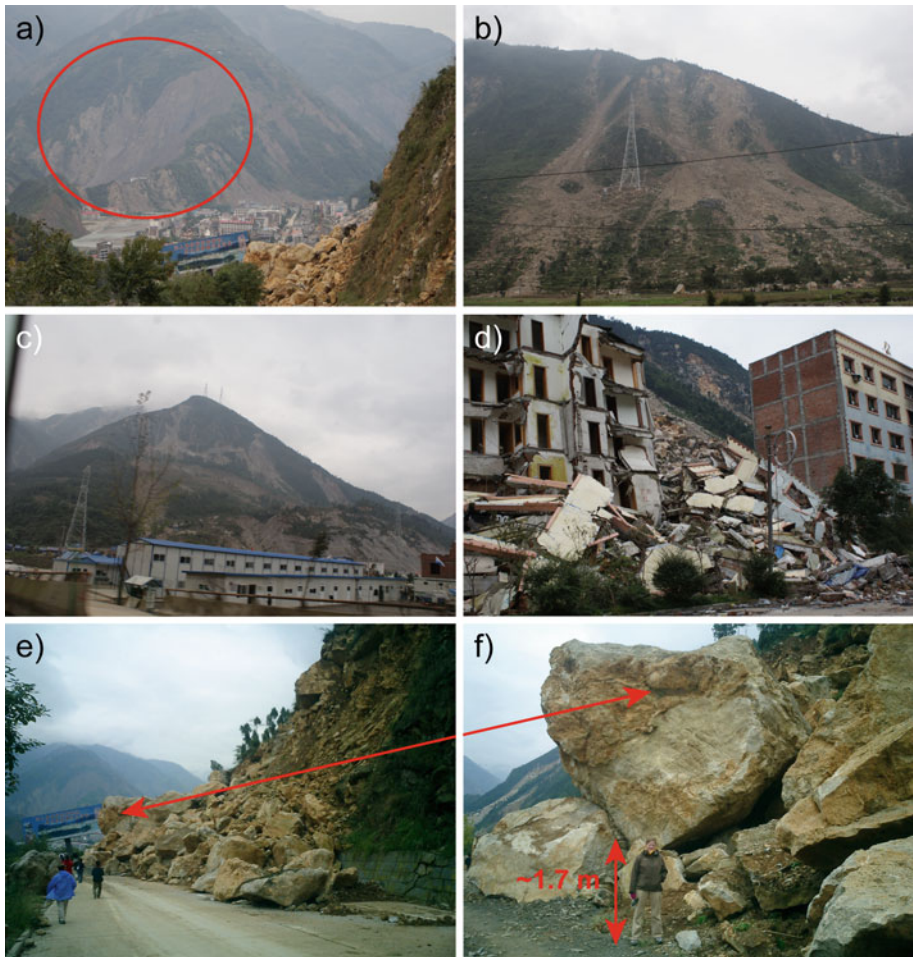
Similarly, Beichuan is surrounded by steep mountains, and the city sustained significant damage as a result of a large number of landslides and rock falls (Fig. 17). Large volumes boulders and large blocks have caused severe damage both to infrastructure (blocking roads and tearing down communication lines) and to buildings in the city. Several landslide scarps were visible in the city (Fig. 17a–c). We saw several structures in the city, which appeared to have withstood the strong ground shaking but were later destroyed by the triggered landslides. An example of this is shown in Fig. 17d, where an apartment building is completely destroyed by a landslide, while the two neighboring buildings are still standing, one of them without any apparent structural damage. Also, large blocks from the rock falls caused damage to the infrastructure blocking the roads leading in and out of the city (Fig. 17e,f).

Fig. 17 Landslides and rock falls in Beichuan. **a–c** Landslide scarps visible on the steep mountain slopes surrounding Beichuan. Temporary shelters are visible in the foreground of **(c)**. **d** Landslide in the center of Beichuan, causing an apartment block to total collapse. To the right a building with no apparent damage is visible. **e–f** Large rock falls and boulders blocking the road to Beichuan, notice the huge size of the boulder in **(f)**

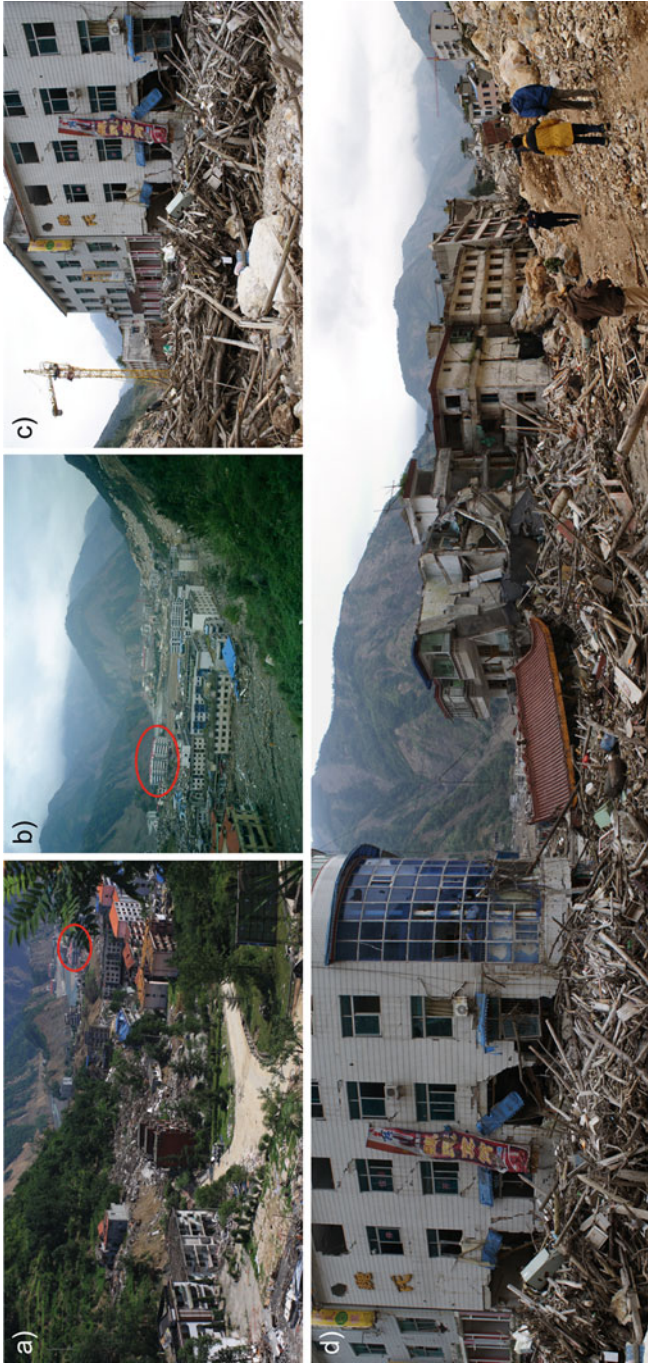
On September 21, 2008, Beichuan was struck by a large debris- and mudflow which covered the SW part of the city with up to 3 m of debris material and mud (Fig. 18). The debris flow did not cause further structural damage to the buildings in the area (comparing Fig. 18a,b). However, the roads in the city were covered by the large amount of debris material and mud, making it difficult to get around in the city. Broken trees were brought to the city from the mountain sides, creating a natural dam (Fig. 18c,d). Houses located in the debris flow area had diagonal cracks in the walls caused by the strong ground shaking during the earthquake

(Fig. 18c). In the older part of the city, towards the river, there was a large row of damaged houses surrounded by debris material, where rubble from damaged structures has been transported to the central part of the city during the debris flow (Fig. 18d).

Fig. 18 Debris- and mudflow in Beichuan. **a** Overview of Beichuan after the earthquake, but before the debris flow (Reprinted by permission from Macmillan Publishers Ltd: [British Dental Journal] (Dai et al. 2009), copyright (2009)). **b** Overview of Beichuan after the debris flow. The red circles mark the same building in (a) and (b) for correlation. **c–d** Natural dam created of broken trees and building material brought to the city by the debris flow. Diagonal cracks in the walls caused by strong ground shaking are visible
