Performance of industrial buildings during the Emilia earthquakes in Northern Italy and recommendations for their strengthening

Dionysios A. Bournas · Paolo Negro · Fabio F. Taucer

Abstract A series of earthquakes, the highest of magnitude M_w 5.9, hit a portion of the Po Valley in Northern Italy, which was only recently classified as seismic. The paper reports the findings and the lessons learnt from a preliminary field survey which was conducted immediately after the second event. As a result of the economic attitude of the affected area, and possibly of the characteristics of the event, an unprecedented number of industrial precast buildings were affected, resulting into most of the casualties as well as in large economic losses. Whereas most of the damaged and collapsed buildings were designed for gravity loads only, evidence of poor behavior of some precast buildings designed according to seismic provisions were discovered. The paper provides a description of the performance of precast buildings, highlighting the deficiencies that led to their poor behavior as well as some preliminary recommendations.

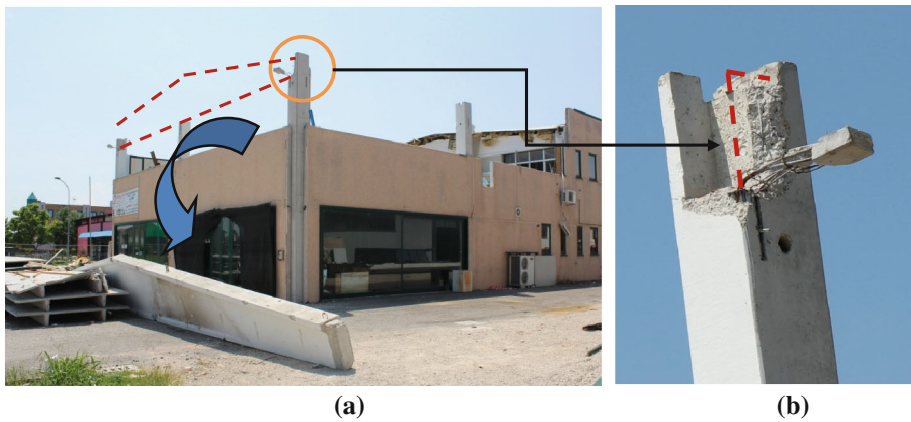
Fig. 9 **a** Out-of-plane collapse of a double slope precast beam after unseating following failure of the lateral restrain of the fork at the seat pocket; **b** detail of the shear failure of the fork

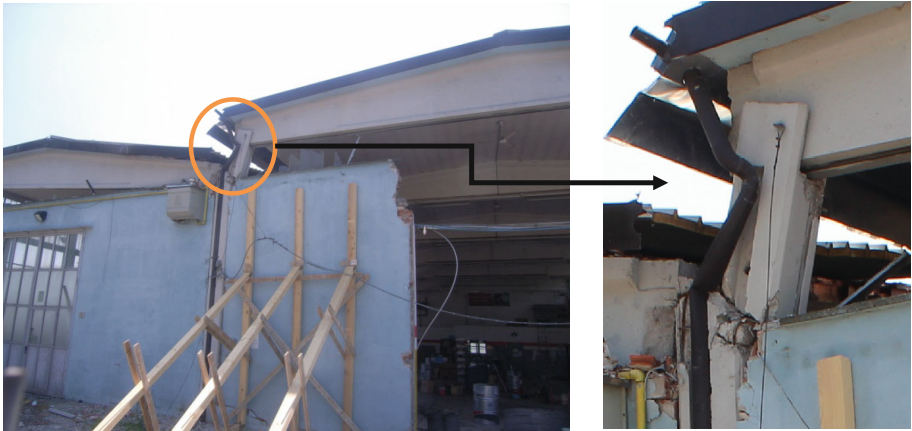
The interaction with masonry panels distributed non-uniformly across the structure often led to non-synchronous displacements at the top of columns, thus contributing to unseating of the girders as presented in Fig. 10. Masonry panels, when not covering the full length of the column, led in many cases to the formation of short-column failures (Fig. 10).

Fig. 10 Loss of the left girder seating due to the interaction with masonry panels (short columns/shear failure)

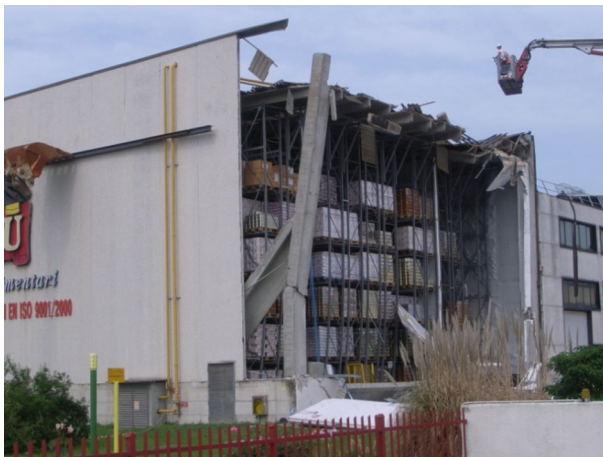
Concerning the loss of seating of beams and columns, it is noted that the flat (Fig. 11) and the sloped roof systems are equally vulnerable. The main difference between the two systems is that the sloped roof corresponds to a generally older design, where the girder has a smaller width (due to its higher section height) that leads more easily to out-of-plane failures.

Fig. 11 Partial collapse of the roof, longitudinal girders, column and front cladding of a flat roofed precast building

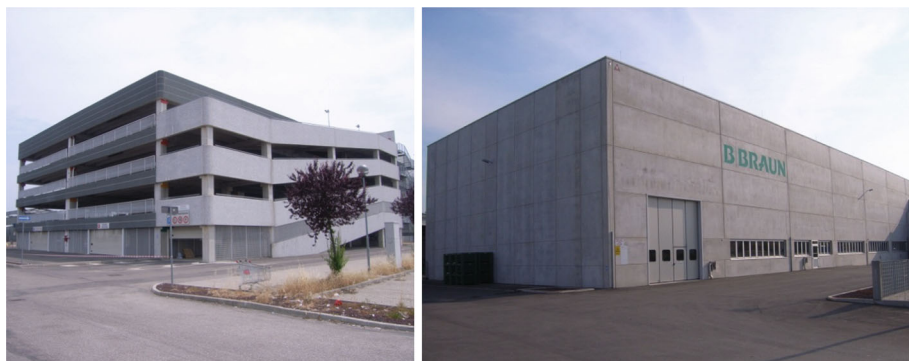
Fig. 13 Recently constructed precast concrete buildings exhibiting good performance

In general, recently constructed precast concrete buildings, including a high-rise precast parking structure, which most probably incorporated steel dowels in the beam-column joints, exhibited apparent good performance, as shown in Fig. 13. It should be noted that, due to safety measures in force immediately after the main shocks, no inspection near or inside these buildings was possible.

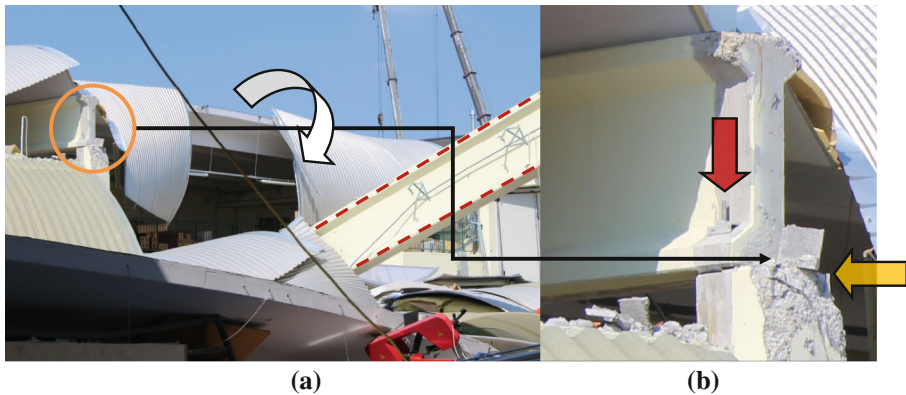
It is worth mentioning that a building completed in 2010 showed partial collapse, in spite of having been designed (according to information provided by the owner) with pinned beam-column connections following the new Italian construction standards. Visual inspection revealed failure at the top of one of the central column beam-column connections. This failure was followed by loss of the girder seating and its subsequent collapse (Fig. 14a).

The rather limited distance of the dowels from the edge of the column and the limited amount of transverse reinforcement might have resulted into the formation of a shear crack across the concrete cover (Fig. 14b), followed by the loss of the dowels anchorage and consequently the loss of the girder seating. This failure reveals the absence of specific provisions for detailing the beam-to-column connections in the current Italian construction standards and the as well as in the Eurocodes (CEN 2004).

Fig. 14 Loss of girder seating in a recently constructed industrial building after failure of the pinned beam-column connection: **a** general overview of the collapsed beam (*red dashed lines*); **b** detail showing failure of the column support at the beam-column pinned connection. *Orange arrow* shows damaged area at the *top of the column*, while *red arrow* shows an undamaged pinned connection

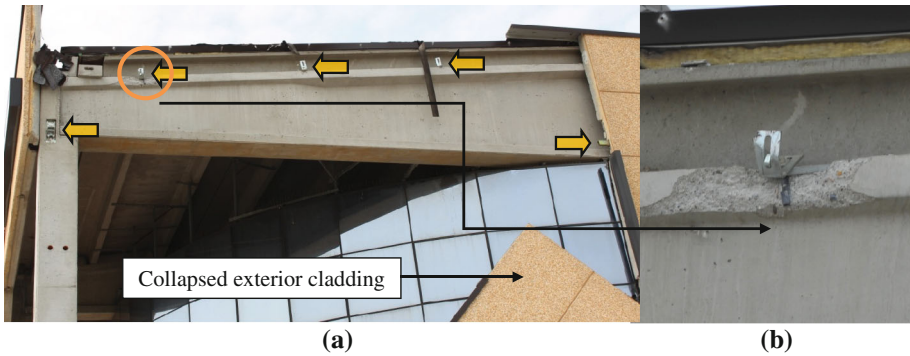
Figure 15a illustrates the in-plane detachment of an exterior cladding element after failure of the connections (Fig. 15b) with the main structure. Similarly, the excessive drifts which were experienced by the precast building in Fig. 16 exhausted the displacement capacity of the connections of the panels, leading to the development of high forces that led to failure of the connections and unseating of the horizontal panel.

Fig. 15 **a** Cladding panel collapse after failure of the connections with the main structure (*orange arrows* showing the location of connections of the collapsed exterior cladding); **b** detail showing failure of the mechanical connection

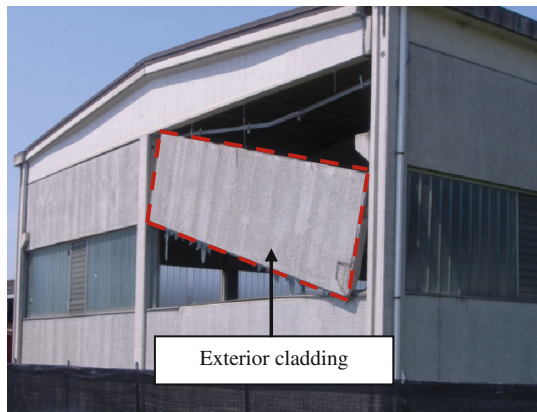
Fig. 16 Detachment of exterior cladding after failure of the connections from the main structure: in plane rotation

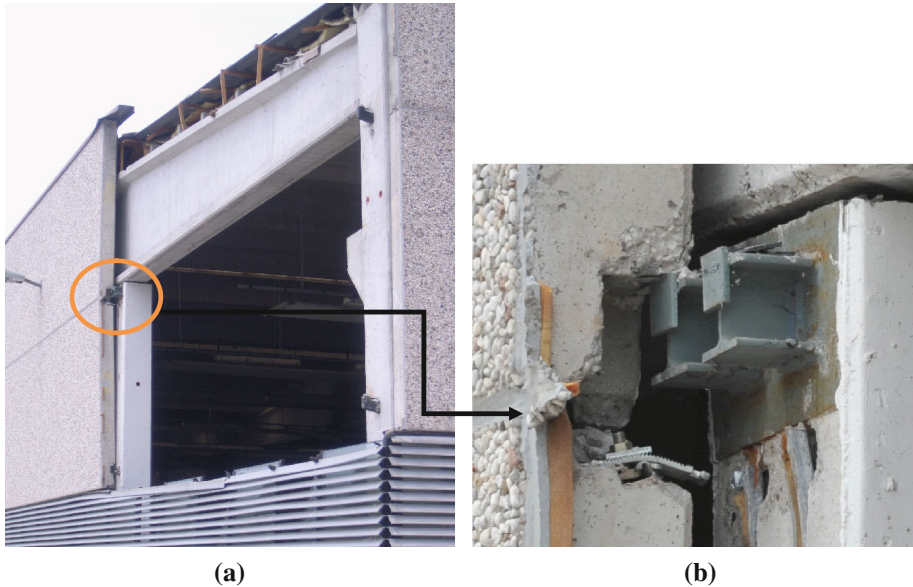
Figure 17a presents a horizontal panel detached from the frame, (possibly) due to the high out-of-plane inertial seismic forces that caused failure of the fastenings (Fig. 17b). In other cases, the high out-of-plane inertial effects led to the development of high rotations (especially when more than two horizontal panels were used—Fig. 18), which together with vertical inertia effects, led to unseating and loss of the panel connection.

Fig. 17 Out-of-plane detachment of horizontal cladding: **a** overall view; **b** detail of the failed fastenings

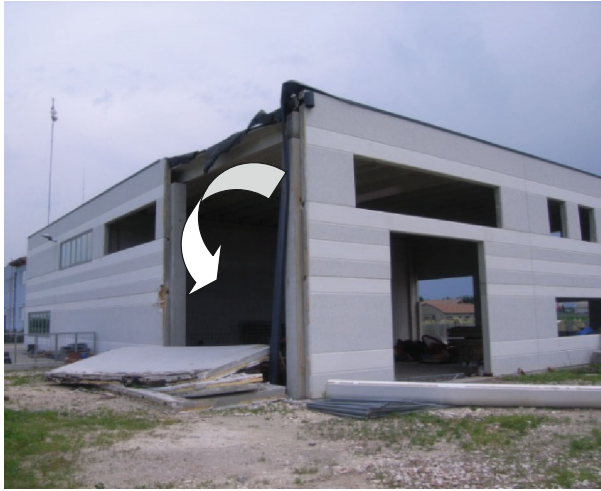
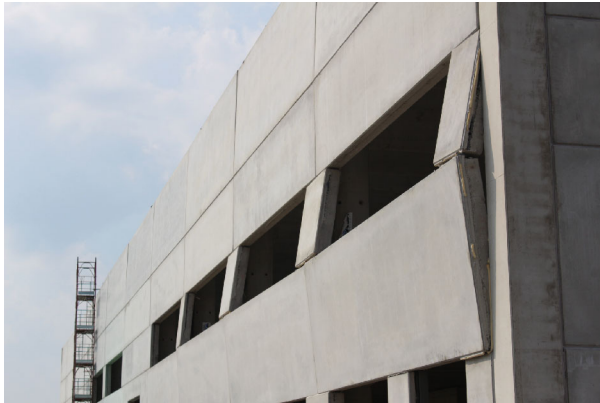
Fig. 18 Out-of-plane overturning of exterior claddings

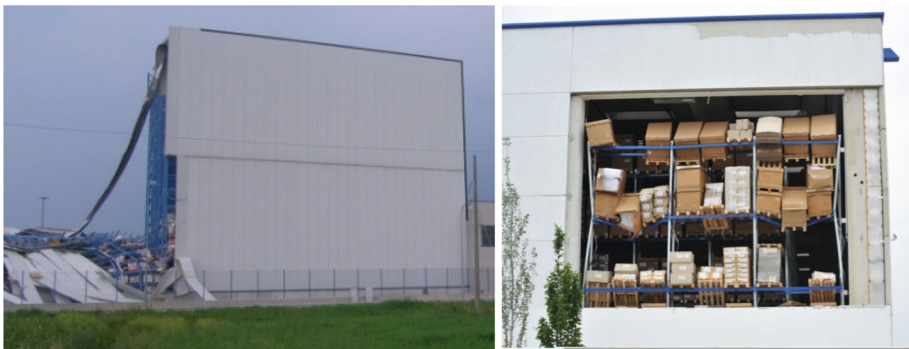
Finally, in some industrial buildings the failure of steel racking systems, especially very tall ones (in excess of 10 m), was observed, with important economic consequences. In some cases, their large mass and the resulting high inertia forces developed during the earthquake induced ramming and consequent collapse of exterior cladding (Fig. 19).

Fig. 19 Collapse and local failures attributed to the failure of rack systems

- Failure of steel racking systems was observed in several industrial buildings, leading in many cases to the subsequent collapse of the exterior cladding. It is recommended that guidelines for the design of steel racking systems in seismic regions are developed in order to prevent such type of failures.

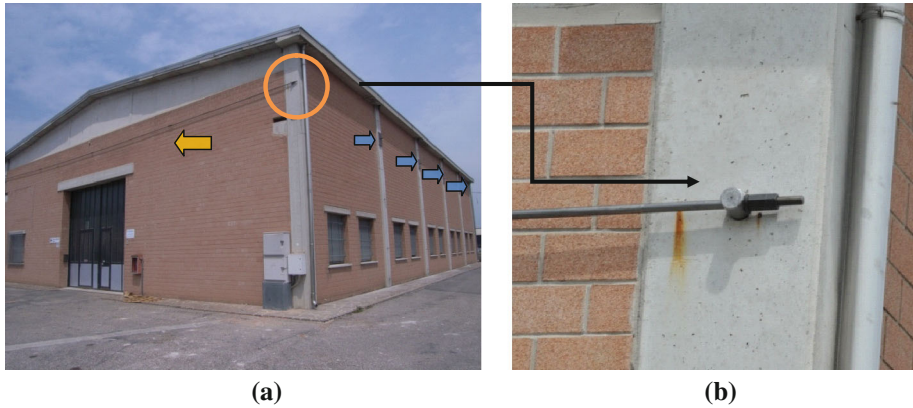
Fig. 20 **a** Steel ties anchorage system installed after the main event to stabilize the structure: *orange arrow* showing the external tie, *blue arrows* showing the internal ties. **b** Detail of the anchorage at the external tie
