# Using Observational Method to Manage Safety Aspects of Remedial Grouting of Concrete Dam Foundations

**Abstract** As concrete dams age, the need for remedial grouting to reduce the seepage and uplift pressure in the rock foundations under them increases. Based on a case study of a Swedish dam with very low calculated safety against sliding, this paper discusses the application of the observational method (as defined in Eurocode 7) to manage safety aspects during remedial grouting. The studied case was complex in that grouting works posed the risk of causing increased uplift pressure, which could have induced sliding failure along a shallow, persistent, horizontal rock

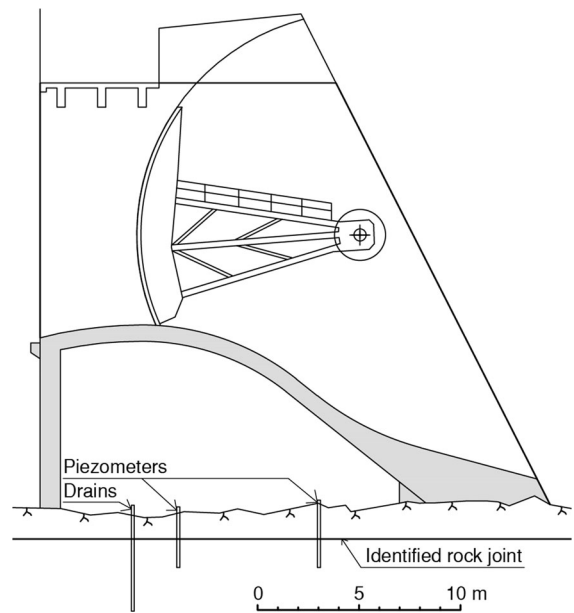
**Fig. 2** Cross section of a spillway monolith seen from the side. A shallow and persistent horizontal rock joint led to low sliding stability

rock joint extending under three of the monoliths (Figs. 2, 3, 4).

To improve the sliding stability, drilled and grouted micropiles were planned for installation. However, first, to avoid the immediate erosion of the grout when installing the micropiles, remedial grouting of the curtain was required to reduce the flow rates. This would, in itself, also increase the sliding stability by decreasing the uplift pressure. The stability-enhancing modifications started in October 2011.

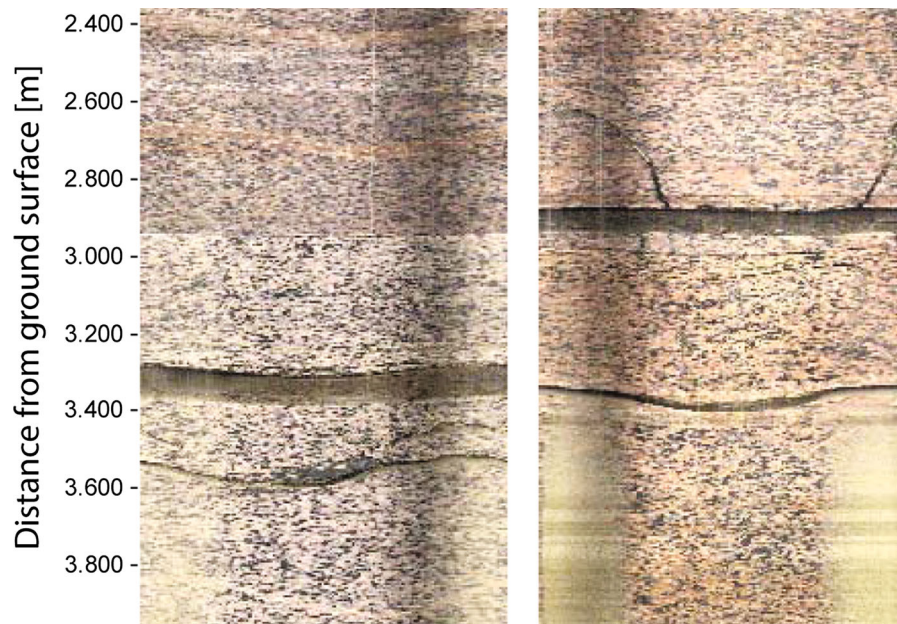
**Fig. 4** Images of the persistent fracture taken in two boreholes (diameter: 76 mm) close to pier 2 with a borehole camera in December 2008. The fracture was found to be partially filled with grout. (The ground surface level differs slightly between the two boreholes)

(Fig. 4). Although the uplift pressure dropped, which increased the safety margin against the sliding of the dam, the planned grouting had to be redesigned and extended to seal this new leakage as well, as the grouted micropiles were yet to be installed.

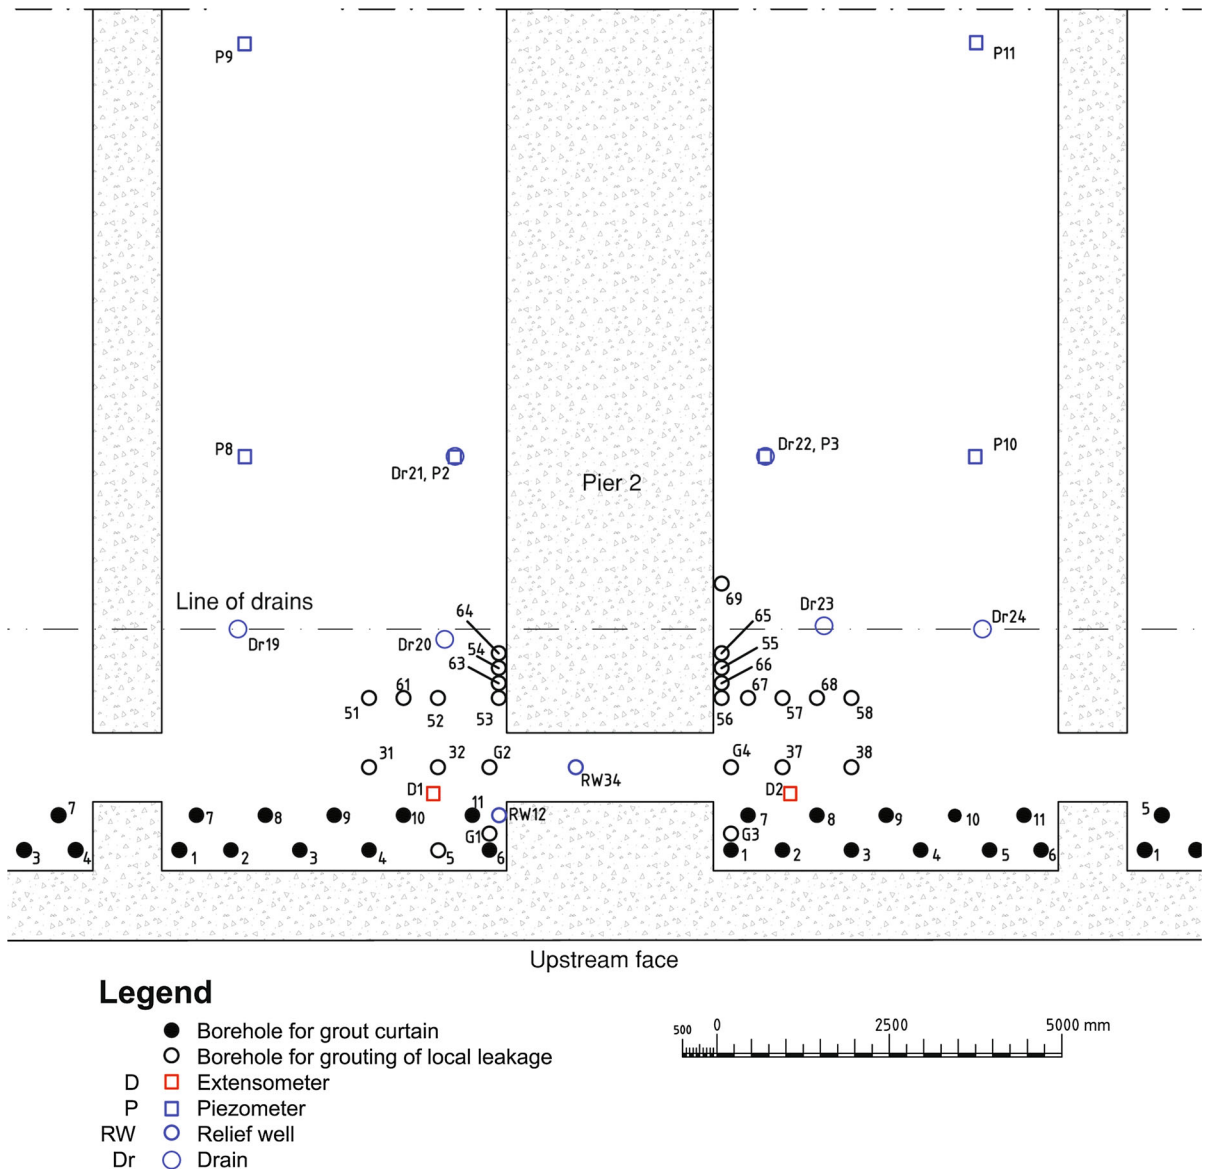
On 15 November 2011, a dramatic event caused serious problems. While drilling hole 1 and 2 in the first row of boreholes for the remedial grouting (to the left of and under pier 2 in Fig. 5), the infill of a fracture, ~200 kg of sand, was unexpectedly washed out from these holes. Later, while drilling hole 5 in the same row, the flow rate emerging from the new boreholes increased from 0.5 to 4.7 L/s. This event was registered an immediate drop in uplift pressure at piezometer P2, as the leakage improved the drainage capacity (Fig. 6). The flow was large enough to completely flood a temporarily installed weir. The fracture aperture was estimated to be 1–10 cm

**Fig. 5** Plan view of the boreholes used to seal the leakage under pier 2 (by RW34). Two relief wells and a surrounding horseshoe-shaped grout curtain (*unfilled black circles*) were

required to reduce the flow so that the area enclosed by the curtain could be grouted to seal the leakage

The main improvement made in the new methodology was the drilling of two relief wells (RW12 and RW34 in Fig. 5) to reduce the uplift pressure and seepage flow. This would enable the grouting of a horseshoe-shaped curtain (boreholes 31, 32, 37, 38, and 51–58 in Figs. 5, 7) beside and downstream of the relief wells to enclose the leaking area. Thereafter, the two relief wells (RW12 and RW34) could be sealed. The enclosed area could then be grouted, as the new horseshoe-shaped curtain would serve as a barrier for the flow.

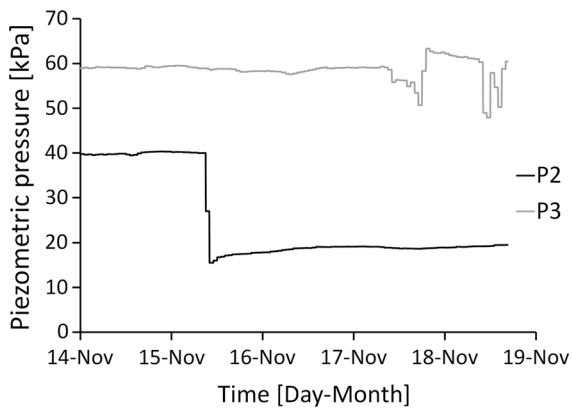
**Fig. 6** Measured piezometric water pressure in piezometers P2 and P3 (locations shown in Fig. 5) around the time of the washout on November 15, 2011

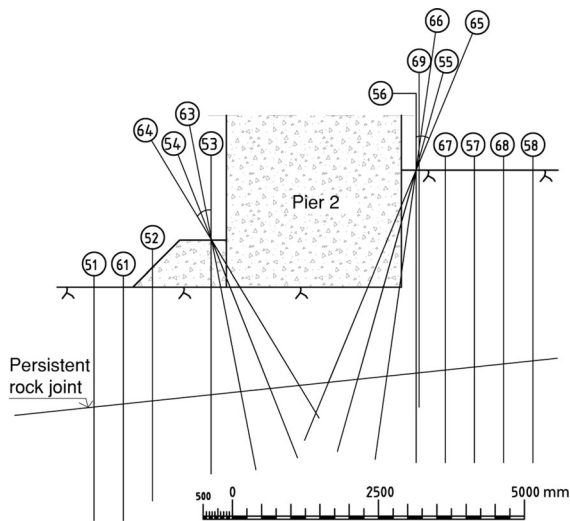
**Fig. 7** Cross section along the line of drains in Fig. 5. Inclined boreholes were used under the pier to seal the horseshoe-shaped grout curtain

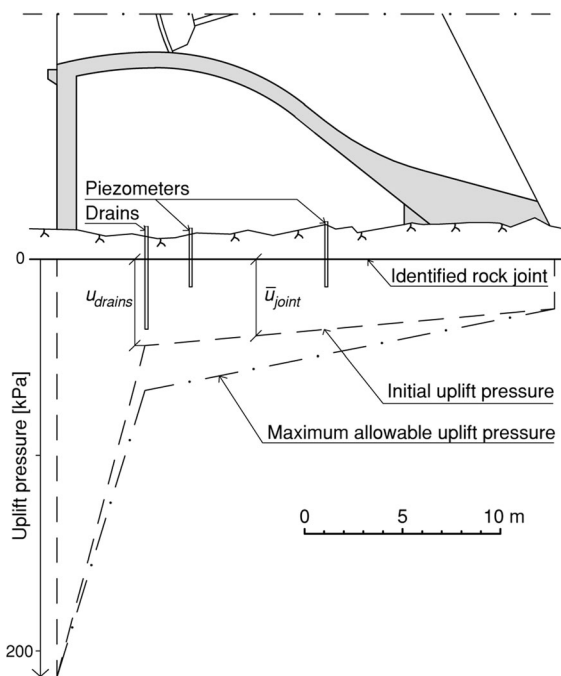
Limits of acceptable behaviour (alarm thresholds) that were linked to the control parameters were established. The maximum average piezometric water pressure allowable in the rock joint downstream of the drains,  $\bar{u}_{joint,lim}$ , was set to 56 kPa (Fig. 8). This limit corresponded directly to an average piezometer reading,  $\bar{u}_{piez,lim}$ , of 70 kPa (the piezometers were positioned below the rock joint).

**Fig. 8** Cross section of spillway monolith 2 showing the initially measured average uplift pressure,  $\bar{u}_{joint}$ , downstream of the drains in comparison to the maximum allowable uplift pressure,  $\bar{u}_{joint,lim}$ . The joint orientation is clear from Fig. 3

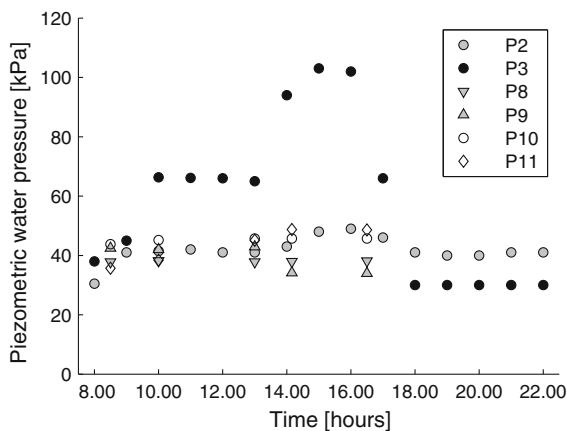
The piezometric pressure increase in P3 indicated that the grout curtain leaked there. However, the leakage was judged small, as the surrounding piezometers did not indicate any pressure increase; therefore, the enclosed area around the relief well was grouted next. This was judged the most critical part of the project in terms of risk for hydraulic jacking owing to the required grout pressure of 250 kPa to overcome the high water pressure. However, the new horseshoe-shaped grout curtain (Fig. 5) was assumed to serve as a hydraulic barrier, thereby limiting the pressurized area.

**Fig. 11** Registered pressure changes in piezometers under the monolith during the test of the grout curtain on May 7, 2012

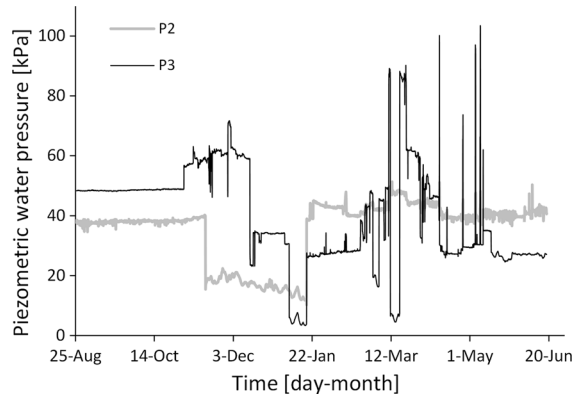
During grouting (round 6 in Table 4), the extensometers did not register any movements (in fact, they did not register any movement at all throughout the whole project). Instead, the piezometric pressure in P3 decreased from 62 to 37 kPa and the other adjacent piezometers registered constant, low pressures. Furthermore, as no leakage could be observed visually on the rock surface, the grout curtain was considered completed. A comparison of the situation before and after the grouting shows that the piezometric pressure at P3 had been reduced significantly from 48 to 27 kPa (Fig. 12).

**Fig. 12** Registered pressure changes in piezometers P2 and P3 throughout the project. Note the pressure drop in P2 caused by the washout on November 15. The spikes from March to May are caused by grouting activities and tests of the hydraulic conductivity. The last activity took place on May 9
