Assessment of Coating Performance on Waterwalls and Superheaters in a Pulverised Fuel-Fired Power Station

Nigel Simms¹ · Maud Seraffon² · Andy Pidcock¹ · Colin Davis²

Abstract Protective coatings offer one route to increase the lives of heat exchangers in pulverised fuel power plants. A range of candidate coatings have been exposed on the waterwall and superheaters of a 500 MWe UK power station unit for periods of up to ~ 4 years (24,880 operating hours), during which time this unit was fired on a mixture of UK and world-traded coals. Both nickel- and iron-based candidate coatings were included, applied using high velocity oxy-fuel or arc-wire process; a selection of these also had a surface sealant applied to investigate its effectiveness. Dimensional metrology was used to evaluate coating performances, with SEM/EDX examinations used to investigate the various degradation mechanisms found. Both the waterwall and superheater environments generated their characteristic corrosion damage morphologies which depended on the radial positions around the tube. Coating performances were found to depend on the initial coating quality rather than composition, and were not improved by the us

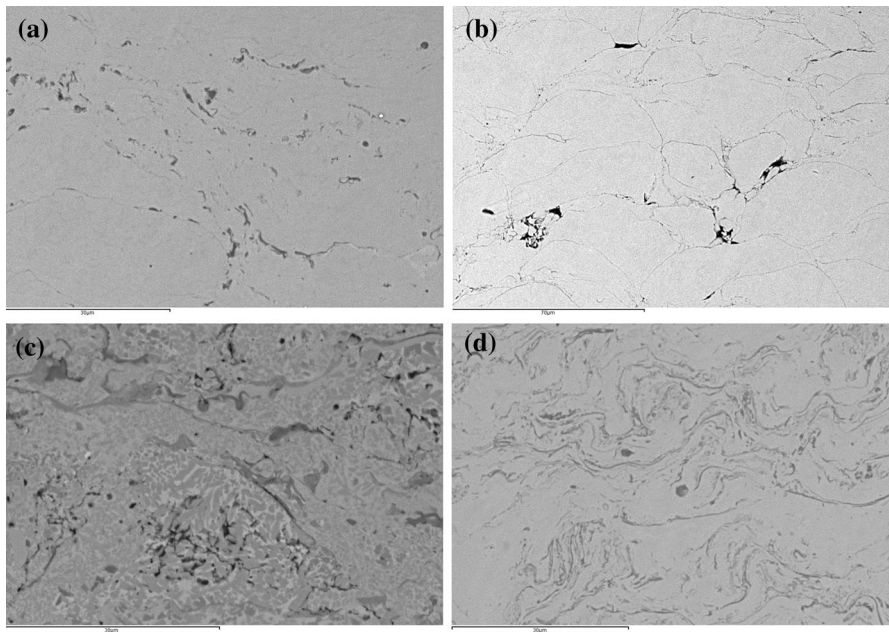
Fig. 4 Representative microstructures of different as-sprayed HVOF coatings. The images have been selected to illustrate the variations in coating microstructures observed. **a** Ni–50Cr, **b** FeCrAl, **c** Cr₃C₂–NiCr matrix, **d** alloy 625 NiCrMo(Nb+Ta)

1% voidage previously considered necessary to ensure good coating performance. One exception to this was for the alloy 625 coating which was observed to contain a unusually high oxide content (Fig. 4d). The Cr₃C₂-filled NiCr matrix coating contained a considerable amount of the hard, erosion-resistant carbide material as expected (Fig. 4c), although this prevented the assessment of its oxide and porosity content.

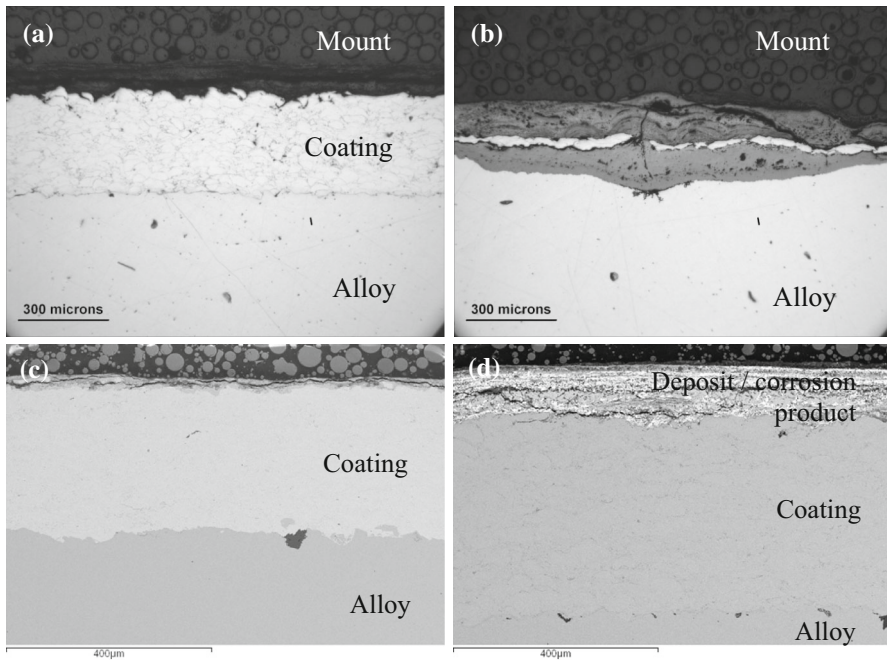
Fig. 7 Examples of variation in appearance of coated waterwall tubes after exposure (more detailed coating thickness information shown in Fig. 5). **a** ‘Crown’ of HVOF FeCrAl waterwall tube, **b** right side of HVOF FeCrAl waterwall tube, **c** ‘crown’ of HVOF alloy 276 waterwall tube, **d** ‘crown’ of Ni-50Cr waterwall tube

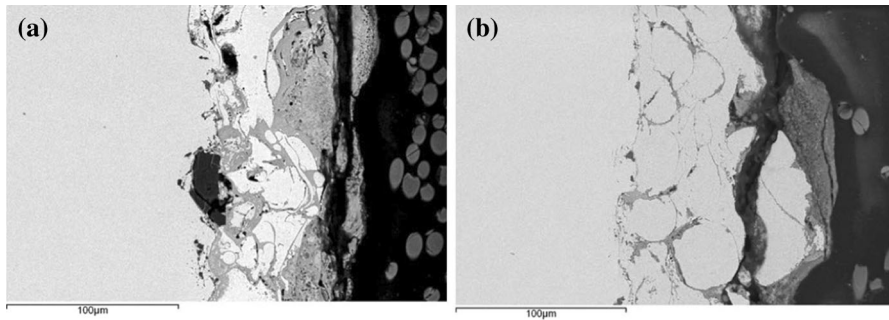
Similar examinations were carried out for the coatings exposed on the superheater tubing. SEM/EDX examinations of the cross-sections through the coatings confirmed the coating compositions. These examinations also characterised the deposit compositions that had formed on the tube surfaces and that the corrosion damage morphologies (e.g. Fig. 8) were consistent with typical superheater corrosion damage for a coal-fired boiler [7].

Fig. 8 Summary of coating performances on the superheater, **a** arc wire alloy 625 3 o'clock position, **b** HVOF NiCrAlY 3 o'clock position

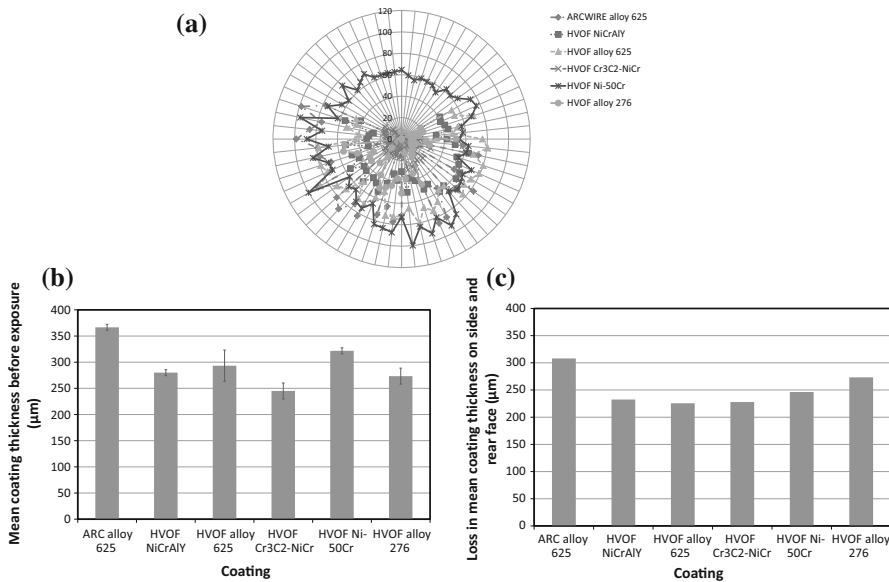
Figure 9a shows the thicknesses of the sealed coatings after their exposure. This shows that only HVOF Ni-50Cr had survived on the upstream surface of the tubes,

Fig. 9 Examples of coating performances on the superheater. **a** Coating thicknesses (µm) as a function of radial position around superheater (upstream tube face at top), **b** mean coating thicknesses before exposure on the superheater, **c** mean loss in coating thicknesses from the sides and downstream faces during exposure on the superheater

but all the coatings were present around the rest of the tube surfaces. Pre-exposure coating measurements were in the range ~ 250 to $350 \mu\text{m}$ (Fig. 9b), with some coatings having initial thicknesses on average $100 \mu\text{m}$ less than others (the bars in this figure show the standard deviations of the initial coating measurements). Figure 9c shows the differences between the average coating thicknesses before exposure for these samples and those measured on the sides/downstream surfaces of the samples after exposure. Given the spread in the measurement datasets, the results for the HVOF coatings, with thickness losses of ~ 220 to $260 \mu\text{m}$, indicate similar levels of behaviour (i.e. ~ 9 to $10 \mu\text{m}$ per 1000 h). However, the arc-wire alloy 625 coating performed worse with an average downstream coating thickness loss of $\sim 300 \mu\text{m}$ (i.e. $\sim 12 \mu\text{m}$ per 1000 h).
