# Fracture of a Paper Manufacturing Machine Felt Guide Roll

Tim A. Jur · R. Dean Harris

Submitted: 31 March 2014 / Published online: 4 July 2014  
© ASM International 2014

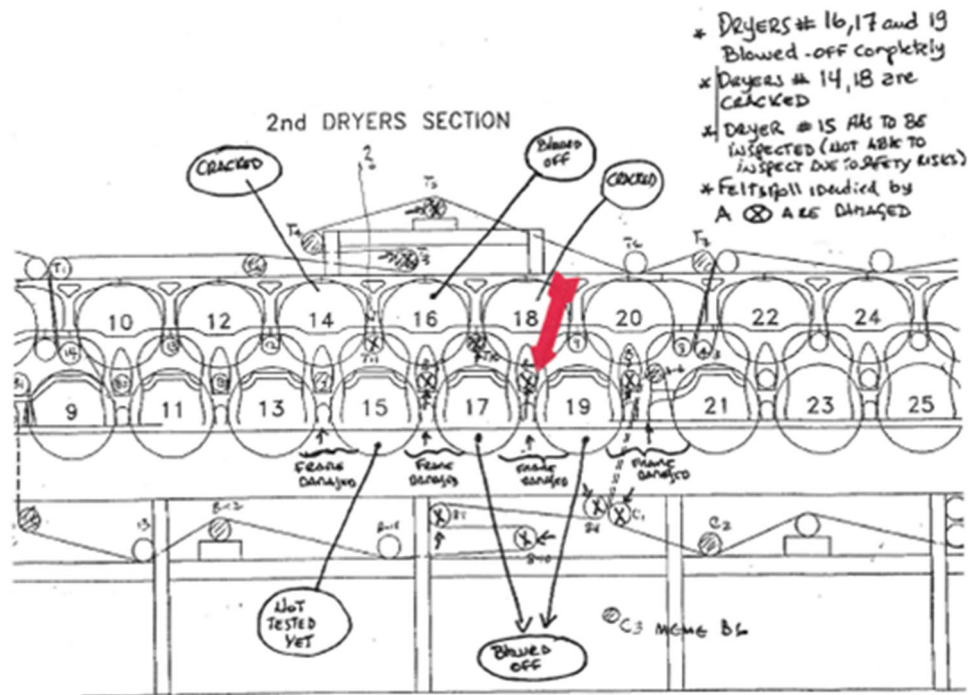
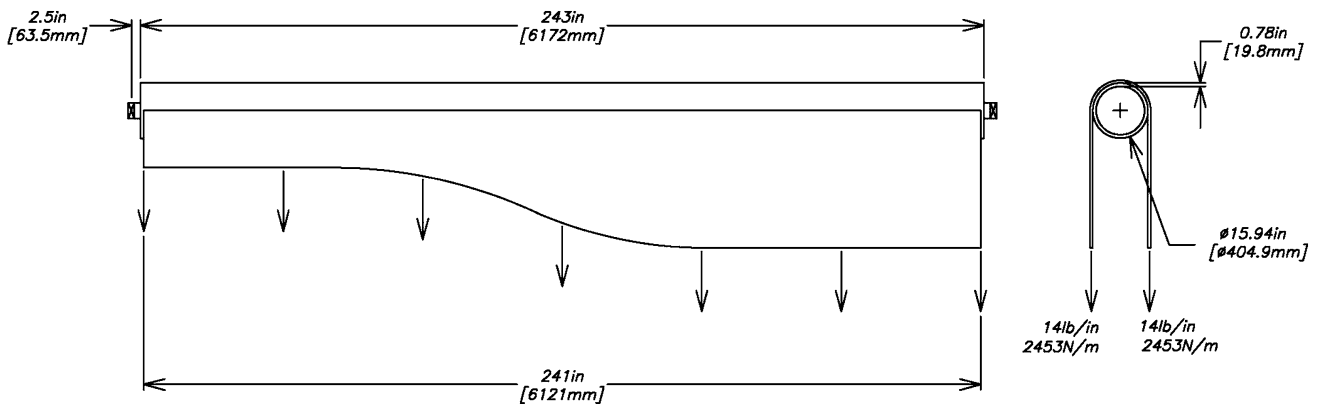
**Fig. 1** Schematic drawing of paper machine dryer section showing notes from actual inspection; large diameter rolls are dryer rolls; small diameter rolls are felt guide rolls

Figure 1 shows the involved paper machine dryer section in schematic form, depicting both dryer rolls and felt guide rolls. Guide rolls serve to hold the felt up against the surfaces of the dryer rolls. It was one of the felt guide rolls

that fractured. The fracture of this roll not only shut down the machine but also damaged the belt, damaged multiple of the dryer rolls, and damaged other felt guide rolls in the vicinity. The frame of the machine was also damaged.

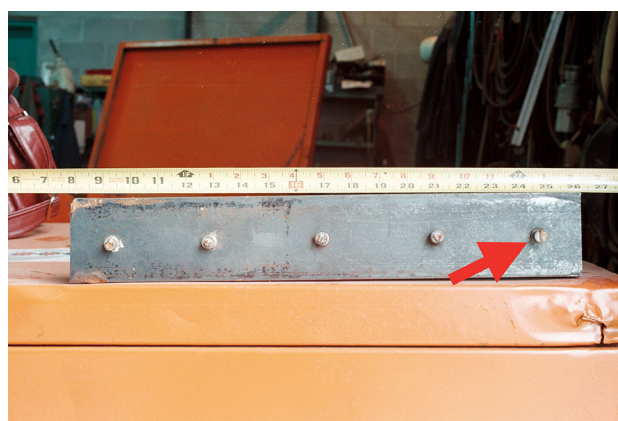
**Fig. 8** Balance weight that had been installed on short end of fractured roll; Arrow points to fractured screw originally located at origin of fracture

weight that had been attached to the roll and that involved the screw insert that was the origin of the fatigue fracture. All five attaching screws were found fractured. The weight was found to have dropped loose and away from its

attached position when the roll was examined after the fracture. The arrow in Fig. 8 points to the fractured screw that had been located at the origin of the roll fracture. A close-up of the fracture surface of this screw is shown in Fig. 9. This screw fractured in fatigue, as did the other four screws that had been holding the balance weight in place.

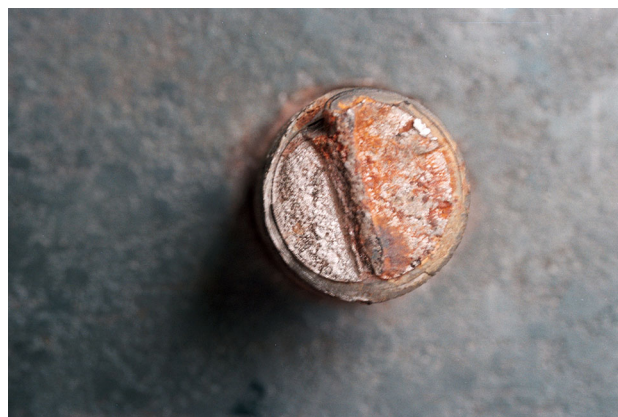
**Fig. 9** Close-up of fracture surface of screw identified by Arrow in Fig. 8

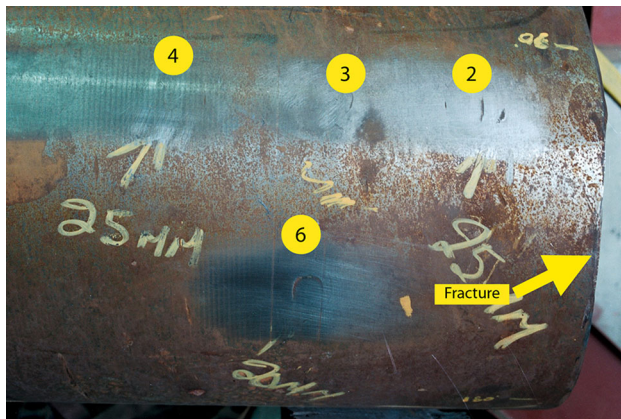
**Fig. 10** Short end of fractured roll with surface of roll cleaned to reveal cracks developed at other locations where screws placed to install balance weights

Figure 10 shows once again the short end of the roll with roll surface now partially cleaned for further observation. The arrow in the figure points to the fractured end and specifically to the point of fracture initiation where the balance weight screw had been located. Locations 2, 3, and 4 are the aligned positions of three of the additional four screws that had been securing the balance block. Location 6 is the place position of yet another screw securing another balance block installed nearby (see Fig. 4 where this additional balancing weight is shown to be still attached). Each of Locations 2, 3, 4, and 6 display developing fatigue cracks. A close-up view of one of these locations is shown in Fig. 11.

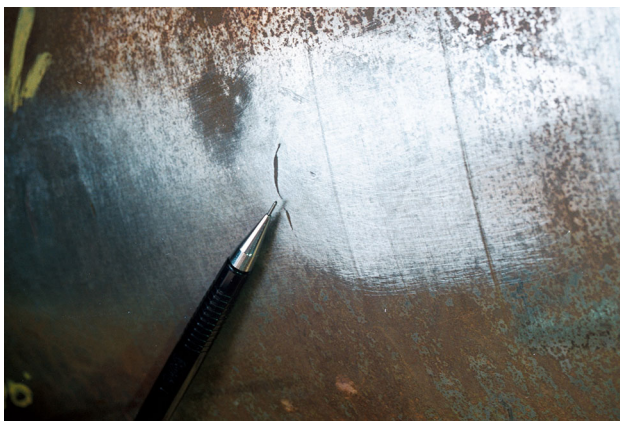
**Fig. 11** Close-up of one of crack locations identified in Fig. 10

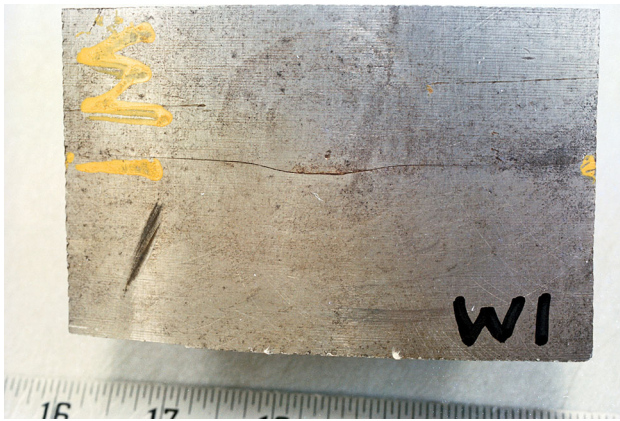
**Fig. 13** Piece of roll, as removed at location of crack in roll at balance weight screw location

Reference here is to Fig. 7 which shows that the fatigue fracture of the roll initiated where a screw was installed to secure a balance weight. To better determine the manner in which this screw had been installed, a crack location away from the fracture was removed from the roll for examination. Figure 13 shows the piece of the roll removed with a

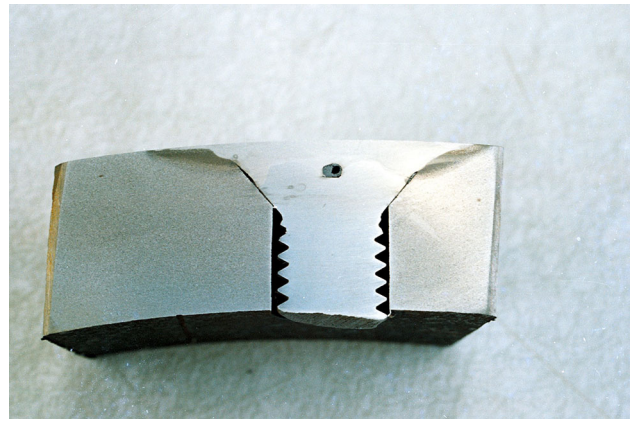
**Fig. 15** Crack location shown in Fig. 14, polished and etched to reveal manner of installation of screw in detail

crack intact. Figure 14 shows the crack opened, displaying the screw in place, the weld overlaying the head of the screw, and a fatigue cracks migrating from the screw head. Figure 15 is the same location shown in Fig. 14 but now polished and etched to further reveal the manner of the assembly.

Returning to Fig. 15 and the consideration of fatigue stress concentration,  $K_f = 14.3$ , conditions contributing to the stress concentration at this location would be the following:

1. A hole drilled through the roll wall.
2. Reduced wall thickness.
3. A sharp-tipped notch where the weld metal overlays the screw head.
4. Localized variation in microstructure at the sharp notch at the screw head (metallurgical notch).
5. The absence of stress relief of the weld.

These considerations, taken together were determined to have resulted in a manufactured condition sufficient to create a stress concentration at the screw inset location which would then have initiated the fatigue fracture of the roll.

Since the method of manufacturing has been in place over an extended time, it is unlikely that the process of drilling through the roll wall and using screws to attach balance weights would be subject to change. There is, however, a significant step that can be added to the manufacturing process that would reduce stress concentration and promote survival of such rolls—stress relieving the plug weld location.

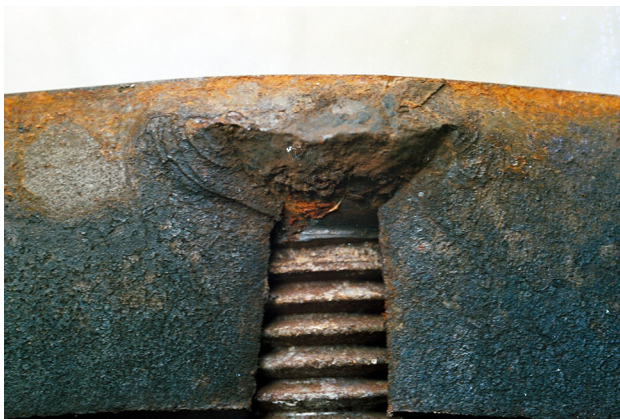
**Fig. 14** Crack shown in Fig. 13 now opened to expose screw as-installed and related fatigue crack surface
