#### *Another complication associated with videolaryngoscopy*

### Failure of an *iv* fluid warming device

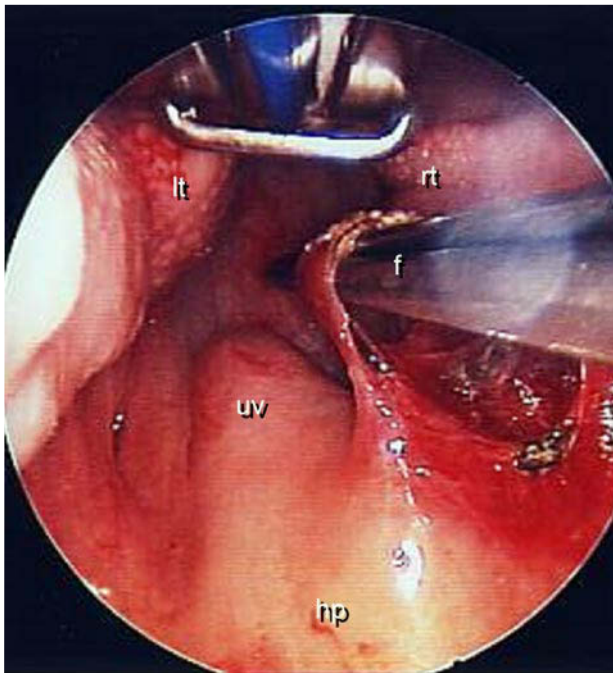
FIGURE Oropharyngeal view under anesthesia with a tonsillectomy gag *in situ*. The original endotracheal tube was removed and the patient's trachea was re-intubated. The forceps reveal a false mucosal tract through the right palatopharyngeal fold.

However, at the end of the case, it was discovered that the ETT had perforated the right palatopharyngeal fold (Figure). An otorhinolaryngologist was consulted and hemostasis was established with electrocautery; there was minimal bleeding. Thereafter, residual neuromuscular block was reversed, the patient was allowed to awaken while breathing 100% oxygen, and her trachea was extubated. The patient experienced a sore throat postoperatively, but had an uneventful recovery. She remained in hospital overnight for observation, and was discharged the following day with no sequelae. At outpatient follow-up six weeks later, good wound healing of the palatopharyngeal laceration was observed, and throat discomfort had fully resolved.

While advantages of GVL have been well demonstrated,<sup>2,3</sup> there is an inherent risk of trauma to the pharyngeal mucosa, as with any airway device. As highlighted by Cooper,<sup>1</sup> a potential blind spot exists at the point where the operator loses sight of the ETT tip at the back of the pharynx, until it resurfaces within the camera's visual field at the laryngeal inlet. The extent of the blind spot is very patient-dependent. We suspect that the pharyngeal mucosa of this patient was injured during ETT passage through this blind spot. This suggests the need for operator vigilance in viewing the tip of the ETT as it advances into the pharynx without causing any trauma. The operator should also examine the ETT as it 'resurfaces' to see if there are any blood, as possible evidence of trauma to the mucosal tissues. Another refinement might be to insert the ETT with the tip facing against the blade of the GVL. Once it is visualized on the monitor, the ETT can then be redirected with stylet *in situ*. This would be different from Cuchillo *et al.*'s technique of turning whilst inserting the ETT.<sup>4</sup> Passing the tube from the lateral side of the patient's mouth should also be avoided, as the palatopharyngeal fold may be taught. However, this technique has been suggested by others for tracheal intubation.<sup>5</sup>

In conclusion, complications for the GVL, while rare, are now being reported. Such complications mandate vigilance on the part of the anesthesiologist while the ETT is advanced, with consideration of preventive maneuvers as described.

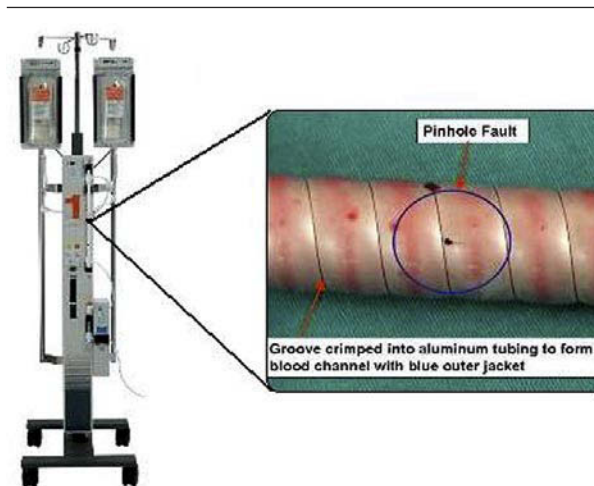
At the end of the operation, a small pool of blood was observed near the base of the Level 1 fluid warmer. Further investigation revealed that fluid in the reservoir of the Level 1 was mixed with blood. We assumed that a communication must have existed between the infused fluid, and the warming fluid within the counter-current aluminum heat exchanger of the warmer. We could not establish if the exchange of fluid occurred unidirectionally (from the *iv* infusate into the warming fluid), or if the patient had been transfused with fluid from the warming reservoir.

We reported the problem to our quality assurance officer, and to the manager of the anesthesia technicians. They involved the Biomedical Engineering Department of the hospital, whose investigators discovered a small hole in the aluminum tube of the counter-current heat exchanger (Figure). It did not appear that this hole was the result of mishandling

FIGURE The pinhole which allowed communication between the infused fluid and the warming fluid. The fault was found in the aluminum tube inside the heat exchanger disposable unit, as shown.

or faulty installation of the heat exchanger and tubing assembly prior to use. The source of the defect remains unresolved, and the Level 1 manufacturer has been advised of the issues.

This case highlights the importance of testing the integrity of the lines of fluid warming devices prior to their use. The testing is simple, as indicated by this excerpt from our departmental policy for this device:<sup>A</sup> "attach the disposable set to the Level 1 Fast Flow Fluid Warmer at steps 1, 2 and 3. The unit may then be turned on before connecting the disposable set to any fluid intended for administration to the patient. The appearance of fluid in the disposable set, within a one-minute period, would indicate failure of the disposable and would require a replacement set with a re-test." The anesthesia technician who set up the room could not recall with certainty that the set had been tested.

A larger issue that this incident raises relates to the safety of counter-current heat exchangers which use fluids as the heat transfer medium. While failures like the one reported are rare, the potential complications from an infection control perspective could be serious. Preoperative inspection and ongoing vigilance when using these devices are warranted. Further, as new technologies emerge which appear to be safer, and equally effective,<sup>2-4</sup> perhaps we could eliminate one more risk from the operating room environment by adopting alternative fluid-warming methods.
