Wenchuan earthquake fault and seismic disaster*

Boming Zhao^{1,*} and Xiwei Xu²

Abstract Major cases of the $M_S8.0$ Wenchuan earthquake are obtained through field investigations of the epicenter and high-intensity areas, and the relationships among earthquake faults, ground motion and earthquake disasters near fault zones are analyzed. Both strong deformation and ground rupture lead to significant damages of the buildings, indicating that it is necessary to keep safe distance away from active faults and to take other necessary measures. There are two reasons for that the buildings near the surface rupture zones have withstood in the strong earthquake, other than their seismic resistance capacities, with the first being the site condition, and the second the reduced effective stress and low rupture velocity. The forms of structural damages are complex in the fault areas, with shear failure and tensile and compressive damages. Those structures in urban areas that have used qualified materials and followed the building codes performed well in the earthquake. Survey results also indicate that structures of flexible materials may show better seismic performance.

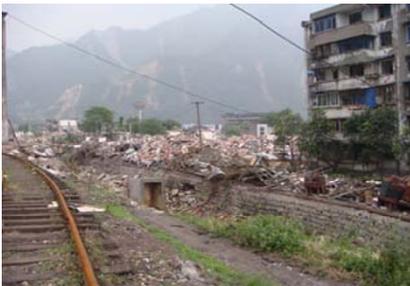
Near-fault region generally refers to the region less than 15 km away from the fault. According to the survey, earthquake damage is very intensive in near-fault region. Through inspecting serious damage areas of the towns such as Yingxiu, Hongkou, Xiaoyudong, Hanwang, Leigu and Pingtong, it is found that destruction of buildings took place extensively in these areas. In the light of post-disaster assessment, the towns of Yingxiu and Leigu are identified as XI degree, others are identified as X degree. Photo 1 shows places of the town of Hanwang where large scale areas are destroyed (on the right side) and a corner of a station. It can be seen that the residential buildings have serious damage and collapse, while station of the frame construction has good seismic performance. Photo 2 shows that serious shear

Photo 1 Damaged residential areas

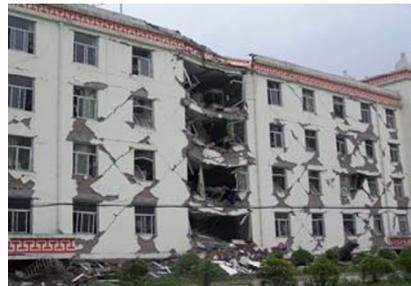
failure takes place in the teaching building of the town of Yingxiu. On the wall shows typical X cracks caused by horizontal force. Photos 3 and 4 show the collapse of the teaching building with prefabricated floors and stairs of Beichuan middle school and Pingtong middle school, respectively. Owing to lacking of the connected measures, the masonry construction leads to the whole damage. The mixed structure of underlying framework is also destroyed at a large scale. The failure of concrete materials and shoddy construction quality are important factors for it (Photos 5 and 6).

Photo 2 Damaged teaching building

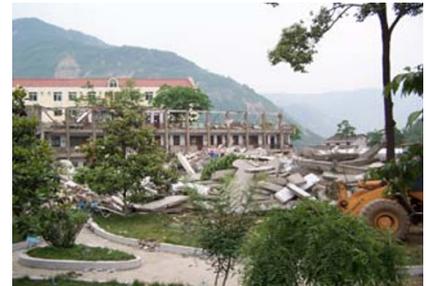
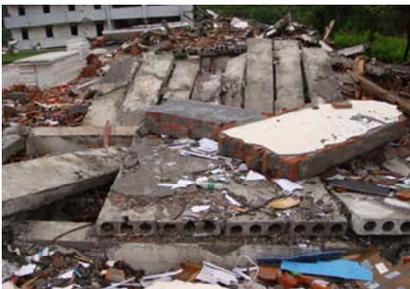
Photo 3 Construction using prefabricated parts

Photo 4 The same as Photo 3

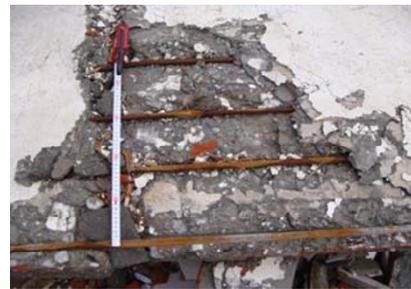
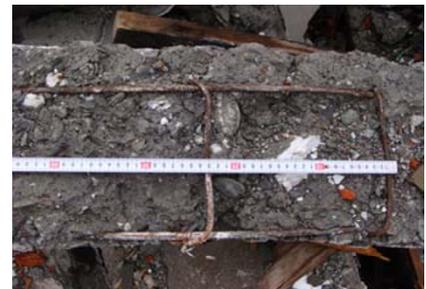
Photo 5 Substandard building materials and construction

Photo 6 The same as Photo 5

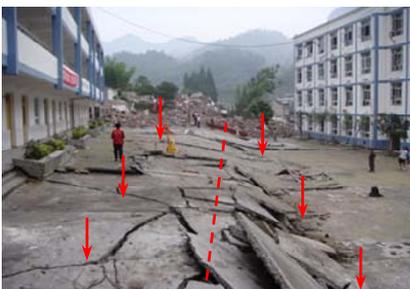
The two teaching buildings of Bailu middle school are separately located in two sides of the rupture zone of Guanxian-Jiangyou, only a few meters away from the rupture zone (Photo 7). According to measurements at the scene, the width of fault deformation belt is about 18–20 m, vertical displacement is more than 2 m, and

Photo 7 School buildings and surface rupture

the shortening distance 1.8 m. The building lying at the right side of Photo 7 is a four-story brick structure, and the main structure is seriously damaged but do not collapse. The building was completed in the early 1990's in accordance with the norms for the design and construction. Obvious reinforced tension appears in the structural columns of the first floor (Photos 9 and 10) and necking damage occurred in that building (Photos 11 and 12). All show that the building is substantially up and down, resulting in failure of the masonry and concrete structure. The building lying at the left side of Photo 7 is a three-story brick structure. The teaching building is not destroyed owing to following the revised norms of the new seismic design in 2001.

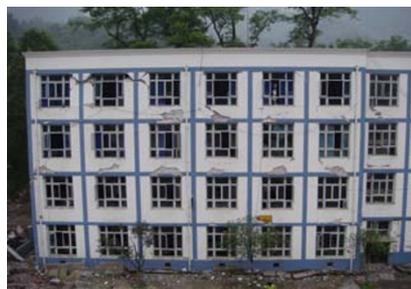
Photo 8 Damaged old teaching building on foot wall

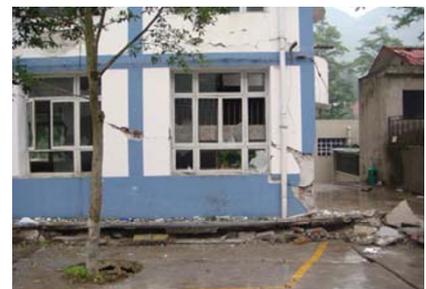
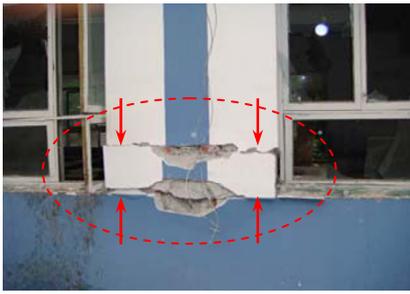
Photo 9 Horizontal cracks on wall

Photo 10 The same as Photo 9

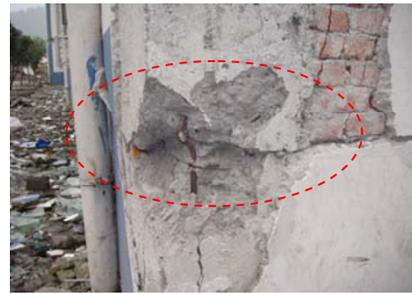
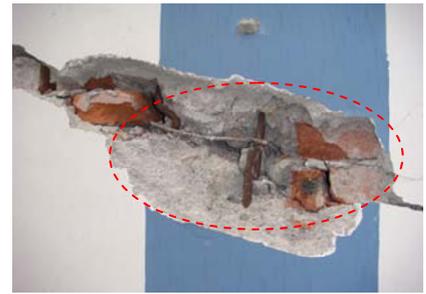
Photo 11 Reinforced reduction efforts

Photo 12 The same as Photo 11

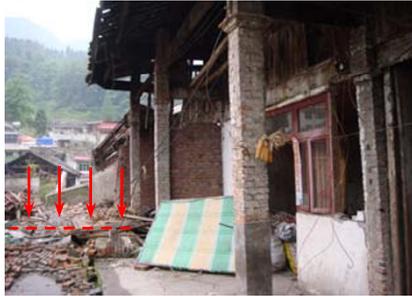
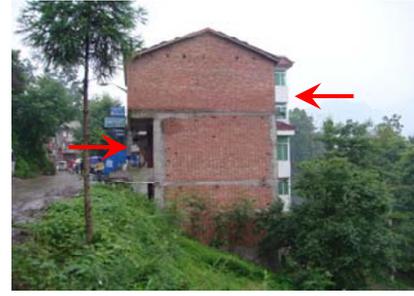
Photo 13 No-collapse old house on hanging wall

Photo 14 No-collapse two multistory building on slope

Investigation suggests that the buildings lying on the fault rupture belt almost completely collapse, while most of the buildings near the fault rupture do not collapse, even the folk houses only a few meters away from the rupture belt have also withstood (Photos 13). Although the physiognomy and geological conditions in the region bring much challenge to the construction site, many buildings constructed on the hill are not broken down or damaged seriously on a large scale. Photos of 13 and 14 are good examples of no-collapsed buildings on hanging wall.

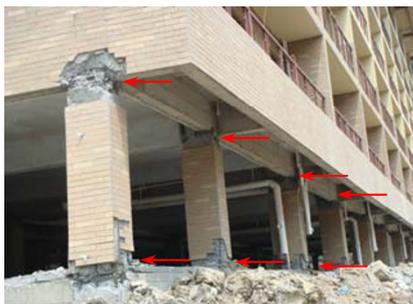
Photo 15 Damaged multistory building

quake-proof and the quality of the building materials. In urban areas, buildings designed in accordance with the seismic design code show better seismic performance, mostly achieving the goal of earthquake-proof. However, there are individual cases. For instance, the use of rigid structure causes brittle damage of concrete structure (Photo 15). Photo 16 shows upper part of masonry structure is apparently damaged compared with that of the steel structure.

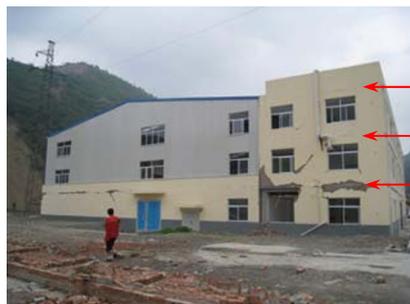
Photo 16 Damaged plant
