Weld Failure Analysis of Air Radiator

Fengjun Lv · Guoru Fu

Abstract The air radiator had been in service for more than 30 years until a notch failure occurred. In this paper, a rare notch failure is completely investigated by means of macroscopic and microscopic observations, microstructural inspection, chemical analysis, and residual stress test. The results show that the notch failure mode of the air radiator is attributed to high-cycle fatigue fracture, due to the welded lapping surfaces near the notch on both sides of the corrugated plate trough not being put onto one plane during the welding process. Therefore, in order to prevent or reduce possible tensile stress, it is recommended that the welded lapping surfaces be put onto one plane before welding.

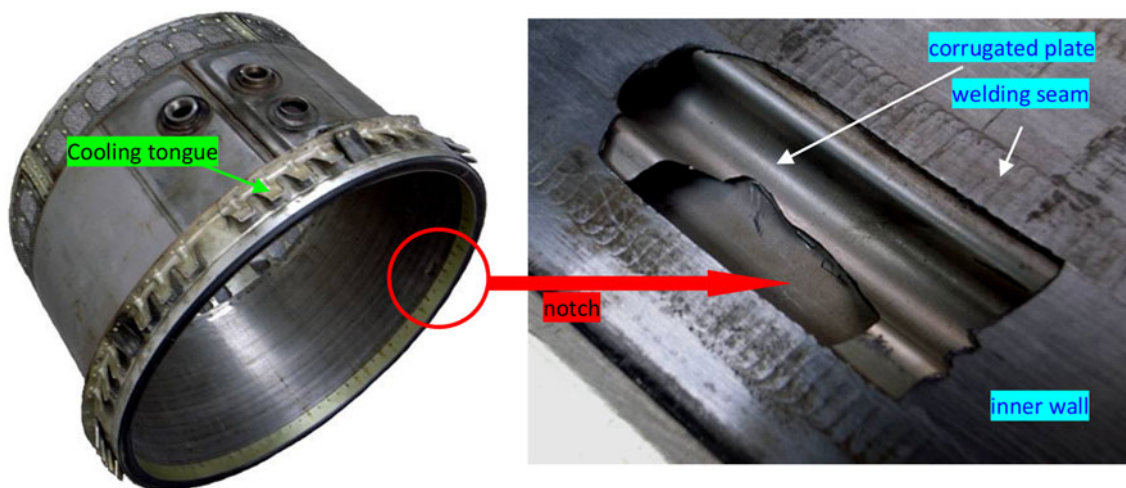
The failed air radiator is a 1st stage cooling accessory for aircraft temperature-controlled air supply, which is a heat exchanger with a thin-walled sandwich structure made of 1Cr18Ni9Ti stainless steel as shown in Fig. 1. Between the inner wall and the outer wall, there is a corrugated plate. The inner wall and the corrugated plate are seam welded through lapping. Thus, two air stream passages among the inner wall, outer wall, and corrugated plate are formed, and the cooling gas is imported via 320 small holes of 2.5 mm diameter located at the inner wall. Based on the layout of

Fig. 1 The failed air radiator

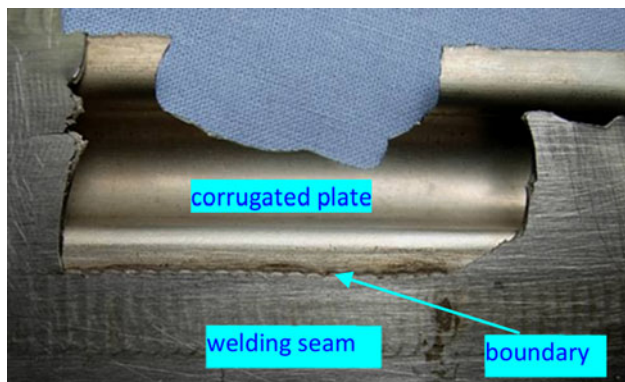
The failed air radiator is shown in Fig. 1, and a rectangular notch left in the inner wall is shown in Fig. 2. The two long sides of the notch are roughly parallel to the circumferential direction of the air radiator, which correspond to the indentation boundary of the seam weld formed in the course of the welding process, and four cracks are also found at the notch borders. Contrasting with the notch in the inner wall, the notch in the corrugated plate is a little bigger; as shown in Fig. 3, its shape is jagged and the position of one side is in accord with one long side of the notch of the inner wall. The indentation boundary along both sides of the corrugated plate is visibly cracked. The surfaces near both notches are intact, and no abnormal welded traces are left [1–3].

Fig. 2 The notch of the inner wall

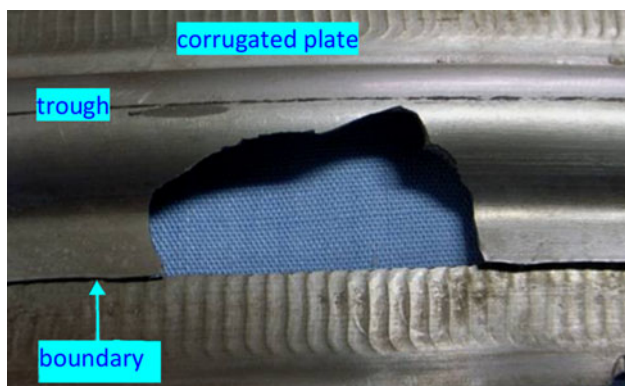
Fig. 3 The notch of the corrugated plate

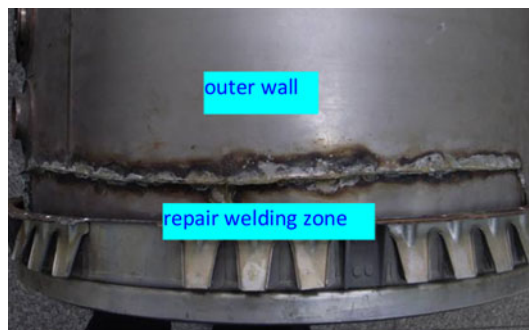
Viewed from the outer wall of the air radiator, there is a rectangular repair welding zone at the bottom of the cooling tongue (Fig. 4), of the size 55 mm × 580 mm. The inner wall corresponding to the back of rewelding zone is slightly humped. In order to find the cause of deformation, the air radiator is disassembled and another rewelding zone along the direction of the corrugated plate trough with a length of 254 mm is also found. It corresponds to the humped zone (Fig. 5), which show that the humped deformation is formed because of repair welding.

Fig. 4 The repair welding zone of the outer wall

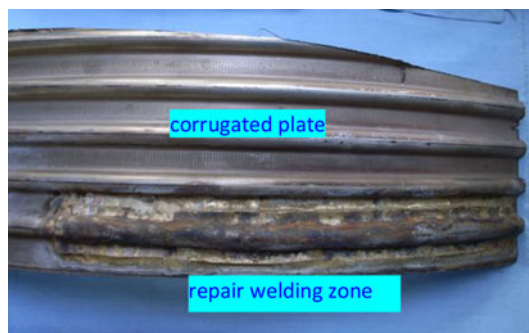
Fig. 5 The repair welding zone of the corrugated plate

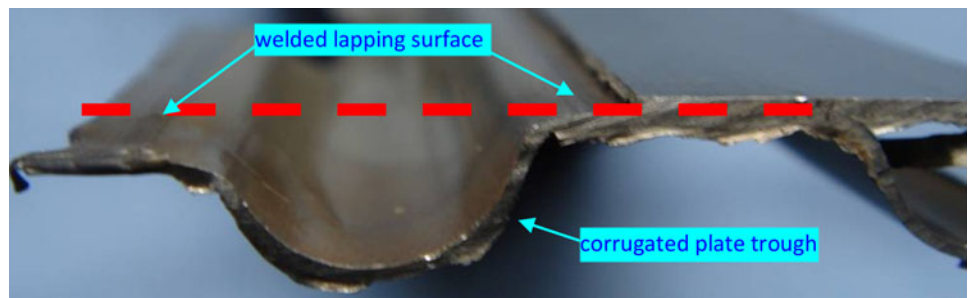
Fig. 7 The notch fractures of the inner wall and corrugated plate

same macrocharacteristics as shown in Figs. 7 and 8. Both fractures are flat and perpendicular to the exterior surfaces, with dark black colors and non-metallic luster. No plastic deformations are found either. On both fractures, the jagged stripes corresponding to the positions of the welding corrugations are parallel to each other and uniformly spaced, with a spacing of about 1.5 mm.

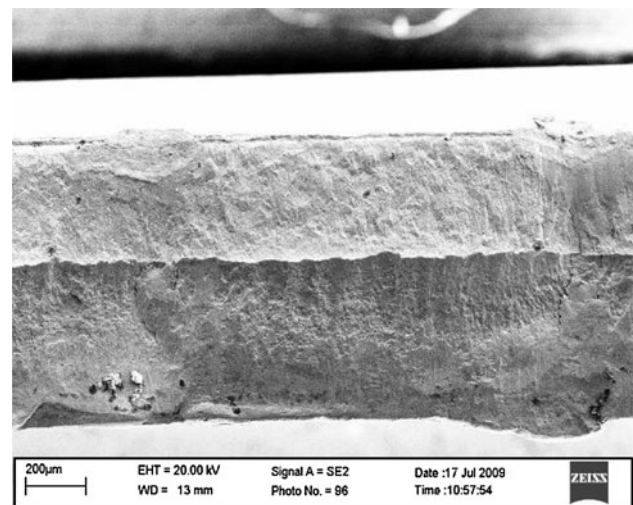
The fractures of the inner wall and the corrugated plate along the weld indentation boundary have obvious fatigue characteristics. Between each welding corrugation, there is a linear fatigue origin, and the fatigue crack starts at the welded interface between the inner wall and the corrugated plate as shown in Figs. 9 and 10. No cracks and defects are found in the fatigue origin zone as shown in Fig. 11. In the fatigue propagation zone, the radical lines and fatigue steps

Fig. 10 The characteristics of fatigue origin

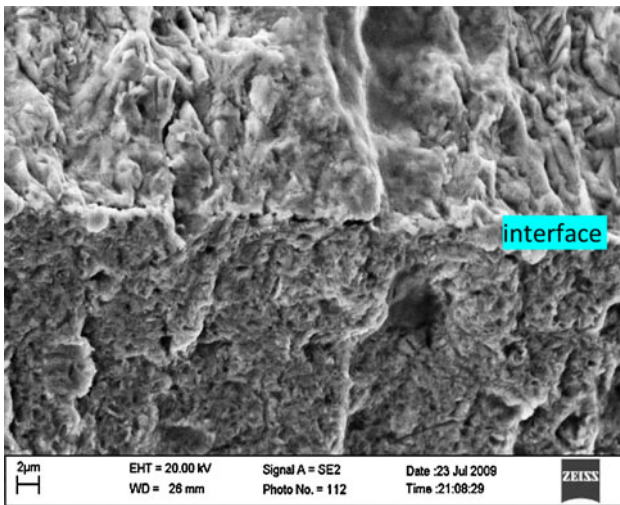
Fig. 11 The welded interface

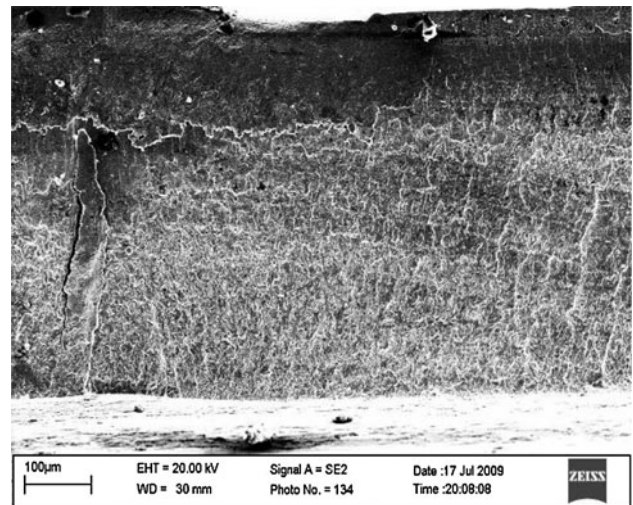
are particularly evident, and the fatigue striations are dense as shown in Figs. 12, 13, 14, and 15. In the later fatigue propagation zone, the fracture is badly damaged.

Fig. 14 The fatigue beaches of the corrugated plate

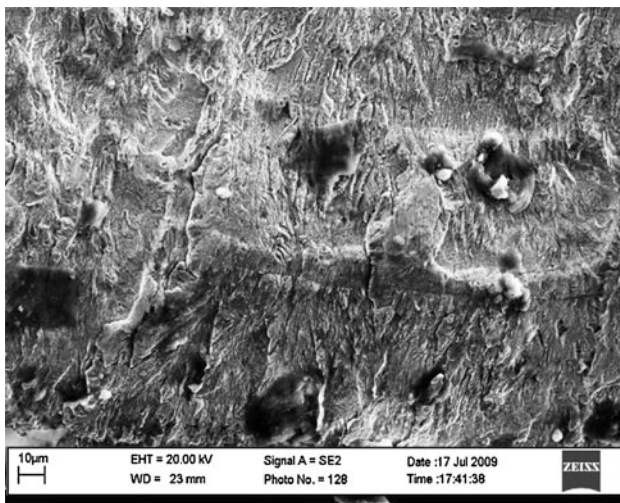
Fig. 12 The fatigue beaches of the inner wall

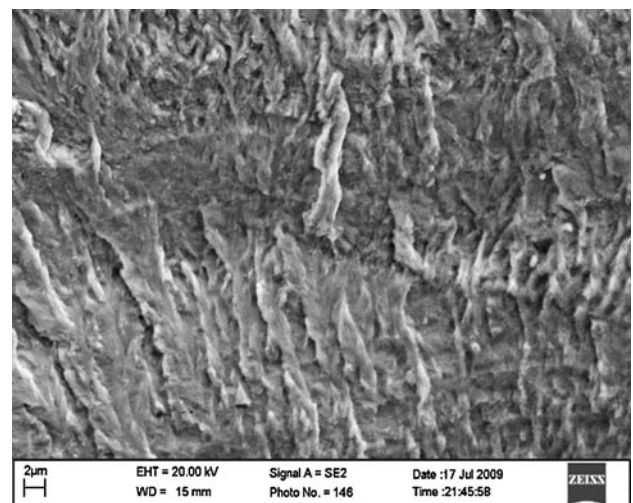
Fig. 15 The fatigue striations of the corrugated plate

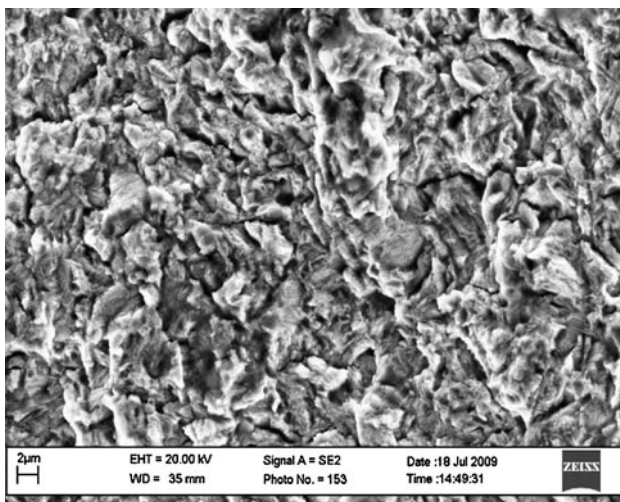
Fig. 13 The fatigue striations of the inner wall

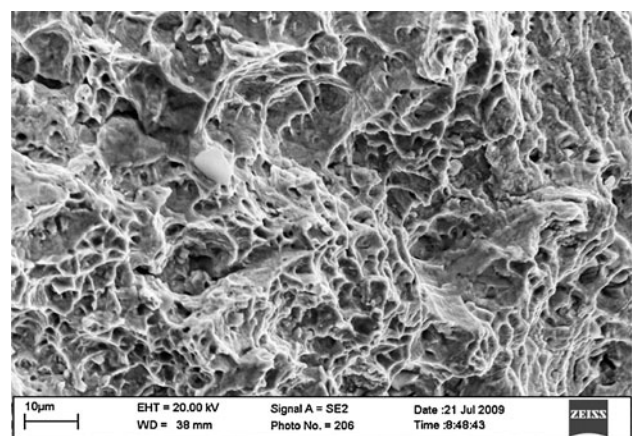
The other two-side fractures of the inner wall have been scraped to different degrees, and the dimple characteristics can be seen at the local non-scraped areas as shown in Fig. 16. The fracture near the corrugated plate trough has two

Fig. 16 The dimple characteristics of the other two-side fractures of the inner wall

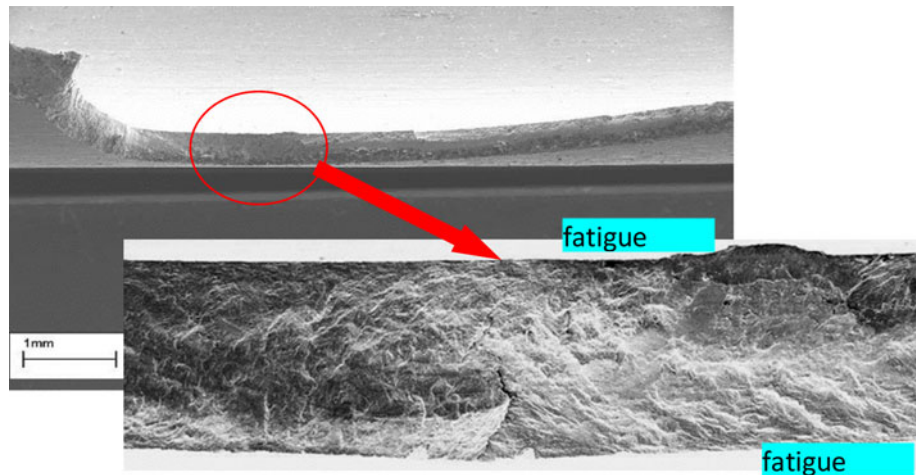
Fig. 17 The fatigue characters of fracture near the corrugated plate trough

fatigue origins that are distributed at the two-side surfaces as shown in Fig. 17. The typical fatigue characteristics, such as radical lines and fatigue steps, can be seen clearly, but no corrosion, defects, and foreign object damage are found in the fatigue origin zone. The result indicates that its failure mode is due to bilateral bending fatigue. The remaining fractures are attributed to the fast fracture region, and local dimple characteristics can be seen.

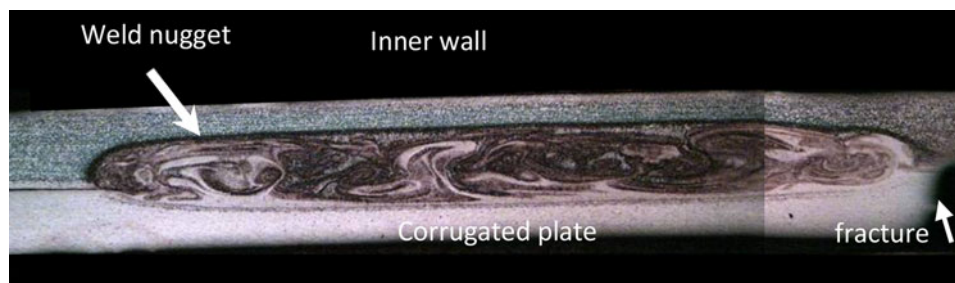
Three samples are cut from the notch, near and apart from the notch, and they are designated as sample 1, sample 2, and sample 3. The measured results are listed in Table 1. In the three places, the sizes of the weld nugget width and height are almost the same, and the welding metallurgical structure is normal, all of which meet the technical requirements as seen in Figs. 18 and 19. No porosities, shrinkage cavities, and welding spatters are found in the welding nugget zones. The fatigue origin is not in the heat-affected zone, so the weld process qualities are specifically excluded to cause the notch failure.

Fig. 18 The welding seam section

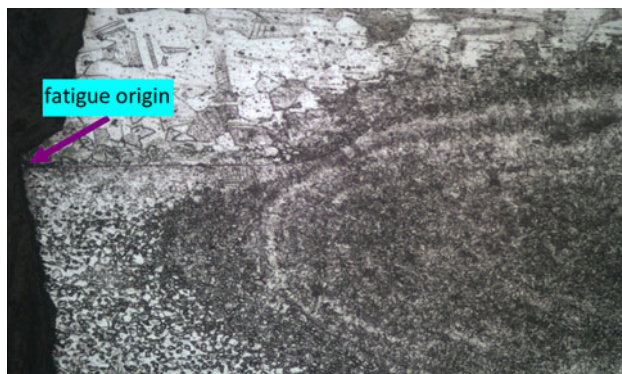
Fig. 19 The microstructure of the welding seam

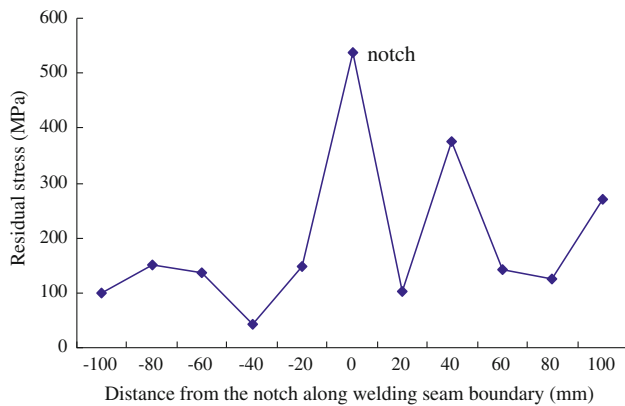
Ten points at the welding seam boundary are chosen to measure the welded residual stress by the x-ray diffraction method using the parameters of Φ2 facula and Fe (2 2 0) crystal face; they are distributed on both sides of the notch along the welding seam, with an interval of 20 mm every two adjoining points, and the results are shown in Fig. 20. It can be seen that the tensile stress exists at the welding boundary, and it is visibly different. Near the notch of the inner wall, the tensile stress nearly reaches up to 538 MPa, which greatly decreases the fatigue resistance of the inner wall and the corrugated plate.

The fractures of the notches have fatigue characteristics, and all fatigue origins are initiated from the welded interface between the inner wall and the corrugated plate. Between the two welded lapping surfaces, there is a gap. Therefore, a stress concentration is formed and the tensile stress easily exists at the seam-welding boundary during the welding process. On the other hand, the welded lapping surfaces on both sides of the corrugated plate trough are not in one plane near the notches of the inner wall and the corrugated plate, while the one-side welded lapping surface is obviously inclined. All these validate that the tensile stress is present at the seam-welding boundary before the fatigue cracks are formed. Besides, the tensile stress is also confirmed to be present by means of the x-ray diffraction method. To sum up, the present tensile stress at the seam-welding boundary is the main reason for the notch failure, and it is formed because the welded lapping surfaces on both sides of the corrugated plate trough are not put onto one plane during the welding process. Besides this, no other unusual lines of evidence are found to elucidate the notch failure.

Fig. 20 The variation curve of residual stress at the welding seam boundary

- (2) The tensile stress at the seam-welding boundary is the main reason for the notch failure, and it is formed because the welded lapping surfaces on both sides of the corrugated plate trough near the notches are not on one plane during the welding process.
- (3) The notch failure of the air radiator is not related to its normal fatigue lifetime, and a suggestion is offered that the welded lapping surfaces should be put onto one plane before the welding process of the air radiator.
