Analysis of structural integrity of a non-completed 28 year-old building in the city of Patos de Minas (MG)

Received: 30 June 2016 / Accepted: 4 November 2016 / Published online: 18 November 2016
© Springer International Publishing Switzerland 2016

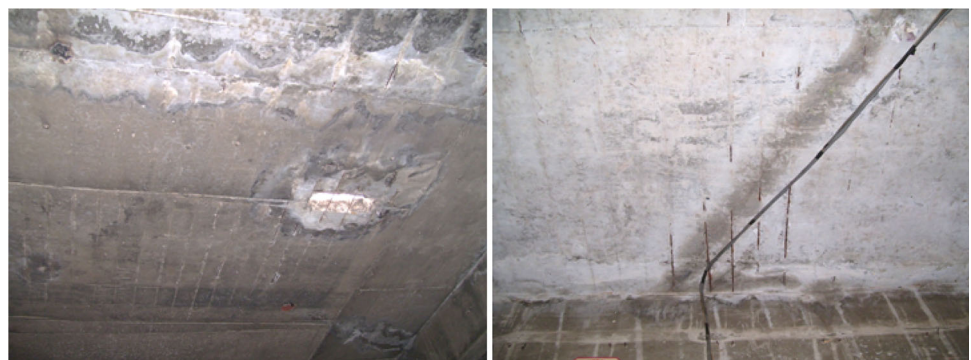
Fig. 4 Analyzed slabs

Initially, it was seen that the slabs of the structure, in their majority, presented a common problem in the execution of structures of reinforced concrete: lack of spacers to guarantee the minimum coating of the rebars. In this case, the distribution rebars had bare spots or insufficient coating in many parts. Another point that should be pointed out is the action of leaching and humidity in these elements. There is formation of spots in the material, as well as the formation of stalactites and efflorescence, resulting from the transportation of products for concrete hydration. Both cases can be verified in Fig. 4.

Due to insufficient cover, it can be seen that the corrosion of the rebar affected the material in a more aggressive way, promoting the peeling of the concrete surrounding the rebars. It can also be seen that the cement laitance, in various structural elements, flowed while the structure was

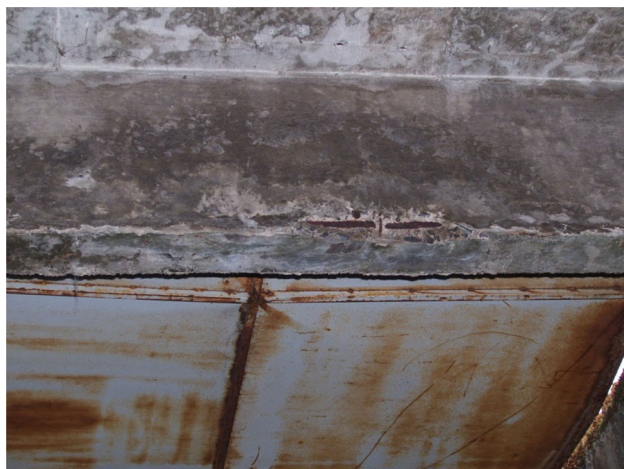
The beams, in general, present fissure and peeling on the coating layer, as it can be seen in Fig. 5.

Despite the rebars being exposed in many points, yet, the beams haven't come to the point of deterioration to which the columns and diaphragm walls have. The corrosion of the rebars affected the beams, at first, not allowing the formation of corrosive products regarding the other elements, to the point of generating break of the concrete coating. It is possible to see that the layer of concrete protecting the rebars suffered the action of carbonation, losing its mechanical resistance, and due to the strain of the structure, over time, there was peeling of the material.

Fig. 5 Rebar exposes on the beam

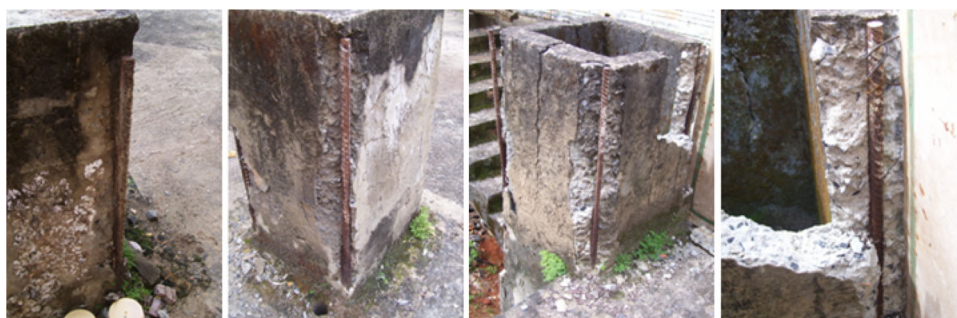
Initially, the ground floor columns were analyzed. As it can be seen in the pictures of Fig. 6, the concrete was porous and fragile. We can notice over the photographic record that there was formation of calcium composites on the

Fig. 6 Exposed rebars on ground floor

surface of the columns (caused by leaching of the hydration products). There is also the biologic attack to the start rebars of the ground floor. Another pathological manifestation that spread over the construction elements was the corrosion of the rebars. The degree of deterioration of these elements is at an advanced stage, since the useful part of the bars was compromised.

In other points, it is visible that the corrosion of the rebars reached the point where they got bent, due to the great formation of iron oxide at the base of the bars, generating an increase of volume. It is interesting to point out that the bars have 25 mm of diameter, showing strain due to the formation of corrosive products so that a bar of bigger gauge could suffer bending. When oxidation products were formed around the rebars, the concrete suffered exacerbated expansion, causing the break of coating by traction, leaving it even more exposed to weather and aggressive agents, as shown in Fig. 6.

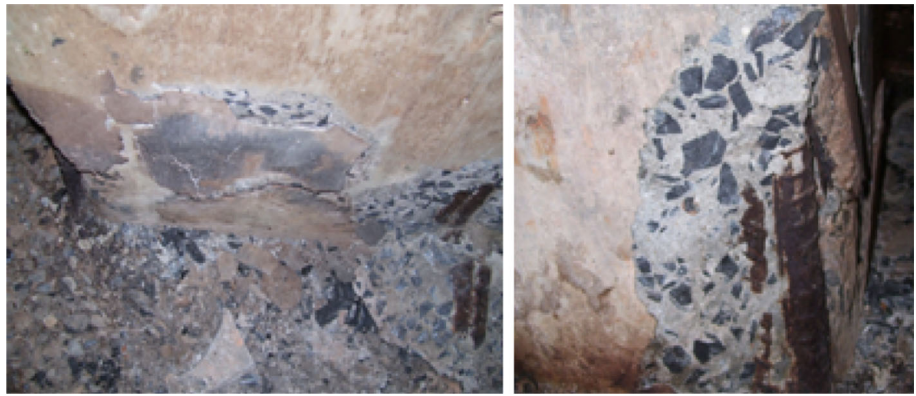
On the underground, it is possible to notice that the biggest part of the pathological manifestations was located at the base of the columns, as it can be seen in Fig. 7; being quite rare the presence of exposed rebars at the mid-high portion of the columns.

Fig. 7 Peeling of the basal cover of the columns and exposed rebar

In the visual inspection, according to Fig. 7, it was verified that the start rebars on ground floor had already deteriorated completely. As for the underground, it was noticed that it is at a lower degree of deterioration than the ground floor, since it is not daily exposed to weather and solar radiation. It was also observed that the corrosion of the rebars destroyed the base of the columns, a very critical region for repairs or therapeutic actions in a visible and severe degree of deterioration.

- (e) It is inferred that the analyzed material has high capillary water absorption. From this, it is observed why the base of the columns had suffered a higher action of corrosion than the rebars, because it received corrosive agents through capillary absorption, since these elements were in contact with humidity.

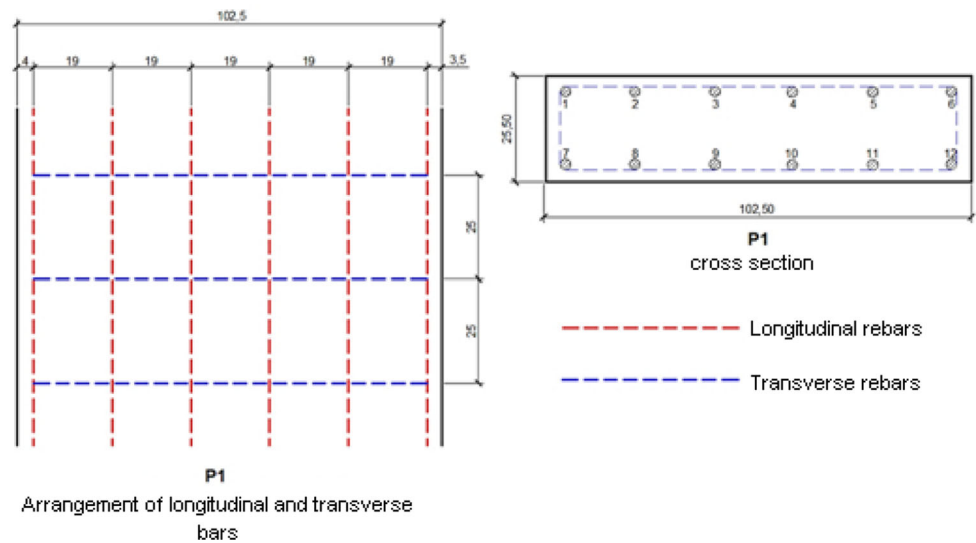
Fig. 8 Detailing of bars of column P1

The systematization of the details was done, as it is possible to observe below, listing the prospected bars and their respective coatings. The coatings of the prospected columns varied from 23 to 49 mm. Figure 8 illustrates the arrangement of column P1.

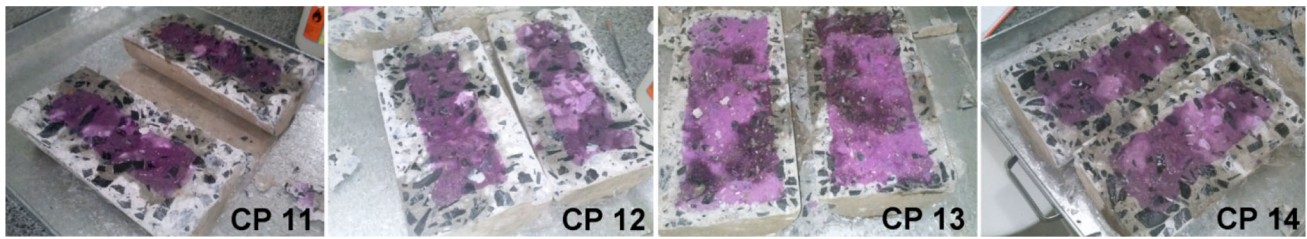
Fig. 10 Specimens exposed to phenolphthalein

Figure 10 illustrates the specimens that were broken by diametral compression and sprayed with a 1% solution of phenolphthalein.

The observed carbonation front was quantified for correlation with the coating of the investigated rebars of the columns. Despite the variety of presentations, it can be inferred from all the collected data that the carbonation front affected the samples in an interval of 14.78 to 41.96 mm of depth.

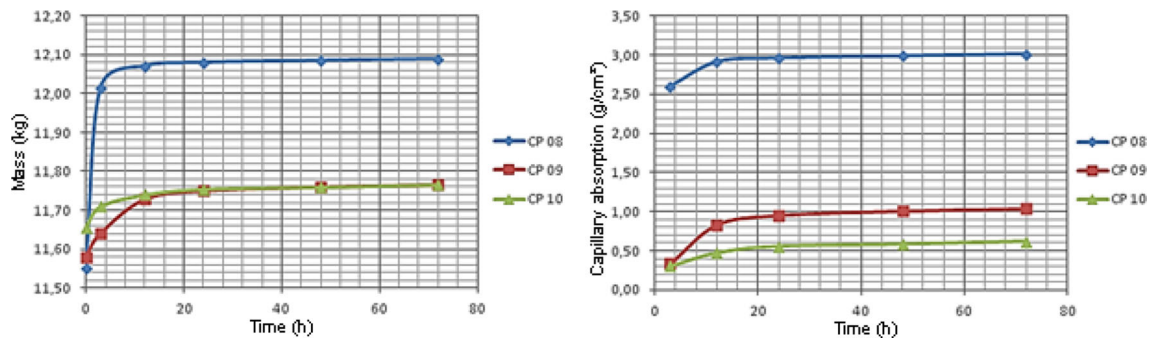
Fig. 11 Evolution of mass × time and capillary water absorption × time

As it can be seen in Fig. 11, there is a great dissonance between CP 8 and the others, showing that it has higher capillary water absorption than the others investigated, besides having higher resistance. It can be noticed that,

- (a) The CP 8 has higher porosity than the others, since it has high capillary water absorption (3.01 g/cm^2) in comparison to CP 10 (0.62 g/cm^2). It also has
