# Evaluation of external FRP-concrete bond in repaired concrete bridge girders and columns

Hemachand Pallempti<sup>1</sup> · Eyosias Beneberu<sup>2</sup> · Nur Yazdani<sup>2</sup>

Received: 19 March 2016 / Accepted: 23 May 2016 / Published online: 21 June 2016  
© Springer International Publishing Switzerland 2016

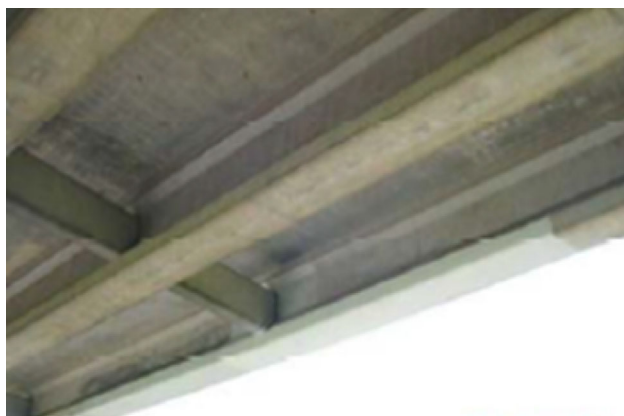
**Fig. 1** CFRP strengthened concrete bridge girder

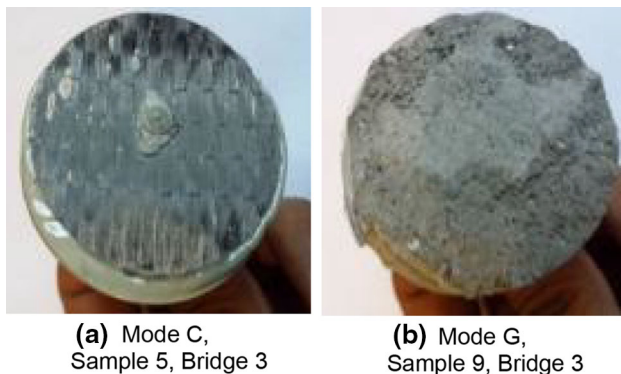
A total of 29 pull-off tests were performed on various FRP strengthened sections on the selected bridges. Three of the samples failed in the core, while scoring the FRP laminate before attaching the dollies, leaving 26 valid samples. The test results are presented in Table 3, and selected failed samples are shown in Fig. 7.

The pre-dominant failure mode observed was the 100 % cohesive concrete failure in Mode G per ASTM, in 15 samples (58 %) out of 26 valid samples, followed by 15 % in mixed non-ASTM Mode M and 11 % in Mode A. It may be noted that Mode A failure at the epoxy glue next to the testing dolly is most likely associated with improper surface preparation of the dolly or improper application and/or curing of the epoxy on the dolly. Therefore, the underlying FRP-epoxy combination could still be sound in a Mode A failure. The combined Modes C, E, F, and M percentage is 31. The possible causes of failures in these modes are: (1) improper initial storage, surface preparation or preparation/application of the epoxy and FRP, and (2) age-related environmental degradation.

**Fig. 7** Selected failed samples

To adequately assess the FRP-concrete-epoxy bond condition, Mode M failure in the top coat should be avoided through the following alternate steps: (1) avoid top coat application altogether (if possible and allowed) to allow proper in situ inspection of FRP strengthened structures; or (2) remove existing top coat with a sandpaper in the area of the pull-off dolly.

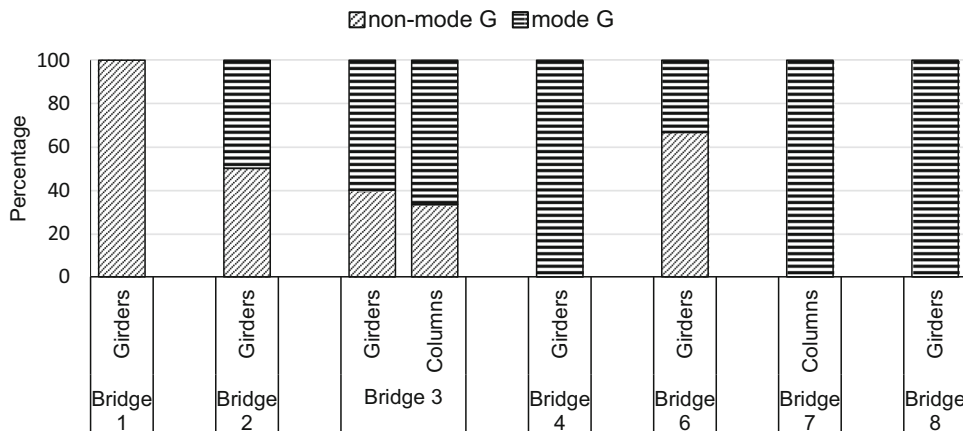
Figure 8 shows that Bridges 3, 4, 7, and 8 had mostly to all Mode G sample failures. Mode G occurred in some samples in Bridges 2 and 6, while only non-Mode G failures were seen in Bridge 1. Interestingly, almost equal percentage of samples failed in Mode G on Bridge 3, showing that the quality of FRP application and/or testing was similar for girders and columns on this bridge.

**Fig. 8** Failure modes for girders and column samples
