Collapsing Structures and Public Mismanagement

Wolfgang Seibel

Collapsing Structures
and Public
Mismanagement

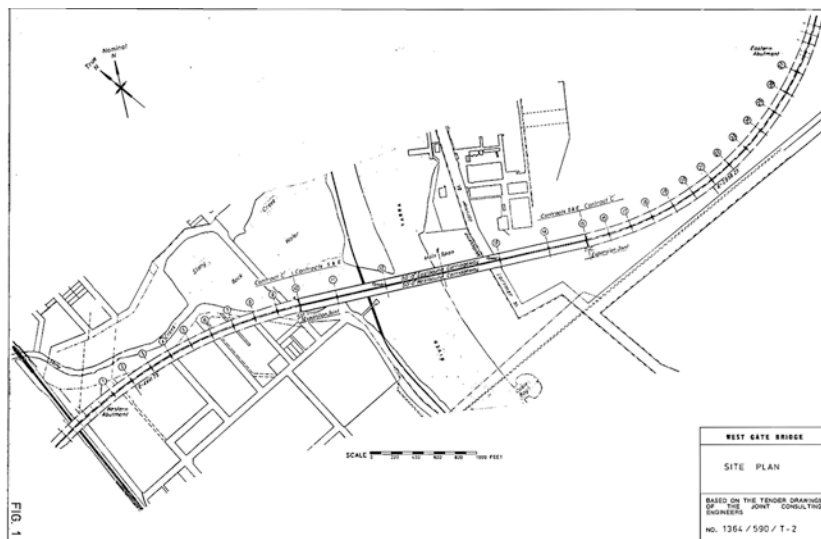
Illustration 2.1 West Gate Bridge, Melbourne, as planned and partly erected before the collapse of 15 October 1970. (Source: Royal Commission, Appendix, p. 123)

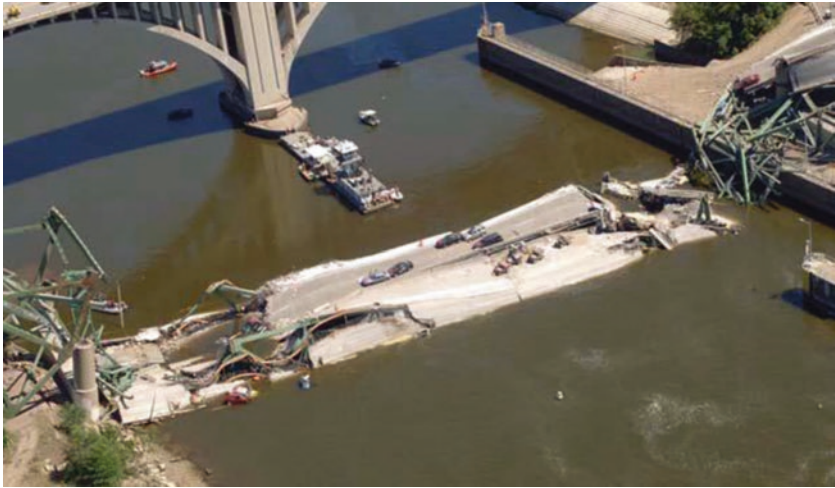
Illustration 3.1 Collapsed I-35W Bridge center section. (Source: NTSB Report, p. 19)

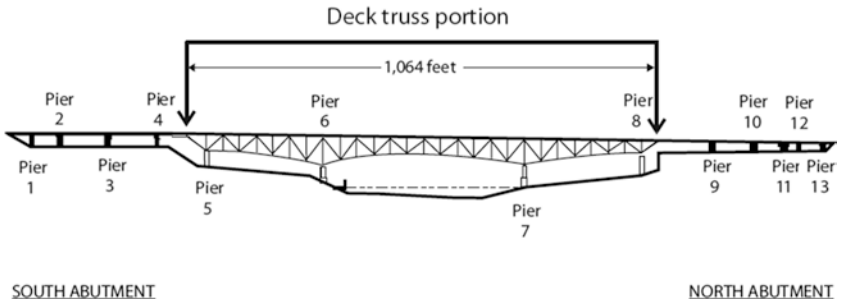
piers carrying fourteen spans. Three of those spans between pier five and pier eight formed the deck truss portion in the middle based on steelwork (Illustration 3.3).

Illustration 3.3 I-35W Bridge, deck truss portion. (Source: NTSB Report, p. 7)

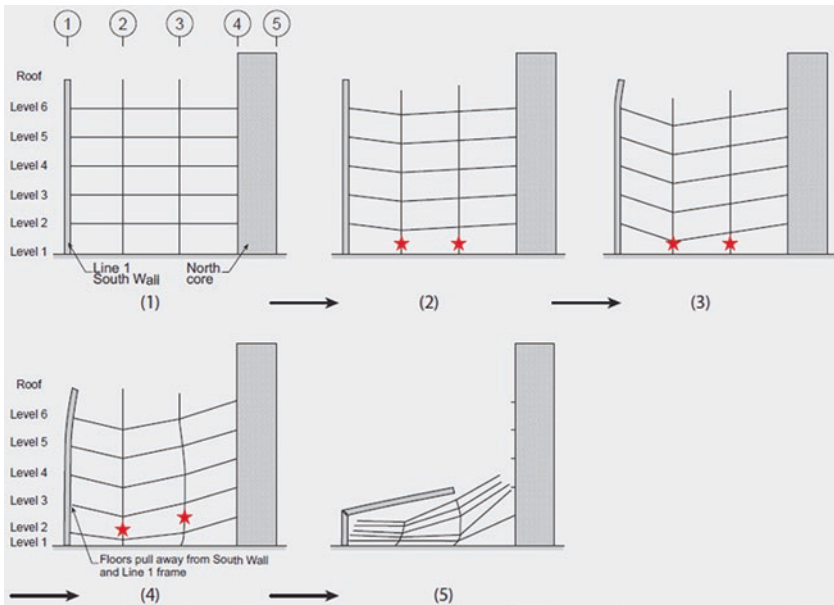
Illustration 4.2 Most likely collapse scenario of the CTV Building with disconnecting floors/diaphragms. (Source: Royal Commission Vol. 6, p. 236 (originally: C. Hyland C. A. Smith, CTV building collapse investigation for Department of Building and Housing: 25 January 2012. Wellington, New Zealand: Department of Building and Housing))
