Landform Geometry for Restoration of Mountain Roads and Landslide Hazard Resilience

Abstract

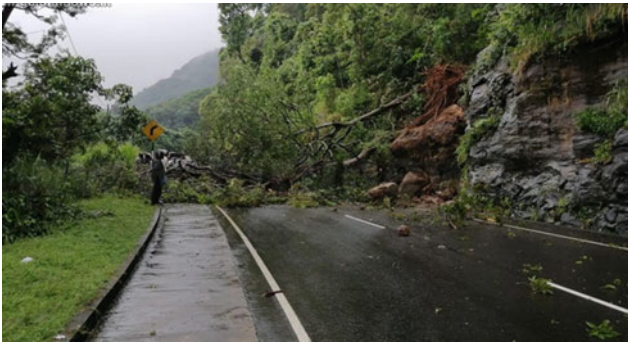
Fig. 2 Traffic disrupted (trees and rock has fallen in to the road) on to the road at 6th bend area of the Kandy-Mahiyangana “18 hairpin road”, 20th January, 2020 (Photo by Hirunews.lk 2020)

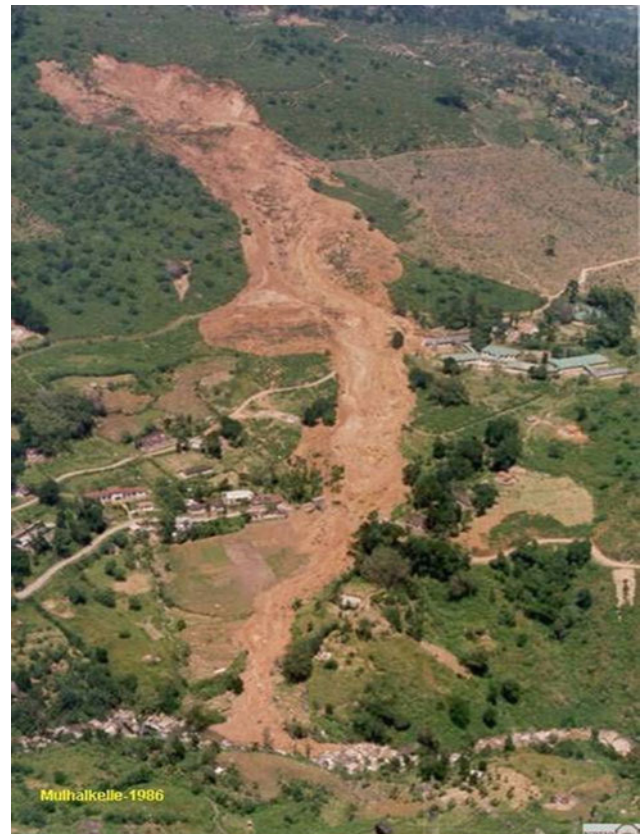
Fig. 3 This photo shows a stretch of a mountain slope destroyed by mudslide in Mulhalkelle, Nuwara Eliya district, 1986, NBRO Report (1988)

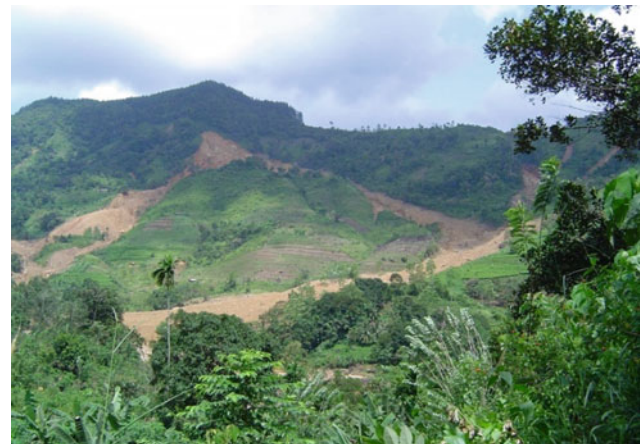
Fig. 4 Gampalakadawala Landslide (6 victims, Kalawana). Outburst floods resulted from mass movements temporarily blocking a “Delgoda Ganga” river at lower elevation, May, 2003

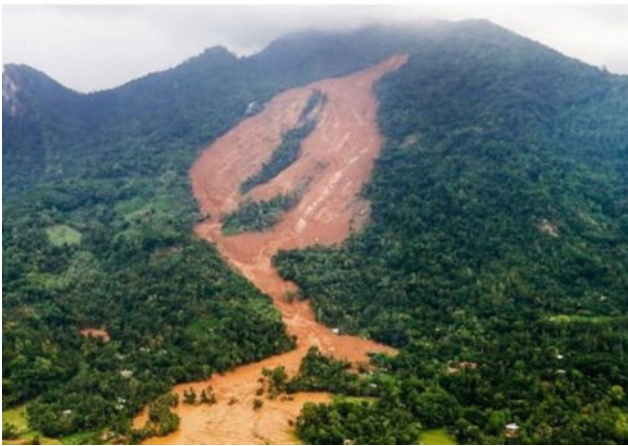
Fig. 5 Aranayake landslide in Sri Lanka is now thought to have killed about 122 people. The landslide was triggered by an exceptional rainfall associated with a slow-moving tropical cyclone, 2016. *Photo by Sri Lanka Red Cross*

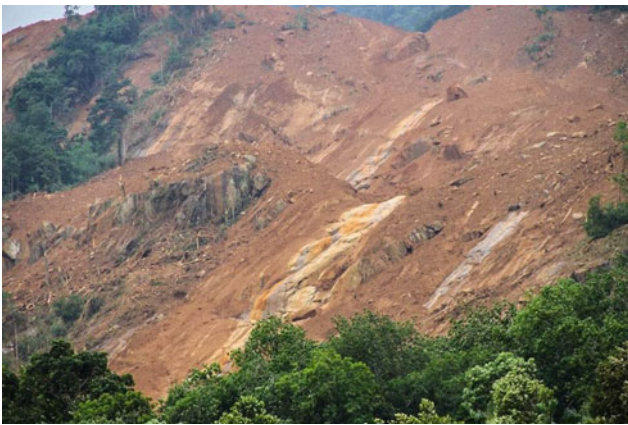
Fig. 6 Sliding surface or the point of initiation of the Aranayake landslide in Sri Lanka, 2016 *Photo by Sri Lanka Red Cross (2016)*

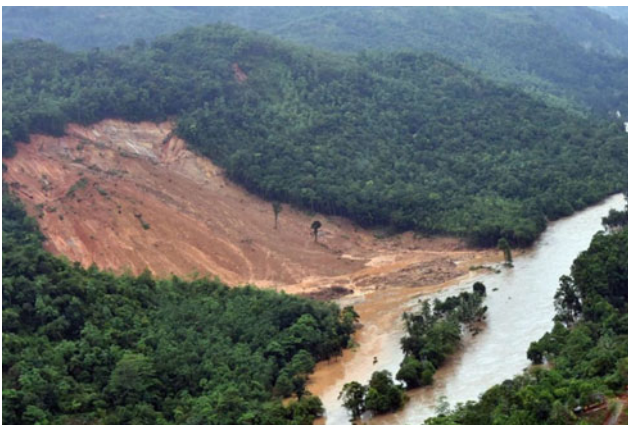
Fig. 7 A landslide area at Kaluthara, 80 km from Colombo Sri Lanka on May 26, 2017, *Photo by The Straitstimes Asia (2017)*

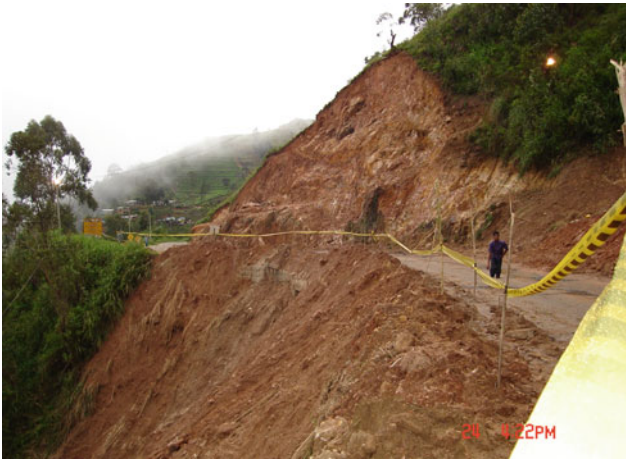
Fig. 10 Upper and lower slope de-stabilization after construction of a road in mountain environment

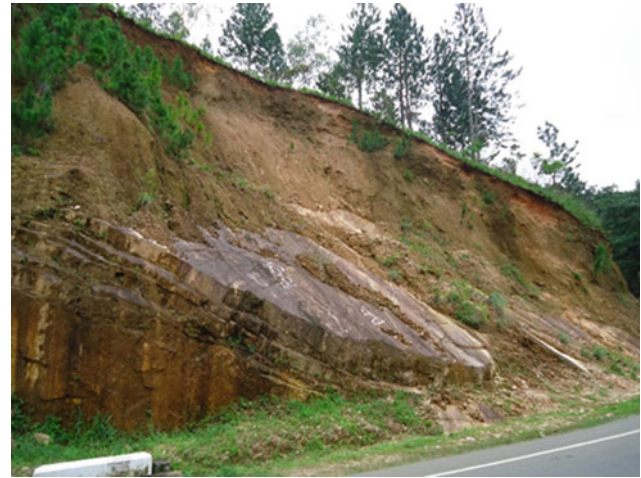
Soil layer contact with impermeable bedrock leads to increased pore water pressure at the interface of soil and

rock and ultimately causes a significant reduction of shear strength. The maximum permissible strain of soil material cannot withstand in-situ and leads to move downward and outward movement (see Figs. 12, 13 and 14).

Fig. 12 Failure observation of a road side slope cut section which was constructed at 0.5 to 3.5 m high without any retaining structures

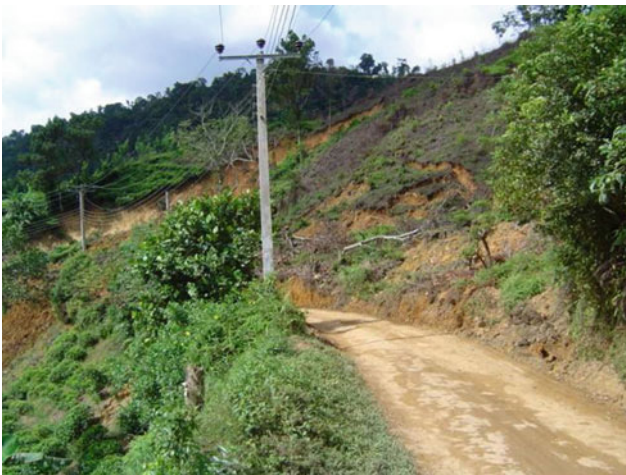
followed by a flowage mass. Observations revealed the fact that heavy rainfall events trigger failures (Fig. 11).

Fig. 11 Immediate upper slope (slope section above the road) de-stabilization, Kalawana, Ratnapura, 2003

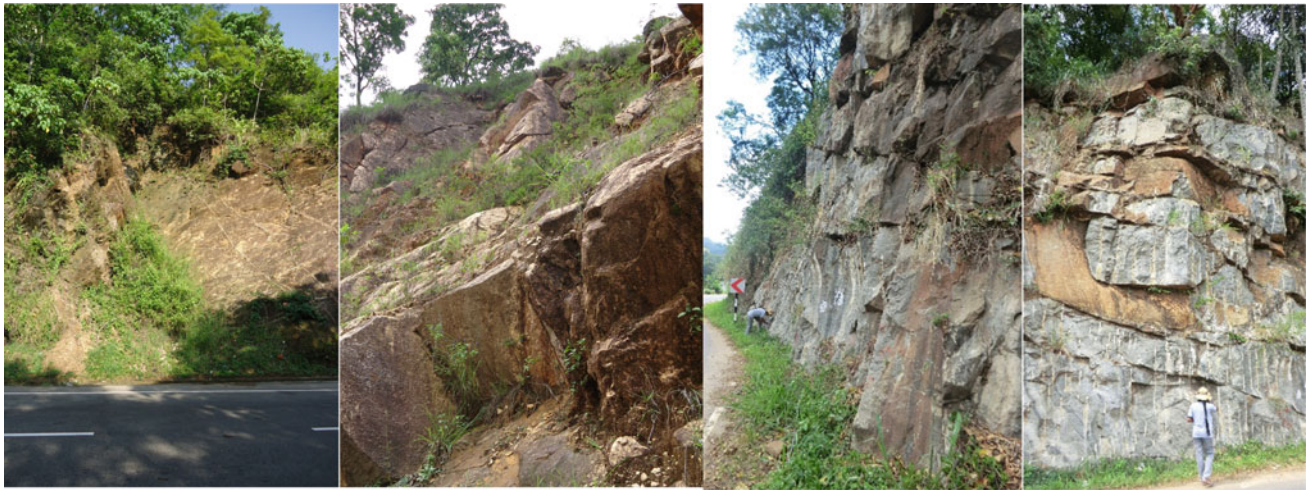
Fig. 13 Example of rock formed failures along the road side slope. Wedge failure, translational slides and falling rocks are very much significant along the road sides. High hazard potential zone can be observed due to foliated and jointed rock formations

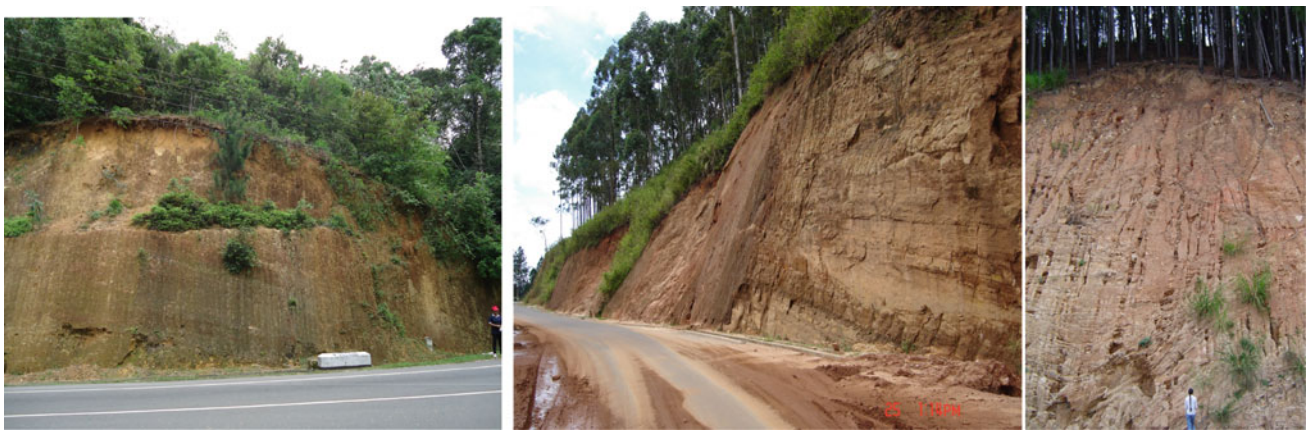
Fig. 14 Some stable landforms were also noticed during investigations. Highly to completely weathered rock surfaces consist of unsaturated soils, each having different visual and physical characteristics. Surface erosional potential is high if the weathered surface

contains any soluble minerals of metamorphic rocks. Usually, those sections stay stable for 20–40 years or more with minor surface improvements

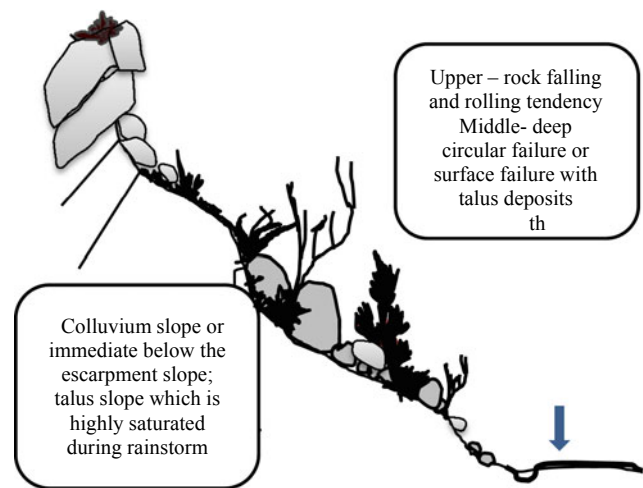
Fig. 17 Type-c: Rock falling, bouncing and rolling tendency of escarpment slope segments. Highly potential failure records at road side slope

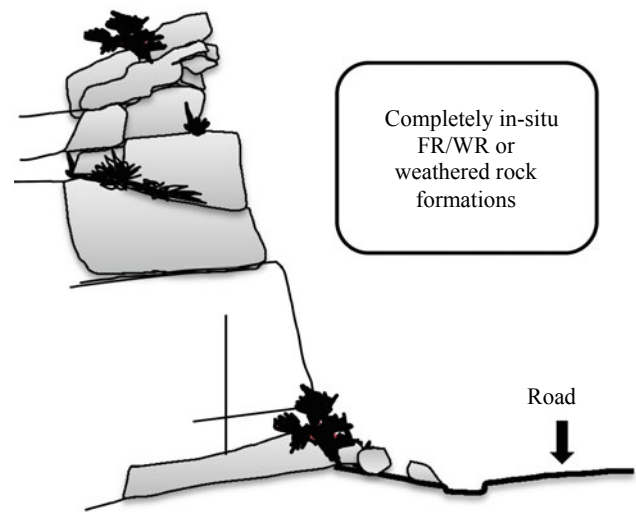
Fig. 18 Type-d: Completely rock slope, moderately to highly jointed/foliated rock face; Limited failure records, but highly potential rock falling, bouncing and rolling

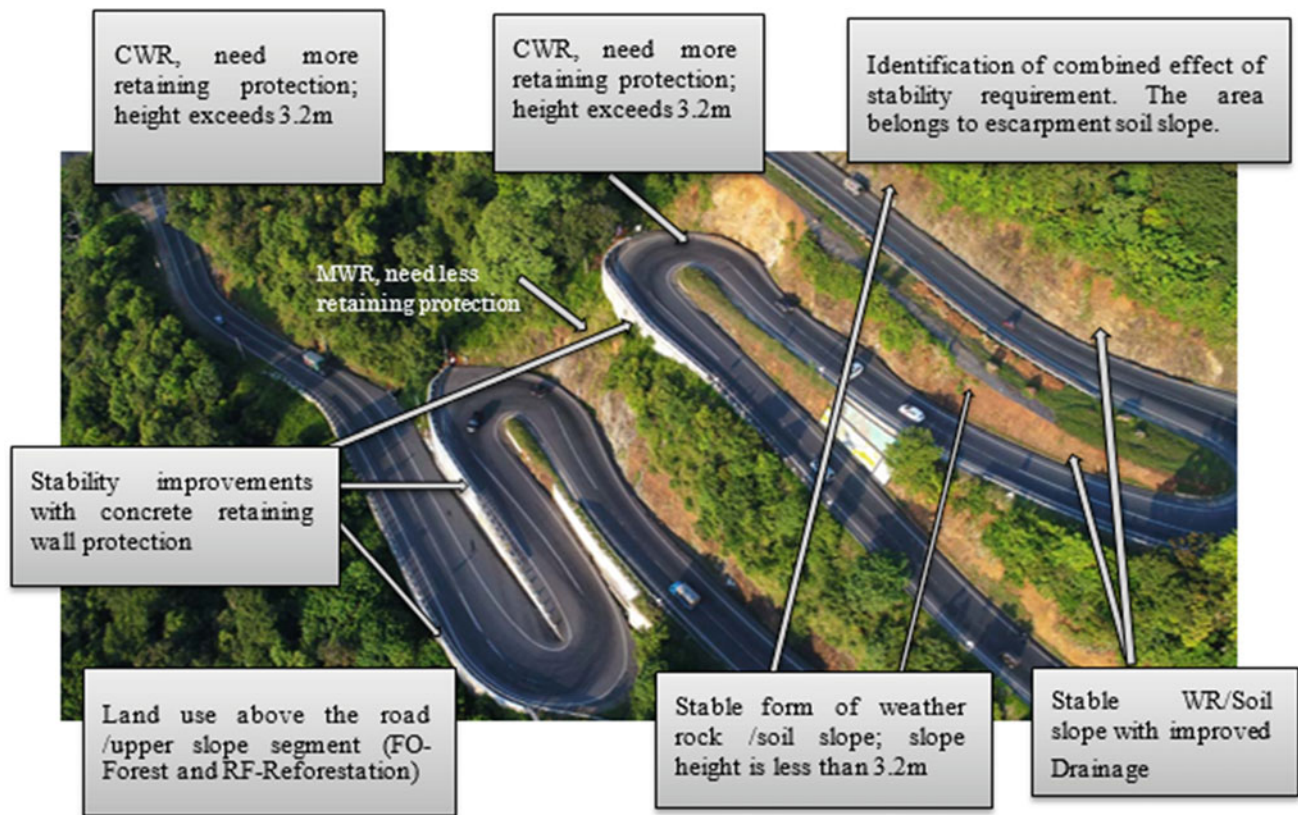
Fig. 22 Mountain slope stability measures adopted in “18 Hairpin Bend” Kandy-Mahiyangana highway (Photo by <https://www.mapakadavillage.lk/En/five-facets-about-mahiyangana/>), Sri Lanka
