Repair Measures for a Seismically Retrofitted Steel Bridge Experiencing Distortion-Induced Fatigue Cracks: Numerical Study

Abstract. This paper studies distortion-induced fatigue cracks in a 1960's era design Missouri Department of Transportation (MoDOT) welded plate girder bridge that developed cracks in the web-gap region shortly after completion of a comprehensive seismic retrofit. Finite Element analysis (FEA) was conducted in order to investigate the cause of cracking and to recommend appropriate repair measures for the bridge. The results indicated that the high stress concentrations were principally a result of replacing K-type diaphragms with stiffer cross-diaphragms as part of the seismic retrofit. Two conventional repair measures in addition to two innovative repair measures were evaluated. The first repair strategy provided a positive connection between the connection plate and the girder flange (referred to as the top-angle repair). The second repair created a 203-mm (8-in.) slot where one-sixth of the connection plate depth is cut from the web (slot-repair) resulting in a softening of the web gap.

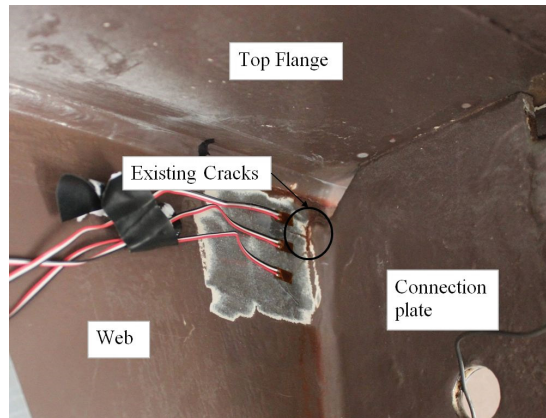
During routine inspection within approximately one year following the completion of the seismic retrofit, MoDOT inspectors identified several cracks in the webs of the longitudinal plate girders. Most of the cracks were found in the three interior girders at the location of the cross-girder retrofit and new “X” bracing as shown in Fig. 3. The majority of the cracks were initially oriented in the longitudinal direction originating from the toe of the web-to-flange weld or the weld at the end of the stiffener plate (connection plate for the cross frames) with some turning downward and progressing deeper into the web. Figure 4 shows a perspective view of a typical crack that has been formed in a web-gap region of the bridge.

Fig. 4. an existing crack in the web gap region of girder 2

FE analysis showed that the distortion-induced stresses developed in the top web gaps for the seismically retrofitted bridge were considerably higher than those for the original bridge. The hotspot stress increased from 24.8 MPa (3.60 ksi) to 94.5 MPa (13.7 ksi) when the seismic retrofitting elements were added to the original bridge. This explained the field observation that shortly after completion of the seismic retrofit a large number of web gap cracks initiated in the longitudinal girder webs originating at retrofit locations. Based on the results obtained from FE analysis the main cause for

those cracks was replacement of the “K”-type diaphragms with the much stiffer cross diaphragms. The new cross diaphragms are $2L4 \times 4 \times 3/8$ angles (compared to single $L3 \times 2\frac{1}{2} \times 5/16$ angles) which are capable of transferring a much large force between girders. These forces generated the out-of-plane distortion in the web-gap region with the potential to result in fatigue cracking since the increased stress exceeds the CAFT for a category C detail (AASHTO 2012).

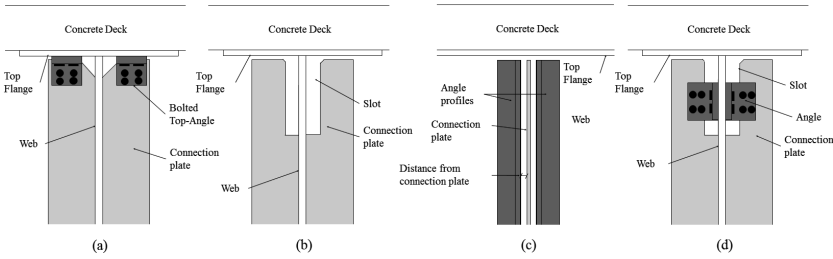
Fig. 8. Retrofit options evaluated by FE models including (a) top-angle repair, (b) slot repair, (c) middle-angle repair, and (d) slot-angle repair

A traditional repair for web-gap distortion is to stiffen the area by positively attaching the connection plate to the girder flange (Fisher 1990; Zhao and Roddis 2004). This attachment restrains web-gap distortion, and as a result, is able to greatly lower out-of-plane displacement in the web-gap region. In order to evaluate the performance of this repair, a $L4 \times 4 \times 3/8$ angle was used to attach the connection plate and top flange. Attachment was provided by modeling bolts which were preloaded to create the minimum required bolt tension specified in AASHTO (2012). As shown in Fig. 9, the bolted attachment resulted in a significant reduction in the hot-spot stress through a reduction in the relative displacement between the girder flange and connection plate. The hotspot stress in the web-gap region dropped from 94.5 MPa (13.7 ksi) to 15.4 MPa (2.24 ksi), 84% reduction, for the bolted connection which is considerably below the CAFT of 68 MPa (10 ksi). Also, this repair option reduced the peak value of stress along the horizontal fillet weld of the web-to-flange joint to 20.9 MPa (3.03 ksi) from 118 MPa (17.1 ksi), 82% reduction.

The second measure investigated to repair web-gap cracking is to soften the area by creating a slot at the top of the connection plate thereby making a softer web-gap. This method was first used in 1980 for the retrofit of the Des Moines (Polk County) Bridge (Fisher 1984). Dexter and Ocel (2013) recommend that the length of the new web-gap be one-sixth the web depth but no greater than 381 mm (15.0 in.). Thus, a cut dimension of 203 mm (8 in.) was utilized for this repair, as shown schematically in Fig. 8(b). The slot repair method resulted in a significant stress reduction in the web-gap region by shifting the stress concentration location down and providing a more flexible web-gap region. The hot spot stress developed in this model is 28.7 MPa (4.16 ksi) compared to 94.5 MPa (13.7 ksi) corresponding to a stress reduction of 70%. The slot repair resulted in a considerable reduction in the peak stress along the horizontal fillet weld of the web-to-flange joint with a stress of only 13.0 MPa (1.89 ksi) an 89% reduction from the post retrofitted bridge. Although this method is an efficient option in reducing web-gap stresses, it has been somewhat less effective in practice. Fatigue cracks were found shortly after this type of retrofit was completed in a Lexington Avenue Bridge (Dexter and Ocel 2013).

An innovative repair option to stiffen the web-gap region is investigated which does not have the same limitations as the top-angle option. In this method, $L4 \times 4 \times 3/8$ angles were placed on the surface of the web and 25.4 mm (1 in.) from the connection plate which provided enough space to accommodate existing bolts. Four angle sections were placed on either side of the connection plate on both sides of the web. This technique reduced the hotspot stress to 49.6 MPa (7.19 ksi) which corresponds to a 48% stress reduction (moderately below the CAFT of 10 ksi). In addition, the peak stress on the opposite side of the web at the web-to-flange joint was reduced to 59.0 MPa (8.55 ksi) which represents a 50% reduction. Also, as Fig. 10 shows, there is a moderate reduction in the peak value of stress along the horizontal fillet weld of the web-to-flange joint compared to the cracked bridge (bridge before repair).

The slot repair showed acceptable performance in stress reduction as it covers one-sixth of the web depth. However, this technique was performed to soften the web-gap of a Kansas Department of Transportation welded plate girder bridge and it failed to prevent cracks from reinitiating at some of the repair locations (Zhao and Roddis 2007). Therefore, eliminating the stress concentrations at the connection plate-web joint end can be an effective way to prevent re-initiation of cracks at the location of the new stress concentration. The fourth repair option evaluated in this study, as shown in Fig. 8(d), involves cutting the connection plate and using a $L4 \times 4 \times 3/8$ angle to attach the disconnected part of connection plate to the web.

This technique softens the web-gap and distributes the load transferred from the diaphragm to a wider area. Also, it restrains large deformations at the top of the connection plate that is disconnected from web. As a result, the hot spot stress drops more than what was observed for slot technique alone. The same slot dimensions were used for this repair and each $L4 \times 4 \times 3/8$ angle attaches connection plate to web using eight bolts, as shown in Fig. 8(d). The hot spot stress was reduced by 96% to 3.99 MPa (0.579 ksi). Figure 9 shows a significant stress reduction within the new web gap as a result of this repair option. Also, the value of peak stress on the opposite side of the web at the web-to-flange joint was reduced to 7.31 MPa (1.06 ksi) from 118 MPa (17.1 ksi) corresponding to a 94% reduction. There was no considerable localized stress distribution for the slot-angle repair option.

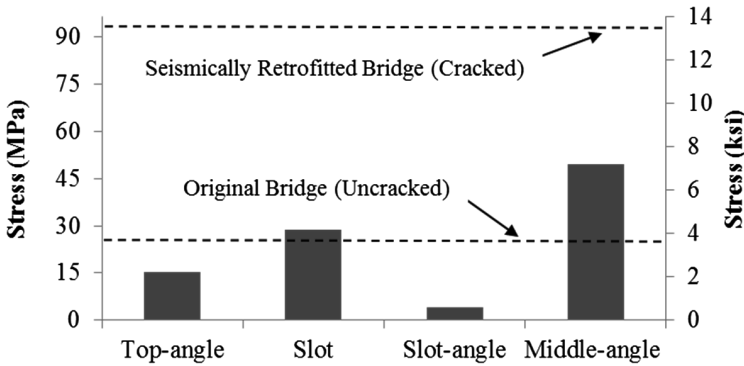
Fig. 9. Comparison of web gap stress values before and after repair

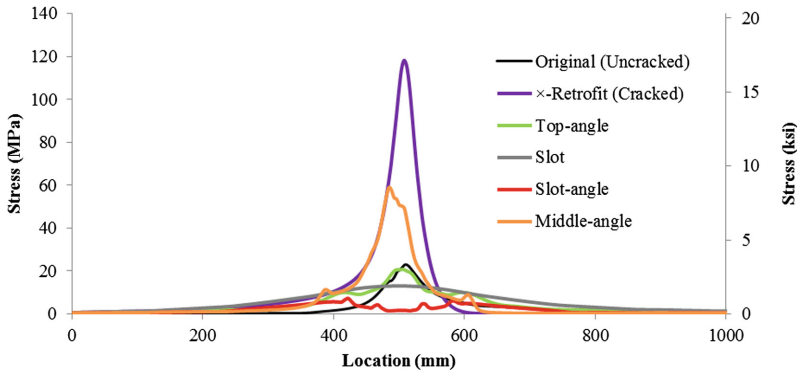
Fig. 10. Principal stress along the horizontal fillet weld of the web-to-flange joint on the web surface
