# The Glendoe Tunnel Collapse in Scotland

S. R. Hencher<sup>1</sup>

## Abstract

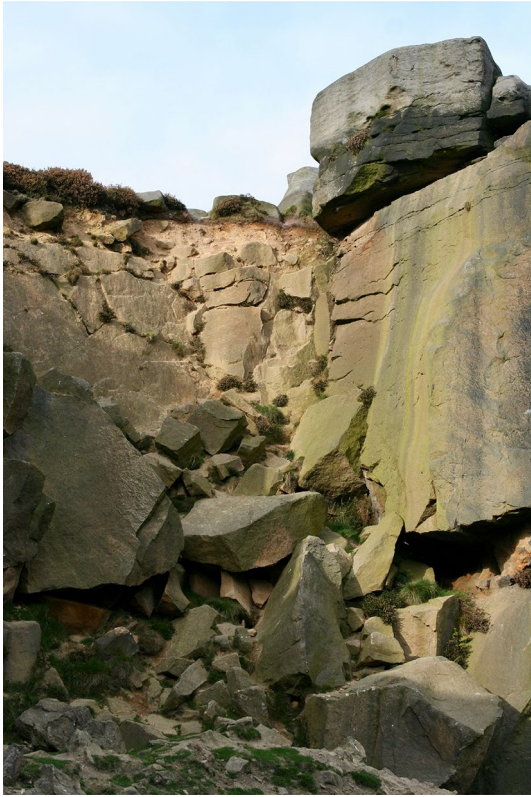
**Fig. 3** Unexpected failure in the corner of the Cow and Calf Quarry

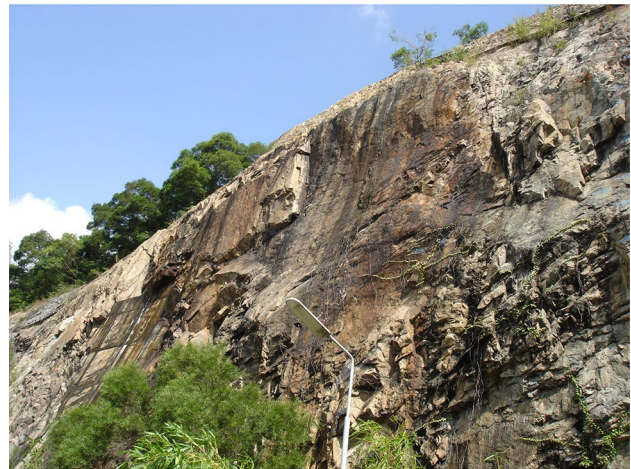
**Fig. 5** Undercut blocks sitting on steeply dipping planes

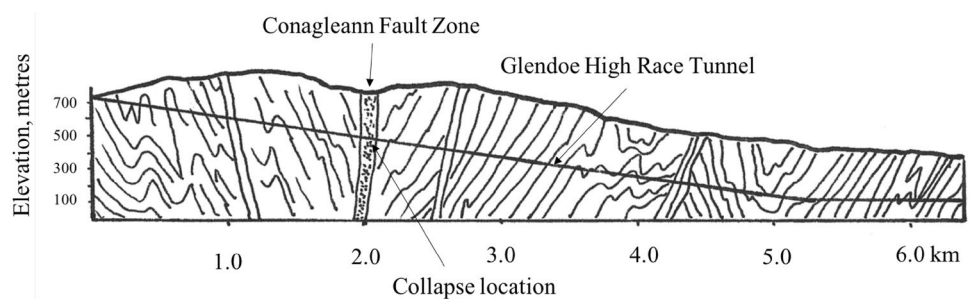
**Fig. 6** Section along the headrace tunnel, showing location of Conagleann Fault Zone where the collapse occurred. (traced from Dr. Smith's presentation to court, slides 5 and 7, Woolman 2016)

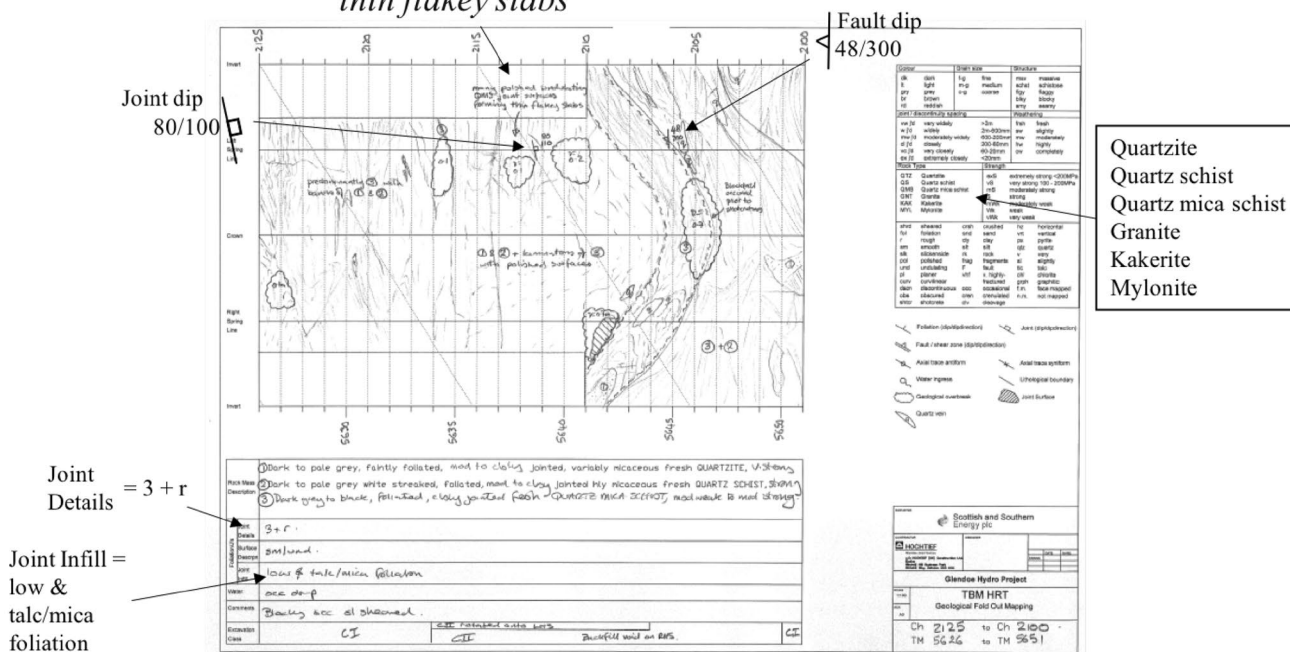
“many polished undulating QMS joint surfaces forming thin flakey slabs”

**Fig. 8** Part of section where collapse occurred, from the Geological Fold Out Mapping Sheet for chainages 2025–2100, reproduced in Lord Carloway’s Opinion at page 138. Note that the first two rock names are typed (presumably typical), with just the strengths added in writing (very strong and strong). Rock type 3 is added, in writing, as “closely jointed fresh QUARTZ MICA SCHIST, moderately weak to moderately strong”. Note also the comment at the top of the page

“many polished undulating QMS joint surfaces forming thin flakey slabs”. This is the likely material that collapsed to form the fine pile of debris seen in Fig. 10. The two discontinuity directions 48/300 in the fault zone and 80/110 in the general rock, form an adverse wedge with a third joint dipping, say, at 70/200. Note that “Joint Details” are defined as “3 + r”, meaning three joint sets plus random joints, for the Q-system

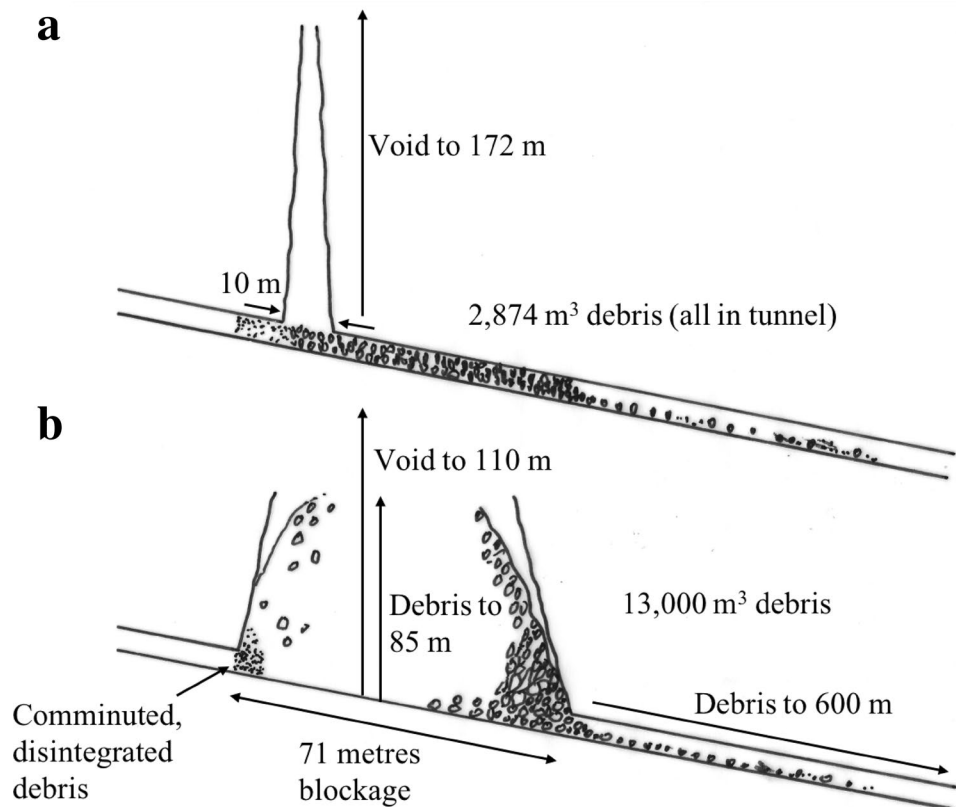
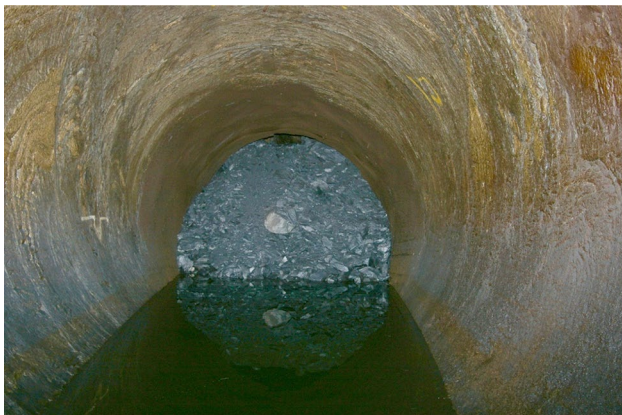
**Fig. 9** Interpretations of debris volumes and dimensions at Glendoe tunnel collapse. **a** Shows an interpretation of a rock fall of  $2874 \text{ m}^3$ , blocking off 71 m of tunnel, with the rest of the debris stretching out 600 m towards the turbines. It is assumed that this is for a block fall from the roof, of dimensions  $10 \text{ m} \times 5 \text{ m}$ . The rock would have fallen from a void extending 172 m above the tunnel invert. **b** Shows an interpretation of an alternative model with collapse throughout the 71 m and debris up to  $13,000 \text{ m}^3$ . For this scenario, there would remain debris to a depth of about 85 m above the tunnel invert and voided ground up to 110 m. For both models, there is comminuted, disintegrated debris blocking the upper part of the headrace tunnel (see Fig. 10 plus Sect. 4)

**Fig. 10** Collapsed ground (upstream end)—taken from Woolman (2016). Note folded and faulted rock in the walls of the tunnel. This must be close to the fault zone. Note that the rock mass is broken down to very fine material, which is remarkable, given the decision not to line this section, and that no one could see the fault. The interpretation is that the material in situ was disintegrated, probably by tectonic action, rather like the ‘Rashings’ material in the South Wales Coalfield which looks intact but on extraction breaks down to sigmoidal fragments

could not have travelled far to become broken up. It has not been abraded by flowing water. It must have been exposed in the walls of the tunnel as ostensibly intact rock that has been broken down, possibly by rock fall-out on incipient discontinuities.

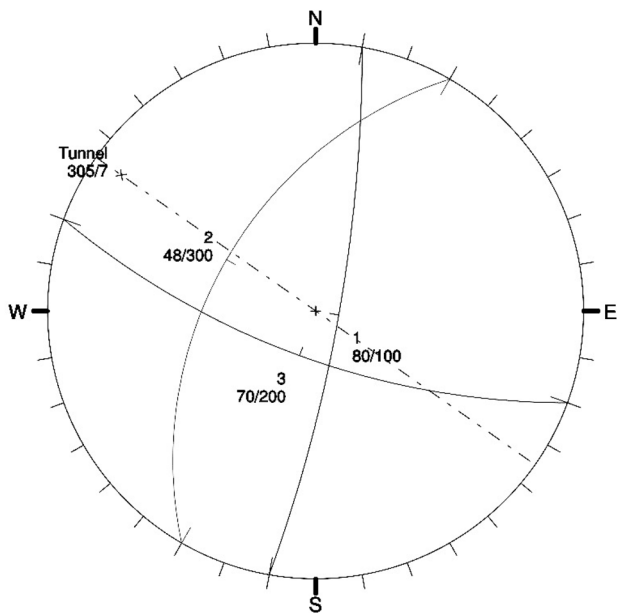
In my opinion, there is far more evidence of the collapse being dominated by large-scale wedge failure and rock collapse on incipient discontinuities than by erosion. In Table 4, I list some of the factors. Firstly, there are the discontinuity measurements in Fig. 8. The two measurements of 48/300<sup>1</sup>

(for a fault zone rock that is moderately weak to moderately strong, meaning 5–50 MPa) and of 80/100 taken in the area of sheared QMS require just one more discontinuity dipping at, say (precision not required), 70/200 to form an unstable wedge as shown in Fig. 11. It is noted that Taylor classified the jointing as “3 + r”, which translates to three sets plus random joints in the Q classification (Barton et al. 1974). Two ‘sets’ (measurements) are recorded, but where is the third? There are possible traces in Fig. 8 with the correct orientation but the traces die out, presumably as incipient discontinuities. Secondly, there is a photograph of large blocks of rock from the downstream end of the debris, reproduced here as Fig. 12. It is probable that the failure was the result of the falling of large wedges of rock, released by discontinuities, over a period of 6–8 months, leading to the collapse of rock up to 110–172 m above the tunnel as depicted in Fig. 9.

**Fig. 11** Stereogram of tunnel in 305 direction, plunging at about  $7^\circ$  with two discontinuities 48/300 and 80/100 (as measured in the Geological Mapping Sheet, in Fig. 8) and a hypothetical third joint (70/200). The three discontinuities produce an unstable wedge in the crown of the tunnel. Note that Taylor classified the rock as “3+r” meaning three sets plus random. Stereogram produced by software UNWEDGE by Rocscience, Canada

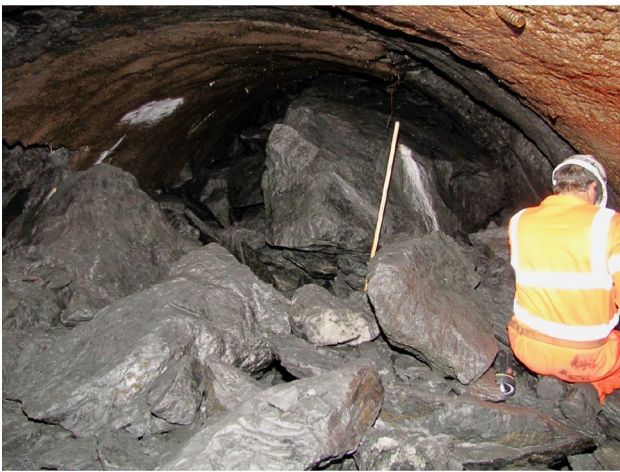
**Fig. 12** Collapsed ground (downstream end). Note that the ground is largely made up of large fallen blocks (according to this photo). Photograph from Woolman (2016)

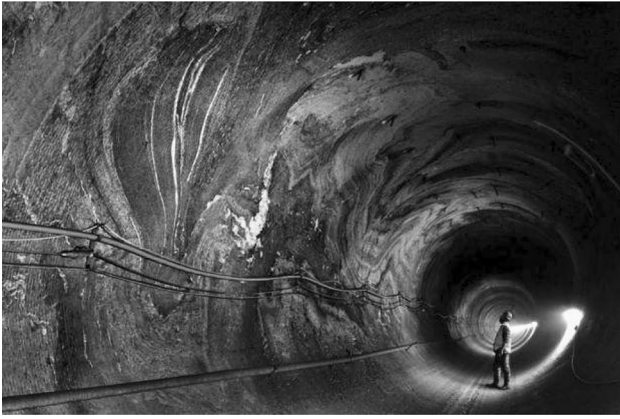
There is one additional, publicly available, photograph showing conditions in the HRT. This is reproduced in Fig. 14 and is apparently a British Geological Survey photograph, taken well away from the CFZ. Note that the rock in the tunnel walls is intensely folded and faulted and that the tunnel is not shotcreted. This is, no doubt, an example of Class 1 rock but the chance of predicting failure in this convoluted rock mass is slight. There are no numerical modelling methods of which I am aware that can deal with such ductile, undulating

**Fig. 14** Folded and faulted (ductile) ground in the Glendoe high race tunnel—well away from the Conagleann Fault Zone (BGS photo)

bands and slithers of rock. If the judgement by the tunnel engineers or geologists, utilising the Q-system, was that no support was required, so be it. There does, however, remain an unquantifiable risk that collapse might occur, which could only be dealt with by lining the tunnel.
