CASE REPORT

Artificial Heart (Clinical)

Twisting and constriction of a HeartMate II driveline in the area of a repair site

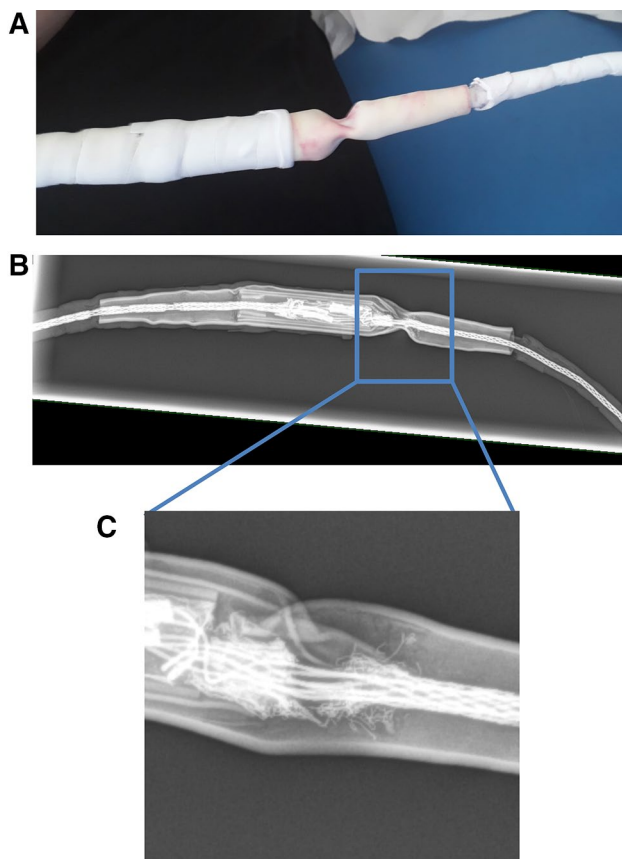
Now, he presented with a kink in the driveline in the area of the repair site in our outpatient clinic. After removing the tape in this area of the driveline, we detected a twist and extremely reduced driveline diameter. We splinted that part of the driveline to stabilize it, and took an X-ray of the driveline, which revealed a major constriction in the driveline in the area of the repaired site, as well as a cleft in the shield

(Fig. 1). No alarms occurred at the LVAD controller. The data analysis by the manufacturer showed no sign of a defect of the leads in the driveline. This dramatic finding carrying the acute risk of a lead fracture meant that the external driveline had to be exchanged again. One day later, the manufacturer replaced the whole external driveline including the repair site, leaving as much of the intact driveline as possible to the driveline exit site.

We suspect two possible mechanisms for our finding: (1) permanent torque of the repaired driveline from wrapping several layers of tape around the driveline during repeated repairs; (2) permanent stress at the same position on the driveline due to the patient's habitual movements, e.g. storing the bag, rubbing the driveline on clothes, or kinking during motion.

Fig. 1 a Repaired driveline after removal of ResQ-tape with constriction, b X-ray of the constriction, c extension with cleft in the shield

To prevent and possibly detect such twisting and constriction of the driveline, the following measures could be helpful: (1) no winding of the ResQ-tape more than twice to prevent a permanent torque—during additional repairs, the tape should first be removed and then rewound; (2) if possible, avoid winding the ResQ-tape always in the same direction so as to prevent constant torque on the driveline; (3) take a precautionary X-ray of the repaired driveline, e.g. once a year.

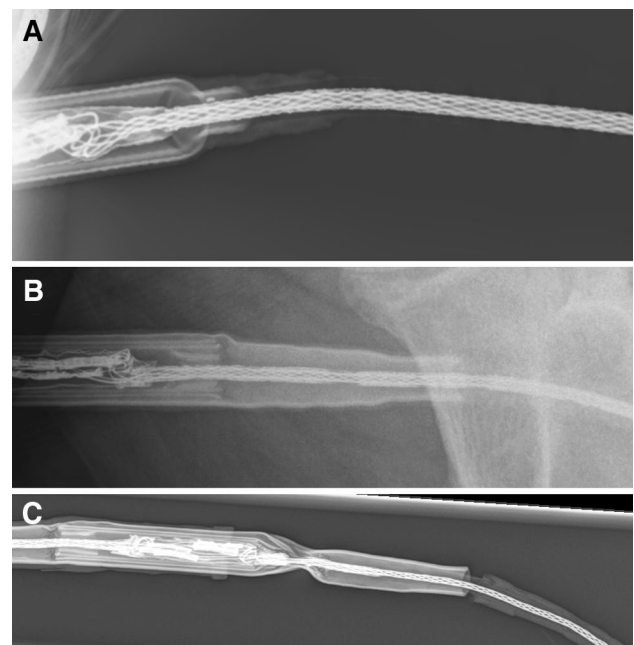
If we had X-rayed the repaired driveline of our patient regularly and not just twice in 2800 days and had not carried out in-depth repairs with tape, we would probably have noticed the break in the shield, the kinking and massive constriction of the driveline much earlier (Fig. 2).

Fig. 2 X-ray of the exchanged driveline after a 606 days, b 1977 days, and c 2801 days
