Landslides in the marly slope of the Kapsali area in Kithira Island, Greece

B. Christaras · M. Argyriadis · E. Moraiti

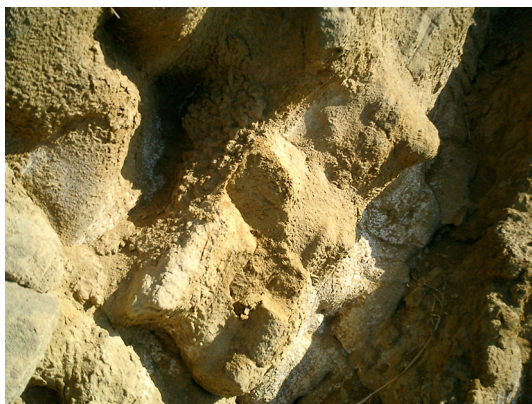
The ground immediately above Kapsali village, consists of partially weathered, marls with occasional thin sandstone intercalations (Fig. 2). The marl comprises low plasticity, silty clay (with occasional low percentages of sand). These stratified sediments have a direction of dip and dip angle of 280/35. The uppermost part of the hillside (called the “Plateau”) comprises calcareous conglomerates (Fig. 3); these sediments overlie the marls. Structurally, the area is divided into large blocks constrained by E–W and NW–SE trending vertical joints. Two NW trending faults limit the northern part of the area. This local structure forms part of the general tectonic framework of Kithira Island (Danamos 1992). In addition, the island is subject to high seismotectonic activity as it forms part of the western Greek arc; during the period 1750 to 1937, earthquakes of magnitude $M = 6.0$ – 7.2 were recorded (Papazachos and Papazachou 2002).

Fig. 2 Marl-rich sediments of Neogene age. Note the interbedded, inclined sequence of sandstone and partially weathered marl

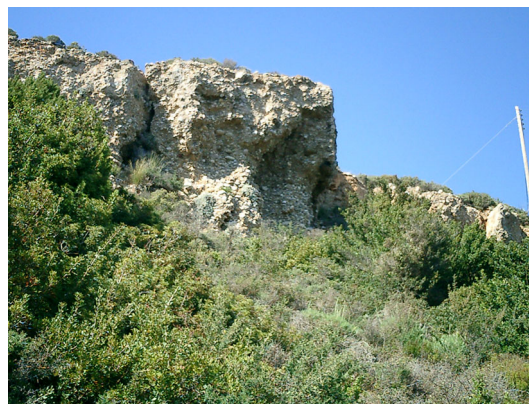
Fig. 3 Calcareous conglomerate of Neogene age. This “Plateau” sequence overlies the marls within which the landslides developed

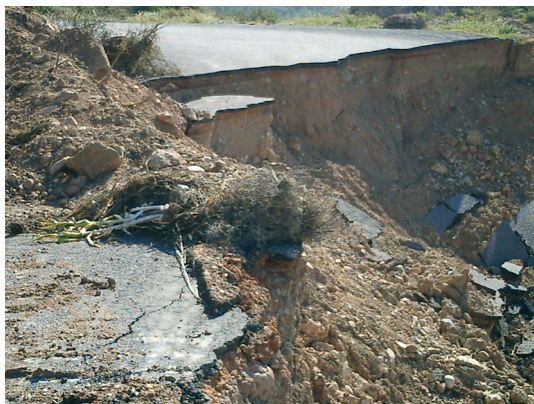
sequence and locally, cut across the road to Kapsali village (Fig. 4). In Fig. 5, the toe of the eastern slide (slide 2) is illustrated.

Fig. 4 The crest of the eastern sliding “slide 2”

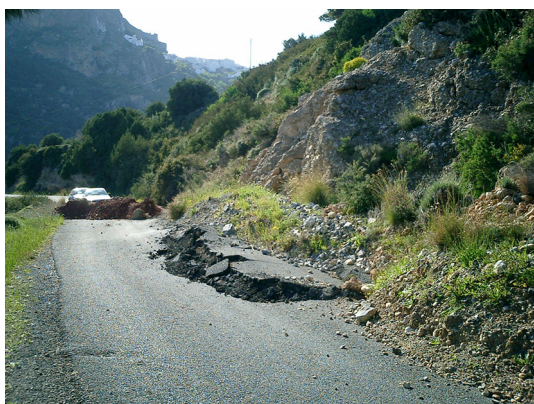
Fig. 5 The toe of the western sliding “slide 1”

The crest of the landslide is located at a height of 71 m (Figs. 1, 6) whilst the toe at a height of 62 m (Figs. 1, 5, 6). The landslipped mass covers an area of about $1,800 \text{ m}^2$, and is circular with an arc of 60 m and W–SW direction. This rotational movement created a backscar wall 2.5 m high and a horizontal opening of 0.5–1.5 m. In order to estimate the cohesion (c) and the internal friction (Φ) of the marl and to perform the slope stability analysis, we used the back analysis technique parameters for saturated ground; this approach simulates the rainfall conditions prevalent at the time of the landslides. From this, we arrived at the following data: $c = 4 \text{ kN/m}^2$ and $\Phi = 18^\circ$, for the given landslide geometry and safety factor $SF = 0.993$.

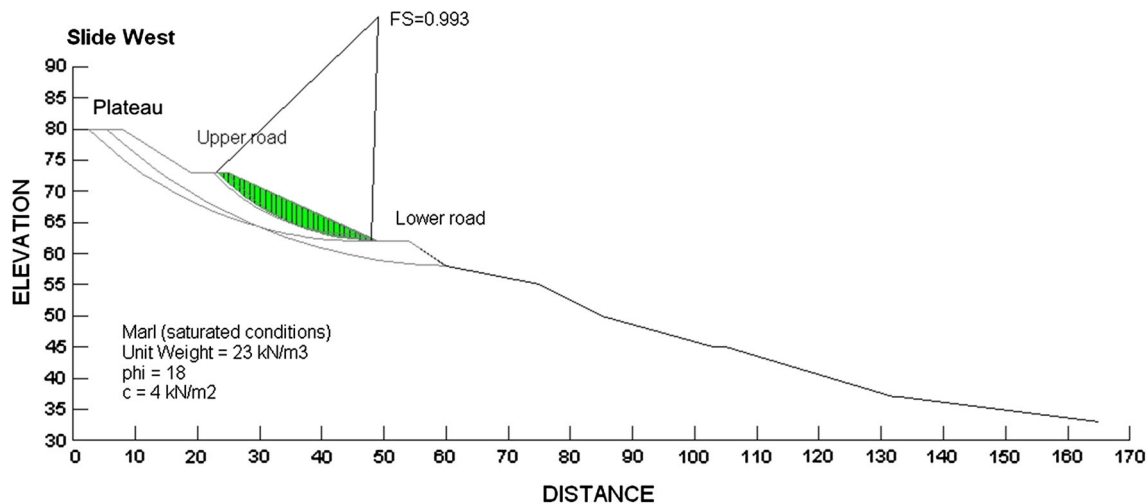
The values used above were also verified in the eastern slide (Slide 2). It is worth mentioning here that several slide rotation circles are possible for the western slide setting; that shown in Fig. 6, equates to the slide that occurred. Thus, there is the possibility that a larger slide may occur if the slope stability is not improved by some means.

Fig. 6 Slope stability analysis of “slide 1” using back analysis technique

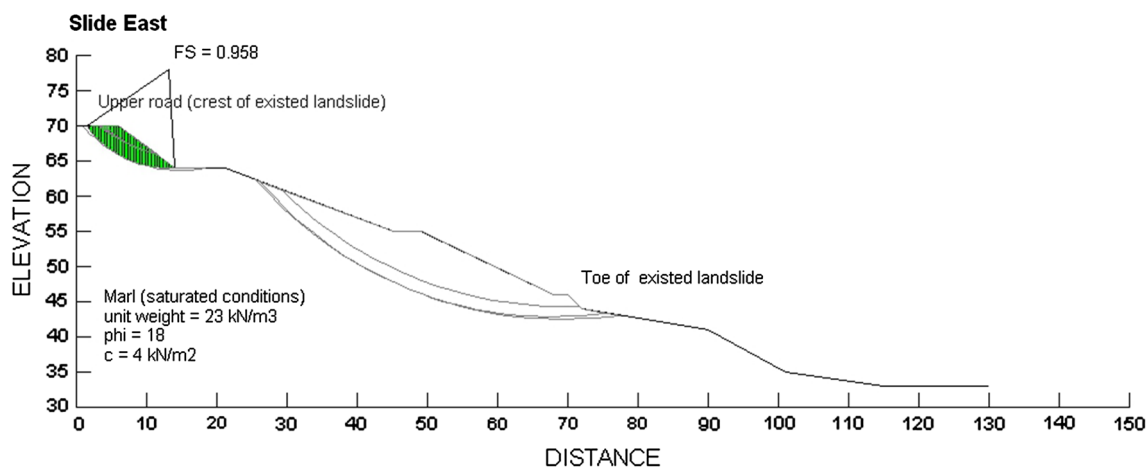
This slide comprises two parts. The crest of the uppermost subslope is located at a height of 70 m (Figs. 1, 4, 7) while its

Fig. 7 Slope stability analysis at the upper part of the eastern slide (slide 2), using back analysis technique

Working on the basis of saturated ground conditions (as for Slide 1), we arrived at the following data: $c = 4 \text{ kN/m}^2$ and $\Phi = 18^\circ$. These parameters gave a safety factor $SF = 0.958$, for the uppermost sub-slide, and $SF = 0.996$, for the second, lower sub-slide.

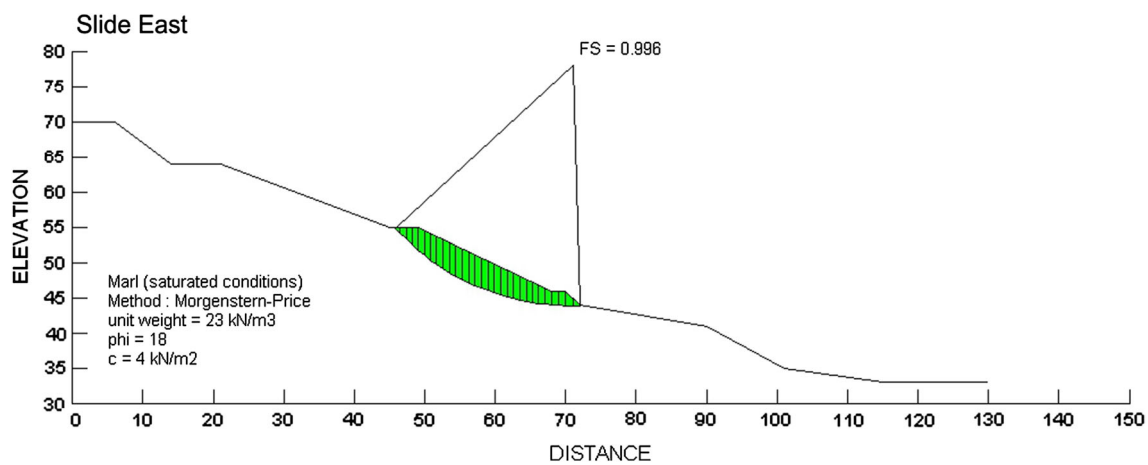
Fig. 8 Slope stability analysis at the lower part of the eastern slide (slide 2), using back analysis technique

toe lies at a height of 64 m (Figs. 1, 7). The crest of the second, lower sub-slide is located at a height of 55 m while its toe lies at a height of 44 m, not far from some houses. The landslipped mass covers an area of about 3,000 m² with a width of 45 m. The slippage was towards the S–SW. The vertical displacement at the crest of the slide was 5 m (Fig. 8).

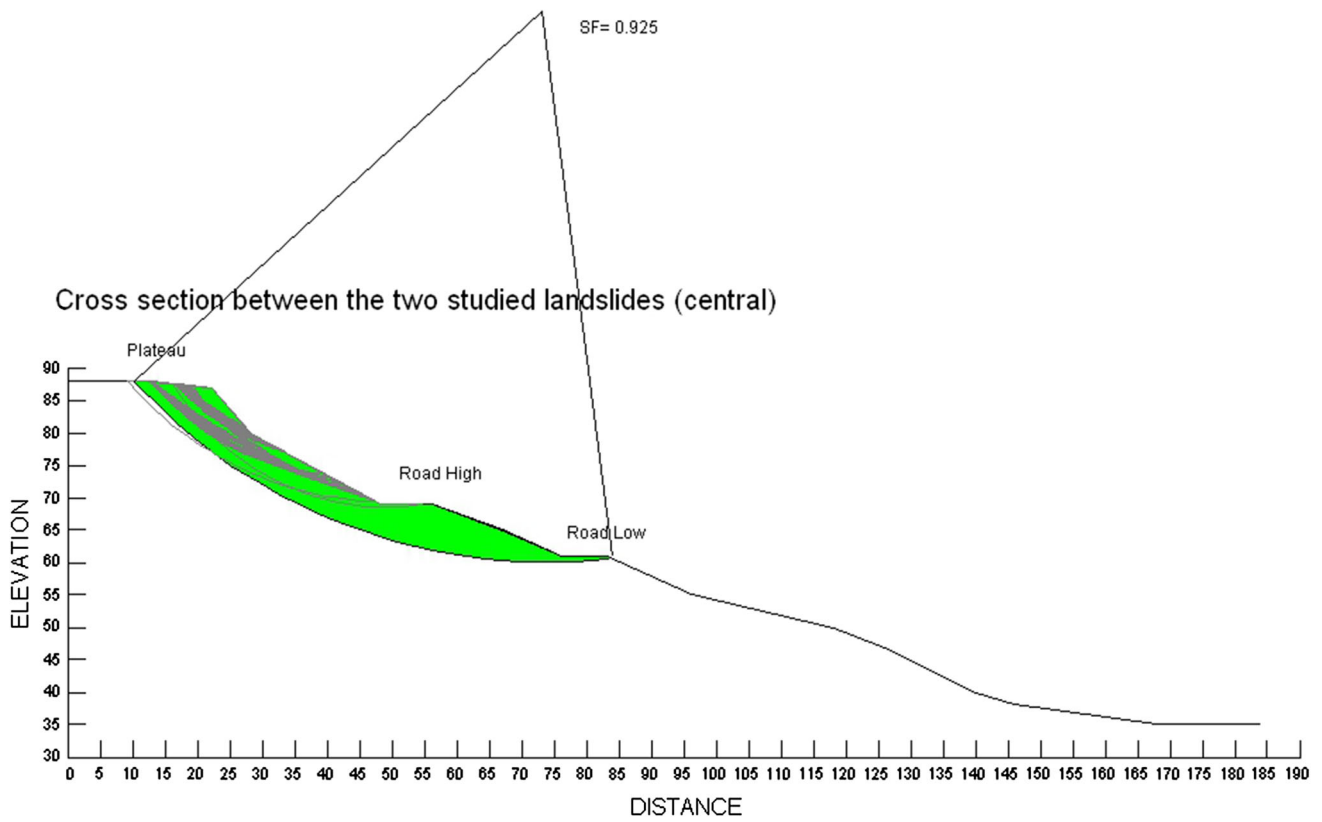
Fig. 9 Slope stability analysis along the axis: A1–A2, using back analysis data

According to our calculations, the slide rotation circles give the following safety factors: for A1–A2: $SF = 0.926$ and B1–B2: $SF = 0.66$. The SF values are very low, because although the material is considered as saturated, this saturation is mainly restricted to superficial layers which does not result in clear, distinct landslides (Figs. 9, 10).

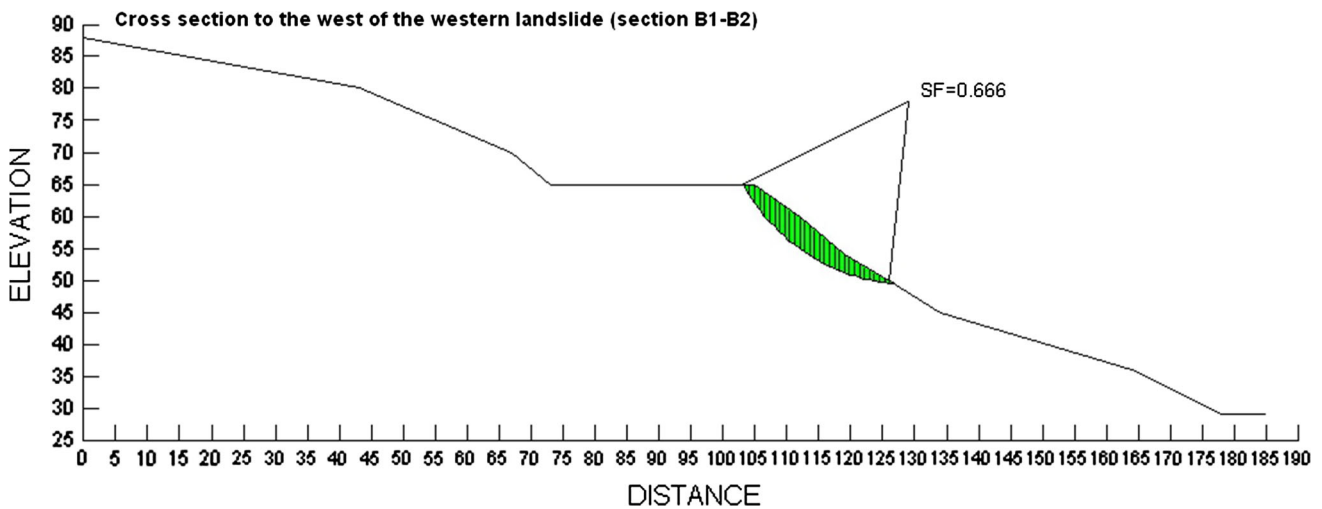
Fig. 10 Slope stability analysis along the axis: B1–B2, using back analysis data
