Dynamic investigation on the Mirandola bell tower in post-earthquake scenarios

This paper proposes a benchmark study for VBM applied to the bell-tower of Santa Maria Maggiore Cathedral in Mirandola (Italy), which was heavily damaged by the 2012 Emilia earthquake sequence. In fact, valuable data gathered during two testing campaigns on the structure evidenced a correlation of different modal features with the post-earthquake scenario. A first dynamic test campaign, conducted in the aftermath of the earthquake, allowed to identify the modal parameters related to the damaged state of the tower bell, whereas the analysis of vibration data collected during a second campaign showed how the provisional interventions influenced the dynamic behaviour, increasing the global stiffness and varying the modal shapes of the structure.

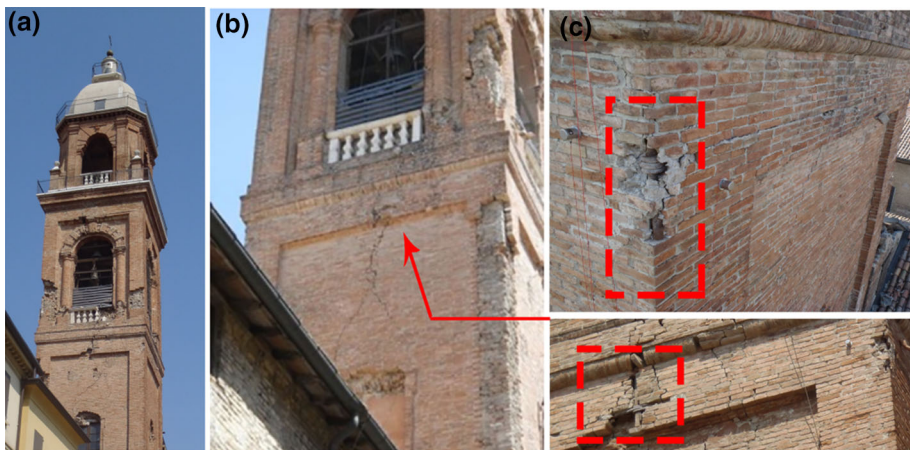
height of 21 m (Fig. 3a, b). Metal chains were revealed by the occurred damages inside the masonry layer around the perimeter at the base of this level of the structure, as shown in (Fig. 3c). The visual and laser scanner surveys did not confirm for the other levels.

Fig. 3 Damage at the level of the belfry of the bell-tower (a, b) and the metal chains (c) at 20 m
