Damage patterns in the town of Amatrice after August 24th 2016 Central Italy earthquakes

Gabriele Fiorentino¹

Keywords Amatrice earthquake · Strong motion records · Field survey · Collapse mechanisms · Vulnerability factors

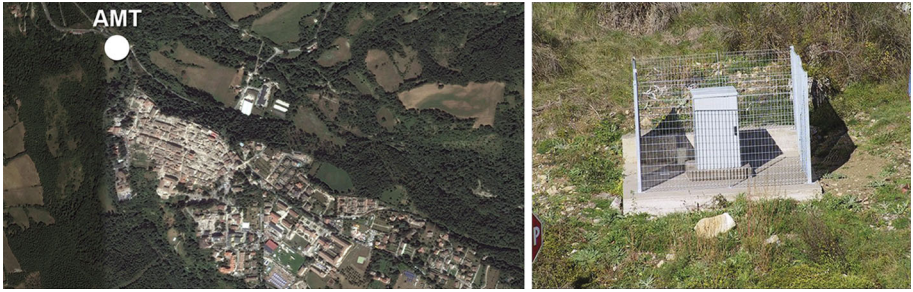
The AMT accelerometric station is located in the municipality of Amatrice, 8.5 km far from the epicenter (Fig. 5). It is placed at approximately 450 meters from the town center (choosing the civic Tower of Amatrice as reference) and it lies at the base of the hill. Therefore there could be some differences with the ground motion on the hilltop. On the basis of microtremor H/V spectral ratio the station site is classified as EC8 soil class B* (ESM 2016).

Fig. 5 Location and picture of AMT seismic station

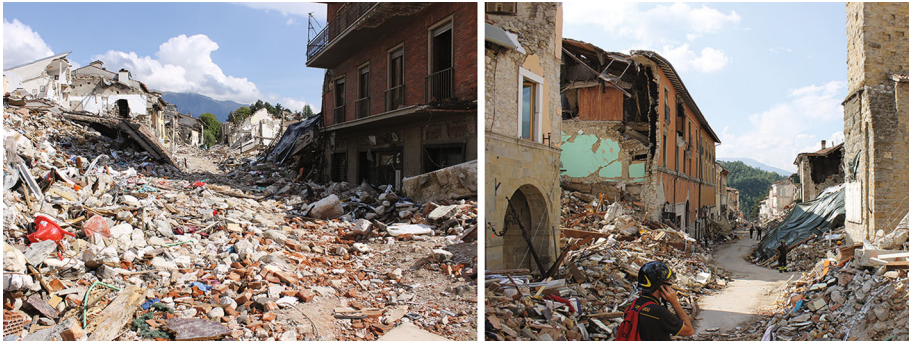
The observation of the map allows to make the following considerations: many of the buildings which suffered major damage or collapsed lied along Corso Umberto, where the majority of the historical buildings are located (32 collapses out of a total of 105); the majority of the collapses in Corso Umberto happened east of Via Roma, while in the west part of the town the damage seems to be more scattered (see Fig. 11).

Fig. 11 Overview of damage on Corso Umberto: east (left) and west (right) of Via Roma

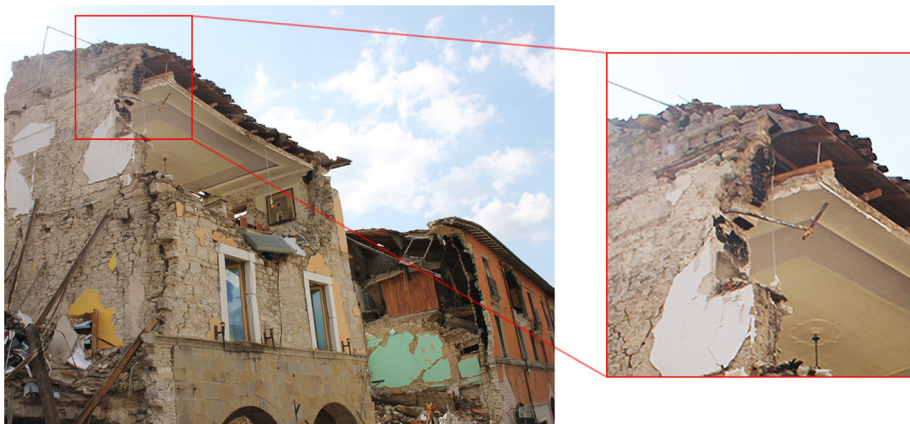
Many of the buildings inspected in Amatrice were provided with retrofitting systems, in particularly tie rods which constitute about 80% of the retrofitting interventions. Figure 13 shows the damage levels of masonry buildings without tie rods (grey bars), with any type of retrofitting system (yellow bars) and those who had only tie rods (black bars). The information was obtained by comparing the pictures of our survey with the images taken from Google Streetview©, dating to July and December 2011. It can be noted that many buildings which had tie rods suffered heavy damage and collapse, probably because in many cases the retrofitting had been made by means of inappropriate interventions, as depicted in Fig. 14. In fact, 31 out of 95 (32%) of the buildings which had a damage level

Fig. 14 Partial facade collapse (mechanism M3) of a building which had tie rods: general view (left) and detail (right)

D5 had been retrofitted with tie rods. For damage level D4 there are similar results: 10 out of 35 (29%) had tie rods.

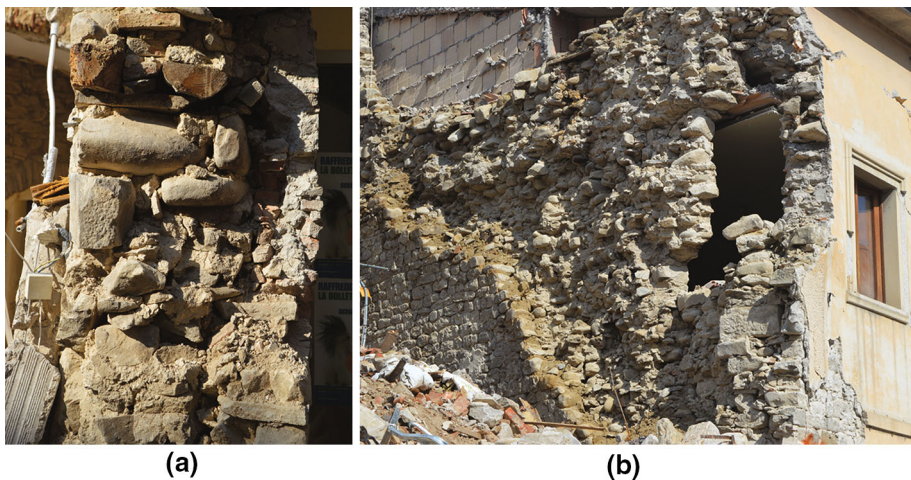
Fig. 18 Example of ev4 vulnerability factor (poor quality masonry): **a** absence of bondstones in the wall-section; **b** cobblestones with poor quality mortar

Examples of the first two vulnerability factors are reported in Figs. 18 and 19. The above listed factors represent almost 75% of the buildings with Damage level D1–D4. It is possible to notice that D4 is mainly connected with vulnerability factors ev1 (absence of walls connection), ev2 (absence of stringcourses), ev3 (floor/walls bad connection), ev4 (poor quality masonry) and only in few cases with ev5 (high percentage of openings), ev7 (variations at upper levels), ev9 (pushing roof structure), ev12 (local discontinuities).

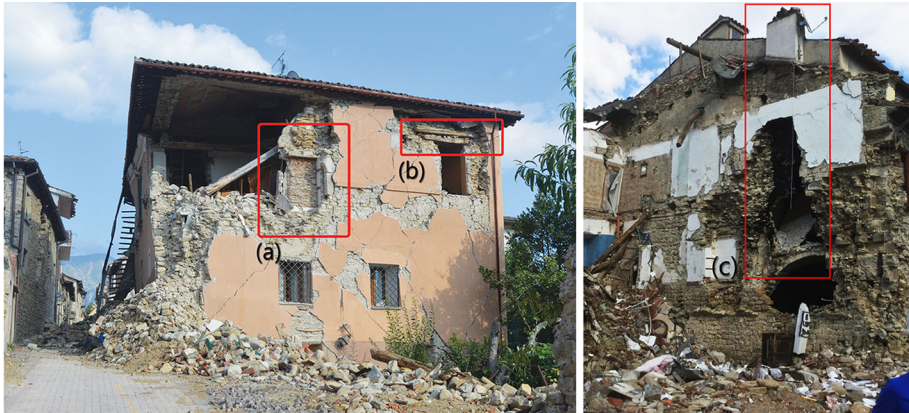
Fig. 19 Example of ev12 vulnerability factor (local discontinuities): closure of previous wall openings (a), presence of weak wooden elements (b), presence of chimney in the wall (c)

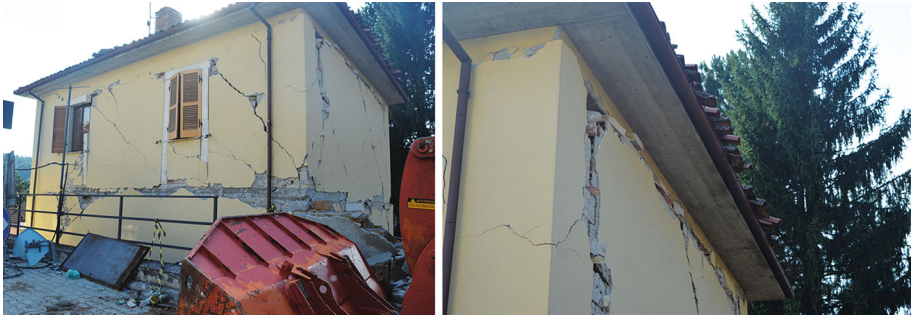
Figure 22 shows the picture of a 3-floors masonry residential building located at the entrance of the town along the provincial road. The assigned damage level was D3 due to the in-plane cracking and partial detachment of the external walls. The visual inspection revealed: poor masonry quality and different types of masonry at various floors (irregular pattern stone masonry at the first floor, regular pattern brick masonry at the second floor); local discontinuities under the windows (hollow bricks); presence of RC roof and RC stringcourses; incipient overturning of the wall corner.

Fig. 22 Residential masonry building: D3 damage level, in-plane cracking shear mechanism (M2), poor masonry vulnerability factor (ev4)

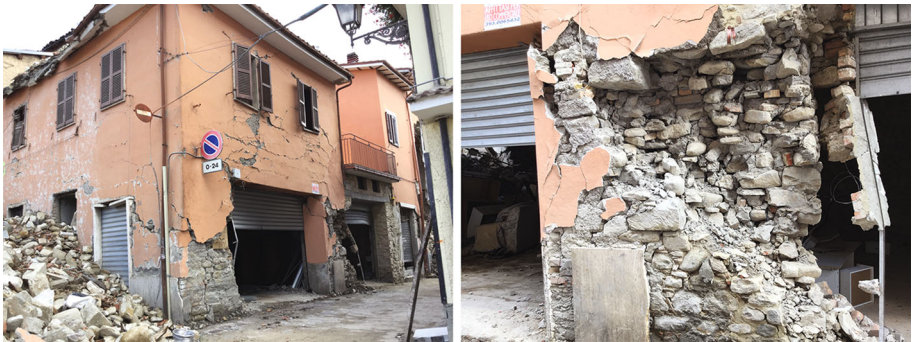
In Fig. 23 a 2-storeys masonry building, located in Via Madonna della Porta and which had a damage level D4 is depicted. The damage mechanism was an in-plane shear walls failure. The assigned vulnerability factors are: the poor quality of masonry, the presence of large openings realized in recent times, the presence of local discontinuities (recess and cracking in spandrel panels).

Fig. 23 Residential masonry building: D4 damage level, shear failure of external walls mechanism (M1), poor masonry vulnerability factor (ev4)

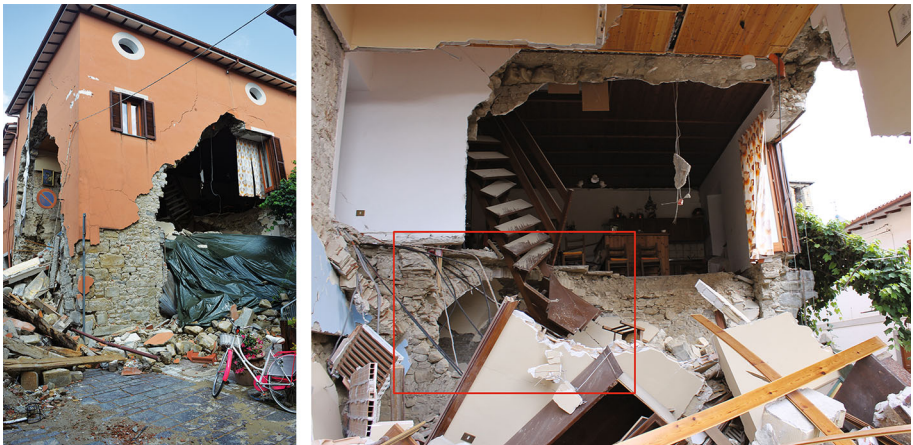
Fig. 24 Residential masonry building: D5 damage level

Figure 24 shows a 3-storeys building which represents an example of a building rated with a damage level D5 (total collapse of the floor) in which the roof did not collapse. In particular, it is possible to highlight the poor quality of masonry, the presence of discontinuities (chimney inserted in the spine wall), the presence of a collapsed arch at the basement, the overturning of external walls.

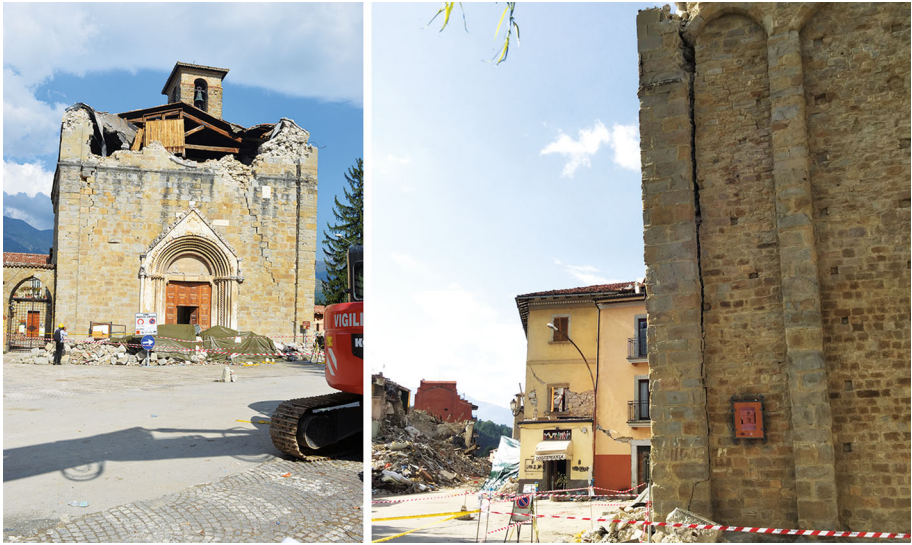
Fig. 25 Church of S. Agostino: damage level D4, collapse of tympanum (M6) and in-plane cracking of façade (left); overturning of façade (M3, right), ev1 vulnerability factor

Figure 25 shows the damage occurred to the fourteenth century church of S. Agostino, which was assigned to a D4 damage level. On the left, it is possible to notice the total collapse of the tympanum and the partial roof collapse. Moreover, on both sides of the façade it can be noted an in-plane cracking bringing to the detachment of the right corner of the façade. In the right part of the picture it is highlighted the overturning of the façade.

This collapse mechanism is probably due to the lack of connections between elements. As in other churches in the area, the ruptures revealed the masonry type, a multileaf masonry with an inner core made of poor quality rounded stones with an external panel made of regular stones.

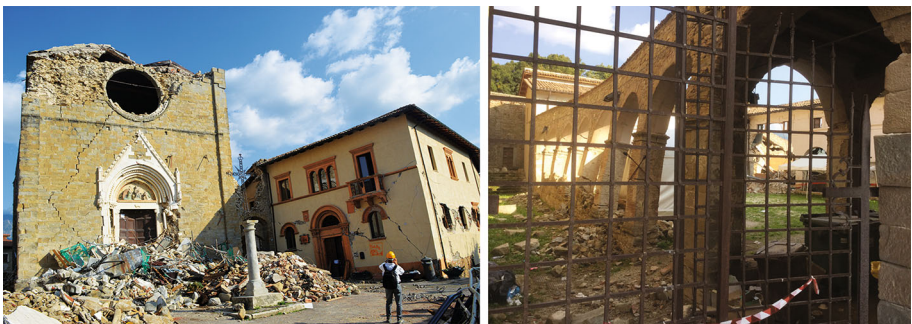
Fig. 26 Church of S. Francesco: damage level D4, collapse of tympanum (M6) and in-plane cracking of façade (left); collapse of columnnade (right), ev1 vulnerability factor

The church of S. Francesco, built at the end of the fifteenth century and depicted in Fig. 26 presents similar damages. It suffered the partial collapse of the tympanum and the partial collapse of the roof. There is a shear diagonal cracking on the façade and an overturning mechanism of the colonnade outside the church. It is worth noting that the collapse mechanism is the same of the church of S. Agostino.

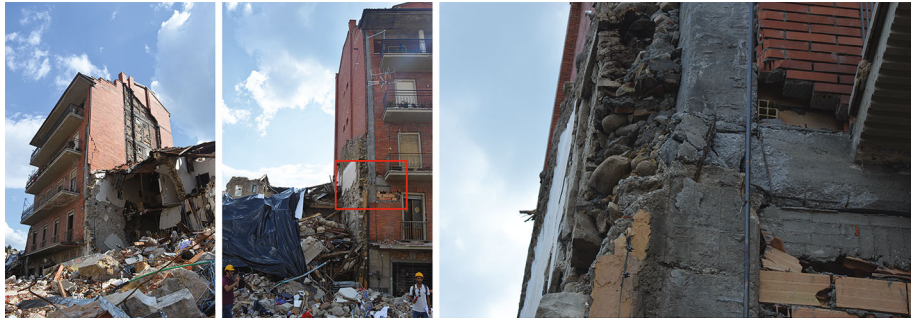
Fig. 27 Residential RC building (damage level D3): global damage (left), damage of beam-column node (center), particular of the node (right). Damage mechanism MC, vulnerability factor e_vD

In Fig. 27 a residential 5-storeys RC frame building is depicted. This building became a symbol of the city of Amatrice in the days after the earthquake because it was one of the few buildings that did not collapse in the eastern part of Corso Umberto. The picture shows in particular the failure of a beam-column node. A detail of the node shows also that the longitudinal rebars are external to the stirrups. The pictures show also the partial detachment of the infill brick panels, poorly connected to the RC frame.
