The M_w 5.4 Zagreb (Croatia) earthquake of March 22, 2020: impacts and response

Abstract

Keywords Masonry buildings · Cultural heritage · Physical damage · Emergency response · Post-earthquake inspection · Social impacts

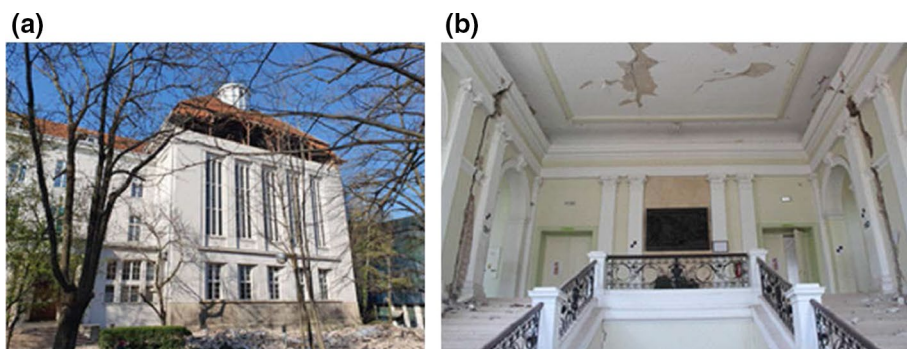
Fig. 13 Damage to buildings of the Zagreb University: **a** School of Medicine and **b** Faculty of Law

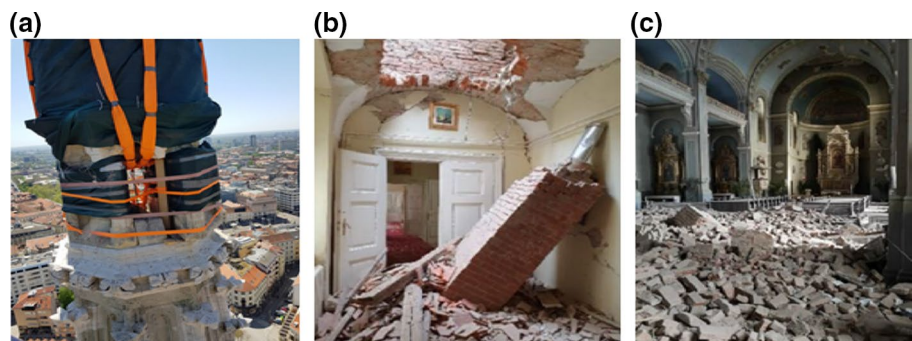
The earthquake also caused important impacts to the protected architectural and historical heritage buildings of inestimable value in the historic downtown. Of different occupancy categories, these old buildings represent a special cultural feature of the City of Zagreb. Almost 500 such were partially damaged with more than 10% red tagged. Among the cultural heritage buildings, the highest damage was sustained by centuries-old churches, 30 categorized as cultural heritage monuments. The first days, much attention attracted the threat of falling debris from these structures. The stone spire of the Zagreb Cathedral's southern bell tower collapsed and caused damage to the roof of the cathedral. During the inspection, significant damage was observed to the spire of northern bell tower as well, which had to be urgently removed (Fig. 14a). In addition, the balustrade above the apse was destroyed, and the façade walls and vaults were significantly damaged. The Archbishop's Palace of the Cathedral sustained significant damage to vaults, roofs and collapsed chimneys (Fig. 14b). The Basilica of the Sacred Heart of Jesus had almost a third of its ceiling collapsed (Fig. 14c).

Fig. 14 Damage to cultural heritage buildings: **a** removal of the bell tower spire, **b** interior of the Archbishop's Palace, and **c** Basilica of the Sacred Heart of Jesus (authors: Filip Foretić, Josip Atalić and Ivan Čurić)

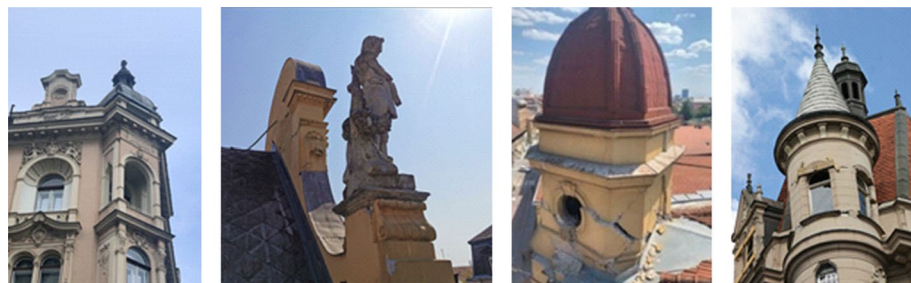
Architectural decorative elements of heritage buildings such as domes, portals, elaborately carved garlands and wreaths, sculptures, etc., suffered significant damage. When not adequately installed and anchored, these elements are usually unable to support lateral seismic forces. Due to their size and weight, they are made mainly of brick and/or concrete, they pose a serious threat to people's lives. Examples of damage to these elements are given in Fig. 15.

Fig. 15 Damage to decorative elements (authors: Mario Todorić and CCEE 2020)

There were numerous warnings from experts, even since the great Zagreb earthquake of 1880 (e.g., Mohorovicic), that decorative elements of heritage buildings pose significant threat to human lives, but were apparently neglected as were those more recent warnings with respect to the seismic performance of masonry buildings in general (Atalic et al. 2018, 2019). In the following text, the focus is on the performance of old masonry housing units in the historic downtown and causes and evaluation of the damage to their structural and non-structural elements.

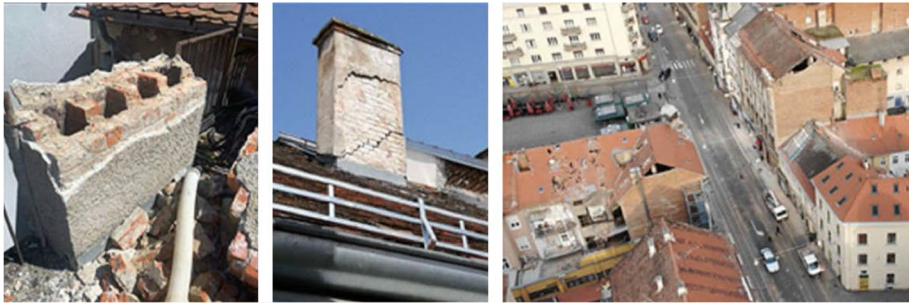
Fig. 16 Typical damage to chimneys (authors: Mario Todorić and CCEE 2020)

Damage and collapse of chimneys: Much of the damage to roofs and attics were caused by the partial or complete collapse of chimneys (Fig. 16). Made of solid brick and mortar, they are not resistant to seismic forces. Chimneys are often free-standing starting from the attic floor, sometimes more than 5 m high, and only in rare cases they are fixed to the roof structure. Damage occurred mainly at the junction with the roof or with the attic floor structure (Crnogorac et al 2020). These types of chimneys make part of the Zagreb cultural heritage that was intentionally preserved, although it could easily be supposed, as it was the case, that their damage would frequently cause damage to roof structures and other building components and threaten occupants and people in the streets.

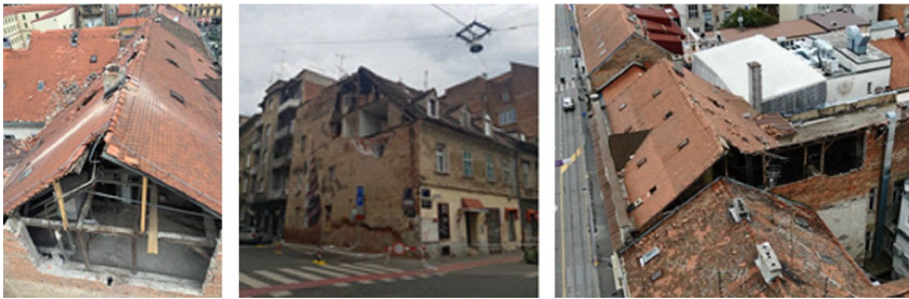
Fig. 17 Typical damage to gable walls (authors: Mario Todorić and CCEE 2020)

Damage and collapse of attic gable walls: In addition to chimneys, the most common damage was the partial or complete collapse of the gable attic walls (Fig. 17). They are built as ordinary, mainly 15 cm thick masonry walls and usually not adequately supported with out-of-plane fixation to the roof structure. In certain cases, unsupported walls orthogonal to the attic gable walls were damaged, such as the longitudinal walls of the front and rear façades (Crnogorac et al. 2020). Additional weakness comes from the

fact that the attic walls are not properly fixed to the floor structure; the wooden joists, spaced approximately 80 cm apart, are embedded in the longitudinal bearing walls without any structural connection to the attic walls.

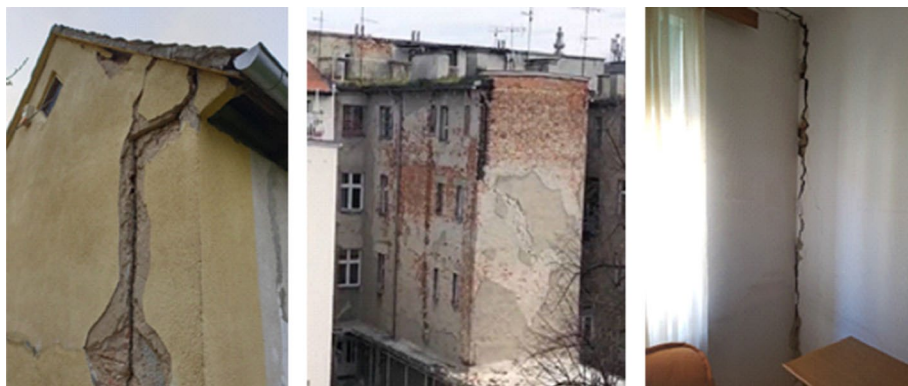
In some cases, there was a significant separation of the gable wall along the height of the building and partial collapse of the façade wall. What could not be observed from the street view were damages to load-bearing and partition walls, and cracks at the contacts occurring mainly inside the buildings. Rarely, during the lateral movement, the wooden joists were completely pulled out from their sockets in the bearing walls and the floor structures collapsed.

Fig. 18 Separation of gable walls and characteristic cracks inside the building (authors: Mario Todorić, Mario Uroš and CCEE 2020)

Separation of gable walls: In severe cases, in addition to the local collapse of parts of the attic gable walls, a separation of gable walls developed along the entire height of the building or across a few storeys (Fig. 18). The reason was again the poor connection with the orthogonal bearing walls and with the floor structure resting on them. Therefore, the gable walls are not built to support much of the vertical load, which contributes to their poor resistance to lateral forces and the resulting differential out-of-plane movement. As a consequence, characteristic vertical cracks appeared in the orthogonal wall and horizontal cracks in the ceilings, mostly at the junction between the floor structure with and the gable wall. Increased separation can lead to overturning and collapse of the gable wall and may pose a danger to the whole structure and to the neighboring buildings as was often the case with tags N1 (unusable due to external risks).

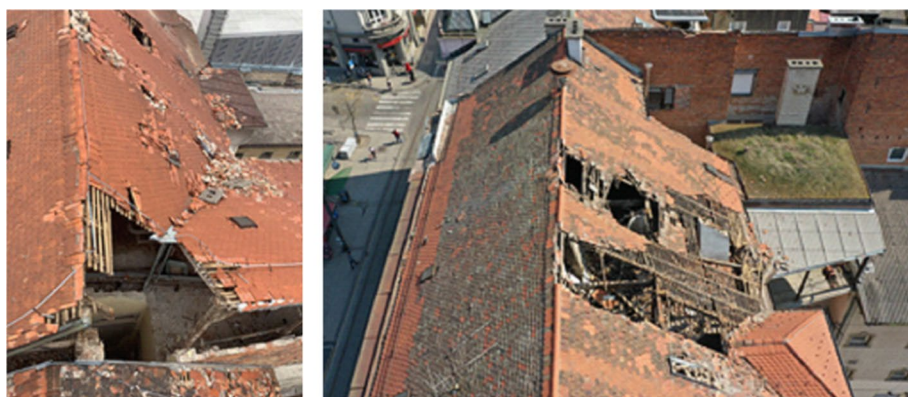
Fig. 19 Examples of roof damage (authors: Mario Todorić and AIR-RMLD)

Roof damage: The most common cause of damage to the roof structure was incurred from collapse of chimneys, gable walls and other poorly supported elements above the

roof surface. These represent mainly local types of damage (Fig. 19). The roof structures are usually of poor framing and diaphragm resistance and, due to lack of maintenance and wear with time, they provide unsatisfactory support to chimneys and attic gable walls. In certain cases, the entire roof structure sustained a permanent lateral displacement requiring a complete reconstruction.

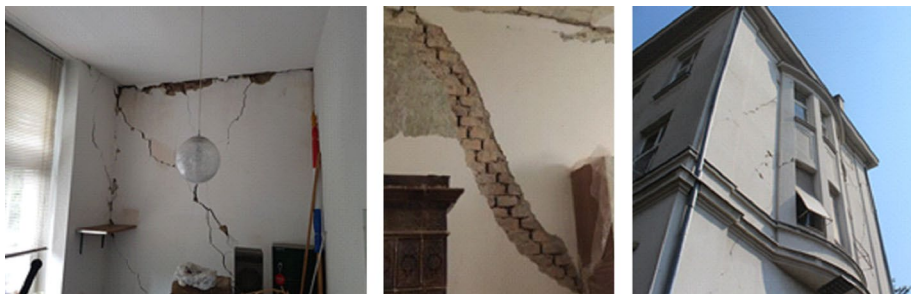
Damage to bearing walls: Masonry load-bearing walls were most vulnerable to in-plane shear and out-of-plane bending culminating in an abrupt collapse at ultimate deformation. The deterioration of the structural material (brick and mortar) due to the long service life of these buildings (over 100 years), often poor maintenance and lack of façade finishing on some external walls, further endangers the stability of these structural elements. Typical diagonal cracks were commonly observed due to exceedance of the in-plane load-bearing capacity (shear strength) of the masonry walls. These were mostly stair-stepped joint shear failures (Fig. 20) due to the poor quality of the mortar, which has lost its mechanical properties. As this situation was widespread in damaged buildings in the city center, costs for repair and strengthening of the brick walls account for considerable part of the economic loss.

Fig. 20 Typical diagonal cracks in load-bearing walls (photos: CCEE 2020)

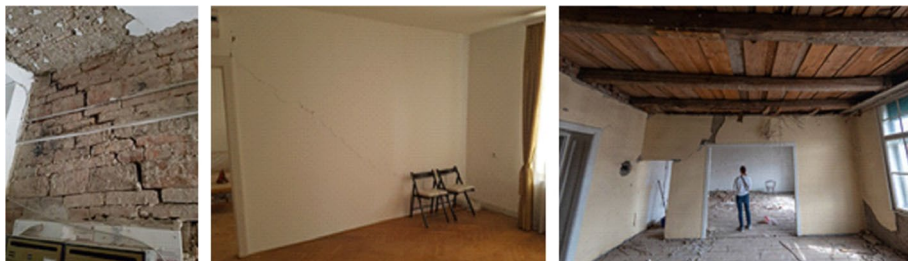
Non-bearing partition walls are mainly 15 cm or even only 7 cm thick. They are supported by wooden joists and are often not uniformly distributed in the vertical direction, what was expected after many adaptations and reconstructions. In case of stronger seismic loading, their contribution to the rigidity of the building is not substantial. As well, due to the low resistance but significant initial stiffness, they are unable to mirror the dynamic deformation of the entire structure and crack regularly. On the other hand, the partition walls constrain out-of-plane displacements of the orthogonal load-bearing walls to some amount, which is of importance to especially long walls. Significant number of damaged partition walls was observed in the direction perpendicular to the bearing walls; a few examples are presented in Fig. 21.

Fig. 21 Typical cracks in partition walls (photos: CCEE 2020)

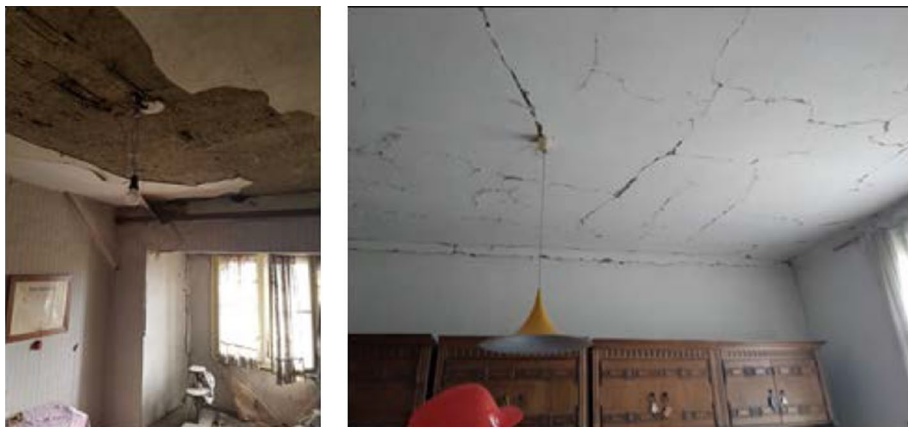
Cracks in the ceilings (floor structure): Cracks parallel to the direction of the wooden joists are most often due to the displacement caused by bending between the joists. Such cracks are within the plaster zone and represent seldom a structural problem as there are rarely tensile forces perpendicular to the joists. Due to the weight of the plaster, this type of damage may pose a threat to the occupants. Other cracks appear at the contact of the wall and the ceiling structure due to the relative displacements between these two elements. Basically, if there is no separation and tilting of the wall, it is again only a matter of cracking of the plaster itself as its tensile strength was exceeded locally (Fig. 22).

Fig. 22 Typical cracks in the ceilings (photos: CCEE 2020)

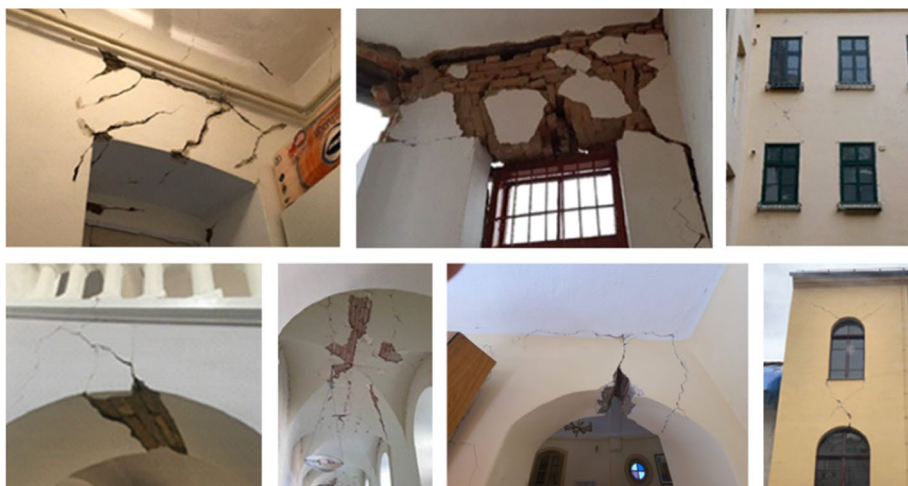
Fig. 23 Cracking of the lintel and vault sections (photos: CCEE 2020)

Damage to lintel and vault sections: Another common form of observed damage was cracking of the lintel and vault sections (Fig. 23). In masonry buildings, openings are often bridged with horizontal wooden, brick or arched lintels. Diagonal cracks in the lintels were sometimes seen in the newer reinforced concrete buildings as well. When the cracks are relatively narrow and of limited extent, they do not necessarily mean any structural failure. However, larger cracks in some cases with material falling off indicate heavy damage to masonry lintels. This type of damage is dangerous and need to be secured against collapsing. Diagonal cracks in the lintel section are due to the exceedance of the shear strength. On the other hand, approximately vertical cracks in vaults are caused by stability disturbance and triggered by exceedance of the tensile strength.

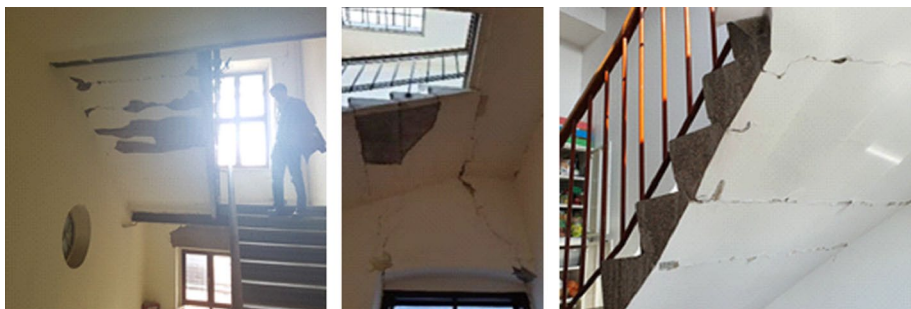
Damage to stairways: Stairways were often damaged in the masonry buildings, where relatively rigid core of thick masonry is found around the staircase (Fig. 24). The older cantilever type of staircase has been mostly replaced and stairs are now often supported by steel girders anchored in the landing zone. This type of damage refers mainly to structural damage in surrounding bearing/landing walls or is due to differential movement between adjacent floors and separation of structural elements. In order to render stairs usable, it was necessary first to clear and prevent additional debris falling in the stairwell.

Fig. 24 Damage to stairways (photos: CCEE 2020)

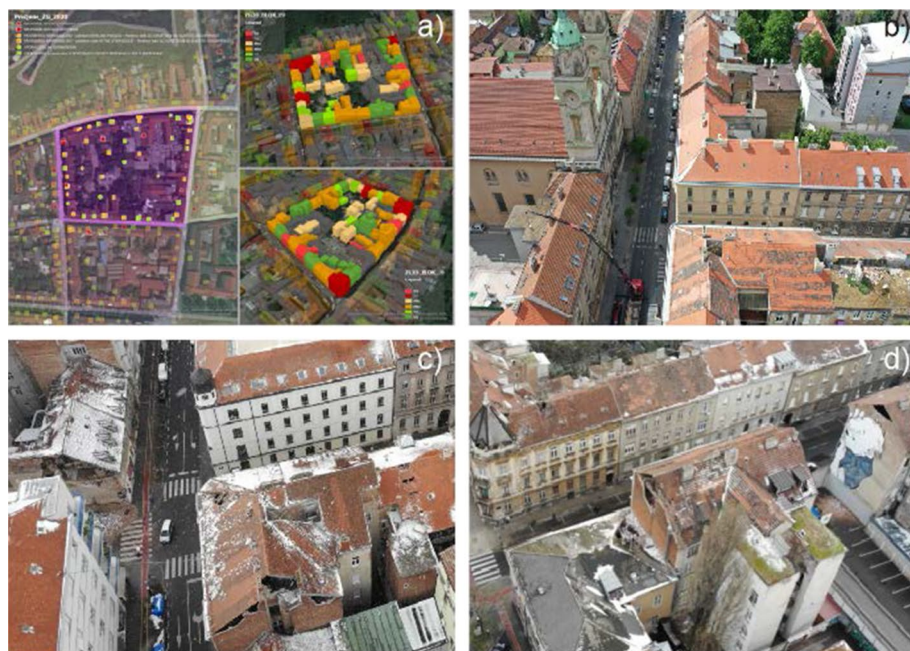
Damage to buildings in blocks: As mentioned earlier, the buildings in the historic downtown are built in relatively regular blocks of 5 or more buildings of varying dimensions, 100×50 m in average (Fig. 25). The sidewalls of these buildings are adjacent to each other and, although there are no common gable walls, they often lean against without any partition. Due to frequent protrusions for drains and/or used water piping, windows, or due to various interventions over time, the gable walls of adjacent buildings are often wedged or joined together. It can therefore be assumed that buildings that are not located at the corner of the block behave more or less as interconnected. The width of the building determines the spanning direction of the floor joists. In general, the floor slabs are supported by the longitudinal walls parallel to the street. This is the stronger load-bearing direction for lateral seismic forces, whereas in the perpendicular weaker direction the stairwell, separation and/or gable walls are unsuited to support significant loads.

The concept of ‘block of buildings’ appeared to be less vulnerable to earthquake loading contributing to fewer damage observations during inspections (Fig. 25). The structural characteristics at the contact with the neighboring buildings, however, remain uncertain and there is a complex interaction in the dynamic response. This further complicated the identification of the cause of damage. Buildings at the corners are generally built with load-bearing walls in both directions, a system which provided relatively

Fig. 25 Examples of observed damage in building blocks: **a** distribution of damage to buildings in a building block (from green: no damage, to red: high damage), **b** buildings without a neighbor on one side, **c** corner buildings, and **d** buildings taller than the surrounding buildings

high seismic resistance. Problems were noticed in buildings that exceeded the height of the rest of the buildings, a common construction practice in Zagreb. There, the damage was concentrated to the prominent "free" floors. Buildings without a neighbor on one side were also susceptible to earthquake damage. Such was the case when the building row was interrupted due to demolition of dilapidated buildings thereby freeing-up space for car parking and access. Damage to these buildings was mainly observed on the free side walls, and occasionally in certain walls within the floor plan and walls facing the neighbor.

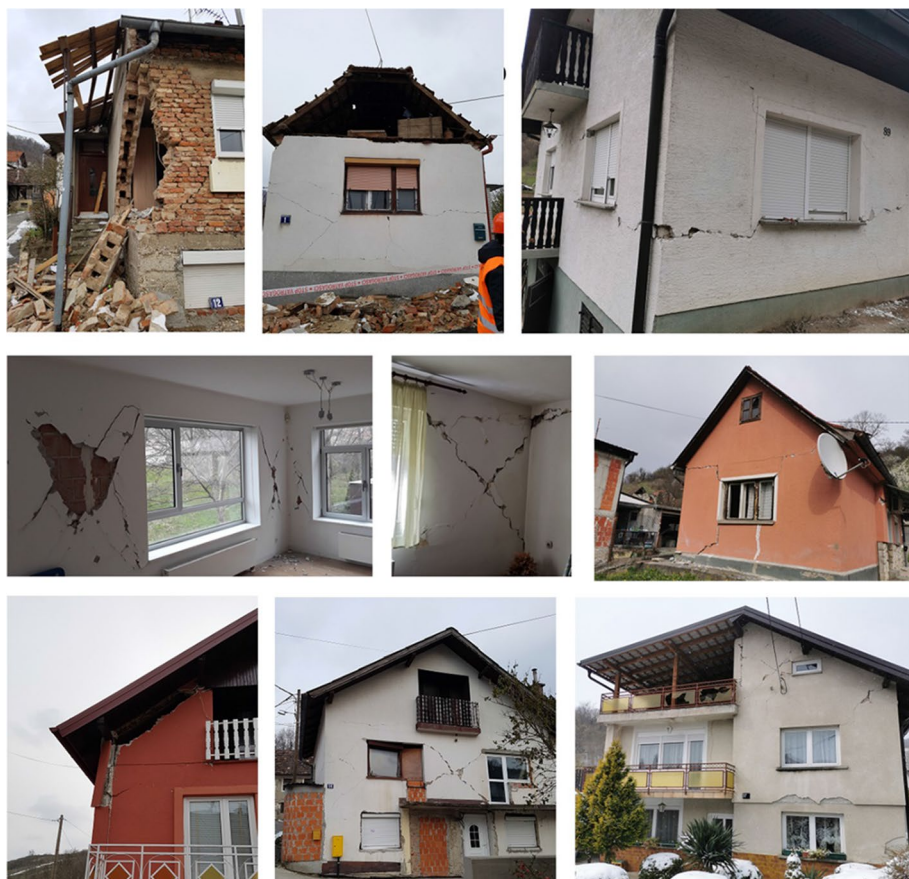
Damage to buildings in the epicentral area: two of the Zagreb neighborhoods are located in the epicentral area, Markuševac and Čučerje. The residential buildings in these areas were built mainly after WW2, most of them with a single residential occupancy. The structural type is mostly brick masonry, reinforced concrete frame with infill brick walls, or a hybrid system without any construction standard. The light roofing material is generally placed or loosely tied at the top edge of the walls. The floor slabs are mainly of prefabricated composite elements resting on the bearing walls, rarely of wooden joists and, in the last decades, of reinforced concrete slabs. The foundation consists of a continuous poured concrete footing and foundation wall or of stone masonry in case of older houses. The brick infill or bearing walls have significant in-plane stiffness, which contributes to the overall stiffness and to reduced deflection to lateral loads. As a result, diagonal cracks were typically observed in all damaged buildings. Damage was most frequent in buildings not properly designed, which have undergone interventions in the structural system (reconstruction, adaptation, enlargement) and/or which were built

illegally without the required building permit and safety inspections. Illegal construction is a problem that plagues communities across Croatia. More than 100,000 applications for legalization were recently submitted in the Zagreb region alone. In Fig. 26 are shown several examples of typical damage to those buildings.

Fig. 26 Damage to residential houses in the epicentral region (authors: Luka Božić, Mario Uroš and CCEE 2020)
