# Seismic performance of strengthened masonry structures: actual behaviour of buildings in Norcia and Campi Alto during the 2016 Central Italy seismic sequence

Romina Sisti<sup>1</sup> · Marco Di Ludovico<sup>1</sup> · Antonio Borri<sup>2</sup> · Andrea Prota<sup>1</sup>

## Abstract

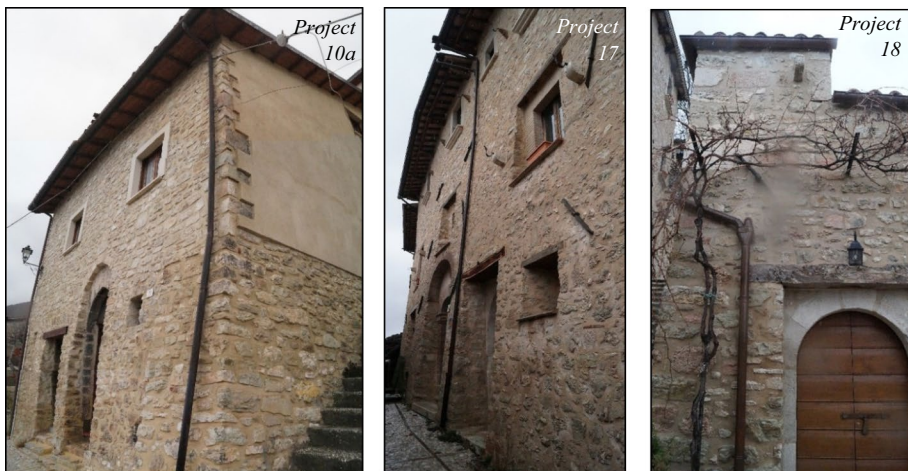
In the N.E.D. group, 3 MSUs had a damage index equal to 0 or 1, see Fig. 18. Although different in size and number of floors, a common factor on such MSUs was the extensive

Fig. 18 MSUs, located in Campi Alto, with no external damage and damage index equal to 0 (project 18) or 1 (projects 10 and 17)

use of strengthening intervention on vertical walls. In particular, the walls that suffered severe damage after the 1979 and 1997 earthquakes were restored by means of several local dismantling and subsequent rebuilding (the so-called “*scuci-cuci*” intervention), and strengthened through G.I. or combining G.I. and R.P. (e.g. project 10, see Annex). Connections between orthogonal walls were improved by inserting S.C. or T.R. (e.g. project 17 and 18, see Annex). Furthermore, a strong replacement of existing walls was carried out by using block masonry (project 10a) or stone masonry (project 17). Thus, extensive intervention on both vertical and horizontal structures clearly led to satisfactory seismic performances of the MSUs. In the remaining 7 MSUs, the damage index resulted in the range of 2–3, however the lack of visible damage prevents understanding the problems that affected these buildings.

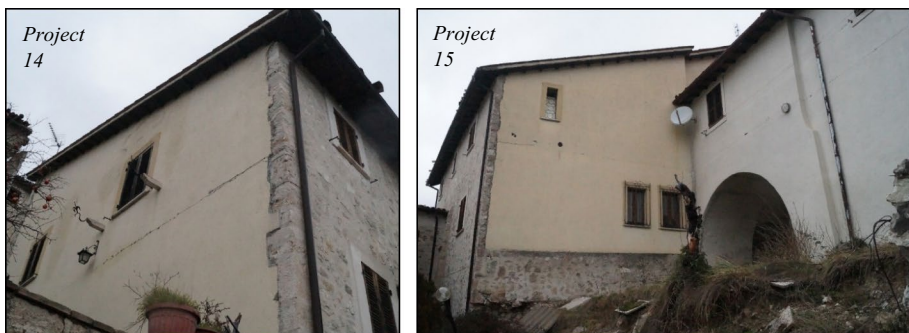
In the E.D. group (i.e. 10 MSUs) the damage index resulted always equal or greater than 2; in 5 MSUs, horizontal cracks, mainly localized at the level of intermediate floors, were detected (see Fig. 19).

Even if the width of the cracks was millimetric, the cracks affect the entire wall thickness and develop along the entire perimeter of the building, revealing the activation of mutual translation between the two portions of the building, above and below the crack. This type of damage was detected on buildings where the upper floors were completely rebuilt, and the cracks were localized on the contact surface between the new floors and the existing ones. The behaviour of such buildings clearly confirms that, in case of reconstruction of floors, it is crucial to properly connect the new floors to the existing ones and vertical structures to horizontal ones. Indeed, in such 5 MSUs the poor attention to details in the adopted strengthening solution was the main reason of the damage detected after the earthquake.

**Fig. 19** Common horizontal cracks at floor level of MSUs located in Campi Alto

Furthermore, the reconstruction of entire floors needs to be accomplished by strong attention on the use of proper connections between new and existing floors in order to avoid the presence of horizontal cracks at the floors interface. This crack pattern reveals a lack of connection between the new horizontal structures and vertical ones (new or existing) and suggests adopting appropriate solutions if similar intervention is carried out in future applications.

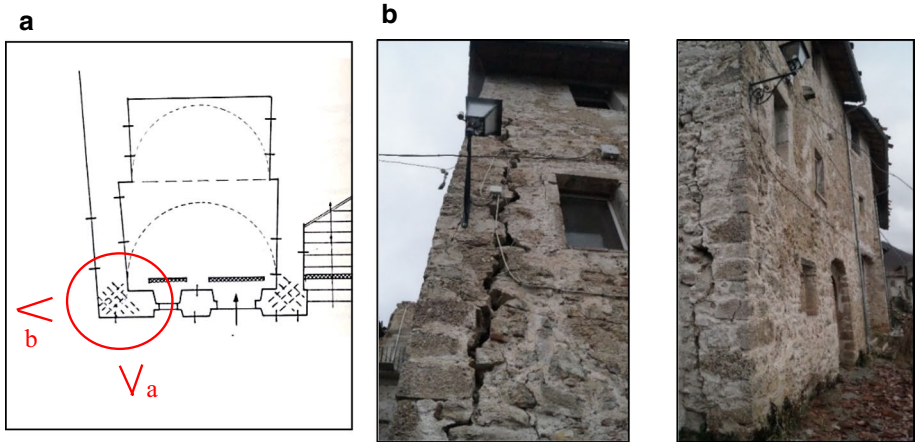
In the remaining 5 MSUs with external damage, the damage was caused by deficiencies correlated to the original vulnerability of the building which were unsolved by renovation works: lack of connections on orthogonal walls and insufficient use of steel connectors as a strengthening technique, (see Fig. 20 related to MSU of project 13); reduced distance between openings and/or presence of openings close to the corners of the building and insufficient use of strengthening aimed at increasing the vertical walls bearing capacity, (see Fig. 21 related to MSUs of projects 6 and 7). In this latter case, MSUs belonging to a row building (adjacent masonry structural units related to each other) reported damages localized at its far end. By analysing the ground floor plan (Fig. 21a), it can be noted that the openings are very close to the corners and the

Fig. 20 Project 13: poor connection of orthogonal bearing walls of a MSU located in Campi Alto

The use of connectors at building corners is crucial to avoid significant damage and collapses and they should be adequately designed (i.e. number, length). Finally, the realization of new heavy roof should be accomplished by strong intervention aimed at increasing the mechanical properties of bearing walls or it can resulted detrimental for the MSU seismic performances.

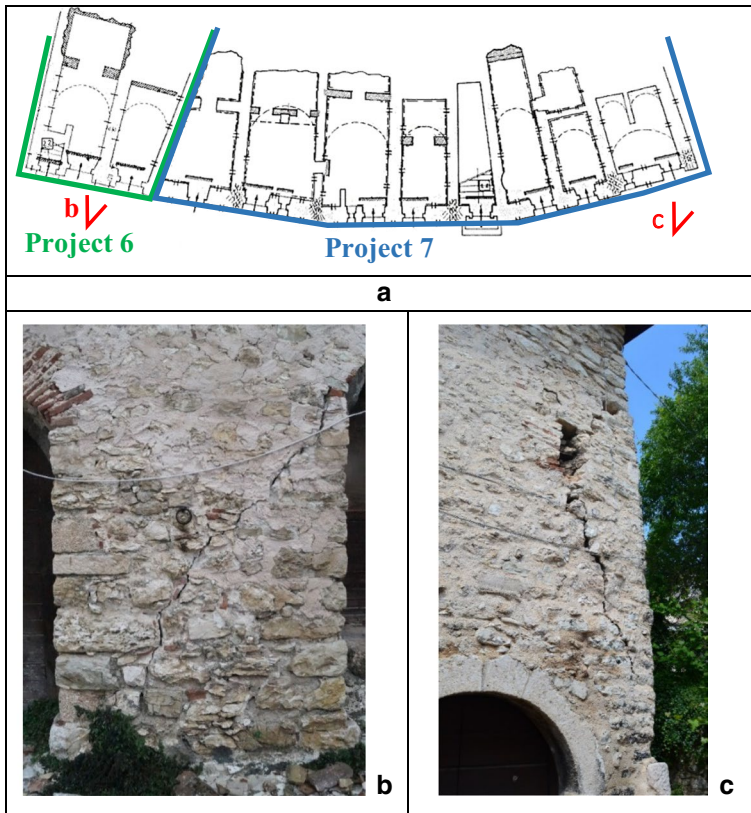
Fig. 21 Projects 6 and 7 (Campi Alto): a MSUs ground floor plan. b–c Damage at the far end of the row building

distance between openings is very small; these two features cause a lack of masonry area that led to the formation of shear cracks in two bearing walls (Fig. 21b, c).

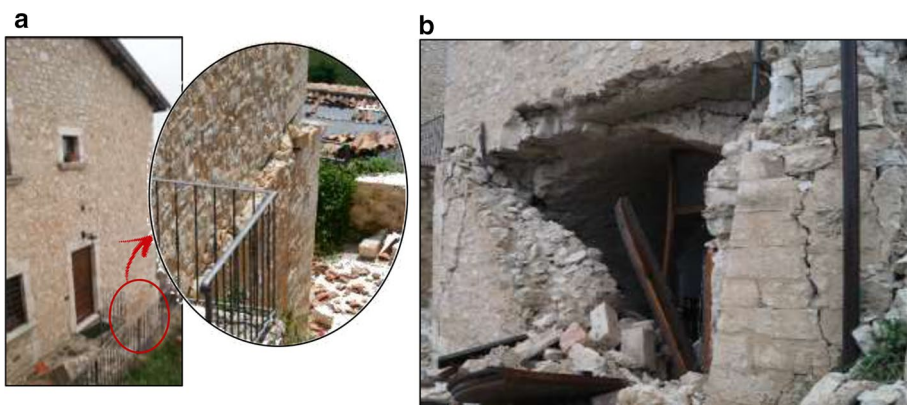
The P.C. group involved 6 MSUs with a damage index ranging between 3 and 5. In all cases the bad quality of masonry led to partial collapses. In particular, the uncomplete replacement of original existing wall in the strengthening interventions designed after 1979 seismic events led to partial collapse of ground floor with limited damage on the upper ones. In particular, the load-bearing walls of the first, second and third floors were demolished and rebuilt with block masonry while ground floor vertical walls were strengthened by G.I. in project 4, see Annex A and Fig. 22. After the 2016 seismic sequence the building experienced a rigid rotation of the three upper floors (with no damage, Fig. 22a) with respect to the ground floor where a large portion of the façade collapsed (Fig. 22b). Thus, the G.I. on ground floor resulted ineffective or insufficient to improve the quality of the masonry at the ground floor and this, along with the presence of two too wide openings in relation to the wall dimension, led to the crumbling of the wall; tie rods were clearly ineffective because of poor quality of masonry wall. Similarly, the masonry at left corner of ground and first floor crumbled due to masonry bad quality in the MSUs of project 8 (see Fig. 23a); also the upper floors suffered damages limited to the walls that were not rebuilt after 1979 seismic events. In the MSU of project 2 an extensive collapse was detected: the original stone masonry of the ground floor and first floor crumbled (Fig. 23b); in addition, the external layer of stone masonry, applied only for aesthetic reasons, collapsed due to the lack of connections with the load-bearing block masonry behind it.

**Fig. 22** Project 4 (Campi Alto): **a** rigid rotation of replaced floors with respect to the ground floor; **b** crumble and collapse of poor masonry wall at ground floor

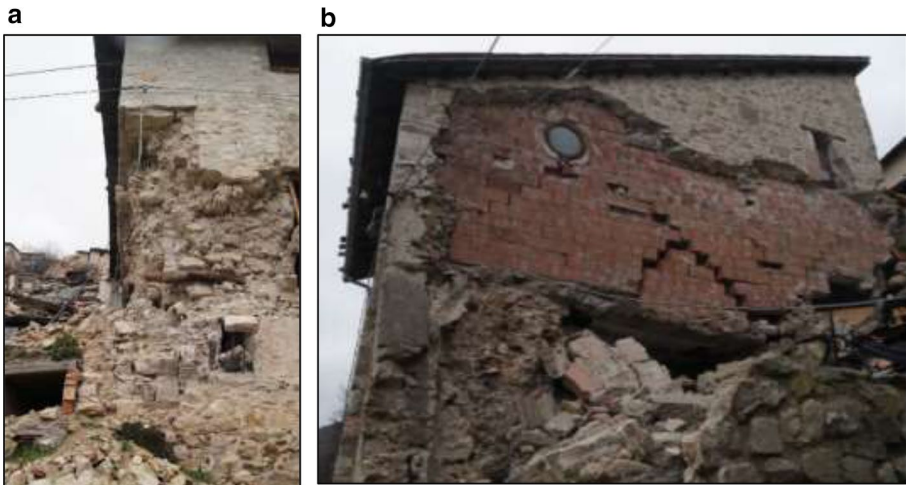
The collapses observed in Campi Alto were mainly caused by poor masonry quality. No out-of-plane mechanisms of wall panels were observed, this is certainly due to the positive action of spurs and buttresses built after the 1859 earthquake and to the insertion of tie rods and the improvement of the connections between orthogonal wall and vertical and horizontal structures carried out in the most recent interventions.

**Fig. 23** **a** Project 8 (Campi Alto): crumble of masonry walls at ground floor; **b** Project 2: collapse of the masonry walls at ground and first floor

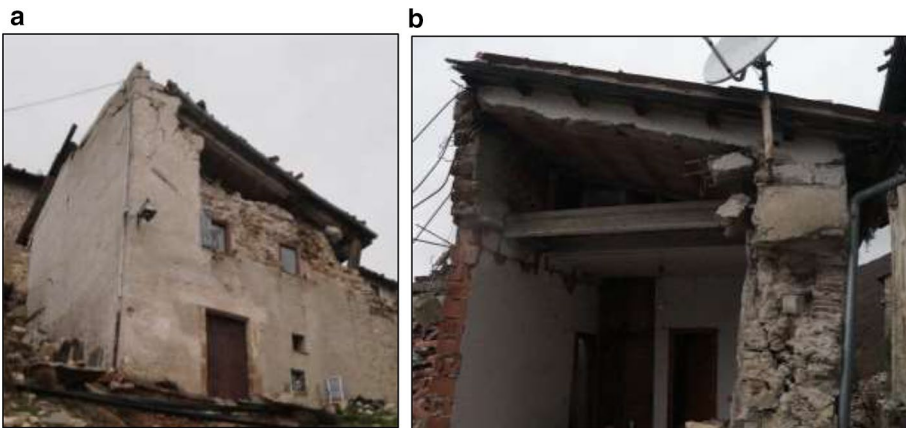
Severe damage after the 2016 sequence was also observed in case of MSUs strengthened by using a very heavy and rigid roof on a bad quality walls which were not adequately reinforced by extensive use of G.I. and R.P. as originally designed, (e.g. MSU of project 11, see Annex A and Fig. 24).

**Fig. 24** Project 11 (Campi Alto): collapse of poor quality masonry walls due to the presence of heavy roof: **a** downstream façade; **b** lateral section
