Damage observations of RC buildings from 2023 Kahramanmaraş earthquake sequence and discussion on the seismic code regulations

Abstract

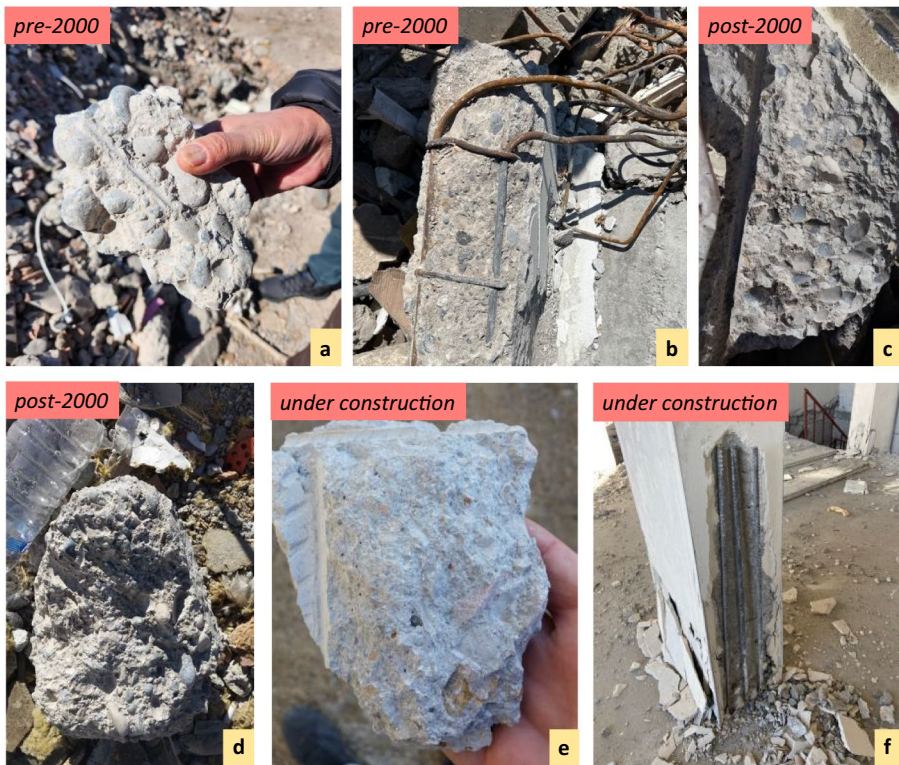
Fig. 4 Partially collapsed pre-2000 building in Osmaniye with inappropriate aggregate and mixture of concrete (a), bond failure of corroded smooth reinforcement (b). Heavily damaged post-2000 building in Kahramanmaraş with inappropriate aggregate and mixture of concrete (c and d). Heavily damaged under construction building in Malatya with inappropriate aggregate and mixture of concrete (e) and lap splice of reinforcement (f)

widespread usage of ready-mix concrete and ribbed reinforcement with larger yield strength capacity, still there are issues observed in the field regarding the use of inappropriate aggregates in terms of shape and granulometry, leading to bonding failure between reinforcement and concrete (Fig. 4c–f). Moreover, the high-strength ribbed reinforcement used in walls and columns of several post-2000 buildings were subjected to brittle fracture in shear and in axial tension as shown in Fig. 5. Such failures of reinforcement deserve attention since the design of post-2000 buildings primarily relies on ductility, a significant portion of which is stemming from the ductile behavior of reinforcing steel as a material by itself.

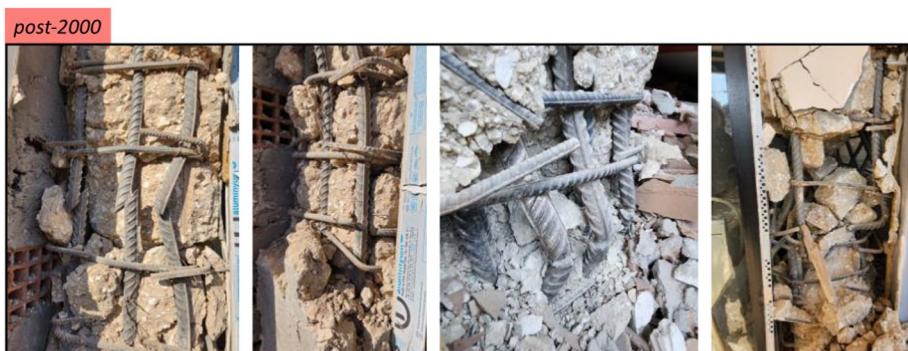
Fig. 5 A heavily damaged building from Hatay with brittle fracture of reinforcement

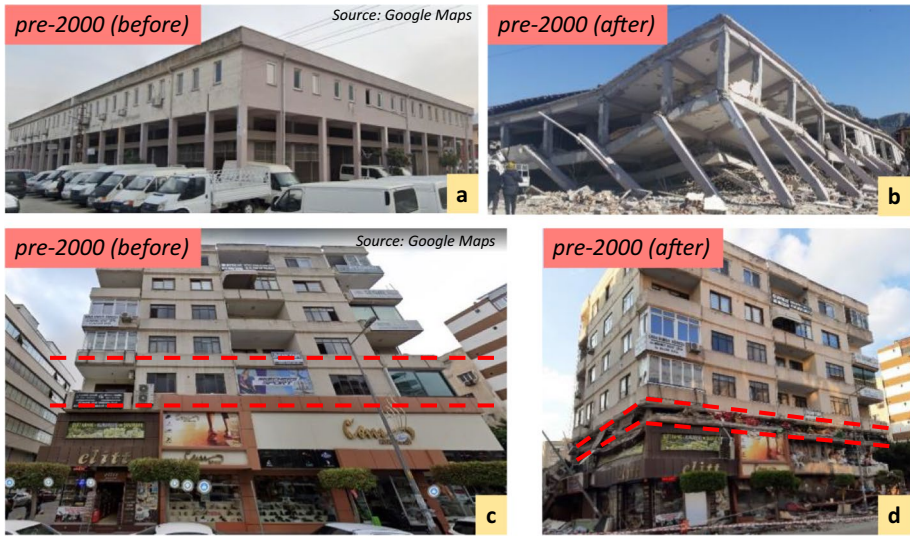
As in previous earthquakes in Turkey, the formation of a storey mechanism has been the reason of collapse of many RC buildings after Kahramanmaraş earthquakes. Surprisingly, among them there were many post-2000 buildings, which exhibited the very same weakness (Figs. 6, 7, 8, 9, 10), despite the fact that they were designed in line with the regulations for irregularity in elevation as well as strong column—weak beam concept introduced in the seismic code to eliminate this structural deficiency. Although no hard evidence is available, a plausible explanation for the collapse of the intermediate storey shown in Fig. 6c and d could be the formation of a weak-storey mechanism, attributed to the lack of infill walls (this floor was used as storage of the shoe shop beneath).

Fig. 6 Collapse of a 2-story old building in Hatay due to soft-storey mechanism (a and b), and collapse of the intermediate storey of a 40-year-old building in İskenderun (c and d)

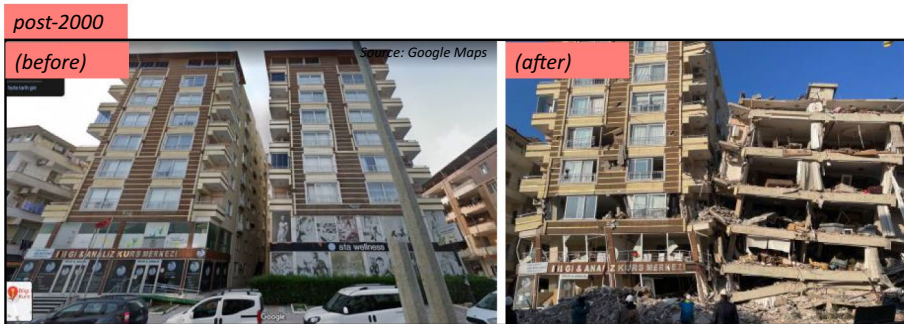
Indicative of the soft-storey collapse mechanism in post-2000 buildings, two identical buildings in Hatay are presented in Fig. 7. The building on the right collapsed due to a soft-storey mechanism, while the one on the left leaned towards left possibly after

Fig. 7 Collapse of two identical buildings due to soft-storey mechanism in Hatay

pounding with the collapsed one. Considering that the two blocks must have been identical, a construction error or a small difference in design must have caused this result.

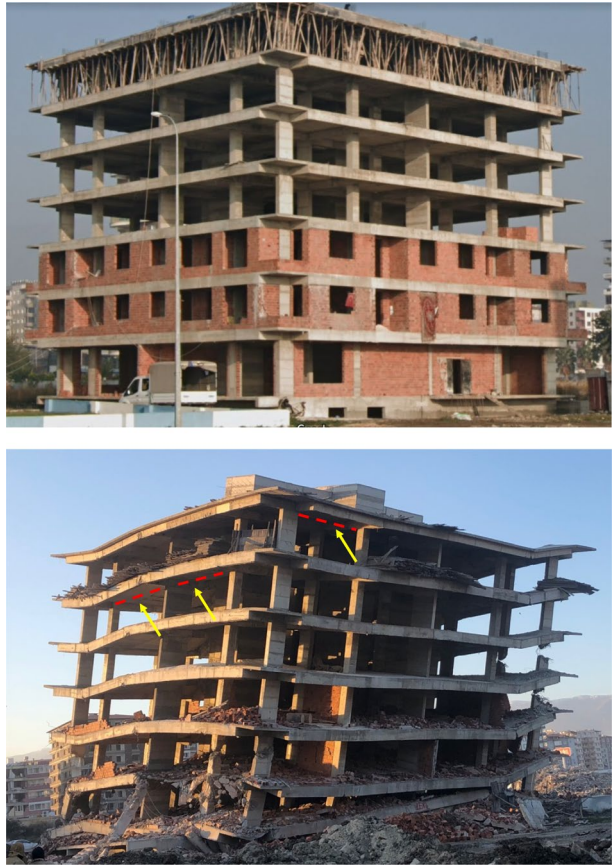
Another new building located in Hatay (Fig. 8), still under construction, developed a soft-storey mechanism, despite the fact that it had not received all the design loads yet, such as the permanent loads from finishing of floors and infill walls, as well as the portion of the live loads. Although the pre-collapse picture (Fig. 8) indicates beams inside the structure, the perimeter beams are absent, not allowing to form a frame action. This is a repeated deficiency in many other damaged and collapsed buildings. Additionally, the presence of a higher ground floor can probably be one of the main causes of this collapse. Similarly, the building in Fig. 9, constructed in 2019, had all the perimeter columns oriented perpendicular to the façade, weakness that led to collapse as the building swayed in a direction parallel to the weak direction of these columns.

Fig. 8 Building under construction in Hatay (above, Google Maps), and collapsed (below) due to storey mechanism (note also the missing perimeter beams between the columns)

Missing perimeter beams between the façade columns is a very common practice in Turkey, that was spotted and analytically proven to be problematic for the pre-2000 buildings (Bal and Özdemir 2006). However, the current seismic regulations still allow this application. According to all the Turkish seismic codes from 1975 (TSC 1975) to 2018 (TBSC 2018), an RC structure without proper frame action (i.e., no beams between columns) is possible to be designed and built. Article 4.3.4.5 of the TBSC 2018, as well as equation 4.2 of the same article relate the frame action to the participation of the shear walls in the overall overturning moment, a condition which is satisfied even if the beams are eccentrically connected to the column heads or no continuous beams are connected between columns along major axes of the building. The behaviour factor for design is selected simply based on the contribution of the wall and the frame to the overall overturning moment. In the design the building is still considered to be a *ductile frame structure* and thus the benefit of a high behaviour factor, up to the level of 8, which decreases the lateral load coefficient significantly, is still possible.

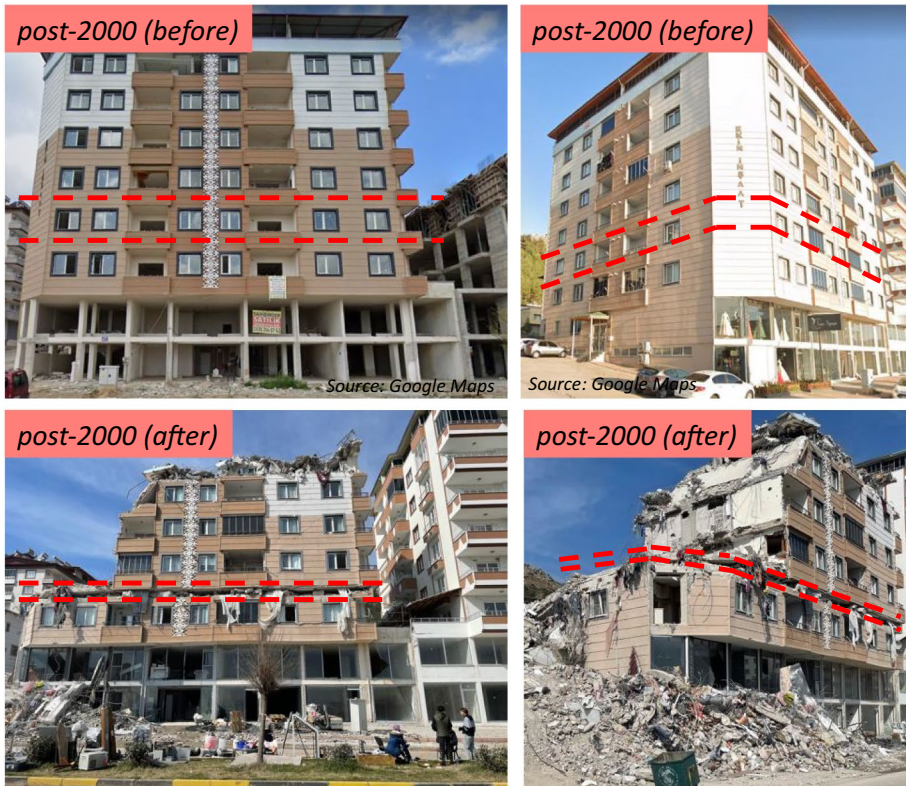
Fig. 9 Collapse of the intermediate story of a post-2000 building in İslahiye (note that the left side of the building was being demolished at the time of the reconnaissance visit)

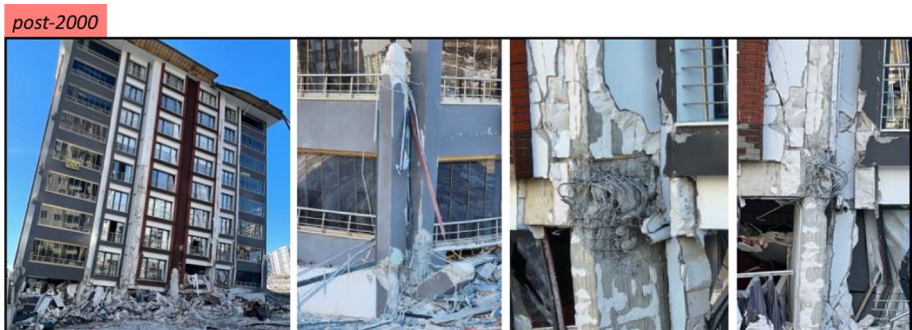
Another characteristic example is the recently constructed building shown in Fig. 10, one of the two blocks of Asur Sitesi, Yeşilyurt, Malatya. Although the building survived the first earthquake of Mw7.8, it did eventually collapse over the ground floor during the second earthquake of Mw7.5. One can argue that the structure received two strong

Fig. 10 Collapse of a new building in Malatya due to soft-storey mechanism, compression and shear failure at beam-column joints

earthquakes, one after the other, which may be beyond what was foreseen in the design, however, poor detailing at the beam-column joints stood out as shown in detail in Fig. 10 and must have certainly contributed to the collapse. Although, design of beam-column joints was regulated in the 1975 code and these regulations have become stricter in the

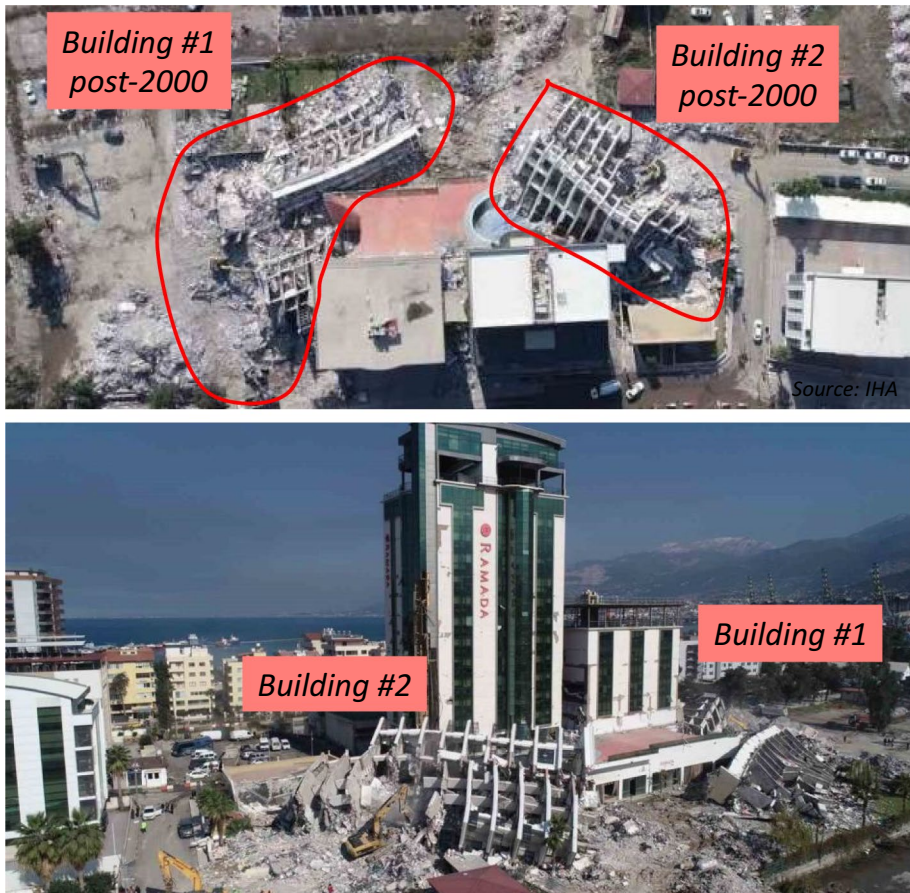
Two of those collapsed buildings, located in İskenderun, are presented in Fig. 11. Building #2 had 13-stories and an RC infilled joist-slab system (*asmolen*), including columns and RC walls. Most likely, because of torsional irregularity, the building twisted while it

Fig. 11 Two post-2000 buildings collapsed in İskenderun (IHA 2023)

One may think the possible effect of the high vertical acceleration component in this type of overall collapse shown in Fig. 11. Incomplete data from the AFAD station #3112, at 2.5 km distance to the location of the collapsed buildings and situated on soft soil deposits, present a maximum vertical acceleration of 0.85 g, which indeed is high. However, it was shown by various researchers earlier (an analytical example can be found in Gazetas et al. 2008) that the vertical component may not play as significant role as believed, for two basic reasons; (1) difference in the frequency content of the horizontal and the vertical components, in combination to the high-frequency behaviour of structures in vertical direction, and (2) extremely low probability of the peaks of horizontal and vertical motions to coincide.

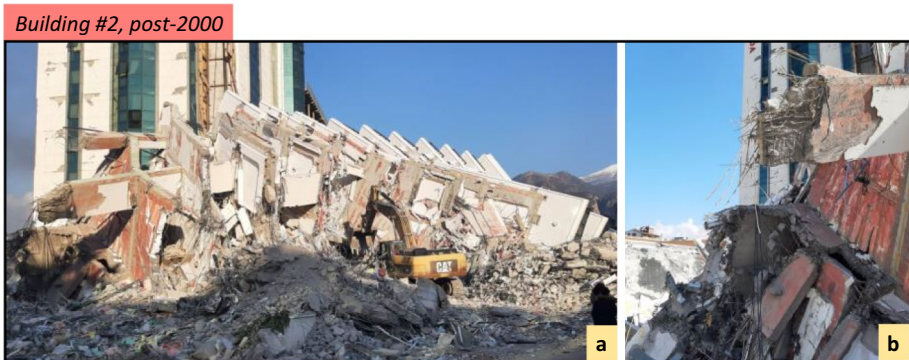
uprooted. Presumably bond-slip failure took place at the end zone of walls and columns, slipping out of the foundation (Fig. 12).

Fig. 12 Collapse of a post-2000 building (Building #2 in Fig. 11) in İskenderun (a), focus on the failure of the ground floor columns at the base (b)

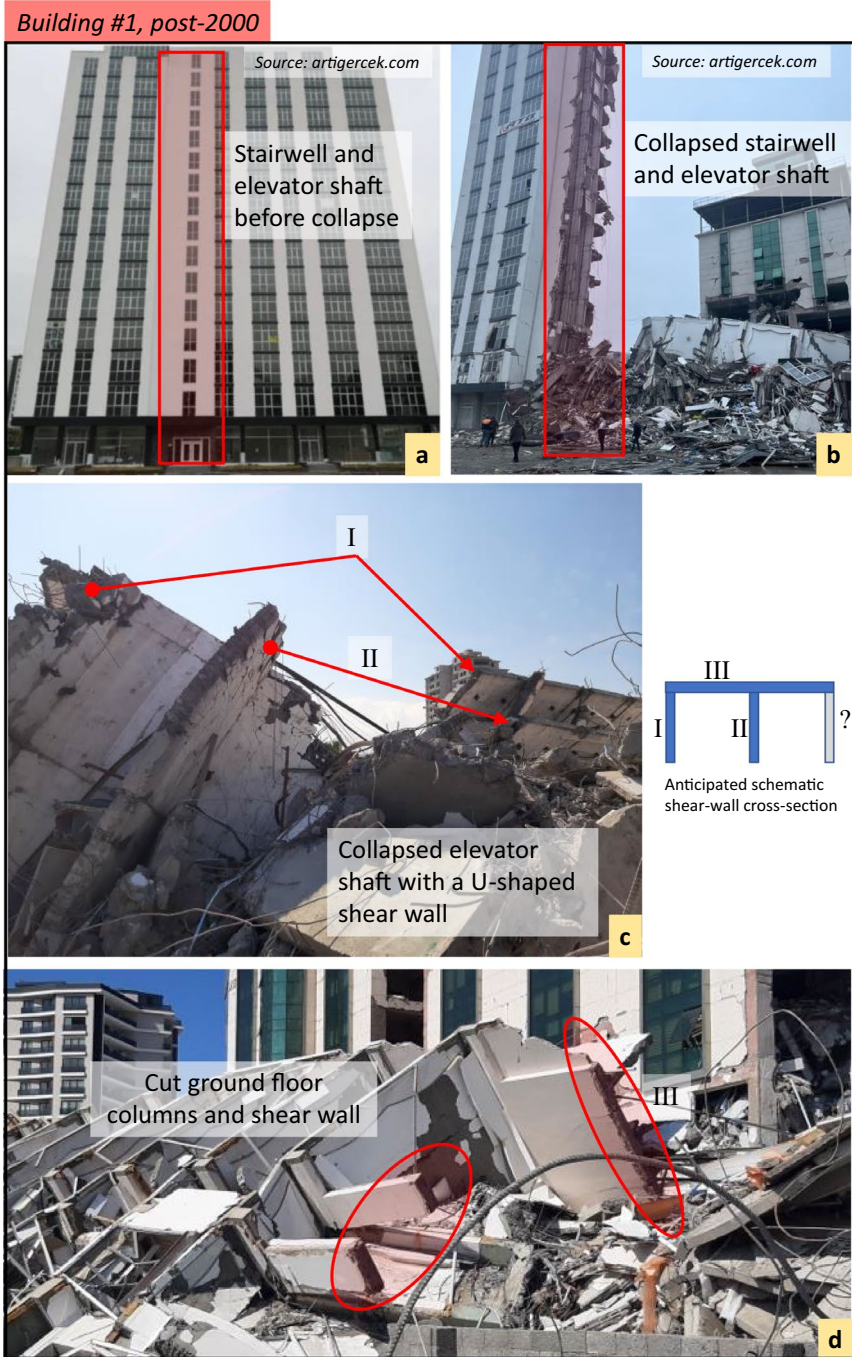
Building #1 (Fig. 13) had 16 stories, was constructed in 2019 and was characteristically narrow and tall in plan. The approximate dimensions obtained from satellite images and street views is 40 m/10 m/45 m (length/width/height). As deduced from available images, the building partially collapsed after the first Mw7.8 earthquake. The right wing of the structure, together with the elevator shaft and the stairwell collapsed, entrapping people in the other half of the building. The remaining half of the building collapsed in the second Mw7.5 earthquake, leading to an estimated death toll of more than 100 persons.

As can be clearly seen in Fig. 13d, its perimeter columns and walls were not connected with beams in the longitudinal direction resulting in reduced moment resisting frame behaviour (see previous discussion). It is possible that the seismic loads could not be transferred to the core wall system at the elevator shaft via the slabs during the first earthquake, causing partial collapse of the right wing. This explanation is supported by the collapsed slab pieces hanging from the remaining part of the building (Fig. 13b). Although there was two opposite facing U-shaped RC walls at the elevator shaft, they were placed only in the one third in plan of the structure causing torsion irregularity.

Furthermore, in a wall-frame structure the presence alone of a core wall does not entail the wall will work as intended under large seismic actions if not properly connected to the frames. The two U-shaped shear walls forming the elevator shaft had flexural cracks at their bottom (Fig. 13c), while the upper part completely disconnected. In other words, while the wall base worked in flexure, the upper portion of the wall, not

Fig. 13 Collapse of the 16-story building in İskenderun, Building #1 (aka MCG Tower) (a), semi-collapsed situation between the two earthquakes (b), source of a and b: (Artigerçek 2023), cut building and the base of the U-shaped RC wall (c), cut ground floor columns and shear wall (d)

withheld by frames, could not accommodate the lateral displacements that were further increased by second-order moments. The aspect ratio of the structure (i.e. width / height) did not work favourably. It should be noted that the seismic design is usually done in practice using linear elastic analysis. After the 1998 Turkish seismic code, there are checks in the code regarding the possible second-order effects, as well as the maximum inter-storey drift ratios. However, it is possible that these checks being in fully linear elastic range may not capture the actual response of the structure in the largely nonlinear region.

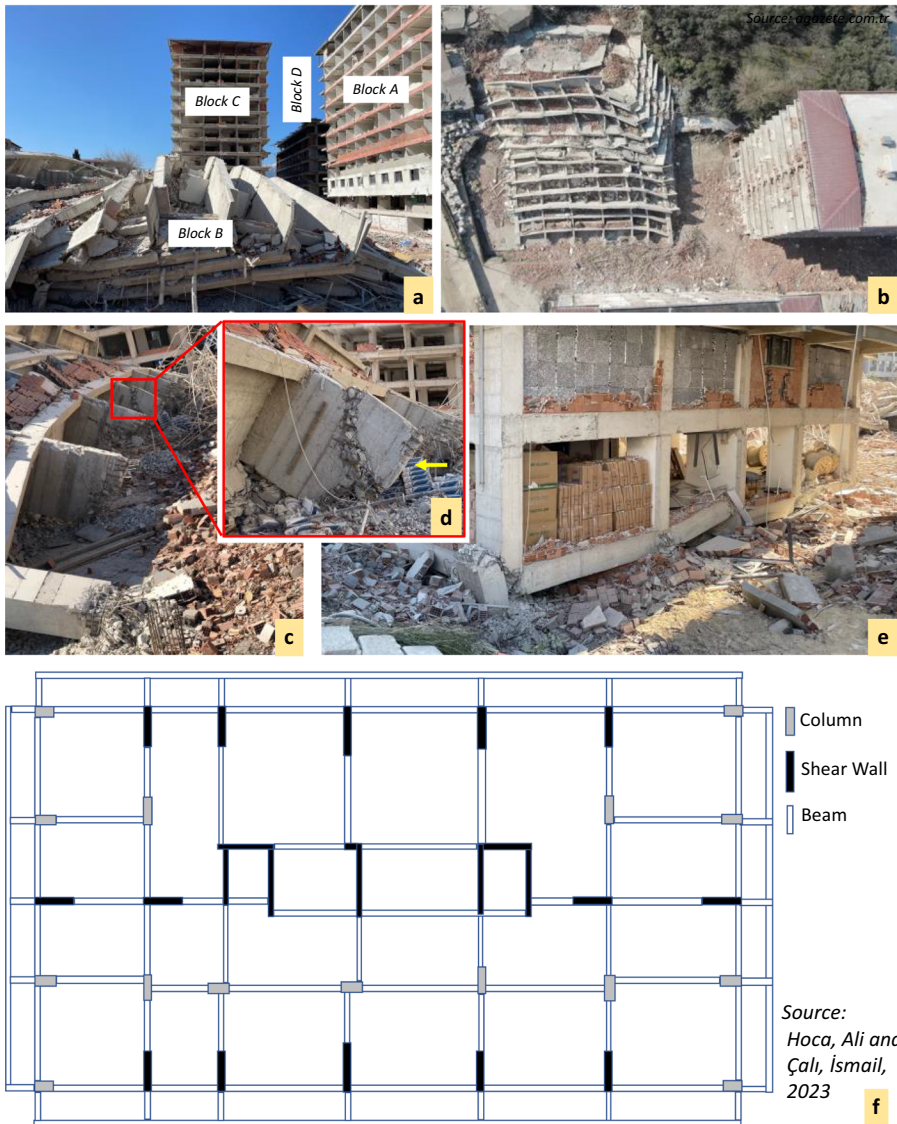
The case of the collapse buildings in the *Altınpark 2 Sitesi* apartment complex in Hatay is presented in Fig. 14. The residential complex consisted of four identical RC blocks with moment resisting frames and structural walls in their structural system, as shown in the formwork plan in Fig. 14f. Blocks A and B collapsed. A soft-storey mechanism over the basement led Block A to collapse (Fig. 14e). Block B was uprooted: column and wall failure at foundation level (Fig. 14c) indicated large moments along the strong axis of these elements resulting in fracture of the longitudinal reinforcement.

The buildings had one basement floor and eleven floors above ground, and were not symmetrical in plan in the two directions. In the centre of each building there were two U-shaped walls in the elevator shafts and one L-shaped wall between the two staircase shafts. These U- and L-shaped walls were not coupled with beams, hence they did not constitute a coupled core wall system. There are RC walls perpendicular to the façade in both directions, connected with beams in their weak axis mainly, but in their strong axis the connection between these walls and the ones in the centre is practically ineffective, i.e. few walls are directly connected to each other, instead a column comes in between to which beams are eccentrically connected. Discontinuous beams entail interrupted load paths and extremely weak joints. Such *awkward* configurations, where columns and walls are placed and connected basically randomly in a grid, are widespread. They are considered code-compliant structures but in fact they behave as substandard, as they do not achieve transfer of loads and do not constitute an appropriate structural system from a structural earthquake engineering point of view.

Fig. 14 Blocks of Altınpark 2 Sitesi under construction during the earthquakes (a), collapsed Block B, source: <https://agazete.com.tr> (b), uprooted columns of Block B above basement level (c), failure of perimeter shear wall of Block B and cut wall base (see the yellow arrow) (d), collapse over the ground floor in Block A (e), and a schematic ground floor formwork plan, without dimensions, of the blocks (Hoca and Çalı 2023) (f)

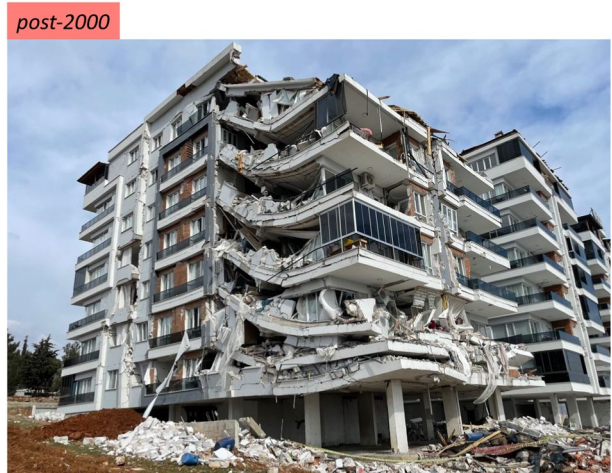
In the Turkish building stock, infilled joist slab system (asmolen) has been commonly used for decades. Although this slab system may provide some economical and architectural advantages, it presents serious adverse effects in terms of seismic resistance. Primary beams usually have 30-37 cm depth, which do not provide sufficient stiffness to create a proper frame action and to limit lateral displacements. Secondly, a thin layer of 7-10 cm topping does not provide necessary amount of strength and in-plane stiffness for the loads to be transferred to columns and walls. Although stricter rules were introduced in the 2018 seismic code, a significant portion of the RC building, built in the period from 2000 to 2018, possesses this weakness. In Fig. 15, for example, a post-2000 building built with infilled joist slab system has partially collapsed during the 2023 Kahramanmaraş earthquake sequence.

Fig. 15 Partial collapse of a building designed with infilled joist slab system in Nurdağı, Gaziantep

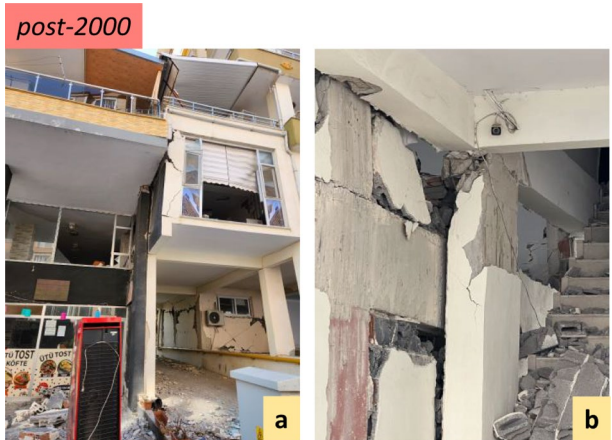
Pounding or hammering of buildings which can be defined as crashing of two adjacent buildings having stories at same or different elevations, respectively, are also observed in 2023 Kahramanmaraş earthquakes. Figure 16 shows an example where the slabs of adjacent buildings are not at the same level, resulting a severe hammering damage. Despite all the precautions made after 1999 earthquakes, such well-known deficiency still continues due to lack of strict design and construction controls. Several buildings sharing the partition wall of the adjacent one are reported by the authors, confirming that there was no spacing at all between two adjacent buildings.

Fig. 16 Hammering of two adjacent buildings in Hassa, Hatay (a), inside look from the building on the right (b)

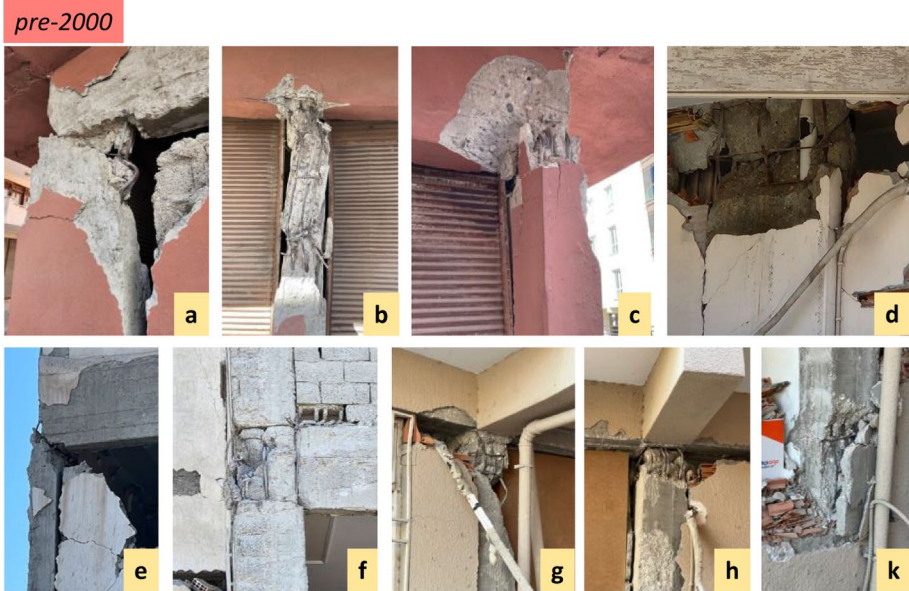
Fig. 17 Heavily-damaged building in Osmaniye, buckling of smooth reinforcement, shear failure of column & beam-column joint (a, b and c), Heavily-damaged building in İskenderun, pipeline passing through a column (d), shear failure of column & beam-column joint (e and f), Heavily-damaged building in Hatay, buckling of column reinforcement (g, h and k)

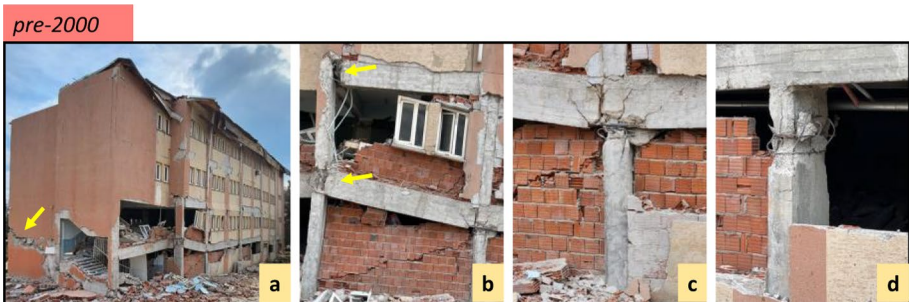
Fig. 18 Old school building with heavy damage in Nurdağı, Gaziantep, shear failure of the shear wall (a), shear failure of beam-column joints (b), and buckling of column reinforcement (c and d)

buildings are not known, the former could reasonably be result of a code-compliant calculation, the wall however still failed and the insufficiency of the stirrups also manifests itself with the buckled vertical reinforcement. The spacing of 25 cm for the transverse reinforcement of such critical U-shaped wall cannot be code-compliant, so the main reason of the failure of the walls in the 8-storey building is either a design mistake and/or a construction error.

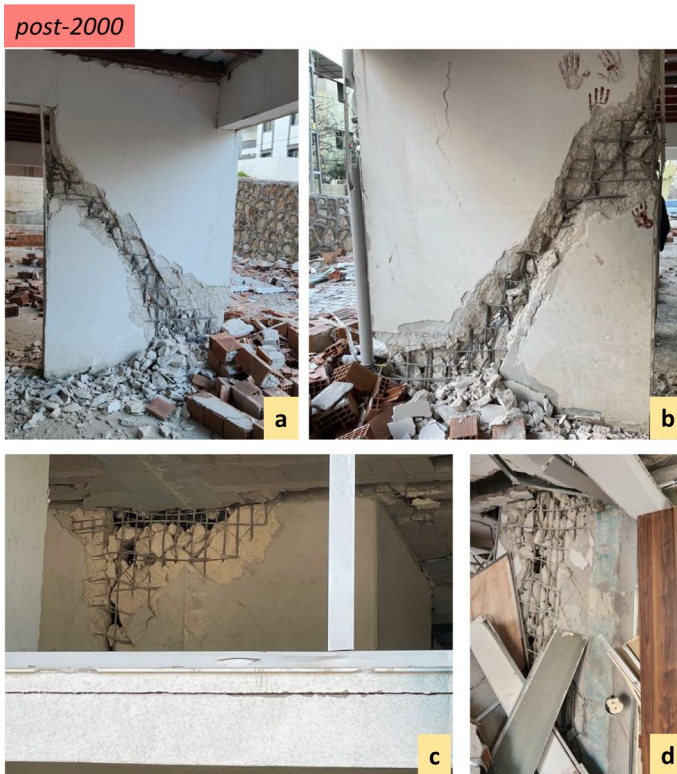
Fig. 19. 9-storey building with heavy damage in Hatay, presenting shear failure at both sides of a structural wall (a and b), 8-storey building with heavy damage in Hatay, with shear failure of structural walls (c and d)

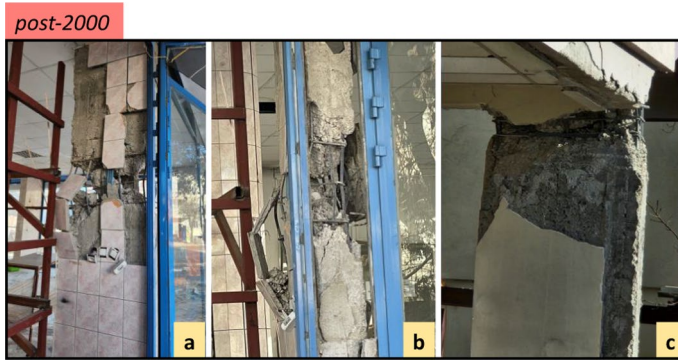
confinement reinforcement for the column end zones by means of an empirical formula, taking into account dimensions of columns, characteristic concrete compressive and reinforcement yield strength, and then automatically increase the spacing for the mid-zone of columns to double of that of the end zones, without actually re-checking the shear capacity of the column as a whole. An example of this is shown in Fig. 20, where a column of a 5-storey post-2000 RC building presumably exhibits a shear failure in its mid-height of which inclined compression stress due to shear likely played an important role as observed from the direction of large cracks and splitting. In the same building, narrow spacing of stirrups can be identified in the corner column, probably result of deficient design and/or construction, even flexural failure at the column top end was present (see Fig. 20c).

Fig. 20 A 5-storey post-2000 building with heavy damage in Elbistan, Kahramanmaraş, shear failure at the mid-zone of the columns with wide stirrups spacing (a and b), and flexural failure at the column top (c)

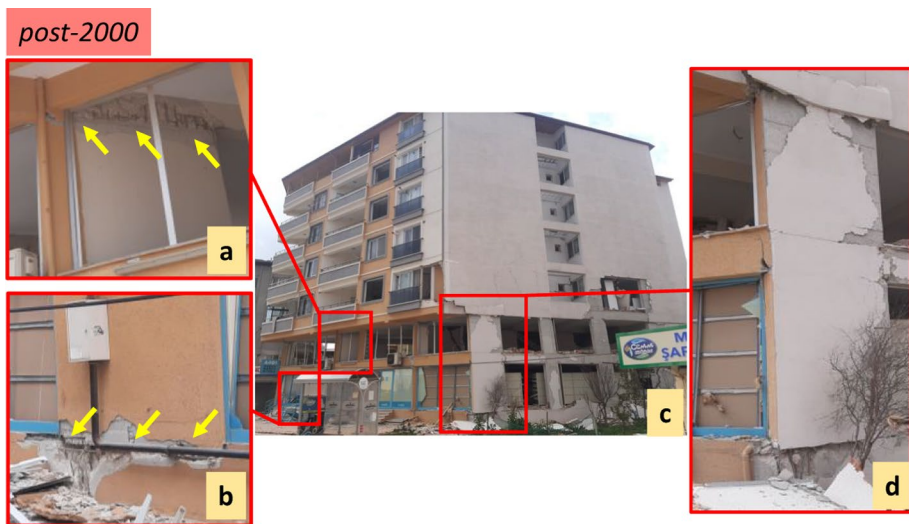
Seismic loads assumed to be acting at storey levels are also transferred to walls through slabs with shear-friction mechanism. In several RC frame-wall buildings, sliding shear failures (exceedance of the shear-friction capacity) are observed at the contact surface between two adjacent wall segments, wall-foundation or wall-slab interface. Sliding shear failure occurred at the perimeter wall of Block B of Altunpark 2 Sitesi, Hatay, while sliding shear is visible at the wall-basement interface (Fig. 14d). In Fig. 21, out-of-plane sliding shear

Fig. 21 In-plane sliding shear behavior between two adjacent wall segments (a) and out-of-plane sliding shear failure at wall-foundation interface (b–d) of a 7-story building (c) in Hatay

behavior at the wall-foundation interface and in-plane sliding shear behavior between two adjacent wall segments at construction joint of a 7-story building are also visible.

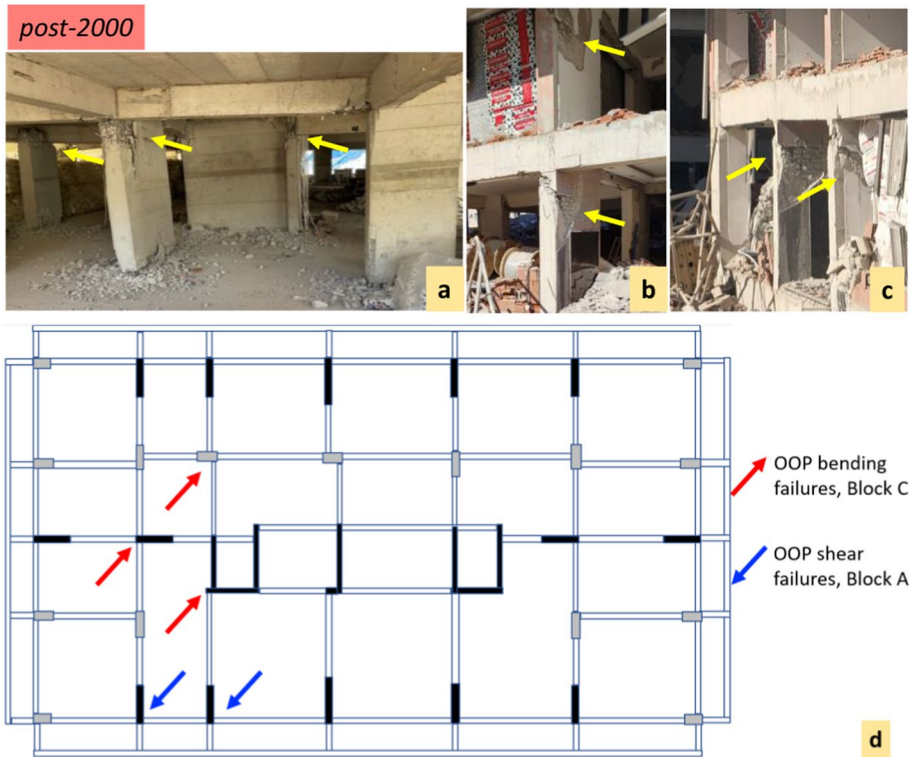
Out-of-plane shear and bending failure of RC walls causing partial or total collapse have also been reported. In Fig. 22, out-of-plane bending failure of an RC wall of Block C of Altınpark 2 Sitesi, as well as out-of-plane shear failure of perimeter RC walls of Block A are shown. Note that the out-of-plane action has also caused fracture of the longitudinal wall reinforcement. In Fig. 23a–e, an 8-storey building with clear out-of-plane shear and bending failures on the RC walls is presented. Considering that the aforementioned buildings were built after 2000, these failures can be result of a common flaw in the design, i.e., the underestimation of the out-of-plane seismic force demand. Similarly, a heavily damaged building in Hassa, Hatay, where residual storey drifts at the bottom four stories can be readily identified (Fig. 24b), experienced out-of-plane failure of a major perimeter RC wall (Fig. 24a, c, d), indicating a design and/or construction flaw. Torsional failure of L, T, C or other polygonal shape structural walls or columns in which beams generally connected to the end of elements and load path was concentrated in this area is another damage type observed in the earthquakes.

Fig. 22 Out-of-plane bending failure of structural wall of Block C (a) and out-of-plane shear failure of structural walls of Block A (b–c) of Altınpark 2 Sitesi, Hatay

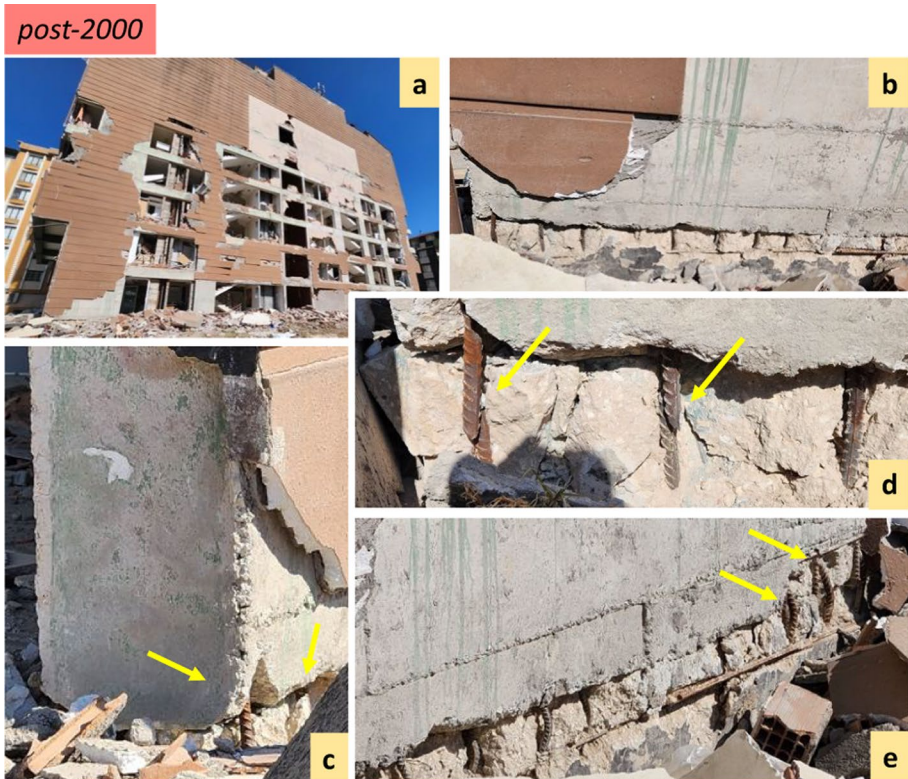
Fig. 23 Heavily damaged building in Hatay (a) with out-of-plane shear failure of RC wall, resulting in brittle shear failure, fracture and buckling of the vertical reinforcement (b–e)

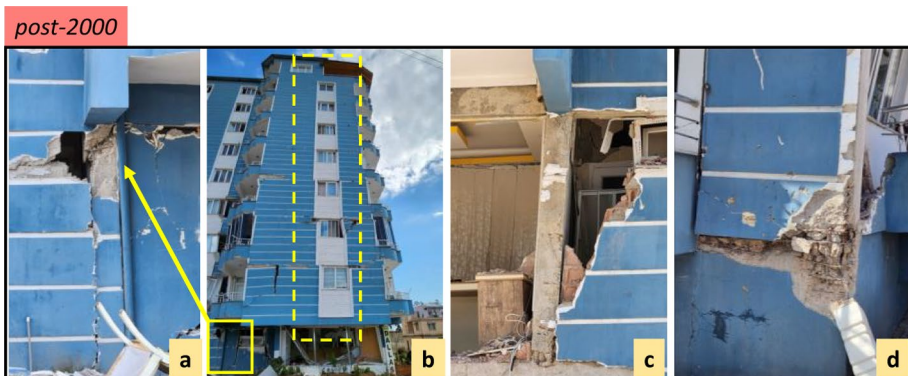
Fig. 24 Heavily damaged 10-story building in Hassa, Hatay with a large residual drift at first four stories (b), and out-of-plane bending and shear failure of the structural wall (a, c and d)

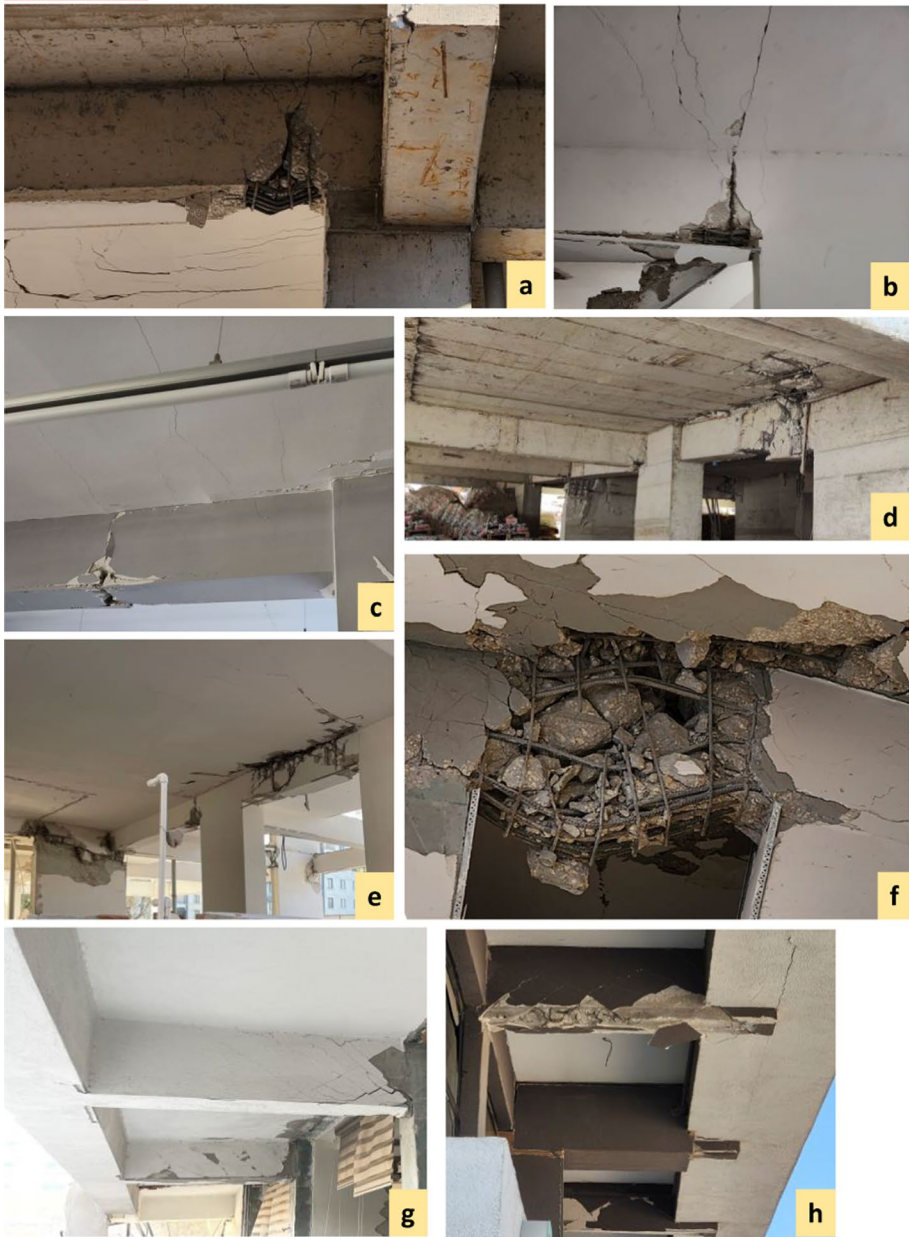
include slab in-plane forces and beam axial forces. Pictures of the beam end-zone failure and beam failure together with the slab (Fig. 25) are good examples of this problem in the post-2000 buildings. In the conventional reinforced concrete design before 2000, bottom reinforcement bars of beams were bent and joined to the top reinforcing bars at about one quarter of the beam span, and then the bent bars were extended through support of the adjacent beam. It is known that, this construction practice continues, as the presence of a crack at the quarter of the beam span demonstrates in Fig. 25c. Typical shear failure of relatively short beams is also shown in Fig. 25d and e. Shear failure mechanism presented in Fig. 25f caused diagonal splitting of the beam into two triangular halves, as described by Paulay (Paulay 1969; Paulay and Binney 1974) for beams that are under-reinforced against shear. Furthermore, It is important to mention that cyclic shear cracks are observed in cantilever beams of several new buildings due to significant vertical component of the earthquakes (Fig. 25g&h).

Fig. 25 Bending failure at the beam end zone (a), tension cracks at the beam support continuing through the slab (b), tensile crack at the one quarter of the beam span (c), and shear failures at relatively short beams of Altunpark 2 Sitesi Block C (d, e) in Hatay, shear failure of a coupling beam from a partially collapsed building in Hatay (f), cantilever beam failures (g, h)
