Destructive impact of successive high magnitude earthquakes occurred in Türkiye's Kahramanmaraş on February 6, 2023

Abstract

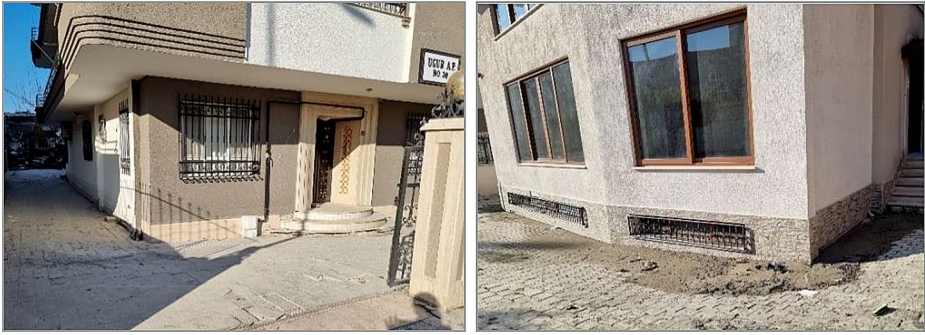
Fig. 4 Uniform settlement of a building (left) and sand ejecta around a structure (right) in Iskenderun coastal region of Hatay

ings in Iskenderun's coastal part are presented in Fig. 4. The field investigations here have shown that the liquefied sand reached out of the surface, especially from the corners and edges of buildings. The structures have made a uniform settlement between 30 and 50 cm but have maintained their functions.

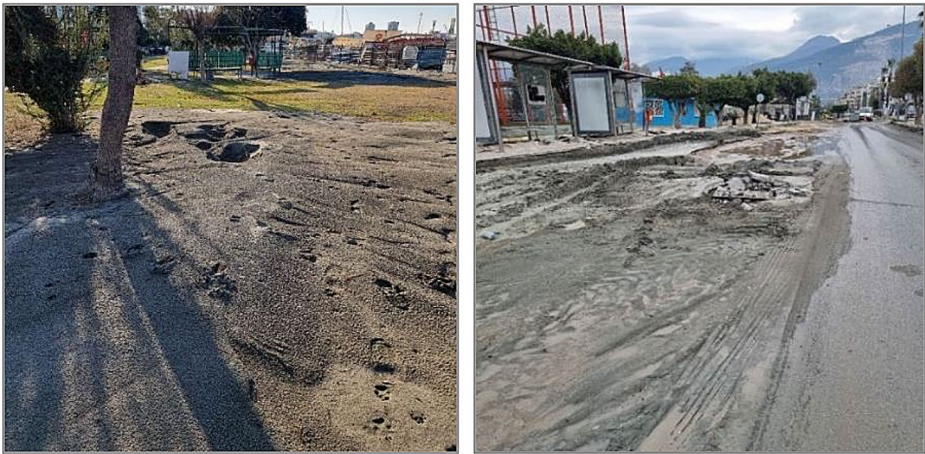
Fig. 5 Sand cones and crater geometries along the coastline (left) and some of the damages on road structures (right) in Iskenderun district of Hatay

Moreover, towards the coastline, commonly, liquefaction and sand cones phenomena in open areas were observed. An example of the sand cones and ejecta can be seen in Fig. 5. Considering the number and volume of the cones, it has been determined that the liquefaction has spread over a wide area here. As a result of that widespread liquefaction occurred in this region; a large amount of water reached out of the ground surface with the liquefied sand. This also caused floods on the coastline, especially along Atatürk Boulevard. Excessive deformations in road structures due to settlements and sand ejecta also became a striking point of the observations (see Fig. 5).

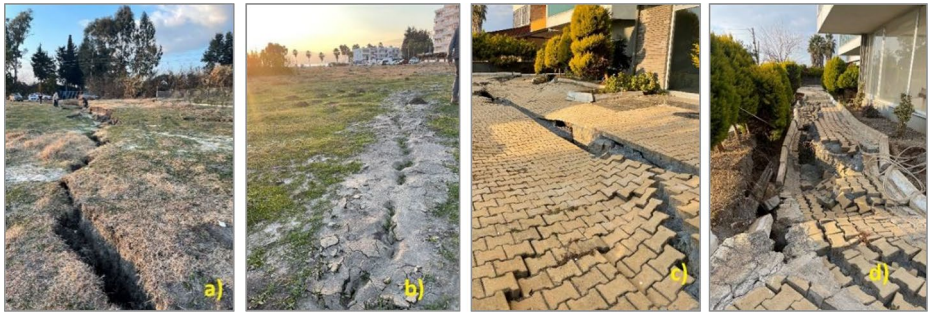
Fig. 6 Liquefaction-induced failures observed in Dörtyol district of Hatay

is given in Fig. 6a. Sand ejecta were observed in the free-field here (Fig. 6b) as a result of lateral spreading caused by liquefaction. As a result of this spread, a failure surface of approximately 900 m length was formed. It was determined that the buildings in the western part of Dörtyol district were exposed to about 80 cm vertical settlements in addition to the lateral deformations. Some apparent examples of these deformations can be seen in Fig. 6c, d.

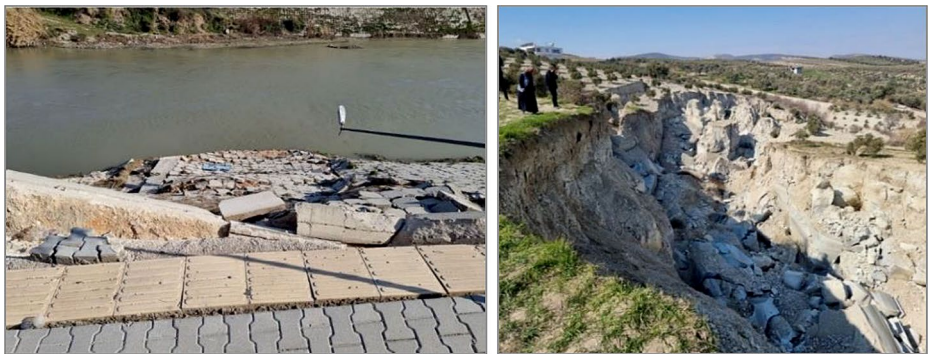
Fig. 7 Landslide damage observed in Antakya (left) and in Altınözü (right) districts of Hatay

Apart from liquefaction, geotechnical damages were also detected in Antakya city center. The first of these was the small-scale slides in the Asi River, which passes through the middle of the city center. Another damage is the large-scale landslide that occurred in Altınözü, approximately 200 m long and 400 m wide. It has been observed that weak sedimentary rocks dominate at the base of the landslide area. The mentioned damages are shown in Fig. 7.

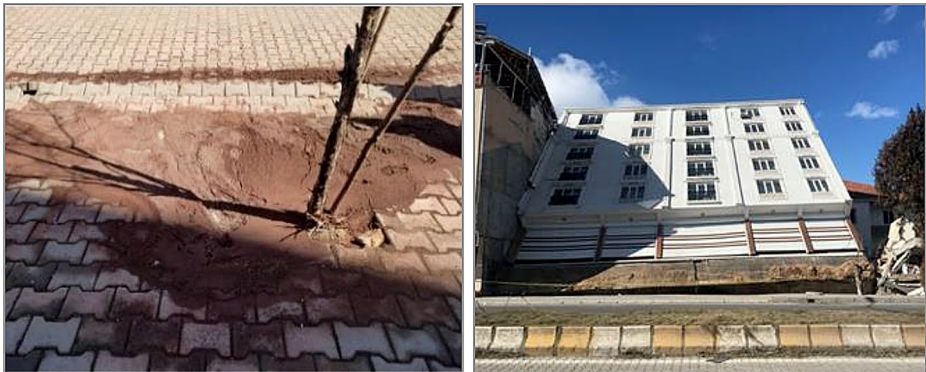
Lastly, during the Kahramanmaraş earthquakes, widespread soil problems were observed in the Gölbaşı area. Many buildings have faced issues such as excessive settlement, tilting and toppling over, etc. These problems are thought to arise from the poor earthquake performance of young alluvial soils with a high groundwater level. Additionally, the presence of sand ejecta in the free-field was also determined, as presented in Fig. 8. A building, near the close vicinity to this sand ejecta, was toppled over along the short side of the foundation. This indicates that liquefaction phenomena have caused many soil problems in Gölbaşı. The low depth of the foundation and the high length-to-width ratio of the building were also determined to facilitate the toppling. Consequently, it has been deduced that similar to past earthquakes, the necessity of considering the soil characteristics in the infrastructure design and construction has emerged again after the recent Kahramanmaraş earthquakes to ensure the safety of the infrastructures to be built in earthquake zones.

Fig. 8 Sand ejecta (left) and an overturned building (right) in Gölbaşı district of Adıyaman

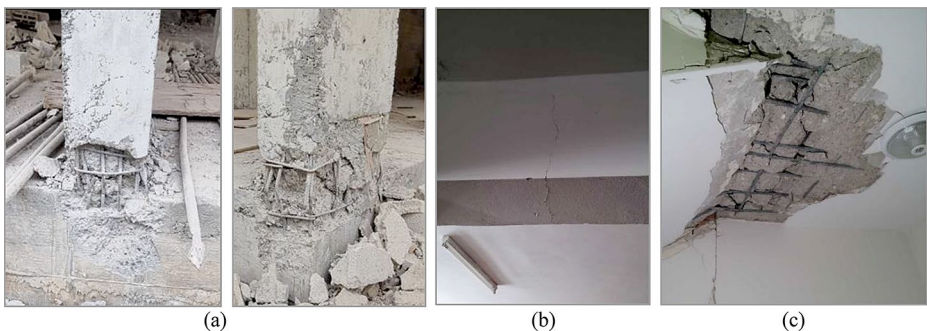
The general building stock has been observed to consist of frame systems with low aspect ratios. While this reduces the seismic force on the structure, it also causes structures to behave flexibly and have larger periods. In fact, in the field surveys conducted throughout the region, column joints at the ground floor foundation or basement walls have caused hinges even in new buildings. Due to the large displacements, it has been observed that concrete was crushed, and reinforcement was buckled or ruptured in the areas where hinges occurred. In buildings with rigid ground floors, hinges have been observed at the endpoints of the ground-floor columns (Fig. 9a). Flexure and shear cracks caused by seismic forces have also been observed in beams (Fig. 9b). Damage has been observed in beams due to torsion and stair landings due to the torsion effect (Fig. 9c).

Fig. 9 Examples of plastic hinges at the bottom of columns (a), flexure cracks in beams (b), and damage in stair landings (c)

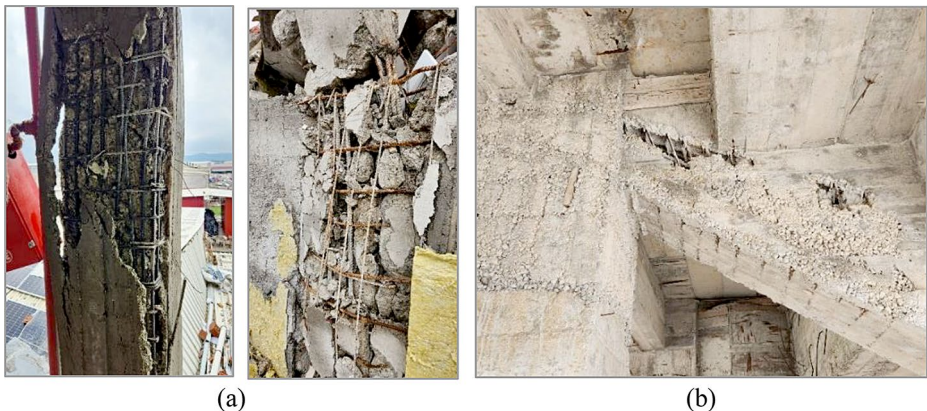
Most buildings constructed before 2000 were built using man-made concrete mixed and manufactured by human labor. Therefore, they have common mistakes such as wrong concrete mix (wrong water, cement, and aggregate ratio), low cement ratio, the existence of organic and inorganic materials in the mix, very small or massive aggregate, wrong place-

ment of concrete (heavy segregation), etc. some examples of poor concrete quality and segregation are depicted in Fig. 10.

Fig. 10 Examples of poor concrete quality (a) and wrong placement of concrete (segregation) (b)

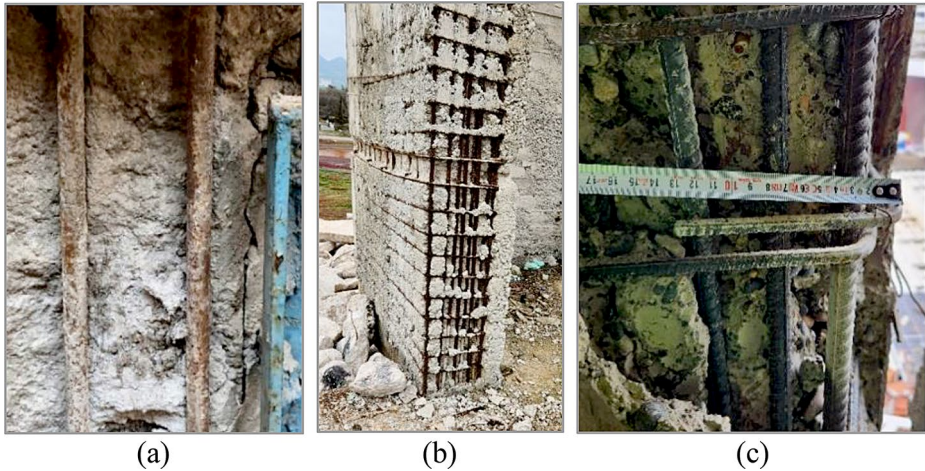
Additionally, it has been observed that plain reinforcing steel was generally used in buildings constructed before 2000. The reinforcement steel also had significant corrosion due to insufficient concrete cover (Fig. 11a). Concrete segregation has also been detected in these buildings (Fig. 11b). In many buildings, stirrups were bent wrongly at 90-degree instead of 135-degree, as prescribed in the TBEC 2018 (Fig. 11c). In many buildings in the region, it was observed that the protruding reinforcement bars of columns and walls from the foundation did not comply with the overlapping length requirement specified in the regulations. In these areas, due to the lack of proper spacing between reinforcement bars and the bending

Fig. 11 Unribbed smooth reinforcement and heavy corrosion (a), insufficient concrete cover and heavy segregation (b), and wrongly bent stirrups (90-degree bent) (c)

of reinforcing bars at 90-degree angles, plastic hinges have formed at the bottom of the columns, causing concrete cracking and reinforcement deformation.

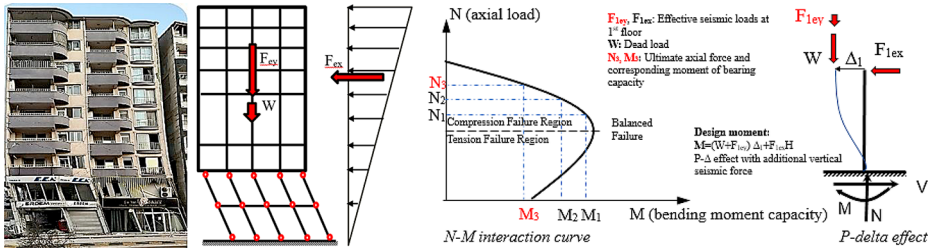
Moreover, examining the building stocks in the earthquake-hit regions, one-way ribbed slabs have generally been widely used in the load-bearing systems of five- to eight-story buildings. It is remarkable to note that the vertical structural elements carrying these types of floor slabs have not been supported by shear walls as clearly specified in the TBEC (2018). Many residential structures having ribbed slab systems (using lightweight briquette blocks or styrofoam between floor joists) were severely damaged due to inadequate shear resistance because they could not exhibit rigid diaphragm behavior. Apparently, the ribbed slab applications in RC structures that are incompatible with the restrictions imposed on such beamless plates in the earthquake codes have caused heavy damage or destruction triggered by the soft story effect. The seismic energy transmitted to the structure was not consumed as required at the beam ends in line with the strong column-weak beam principle. On the contrary, the energy consumption points resulted in the formation of plastic hinges at the whole column ends of the ground floor in the immediate initial vibrations of the earthquake ground motion, making the structure unable to bear the seismic shear forces. Ultimately,

Fig. 12 Collapse mechanism due to soft story effect: P-delta effects with additional vertical inertial forces

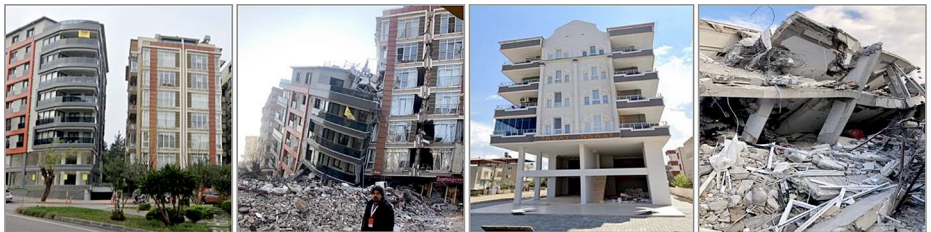
The heavily damaged and collapsed reinforced concrete buildings, which were generally constructed after 2000 years in the densely populated settlements such as Nurdağı, İslahiye, Pazarcık, Türkoğlu, Kırıkhan, and Antakya, are examined closely in the post-earthquake region. Notably, they have similar architectural features and were arranged with the same type of load-bearing system, especially for the floor members. As can be seen from Figs. 12 and 13, the first two floors of such multi-story buildings have been designed for commercial workplace purposes, and the floors above them are used as residential areas with large and heavy overhangs. It has been observed in the field that these types of apartment buildings with similar engineering and architectural design errors failed against seismic forces.

(a) Building 1, before (left) and after (right) earthquakes (b) Building 2, before (left) and after (right) earthquakes

Fig. 13 Examples of typical buildings in the earthquake-hit region and heavy structural damages due to engineering and architectural design errors

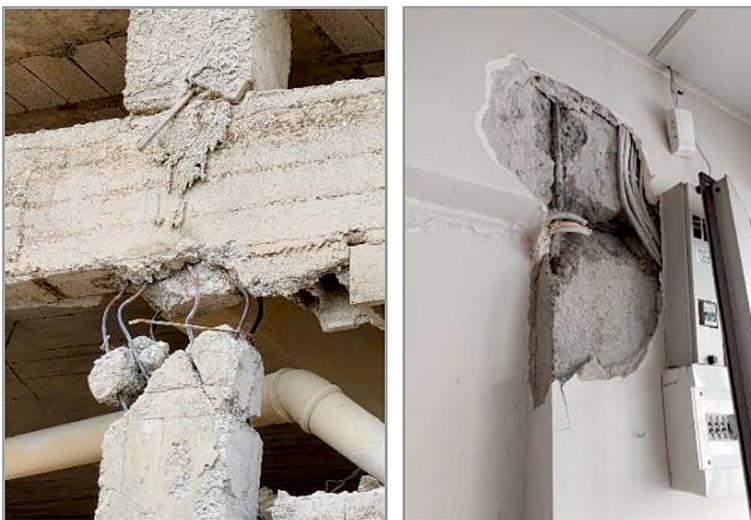
Additionally, the 1998 Turkish Earthquake Code is the first in Türkiye to address the concept of ductility for designing structures that will not collapse in earthquakes, as well as the design of column-beam joint regions and strong column-weak beam design. As a result of field surveys conducted under this regulation, it has been observed that in buildings constructed before 1998, columns have weaker cross-sections compared to beams. Most residential buildings in the region have not been designed to comply with the strong column-weak beam principle. Therefore, those buildings were severely damaged or collapsed during the Kahramanmaraş earthquakes. Lastly, the insufficient resistance of columns to beams has led to the formation of shear cracks and hinges at the top and bottom ends of the columns (Fig. 14).

Fig. 14 Examples of a strong beam weak column design and damage on columns

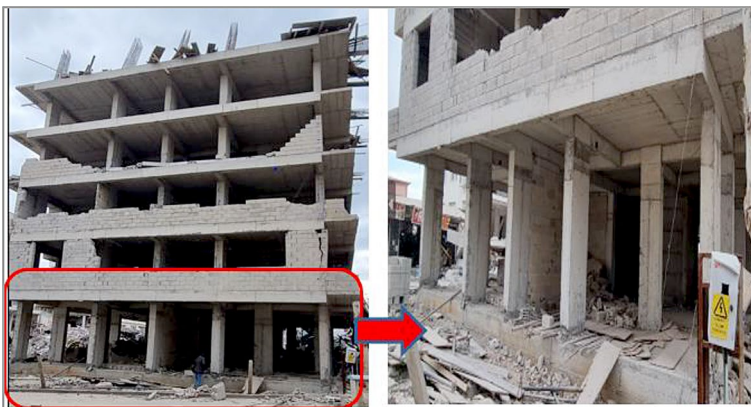
It is prescribed in many earthquake design codes that external eccentricities that may occur in terms of mass, stiffness, and strength can be prevented by arranging a symmetrical structural system. As a result, a predictable seismic behavior can be achieved. When the damaged and collapsed buildings in the region were observed, it was determined that many buildings specifically located on main streets had extensive overhangs extending to 1.5 m. Moreover, the columns carrying those overhangs were not connected with the beams, and that caused the formation of an insufficient tied framing system. Therefore, the columns could not work together or provide proper load transfer (Fig. 15). Moreover, in earthquake-resistant building design, placing shear walls that can withstand a significant portion of the earthquake forces is important. In the region, even if shear walls were included in the buildings, it was observed that they were not symmetrically placed in structures. The resulting irregularity in torsion and the additional moment effects caused by the heavy overhangs resulted in the formation of plastic hinges at the end regions of all columns in the outer axis (Fig. 16a).

Fig. 15 Examples of large and heavy overhangs on RC buildings in the earthquake-hit region

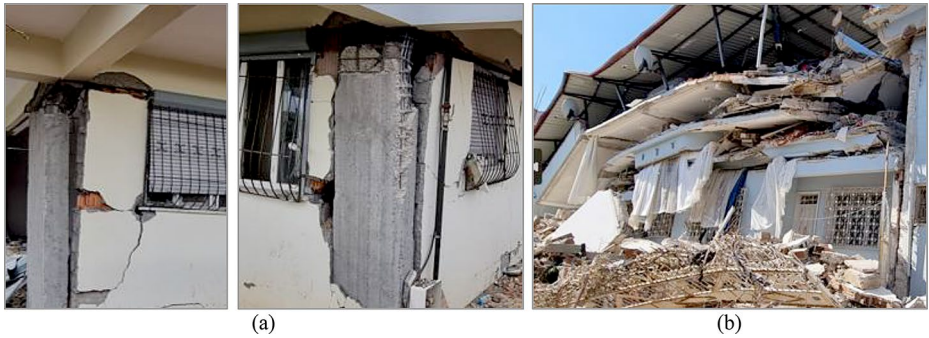
Additionally, one of the most essential structural problems observed in the areas affected by earthquakes is that existing buildings have been completed by the addition of new floors on the structures over the years without having any engineering services. During the construction of these additional floors, the load-bearing system of the existing floor, vertical element continuity in the new floors, cold joints between floors, construction techniques, and material differences were not considered. For example, the building in Fig. 16b was initially built as a single-story masonry ground floor. Over the years, a three-story RC structure was added, and finally, it was completed with a steel frame roof floor. While the original ground floor remained standing, the additional stories built on top collapsed during the earthquakes.

Fig. 16 Examples of column damage due to large overhangs (a) and a building collapse due to additional floors (b)

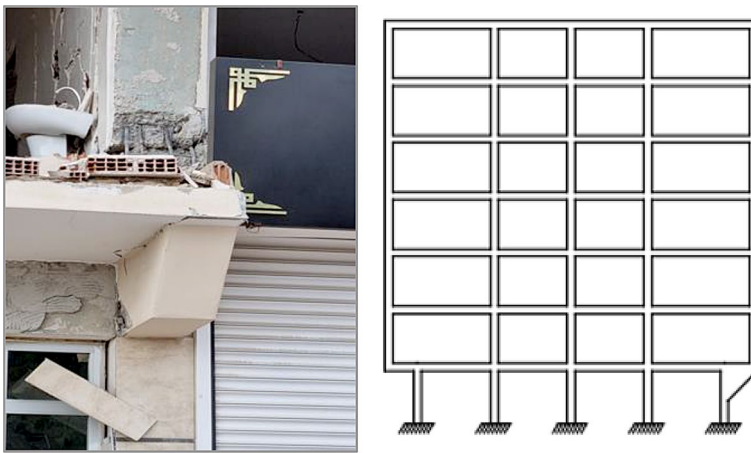
Lastly, many seismic codes never allow the placement of columns on the top or end of cantilever beams or on the gussets formed on the lower columns of any building floor. However, during the field surveys, plastic hinge occurrences have been observed in some buildings due to reinforcement bending and concrete pouring at the bottom of columns as a result of that practice (Fig. 17).

Fig. 17 An example of a column connecting on the end of cantilever beams (the right drawing from TBEC 2018)

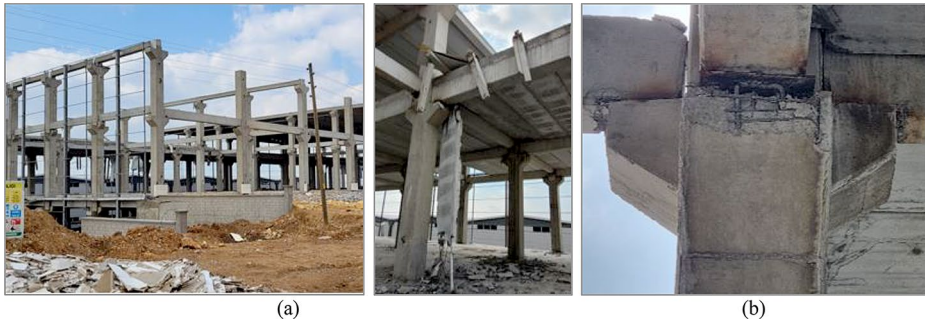
Fig. 18 Examples of insufficient fastening of roof purlins to beams (a), and damage in joint regions (b)

purlins that were not adequately connected to the beams and falling of them to the ground was common (Fig. 18). The damage was generally caused by the inability of the structural elements to respond to the seismic displacement and rotation demands in joint regions, the weakness of the members in the joints, and pin connections that are not filled with cement mortar. Due to the lack of connection details, the precast floor elements sitting on the beams also separated from the connection points, disrupting the integrity of the building and could not show the diaphragm behavior supposed to be provided at floor levels (Fig. 18).

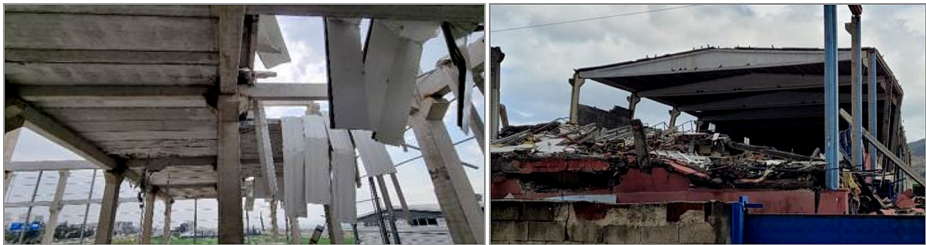
Fig. 19 Floor damage due to poor connection detailing (left) and a precast concrete structure with weak columns and heavy roof beams (right)

The architectural and structural system plans, which were arranged incorrectly, revealed the effects of torsion and caused the beams to be separated from the columns. For example, a 5-meter-high mezzanine floor was built in a part of a reinforced concrete precast building with a floor height of 10 m (see Fig. 19). In these two regions, the damage occurred due to the simultaneous rigid and flexible behavior that differs depending on the column lengths and the mezzanine diaphragm. Moreover, severe damage and collapses were widely observed in prefabricated structures with weak columns and heavy roof beams that could not provide horizontal stability (Fig. 19).

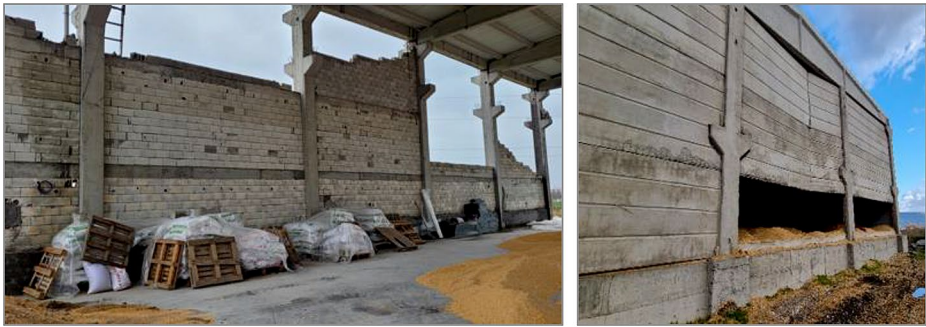
Additionally, infill wall damage in prefabricated buildings was also widespread. Low-strength, hollow briquettes, commonly called “bims” have been widely used in the structures located in the region. Due to low horizontal reinforced concrete beams providing stability in large-span walls and exceeding the maximum unsupported wall length, the out-of-plane movement occurred in the walls during the Kahramanmaraş earthquakes (Fig. 20). Moreover, the panels coming out of the slots supported on the columns or out-of-plane movement were one of the common and typical damages seen in the precast wall panels (Fig. 20).

Fig. 20 Examples of large-span walls exceeding the maximum unsupported wall length on the walls (left) and out-of-plane tipping damage on the precast wall panels (right)

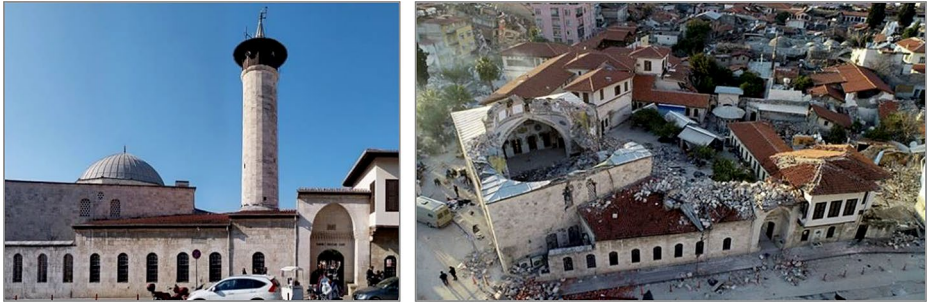
Fig. 21 Habibi Neccar Mosque, Antakya, Hatay, before (left) and after (right) the Kahramanmaraş earthquakes

More than half of the buildings collapsed in the historical city center of Hatay. Among them, Habib-i Neccar Mosque, Sarimiye Mosque, Historical Saints Peter and Paul Church, Greek Orthodox Church, and Iskenderun Italian Latin Catholic Church are essential structures of our historical architectural heritage that were partially damaged or collapsed in the historical city center of Hatay. Those structures' pre- and post-earthquake situations are depicted throughout Figs. 21, 22, 23 and 24, respectively.

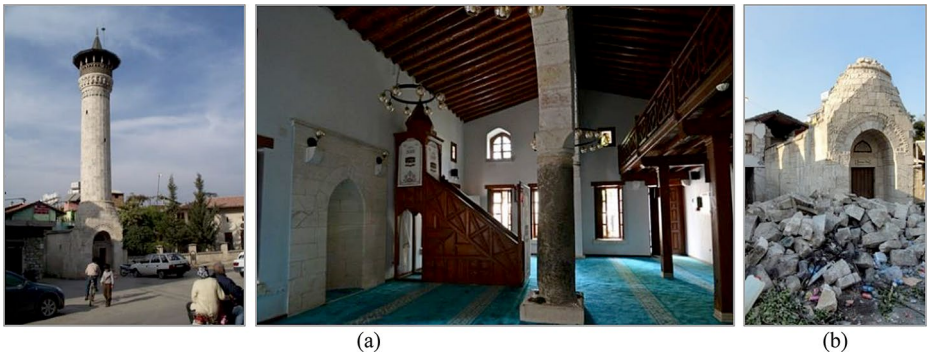
Fig. 22 Sarimiye Mosque, Antakya, Hatay, before (a) and after (b) the Kahramanmaraş earthquakes

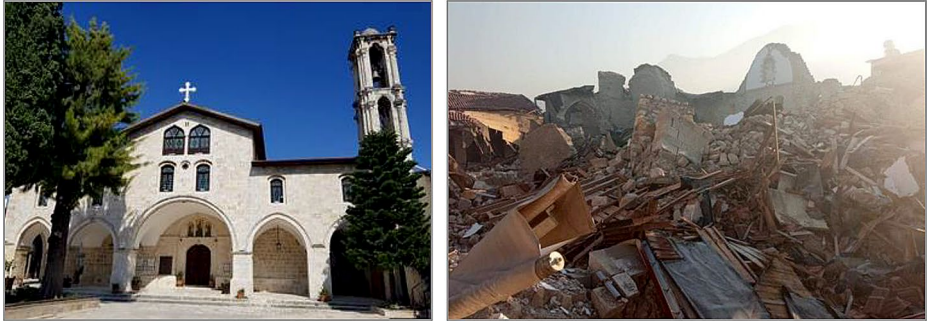
Fig. 23 The Historical Church of Saints Peter and Paul, Antakya, Hatay, before (left) and after (right) the Kahramanmaraş earthquakes

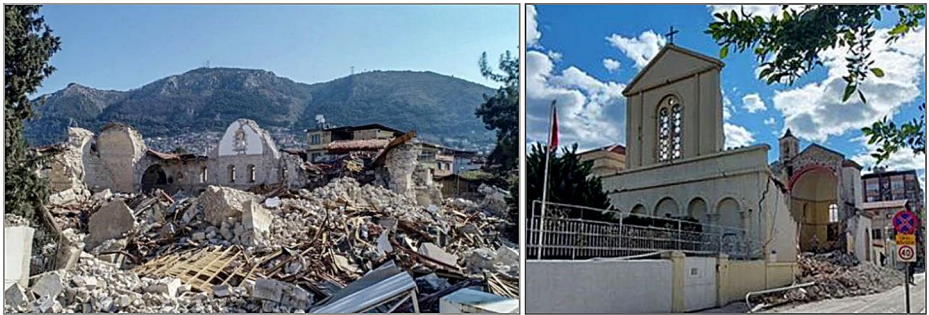
Fig. 24 Antakya Greek Orthodox Church (left) and Iskenderun Italian Latin Catholic Church (right) after the Kahramanmaraş earthquakes

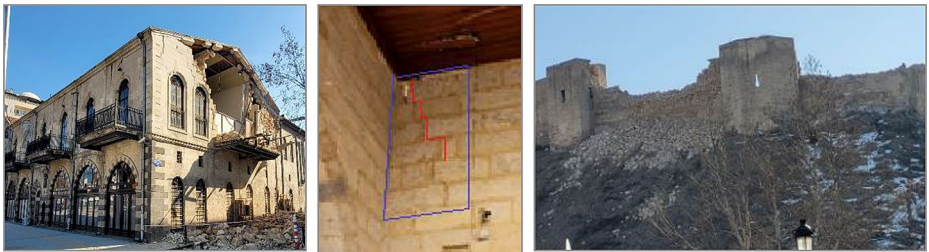
Fig. 25 Examples of damage to the structural main walls

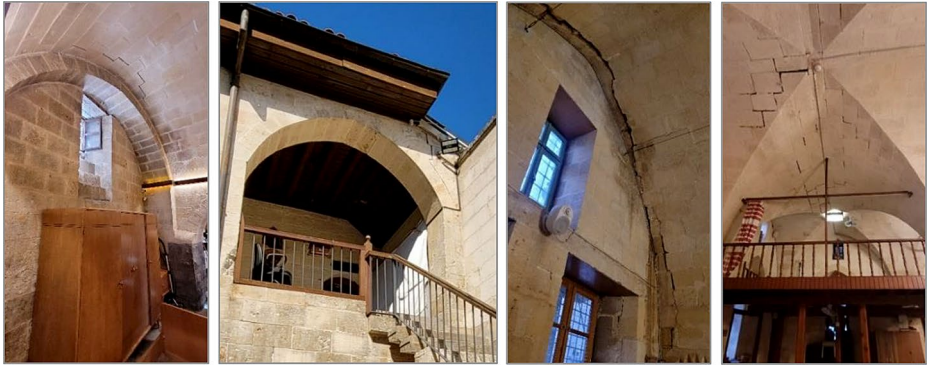
Fig. 26 Examples of tensile cracks at joints in arches, vaults, and domes, out-of-plane movements

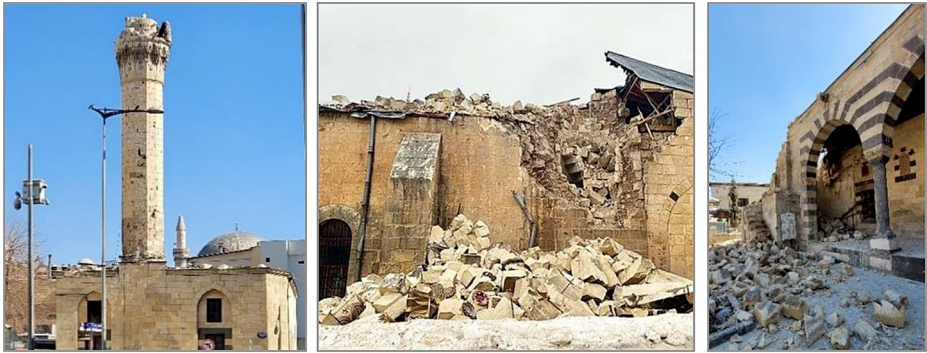
Moreover, the investigated historical buildings in Gaziantep, built mainly between the 17th century and the end of the 19th century, performed better seismic response due to being far from the fault line. Restored historical building examples showing good performance in the historical center of Gaziantep province were examined. Since these structures are relatively far from the fault line, the structures were exited with accelerations smaller than the design earthquake level of TBEC 2018. In the historical buildings inspected in Gaziantep province, slip cracks in the main walls, openings in the joints, and local separations in the outer layers of the walls were observed (see Fig. 25). There was damage to the joints of arches and vaults, and out-of-plane movements were detected at the wall-vault joints (Fig. 26). Opening at the joints, vertical cracks, and overturning on the pedestals were observed in the mosque's minarets (Fig. 27).

Fig. 27 Examples of damage to minarets
