# Investigation of Damage in and Around Kathmandu Valley Related to the 2015 Gorkha, Nepal Earthquake and Beyond

Tsuneo Ohsumi · Yoichi Mukai · Hideo Fujitani

**Abstract** An earthquake with a magnitude of 7.8 ( $M_w$ ) occurred at 11:56 NST (local time) on 25 April 2015, in the central part of Nepal (Gorkha). We organized a damage survey team and dispatched it to the affected area for several periods following the earthquake (May 26 to June 3: first trip, June 17 to 24: second trip, August 16 to 21: third trip and October 27 to November 2: forth trip) to investigate the damage and collect data. We found traditional construction methods are stronger than imagined. Many traditional earthquake-resistance technologies exist in Nepal. The first and second surveys were to collect timely statistical information on the damage to brick and stone masonry buildings and to confirm the availability of data and their sources for subsequent surveys. We also carried out a first-hand building damage survey in selected areas. The investigation of the strong-motion data set from the USGS Center for Engineering Strong Motion Data includes information from stations in Nepal that continued to functio

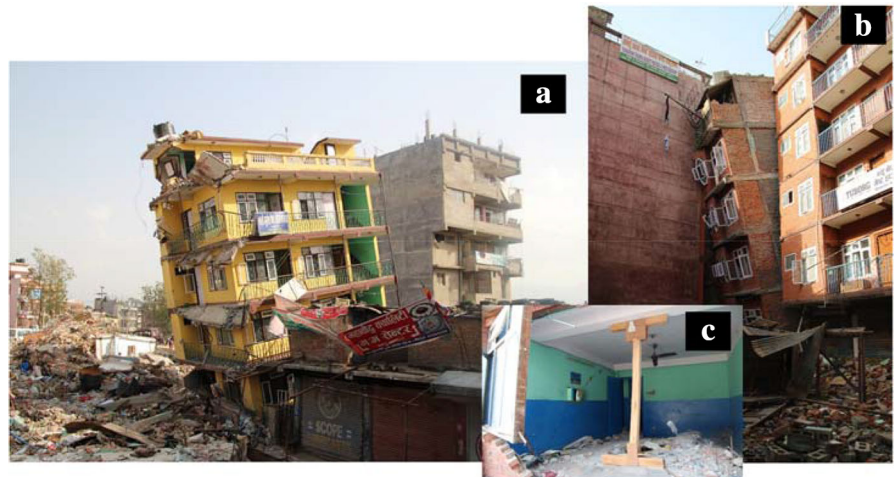
in the city occurred in masonry buildings. At Gongabu, northwest of the Ring Road, many RC buildings were damaged; most of these were four to seven story structures. The damage was sometimes greater at locations with soft ground such as deltaic deposit near river branches (Fig. 3); however, some damage was also likely to have been caused by inappropriate construction methods. At Sitapaila, west of the Ring Road, some RC building collapsed at locations where the ground conditions on terraces

**Fig. 3** At Gongabu, RC frame buildings were tilted (a, b). A shear crack in the first flower (c) (photo by T. Ohsumi)

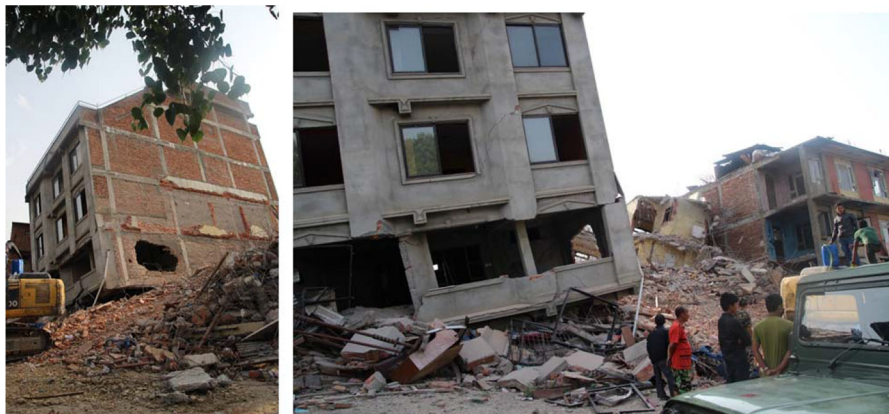
were a bit stiff. At Balkhu, southwest of the Ring Road, RC frame buildings were tilted (Fig. 4). This is near the confluence of the Bagmati and Balkhu rivers, where collapsed buildings fell onto and destroyed a neighboring building (Fig. 5). The ground was soft in Balkhu because of the presence of riverbed sediments. Within our survey area, the liquefaction area was very limited. Building damage was caused by soft ground on the river branch (related to the 2015 Gorkha Earthquake), not by liquefaction.

**Fig. 4** At west side of the Ring Road in Kathmandu, RC frame buildings were tilted (photo by T. Ohsumi)

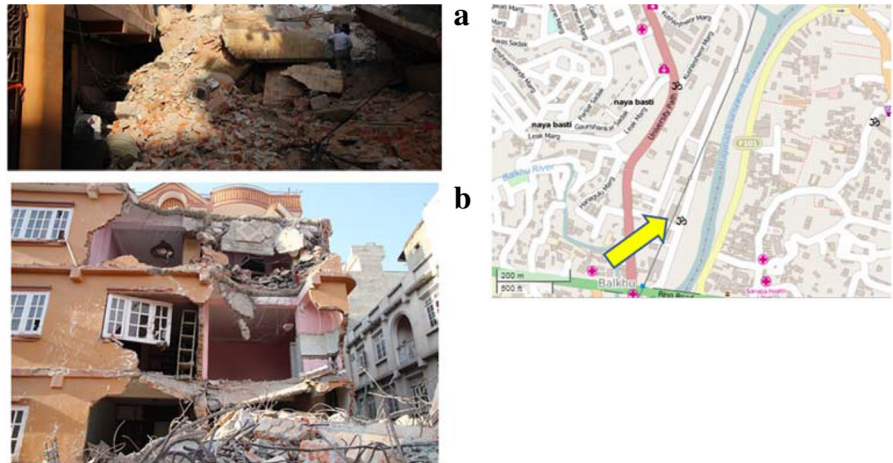
**Fig. 5** At the branch point of the Bagmati River and the Transmor River, collapsed building (a) fell onto and destroyed the next building (b) (photo by T. Ohsumi). OpenStreetMap <https://www.openstreetmap.org/>

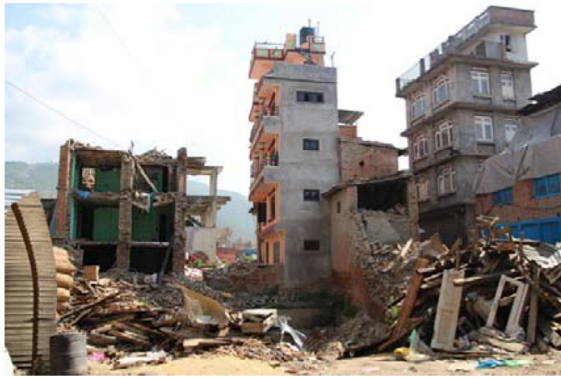
The difference in damage as a result of building type was remarkable. Damage in Sankhu was extensive. Brick and cement mortar houses without RC columns experienced a lot of damage. In contrast, the damage to RC structures—particularly those erected in recent years—was generally minor. These structures were mainly five to six story buildings. In contrast, many of the non-engineered masonry structures that experienced complete collapse or partial damage were two to four story buildings in Sankhu

**Fig. 6** RC buildings were partially damaged, the difference appears remarkable in Sankhu (photo by T. Ohsumi)

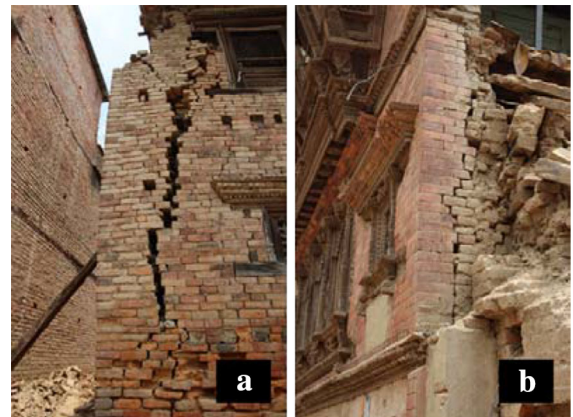
(Fig. 6). Damage in non-engineered masonry structures was initiated by vertical cracks in the corners of the buildings, which contained no RC columns (Fig. 7a), the outer wall structures of such buildings were generally burned brick with cement mortar joints to withstand rain. In several cases, the inner walls of buildings are adobe bricks with mud mortar (Fig. 8b).

**Fig. 7** A vertical crack in a brick masonry wall was generated from the corner (a). Structures having no RC columns on the corner (b) (photo by T. Ohsumi)

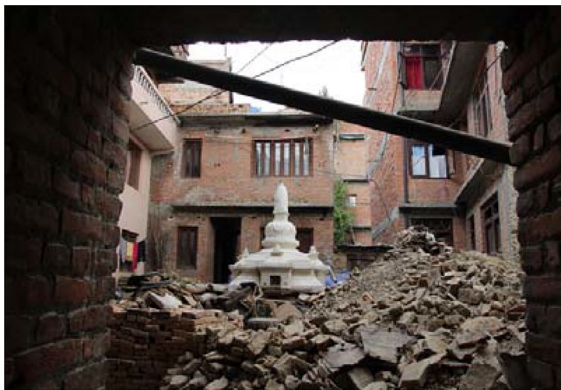
**Fig. 9** Traditional buildings are gradually becoming less common as a result of rebuilding (photo by T. Ohsumi, taken after earthquake in Sankhu)

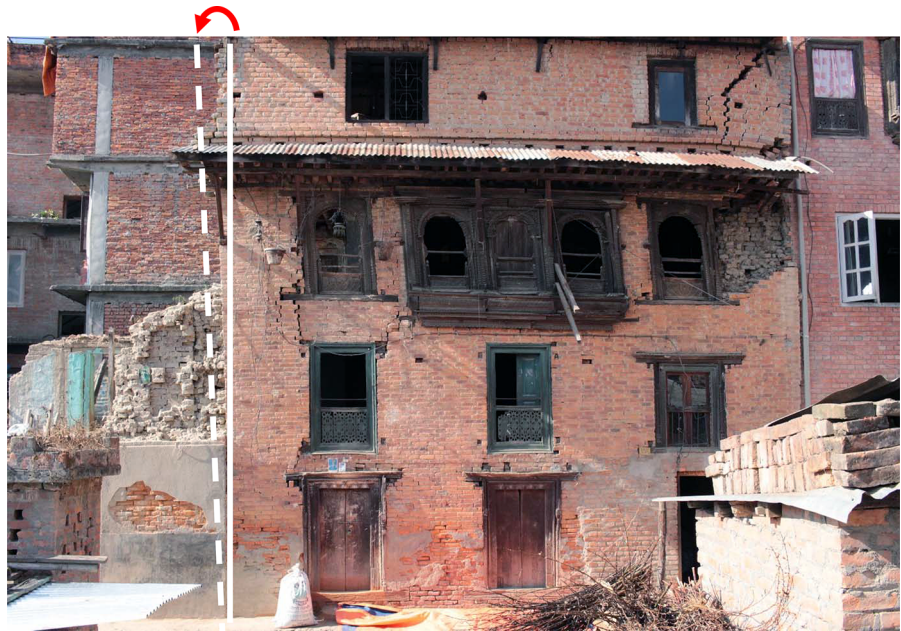
**Fig. 13** Traditional structures caused brittleness deformations and defective corners of the building related to the 2015 Gorkha Earthquake in Khokana (photo by T.Ohsumi after the 2015 Earthquake)

earthquake (Fig. 13). Reinforcement with such components as hold down hardware and battledore bolts is indispensable.

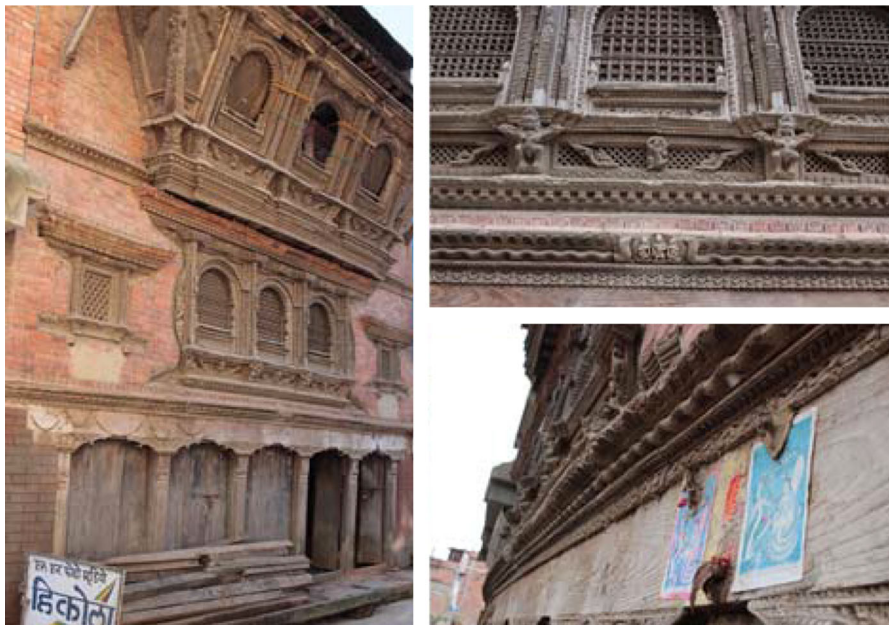
**Fig. 14** Building constructed over 100 years ago that was slightly damaged by the Gorkha earthquake: (photo by T. Ohsumi; photo by T. Ohsumi, taken after Gorkha earthquake in Sankhu)

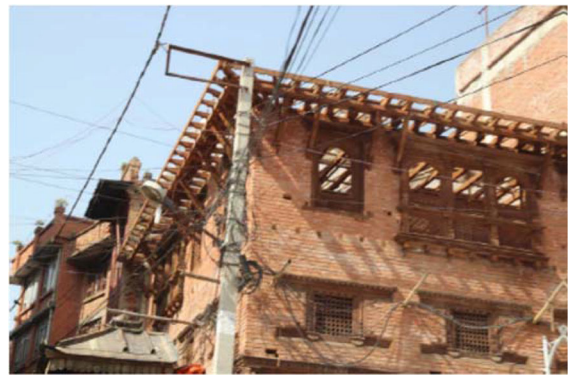
**Fig. 19** Renovation of a house roof was carried out in 2015 (photo by T. Ohsumi)

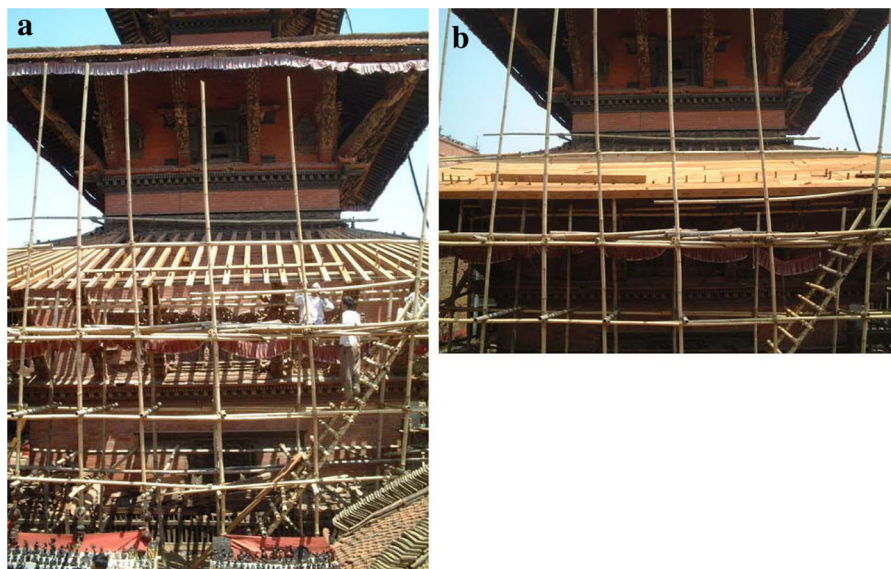
**Fig. 18** Renovation of a temple's roof was carried out in 2015 **a** installation of timber rafters, **b** hand wood planking (photo by T. Ohsumi)
