Mosul Dam: Is it the Most Dangerous Dam in the World?

Nadhir Al-Ansari · Nasrat Adamo · Sven Knutsson · Jan Laue ·
Varoujan Sissakian

Abstract Mosul Dam is an earth fill dam, with a storage capacity of 11.11 km^3 constructed on highly karstified gypsum beds alternating with marl and limestone. After impounding in 1986, seepage locations were recognized. The dam situation now indicates that it is in a state of extreme relative risk. If it fails, then 6 million people will be affected and 7202 km^2 area will be flooded. Grouting operations will elongate the life of the dam but will not solve the problem. Building a protection dam downstream will be the best measures to secure the safety of the downstream area and its' population.

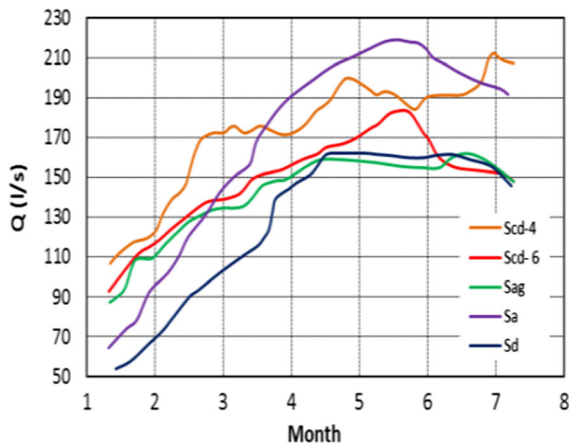
Fig. 4 Spring discharge variation for the period February–August 1986(after Guzina et al. 1991)

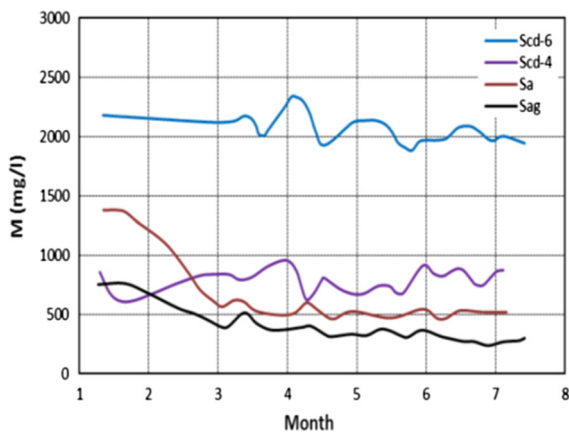
Fig. 6 Soluble salt concentration for the period February–August, 1986 (after Guzina et al. 1991)

clear from Fig. 6 that the dissolution rate of gypsum was very high as the reservoir was rising then it decreased to reach a steady state after some time indicating that large quantity of salts were leached in the beginning from fissures and the crack’s filling materials. Nevertheless, the final rates of dissolution were high which cause much concern.

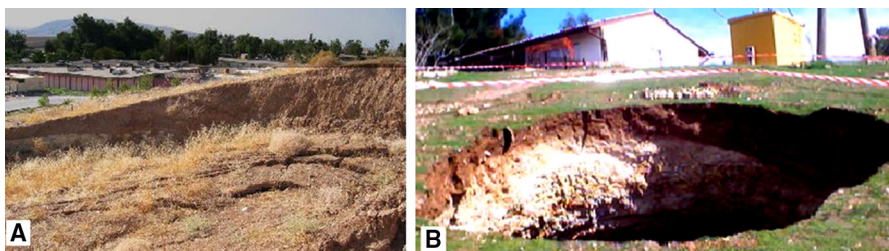
The presence of surface cracking and groundwater fluctuation give rise to the development of sinkholes. One sinkhole on the left flank of the reservoir appeared suddenly overnight in February 2003 and developed rapidly with 15 m of settlement and a 15 m diameter depression (Fig. 9). Other sinkholes appeared on the right side downstream the dam (Fig. 10). The rate of settlements of these sinkholes was 0.25 m when they appeared in 1992 and then it was reduced by 50% in

Fig. 9 The left bank sinkhole **a** early stage **b** full development stage

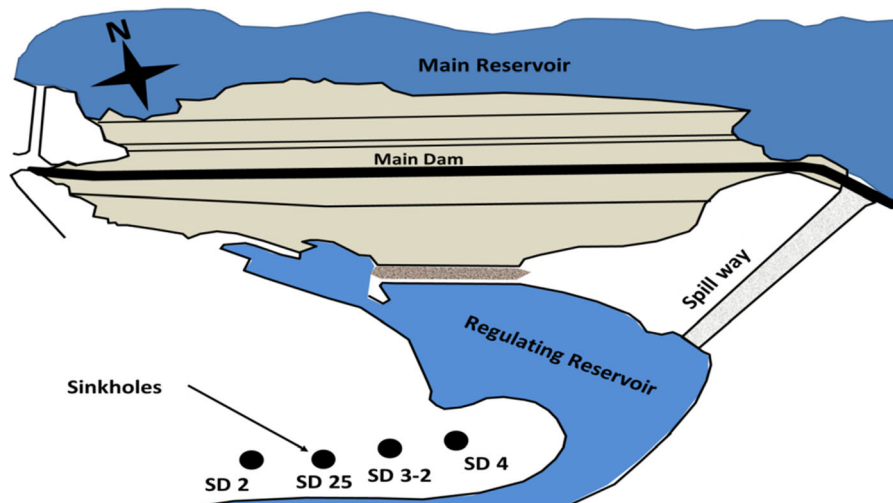
1998. The maximum cumulative settlement was recorded to be 5 m in the sinkhole SD4. It is believed that the formation of these sinkholes is due to the dissolution of surface gypsum beds which led to the formation of conduits under the surface. This took place due to the groundwater flow in Wadi Malleh aquifer toward the River Tigris where the recharge of this aquifer increased tremendously when the reservoir was impounded. The conduit has developed in size due to the fluctuation of the water level in the lake downstream the main dam caused by the operation of the regulating dam. Once the size of these caves increased and became closer to the surface it collapsed after heavy rainfall. Recent bathymetric survey conducted in 2011 showed the presence of a large number of sinkholes within the reservoir area (Fig. 11). This is a dangerous phenomenon where if these sinkholes are connected to Wadi Malleh aquifer it can cause numerous problems for the safety of the dam.

Fig. 10 Sinkholes downstream Mosul Dam-Right Bank

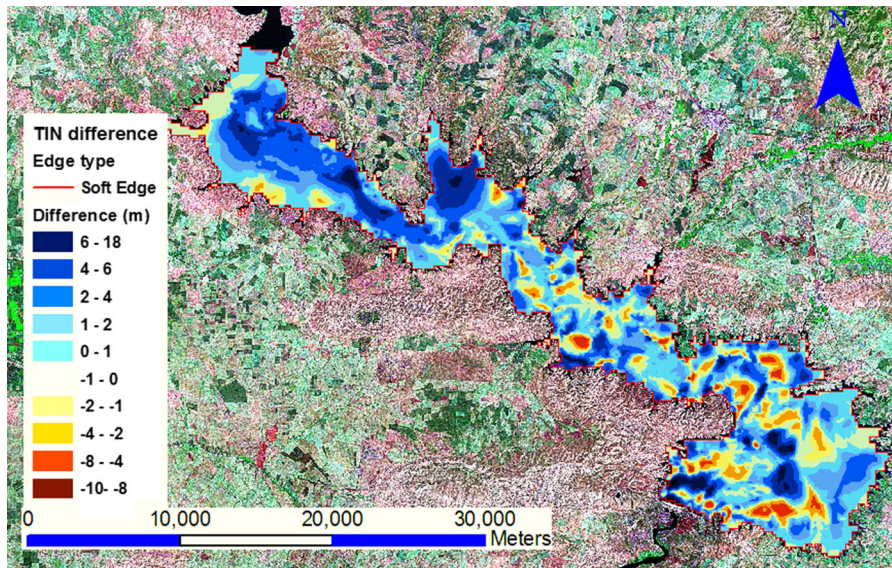
Fig. 11 Holes noticed at the bed of Mosul reservoir (Issa et al. 2013)

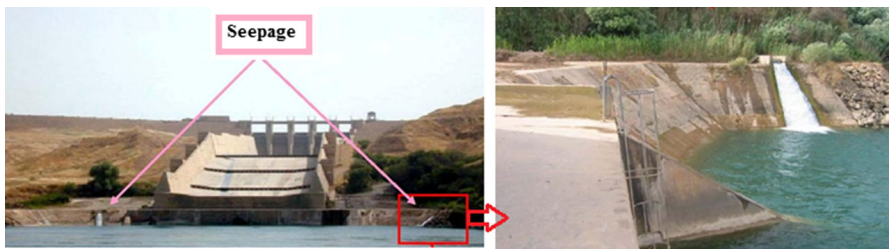
In addition, springs also appeared downstream the dam located on the same line of the sinkholes. The flow from the spring reached 360 l/s (Fig. 12). The water had high concentration of sulphate indicating its origin from Wadi Malleh aquifer (Swiss consultants 1984a). It should be mentioned, however, the amount of seepage flow from the Wadi Malleh aquifer was very high in the pumping storage scheme and the tailrace tunnel and its intake structure. The excavation of the caverns was only possible after performing extensive grouting works all around these caverns. The importance of the Wadi Malih aquifer is not only due to the great difficulties it caused during the construction of the pump storage scheme; but also that it shapes the ground water flow regime in and around the right abutment of the dam in addition to the fact that it contributed to the formation of a series of sinkholes at the right bank downstream of the main dam. The high concentration of sulphate in the water of this aquifer clearly indicates the dissolution of gypsum from the dam site and its vicinity. In addition, the hydrostatic pressure of water within the reservoir in increasing the rates of dissolution. This process is in progress since the operation of the dam. This process also led to the appearance of other features like the fissure near 100 m from the right abutment of the dam which appeared in 1996 (Fig. 13). Furthermore, the dissolution phenomena continued into later years. Figure 14 shows a large conduit which was discovered

Fig. 12 Example of seepage

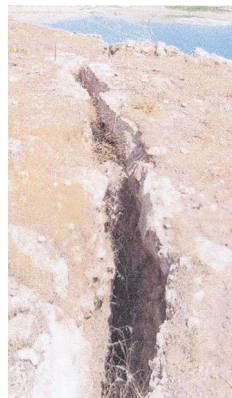
Fig. 13 Fissure on the right slope side of the dam

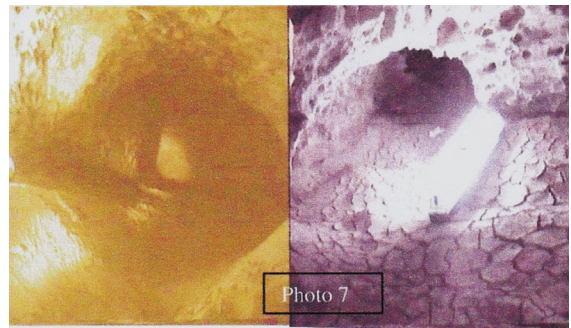
in March 2002 within a gypsum/anhydrite layer on the right side of the reservoir.

Fig. 14 Large conduit found in March 2002 in the upper right rim of the reservoir

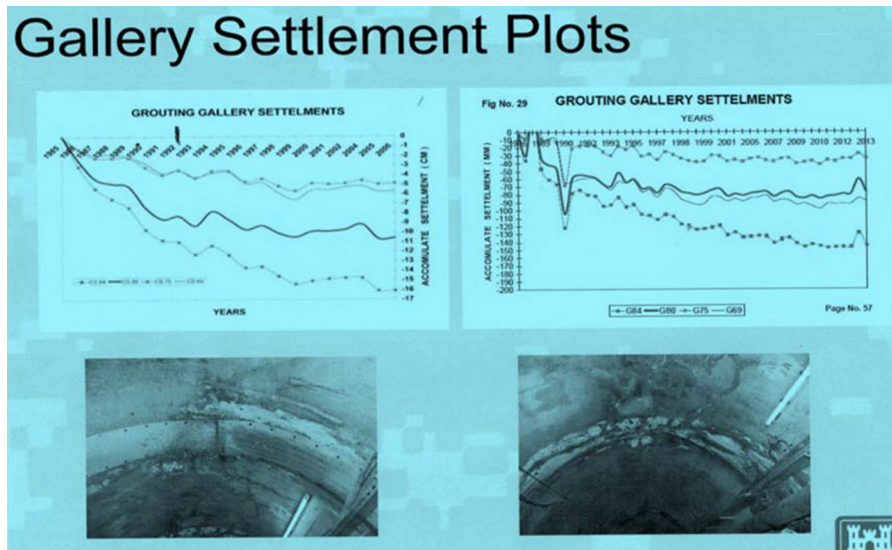
It was a very well known fact to the Engineers working in the dam that there was continuous settlement in the grouting gallery under the dam which is beyond the expected elastic compression values. This indicated that even with the continuous grouting under the foundation for all the past years, dissolution of gypsum continued making room for these high settlements. Records were kept and plotted from 1986 up to summer of 2015. The plot in Fig. 15 shows this settlement in five locations along the grouting gallery in the deep section of the dam.

(Al-Abayachi 2016, p. 12). The movements are believed to be caused due to settlement and not resulting from onsite activity. Cumulative settlement in the grouting gallery from 1986 to the end of 2015 records showed a sharp increase in settlement in 2015 which indicates a worsening situation in the dam foundations (Al-Abayachi 2016, p. 13). Satellite based information also indicated that there are local differential settlement in the body of Mosul Dam averaging from 5 to 10 mm/year (Coffman 2014; Cetinic 2016). In December 2016, Milillo et al. published their findings from space geodetic monitoring of Mosul Dam. They found that the rate of subsidence of Mosul Dam for the period 2004–2010 was 12.5 mm/year has increased to 15 mm/year after 2013 after re-grouting operations stopped (Fig. 16). This subsidence is related to the dissolution of gypsum and the reservoir-induced pressure which is the main cause of an increase in the dissolution rates. They also added that any annual increase of water levels in the reservoir in the future could lead to an increase of water pressure in the dam foundation, which combined with the absence of regrouting could speed up the dissolution of the dam substrate and promote its destabilization.

Fig. 15 Cumulative settlements in five locations in the grouting gallery (Al-Abayachi 2016)

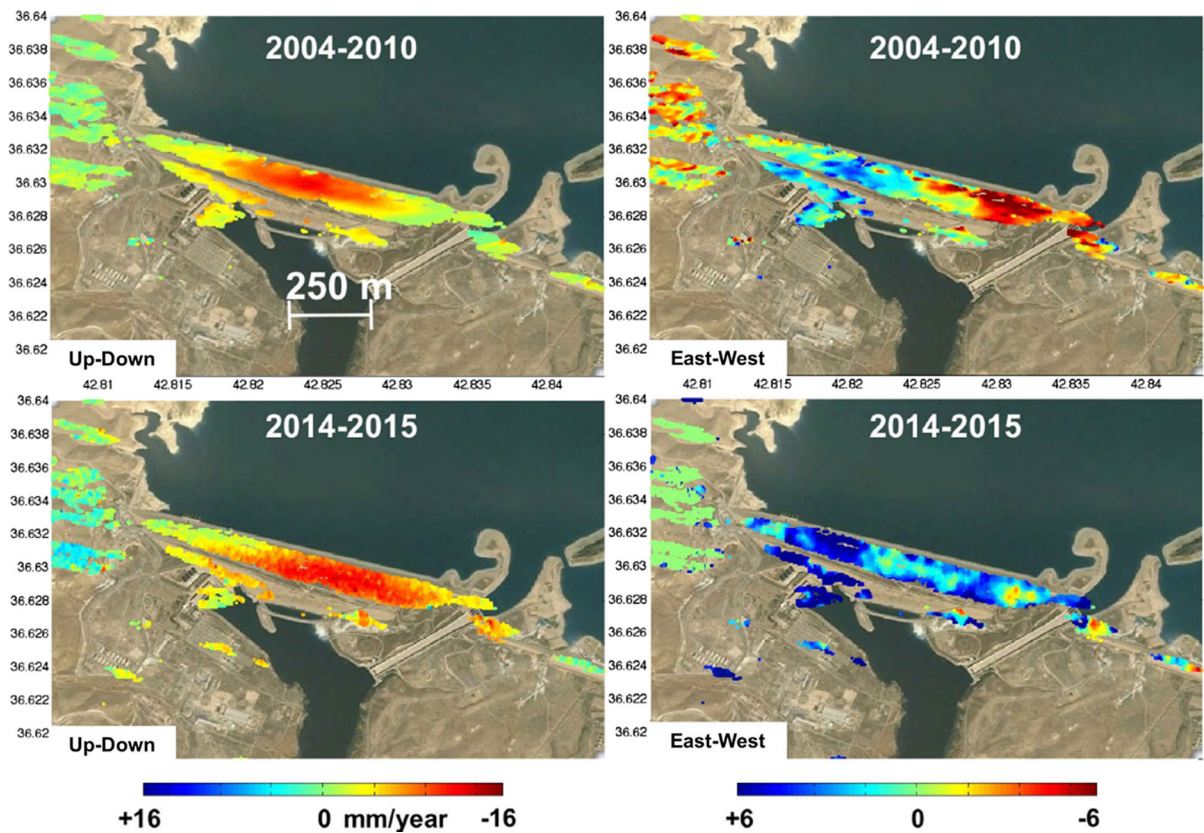
Fig. 16 Up-down (left) and east–west (right) displacement at the Mosul dam, Iraq. Negative values indicate downward and westward motion respectively (Millillo et al. 2016)

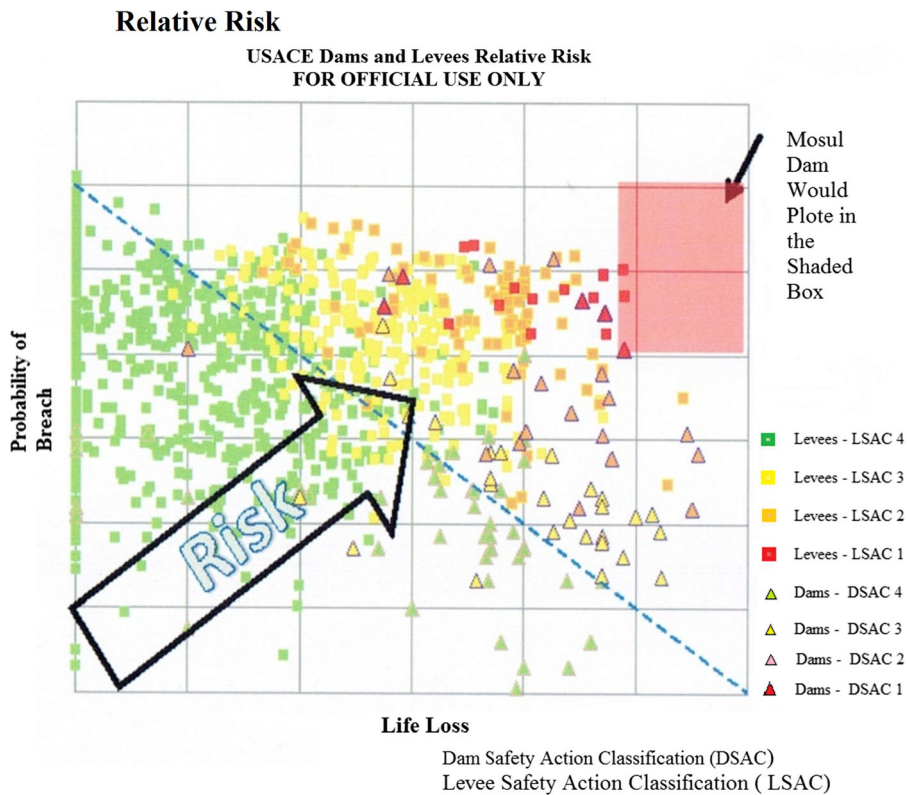
The plot of the data for Mosul Dam on the screening Portfolio Risk Analysis (SPRA) process for Dam Safety is shown in Fig. 17. This plot considers loading frequency, an engineering rating to estimate a relative probability of failure, and both human life loss and economic consequences of failure (MacCleanathan 2009; U.S. Department of the Interior Bureau of Reclamation 2014). This procedure shows that Mosul Dam is in a state of extreme relative risk (Fig. 17). For more details see Adamo et al (2015a, b, c, d); Al-

Fig. 17 Screening Portfolio Risk Analysis (SPRA) for Mosul Dam (after Al-Abayachi, 2016)
