# High shocking and pacing impedances due to defibrillation lead calcification

**Purpose** We have reported the calcification of Endotak defibrillation leads that required replacement. The aim of this study was to assess calcified Endotak Reliance leads in the Food and Drug Administration Manufacturer and User Facility Device Experience (MAUDE) database and compare them to calcified Sprint Fidelis, Sprint Quattro Secure, Riata, and Durata leads in MAUDE.

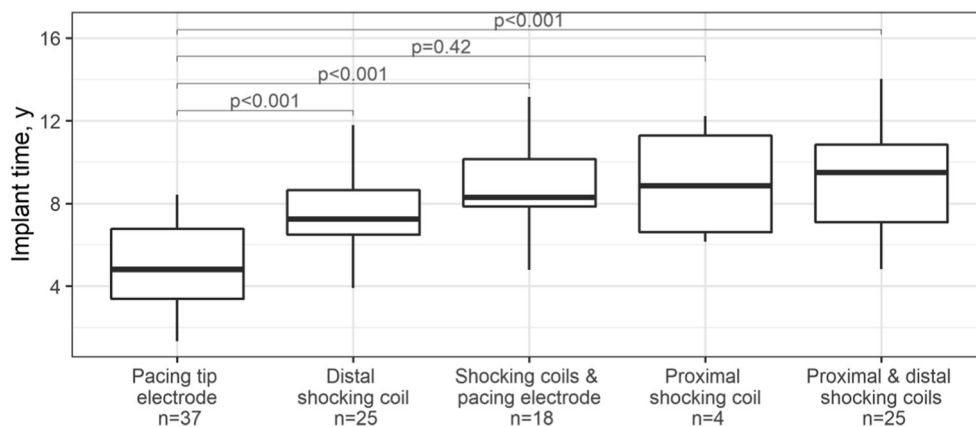
Overall, the average implant time for calcified Endotak Reliance leads was  $7.4 \pm 3.1$  (range: 1.3–16.5) years. Figure 1 shows the median Endotak Reliance lead implant times according to the location of calcification. Pacing electrode calcification appeared significantly earlier than calcification of the distal shocking coil, both shocking coils and the distal pacing electrode ( $p < 0.001$ ).

**Fig. 1** Box graph of Endotak Reliance defibrillation lead implant times according to the location of calcification
