Field reconnaissance and structural assessment of the October 30, 2020, Samos, Aegean Sea earthquake: an example of severe damage due to the basin effect

Onur Onat¹ · Burak Yön² · Mehmet Emin Öncü³ · Sadık Varolgüneş⁴ · Abdulhalim Karaşin³ · Selim Cemalgil²

Received: 14 July 2021 / Accepted: 9 December 2021 / Published online: 22 January 2022
© The Author(s), under exclusive licence to Springer Nature B.V. 2021

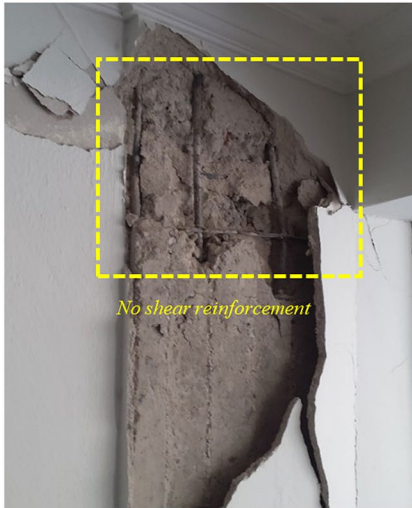
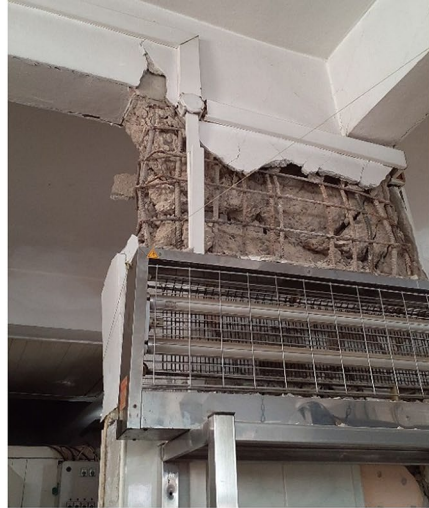
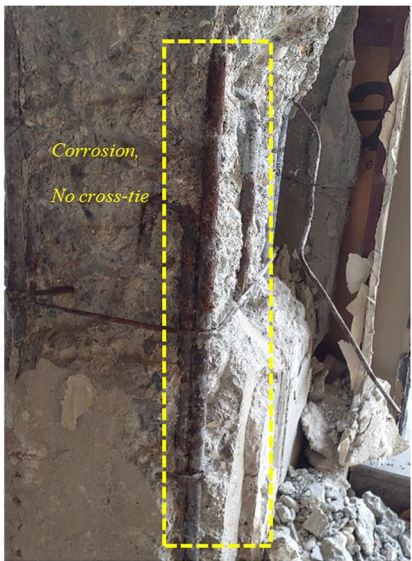
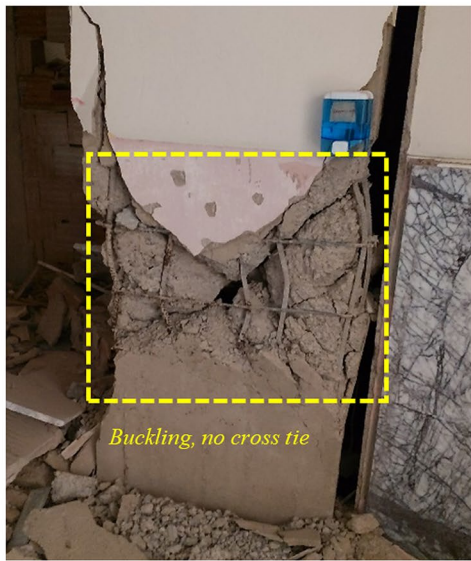
Brittle fractures that occur from shear forces cause great damage and losses, both for the element and structural system. Ensuring shear safety is very important for structural performance, especially under forces that can vary in magnitude and direction, such as earthquake forces. Compressive, friction, and tensile forces in the reinforcements in the bearing elements of reinforced concrete structures create forces that resist shearing. However, shear resistance in structural members is mainly provided by transverse reinforcements.

Fig. 23 Damaged structures due to inadequate spacing between shear reinforcements during the Aegean Sea earthquake

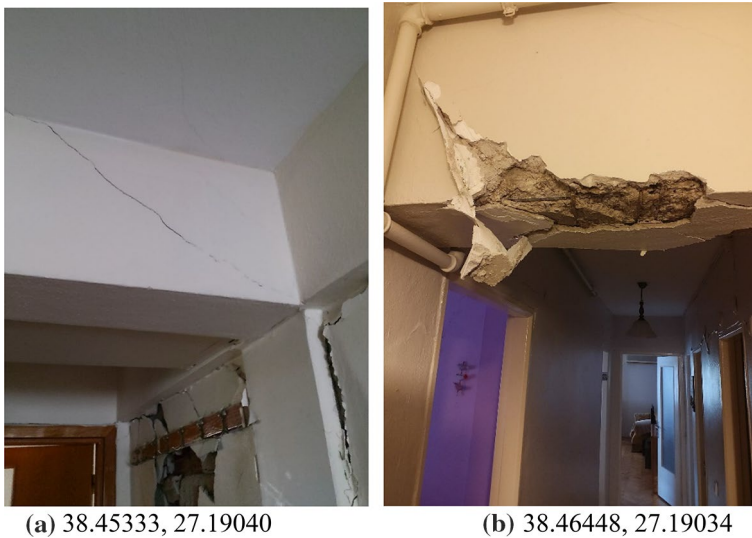
Beams are damaged by deficiencies like columns. Insufficient longitudinal and confinement reinforcement and a low concrete strength caused brittle fractures in beams. While the longitudinal tensile reinforcement ratio ($r \leq 0.005$) is for unribbed reinforcement (for S220) in the 1975 earthquake code, it is given as ($r \leq 0.002$) for ribbed reinforcement (for S420) in the 1997, 2007, and 2018 codes (Fig. 24). When the damaged beams were evaluated, it was seen that even the conditions given for the beams in the 1975 regulation were not met. Figure 25 shows damaged beams resulting from the September 30, 2020, Aegean Sea earthquake.

Fig. 25 Damaged beams during the September 30, 2020, Aegean earthquake

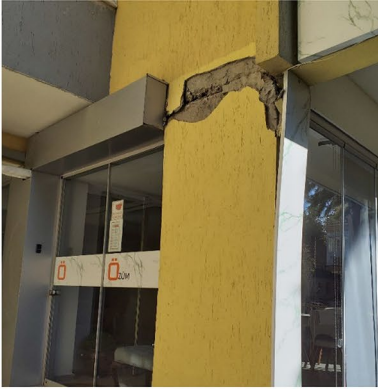
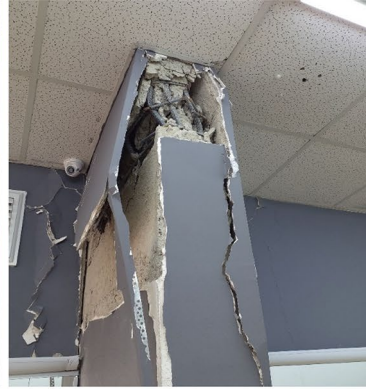
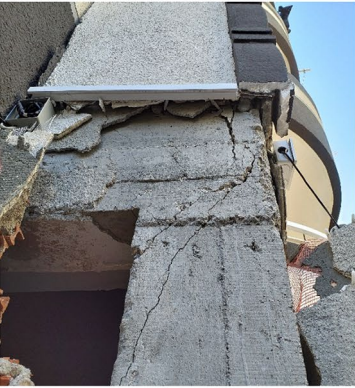
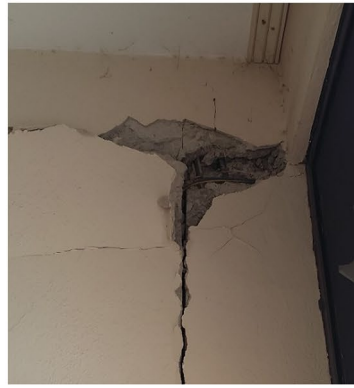
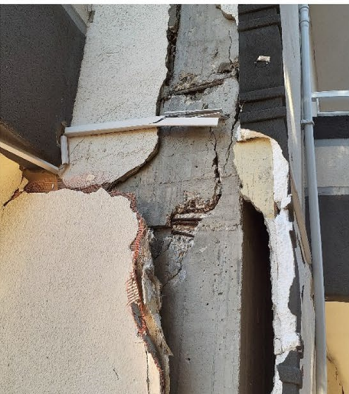
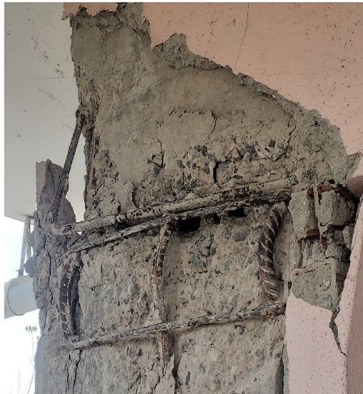
bars for the beams and columns in reinforced concrete elements lead to joint failure. Figure 26 depicts various types of damage. To protect joints from damage, sufficient confinement and shear reinforcement should be used with special attention paid to the design of these elements.

Fig. 26 Beam-column joint damage

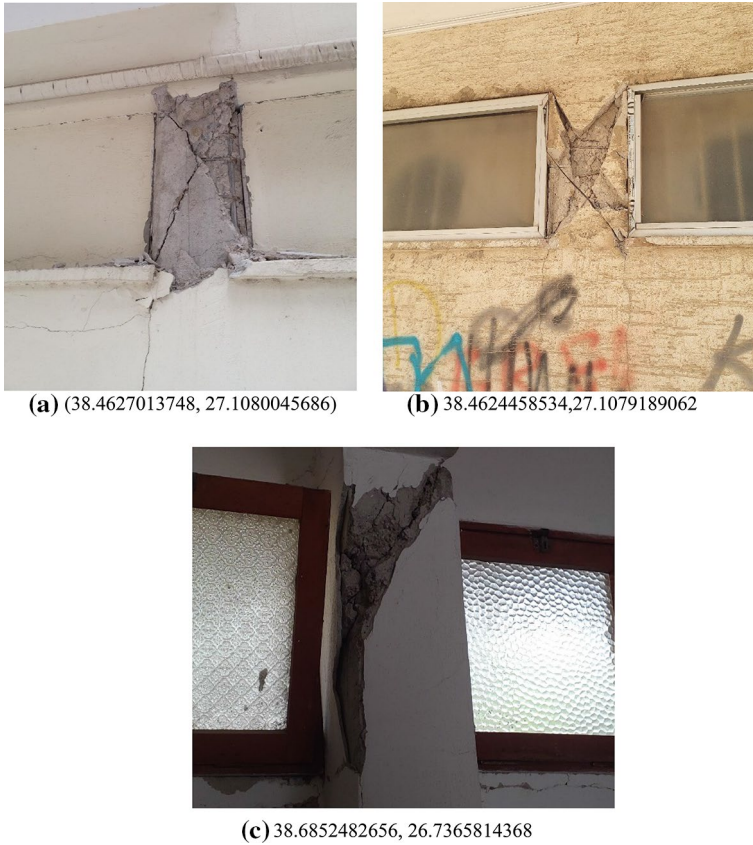
lateral load loading, X-shaped shear cracks are frequently encountered in these columns. The shear cracks that occur completely compensate for the load-bearing capacities of these columns.

Fig. 27 Short column damages

- (1) During construction, a suitable joint gap should be left between the columns and wall, and the gap should be filled with a material that can be tightened.
- (2) To prevent free ends in the column, filling walls should be built on the sides of two columns, and the window space should be reduced. Figure 27 shows this kind of critical failure.

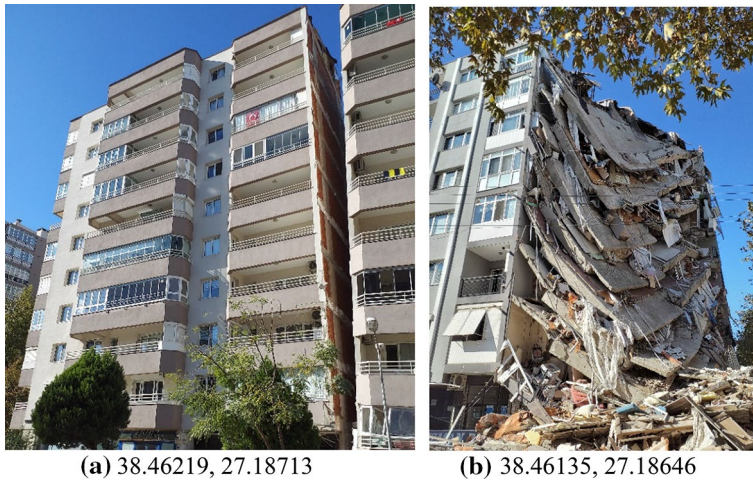
Since the income of the city centres is higher, buildings are built without insufficient gaps being left between the buildings. Since the age of buildings is different, it is expected that adjacent buildings will collide during an earthquake. These collisions can cause significant damage and destruction to structures. This situation has become more dangerous, especially in buildings whose floor levels are not the same. In the 2018 earthquake regulations, the following restrictions were introduced because building blocks that are separated from each other by structural joints carry the risk of colliding and being damaged in an earthquake:

Fig. 28 Damages to adjacent buildings during the September 30, 2020, Aegean Sea earthquake

In addition to this, according to TSC-2007 and TSC-2018, the minimum size of gaps should be 30 mm up to a height of 6 m and from there on, a minimum of 10 mm should be added for each 3 m height increment. These gaps can be filled with construction residue. For this reason, leaving more space than these values would be more appropriate in terms of

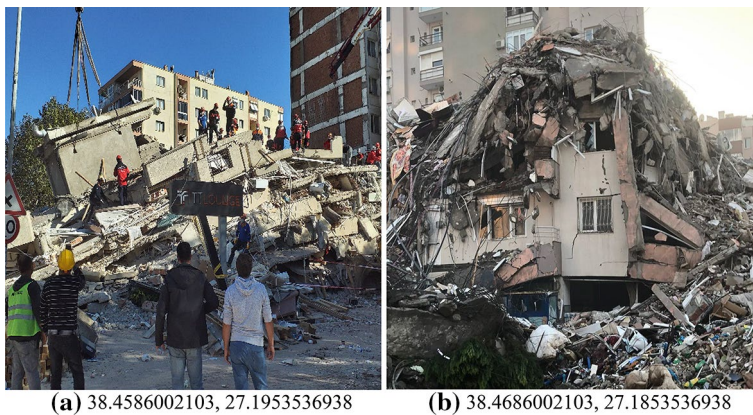
Fig. 29 Total collapse due to strong beam-weak column

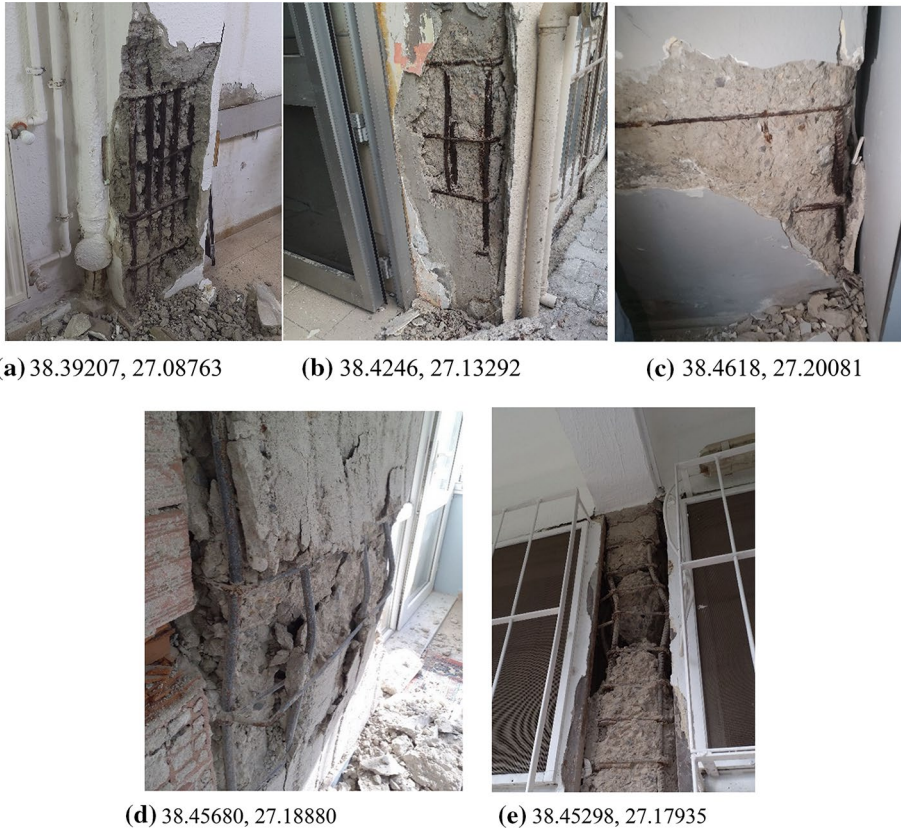
The concrete strength is one of the most important parameters affecting the earthquake performance of a reinforced concrete building. The use of ready-mixed concrete was not compulsory in Turkey until the 1999 Kocaeli earthquake, and handmade concrete was generally used without using a vibrator. After this earthquake, the use of ready-mixed concrete and the compressive strength of the concrete to be poured on-site were required to be at least 20 MPa. With the 2018 earthquake code, the lowest concrete compressive strength was increased to 25 MPa. However, in the 1975 Turkish Seismic code, there is a requirement that concrete with a concrete compressive strength of at least 18 MPa should be used for buildings located in regions with a high earthquake risk. Moreover, the compressive strengths of the concrete cores in the observed collapsed and damaged structures ranged from approximately 6–11 MPa. Another reason why the buildings did not show the expected performance was a lack of ribbed reinforcement in the structural elements and the excessive corrosion that occurred in these reinforcements. The non-ribbed reinforcements prevented the concrete and reinforcement from having sufficient adherence. In addition, the use of aggregate in the concrete of the buildings that was extracted from the Aegean Sea and not washed caused corrosion in the reinforcements and adverse effects on the concrete. Figure 31 shows the poor quality of the concrete and the corroded reinforcement bars in various buildings.

Fig. 31 Failure of column due to poor concrete quality during the September 30, 2020, Aegean Sea earthquake

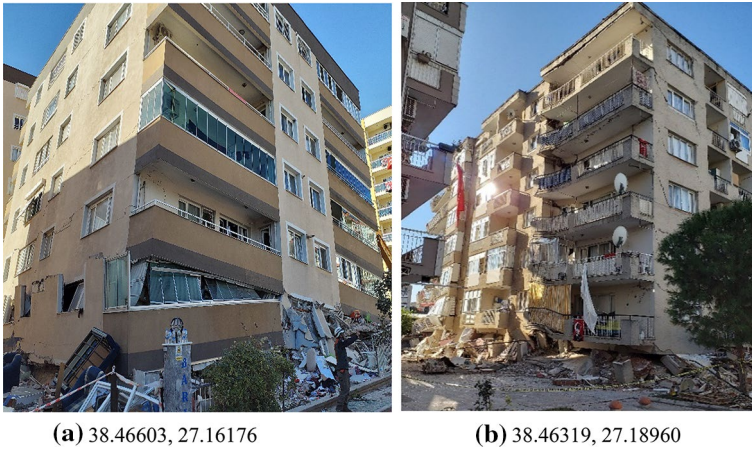
The ground floors of the buildings on the side of the street in the city centre are used as commercial spaces. Larger spaces are obtained by removing the infill walls on these floors. The contribution of partition walls to rigidity is often not considered when designing structures. These walls are only applied to the structure as a load. However, partition walls contribute significantly to the initial stiffness of structures. The absence of walls on the ground floor causes this floor to shift more than the neighbouring floors. Another factor that creates a soft floor is the high floor height on shop floors. The height of the columns causes the stiffness of the floor to decrease. During an earthquake, all the total displacement occurs on this floor, and very large second-order moments occur. Therefore, a building will collapse on top of this floor. The displacement of the ground floor should be limited to prevent soft floor damage. The stiffness of this floor should be increased by increasing the column dimensions and using reinforced concrete shear walls. Figure 32 shows total collapses that arose from soft story mechanisms in various reinforced concrete buildings during the Aegean Sea earthquake.

Fig. 32 Soft-story mechanism

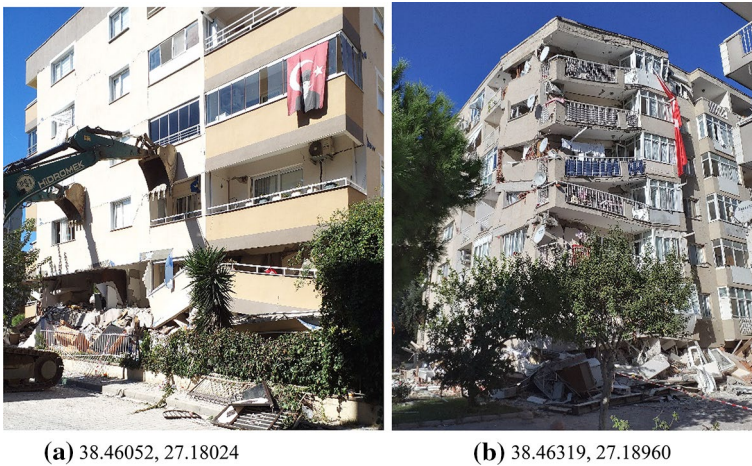
Fig. 33 Soft-story mechanism

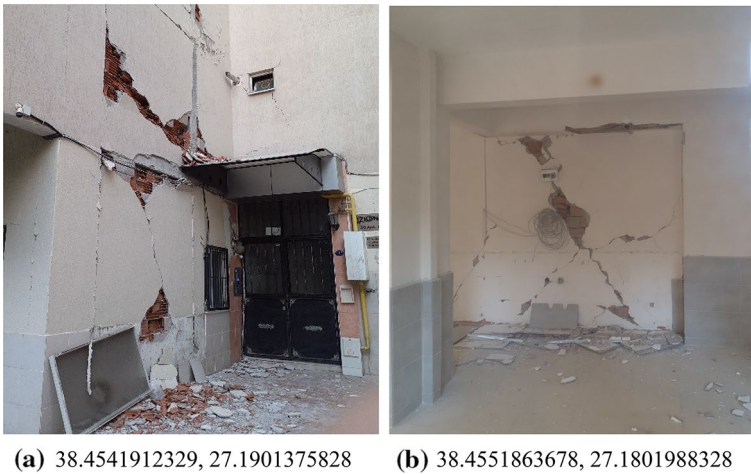
Fig. 34 Shear cracks on walls without openings

Walls without openings are generally supported by columns or shear walls on their two vertical edges. Because the mass of a building is summed at the floor level, horizontal seismic forces can be expected to act at the floor level. Under these loads, shear cracks are enhanced on the infill wall plane. The spread of cracks on the wall plane is affected by the height/length ratio of the wall. Figure 34 depicts the traditional crack shape of an “X”.

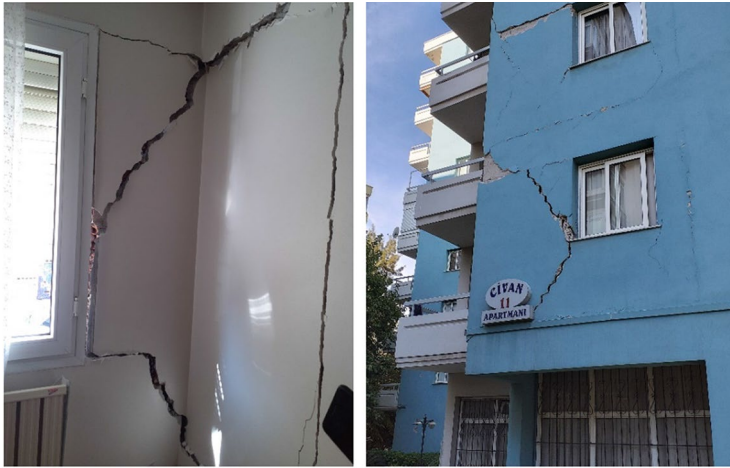
(a) 38.4674770856,27.1608656809

In the corners of exterior walls where there are window spaces, in-plane cracks in the form of steps occur in the plaster lines within the plane of the wall due to shear force. To prevent these cracks, the windows should be kept away from the wall joints, and the wall should be prevented from supporting the wall in this area. Figure 35 shows this type of damage.

Fig. 35 Shear cracks on corner walls with openings

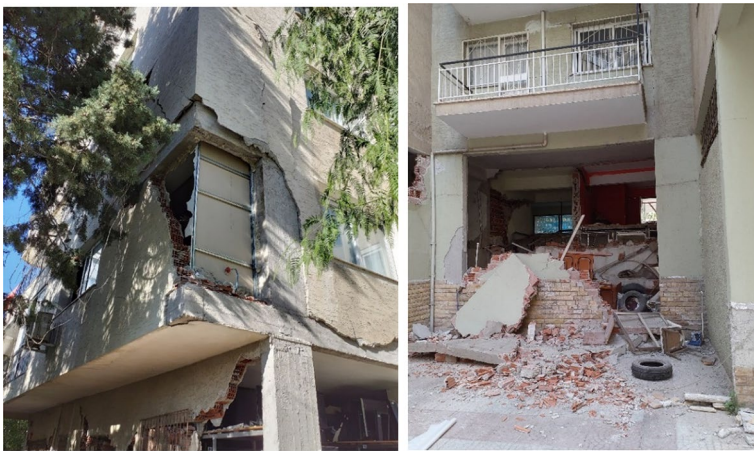
(a) 38.4539375029,27.1902007979

weakens. Thus, since there is no element to support the wall, it is knocked out of the plane of the wall. This type of damage is seen in Fig. 36.

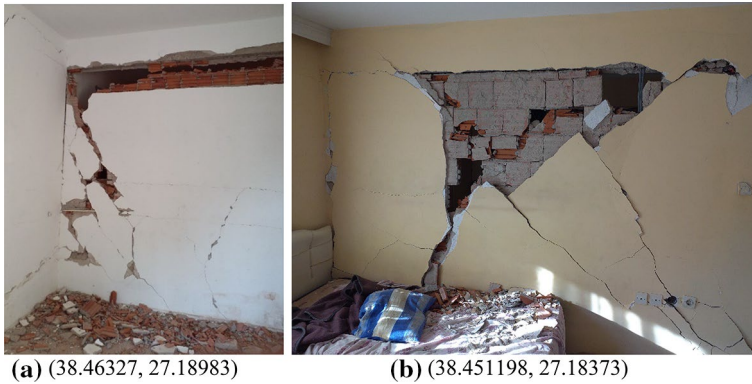
Because the earthquake force acts both on the plane of the wall and outside of it, both in-plane and out-of-plane damage can occur on the wall at the same time. The main reason for these types of damage is that the wall does not have sufficient rigidity in its plane and is not rigidly attached to a frame member. Figure 37 shows this kind of failure mechanism.

Fig. 37 Combined mechanism of infill walls

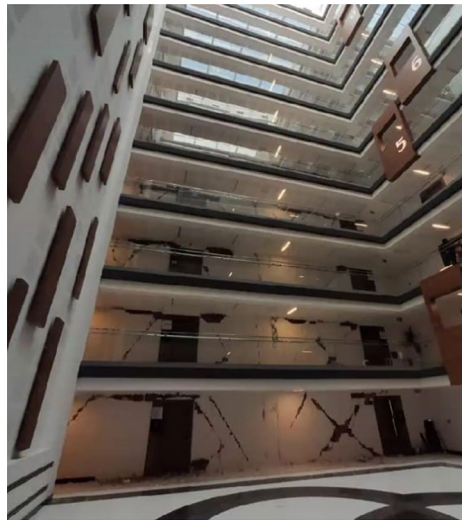
Furthermore, as shown in Fig. 38, heavy in-plane shear damage was observed in new residences. The reason for this damage was the lack of rigid body diaphragm motion of the structural system due to a big opening in the centre of the slab.

Fig. 38 In-plane infill damage of new residence

Figure 38 depicts a public residence with a large central gap. Despite the lack of substantial cracks in the core shear wall, the infill walls showed extensive shear cracks. Damage to the infill walls in a modern house caused by ground motion during an earthquake that is less intense than the design specifications is unexpected. It is presumed that the encircling shear walls were unable to control the inter-story drifts since the structural system lacked a rigid diaphragm contribution. Another theory is that software modelling mistakes were responsible for this unusual type of damage due to incorrect assumptions. Slab motion is believed to be rigid diaphragm motion during the modelling process. Unexpected behaviour can be seen in the absence of rigid motion. Furthermore, the infill walls surrounding the residence doors were severely damaged because of the poor detail design and exhibited unforeseen drift. Due to the severity of this damage, it is imperative that slab discontinuity be considered and appropriate load transfer methods to shear walls be proposed. This is a new type of damage observed during earthquakes in Turkey in the last decade, and there is a consensus among scientists on this finding.

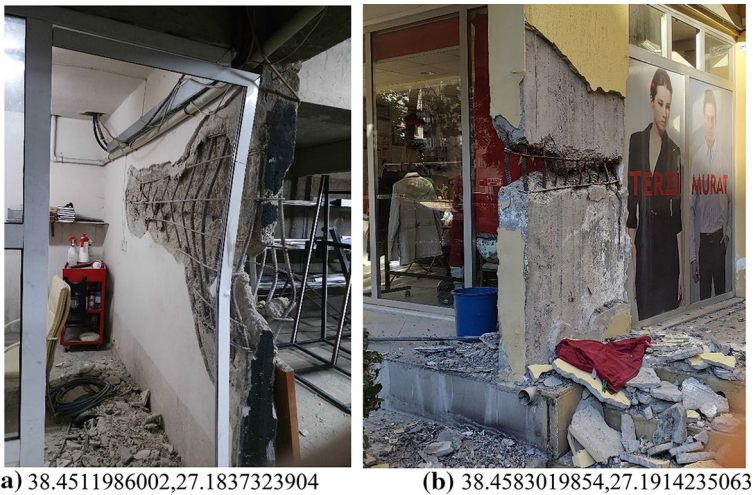
Fig. 39 Reinforced concrete shear wall damages

Reinforced concrete shear walls are important load-bearing elements used to limit floor drifts, provide rigidity to the structure and increase the structural performance of buildings against horizontal shear forces. If these walls, which are subjected to high shear forces during the earthquake, are not designed at the appropriate dimensions, the wall end zones are not formed, and if they are not placed in the appropriate places in the plan, the curtains fail to function and are significantly damaged. Figure 39 shows reinforced concrete shear wall damage during the Aegean Sea earthquake.

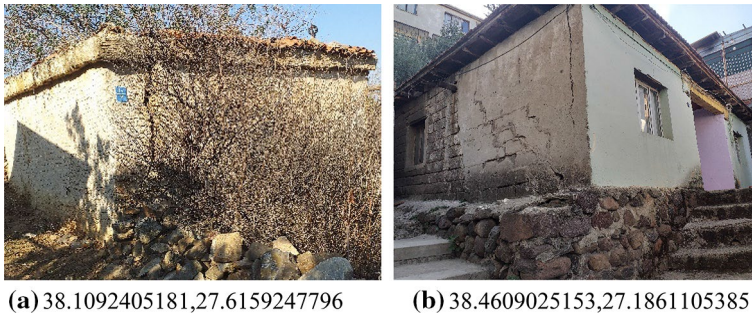
Damage at wall corners is caused by an out-of-plane vibration of the walls and commonly occurs due to a lack of connection between orthogonal walls. Vertical cracks and separations of adjacent walls are signs of corner damage. Figure 40 shows vertical cracks caused because of stress concentrations at the building corners, poor connections between the walls and the absence of bond beams. Vertical confining elements are recommended for confined masonry buildings to prevent this type of failure. According to TBEC-2018, the unsupported plan length between load-bearing walls should be no less than 5.5 m in Seismic Design Classes 1 and 2, and 7.5 m in Seismic Design Class. If this condition is not satisfied, reinforced concrete vertical bond beams should be built on walls with an axis-to-axis spacing of no more than 4.0 m in the plan. However, the unsupported length of such walls should not be more than 16 m.

Fig. 40 Damages at the wall corners

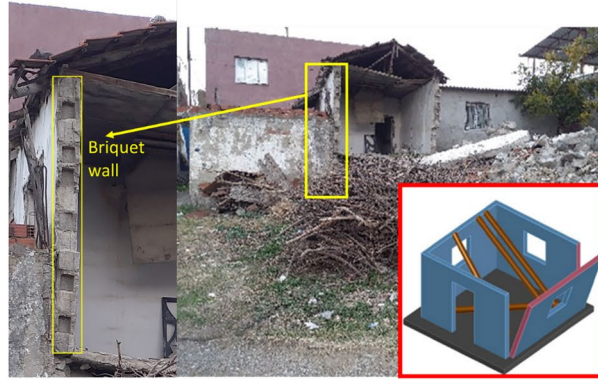
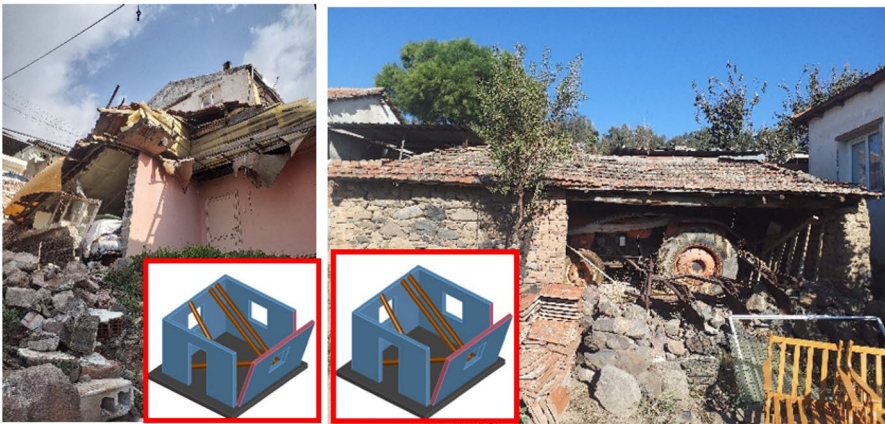
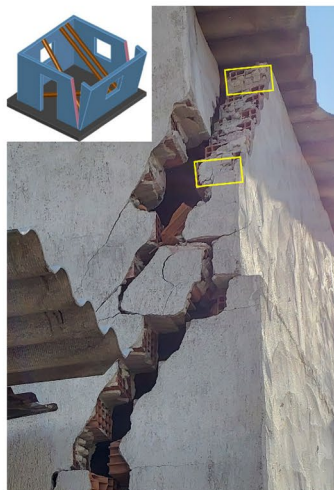
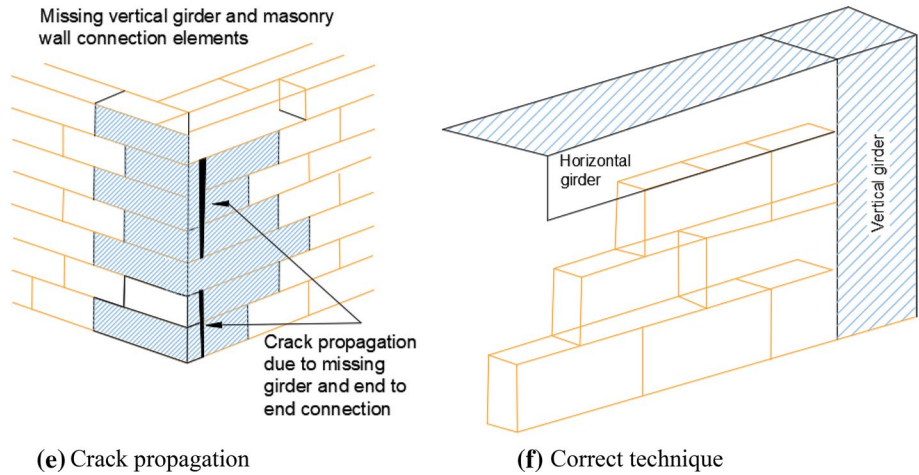
In masonry buildings, failure was caused by insufficient details connecting walls to the roof and walls to each other as well as a lack of bond beams. When masonry buildings are subjected to earthquake effects in the perpendicular direction to the wall plane, out-of-plane mechanisms occur as an overturn of the whole wall or a sizeable portion of it due to the absence vertical bond beams, which contributes to the earthquake resistance of the wall. Fig. 41 shows the out-of-plane mechanism for walls. Different materials were used in the inspected construction, such as briquet, brick, and stone masonry walls in different buildings. Generally, brick and briquet walls were damaged due to unsupported corners with girders (Fig. 41e, f). However, when materials with different properties are used together in a wall or building (Fig. 41c), uncertainties in the rigidity and strength appear and consequently cause problems in the load sharing, especially during earthquakes. For instance, in a building with one edge made of a thick stone wall and the other edge made of thin or unsupported walls, additional torsional moments can come into being because of the rigidity irregularity in the plan.

The workmanship for the walls was not properly been conducted. Clay mortar was employed instead of cement mortar among the stones as a binder due to economic reasons. The binding of clay mortar is weak and becomes weakened over time depending on the weather conditions. Since thickness of the wall was relatively large, the walls were constructed by using more than one stone along the thickness direction. The outer layer of the thick stone walls was built with large coarse stones with a relatively smooth surface. However, smaller rubble stones were used between the two outer layers and did not provide connections among them. This situation caused the inner and the outer layers of the wall to behave independently by weakening the connections along the wall thickness direction.

Fig. 41 Out-of-plane failure mechanism (Small figures were adopted from Altunışık et al. 2021)

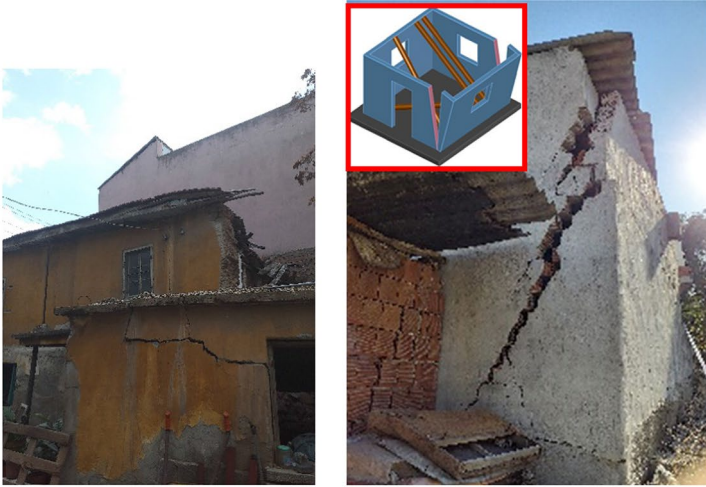
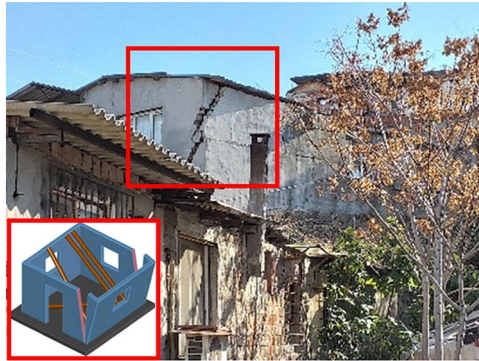
Shear diagonal damage commonly occurs at the edge of window and door openings, in the planes of walls where the shear strength is low and at corners that do not have horizontal and vertical bond beams. Inappropriate openings or their locations in load-bearing walls enhance shear stresses under seismic loads. Thus, the stiffness of the wall decreases, and diagonal cracks occur at the edges of openings. TBEC-2018 requires the use of vertical and

Fig. 42 Shear cracks at masonry building (Small figures were adopted from Altunışık et al. 2021)

horizontal bond beams to avoid this type of damage. Fig. 42 shows diagonal shear cracks in masonry buildings in the earthquake region.
