Case studies of earthquake-induced effects on concrete channels*

Craig A Davis^{1,†} Jianping Hu¹ and Jean-Pierre Bardet²

Abstract Case studies are presented for two concrete lined channels shaken by strong ground motions during the 1994 Northridge earthquake, the high speed channel (HSC) and bypass channel (BC), on the Los Angeles Department of Water and Power's Van Norman Complex. Performances of these two channels as they pass through different subsurface materials identify several important seismic aspects and the critical role of geotechnical earthquake engineering in assessing channel behaviors. Preliminary evaluations using detailed mapping of channel cracks, permanent ground movements, subsurface profiles, and nearby strong ground motion recordings from the 1994 earthquake show that the channel liners may have been damaged from both transient motions and permanent ground movements. Damage from permanent ground deformations is obvious by observation; therefore simplified analyses are presented only for transient movements. Site specific transient response analyses are performed to provide an initial assessment of the differing effects from transient and permanent ground mo

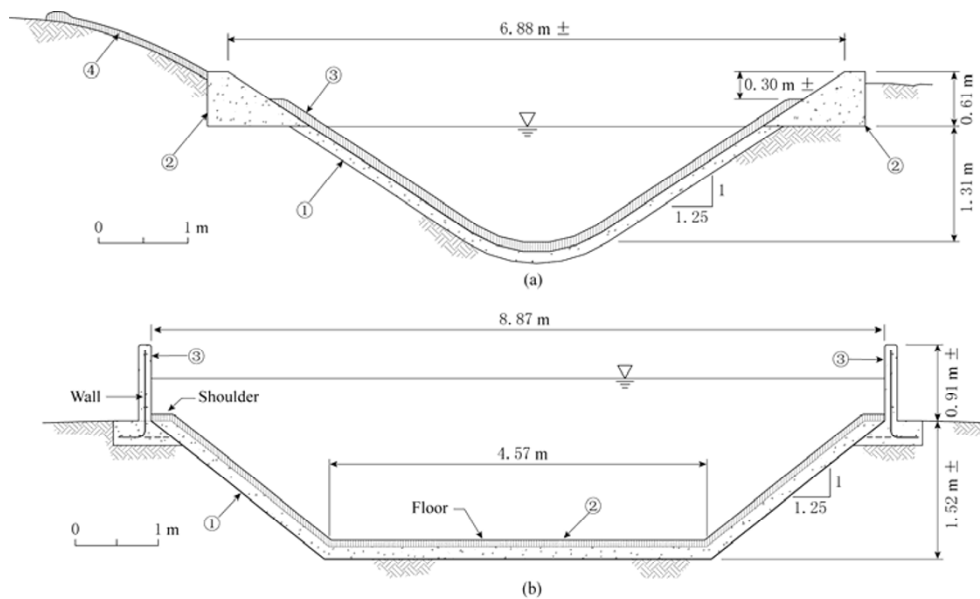
Figures 1a and 1b show the HSC round-bottomed triangular and BC trapezoidal cross sections, respectively. Figures 2 and 3 show HSC and BC profiles, respectively.

Figure 1 (a) High speed channel cross-section. ① Original 1912 channel with 12.7 cm thick unreinforced concrete, ② 1969 unreinforced concrete channel enlargement, ③ 7.6 cm thick wire mesh reinforced concrete gunite overly for post-1971 San Fernando earthquake repair, and ④ 7.6 cm gunite 1972 drainage improvement; (b) Bypass channel cross-section. ① Original 1941 channel with 15.2 cm thick unreinforced concrete, ② 7.6 cm thick wire mesh reinforced concrete gunite overly for post-1971 San Fernando earthquake repair, and ③ post-1971 earthquake channel enlargement.

earthquake caused severe damage to both channels. Channel repairs were made using wire mesh reinforced concrete gunite as shown in Figure 1. Specifications for

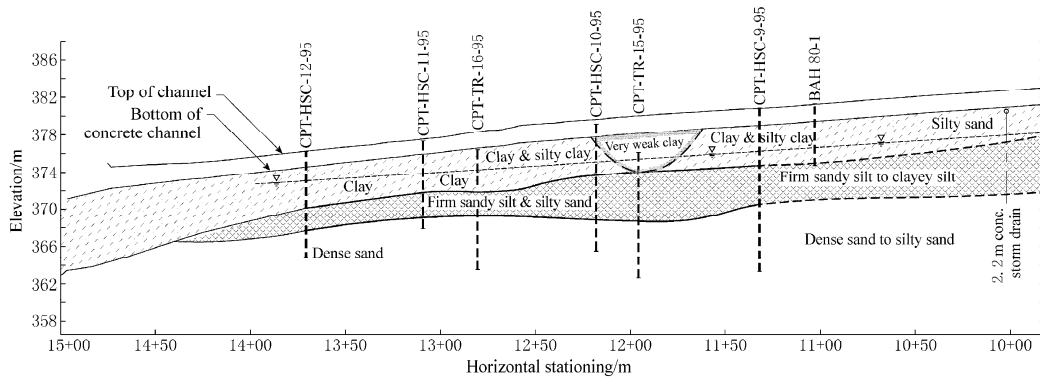
Soil profiles along the HSC and BC are presented in Figures 2 and 3. These profiles were determined using results of cone penetration testing (CPT) and boring logs obtained in the HSC and BC vicinity (Davis and Scantlin, 1997) with aid from the 1940 and 1913 (not shown) ground surface profiles. As seen in Figures 2 and 3, the soil conditions vary along the HSC and BC. Much of the soils consist of interbedded sandy silts, silty clay, and clay alluvial deposits, underlain by stronger alluvial soils above Saugus formation bedrock. In a few places the channels were constructed in fill. There are two zones of very weak clays, one under the HSC as shown in Figure 2, and one under the BC as shown in Figure 3.

Groundwater around the HSC and BC is influenced by water seeping from the channels, which are not considered to be water tight. The natural groundwater has a general downward gradient to the south along the HSC and southwest along the BC. Figure 2 shows the groundwater surface around the HSC measured from subsurface investigations within 10 m of the channel. Groundwater around to the BC was measured near the

Figure 2 High speed channel profile showing CPT locations and interpreted subsurface soil conditions (1 stationing = 50 m).

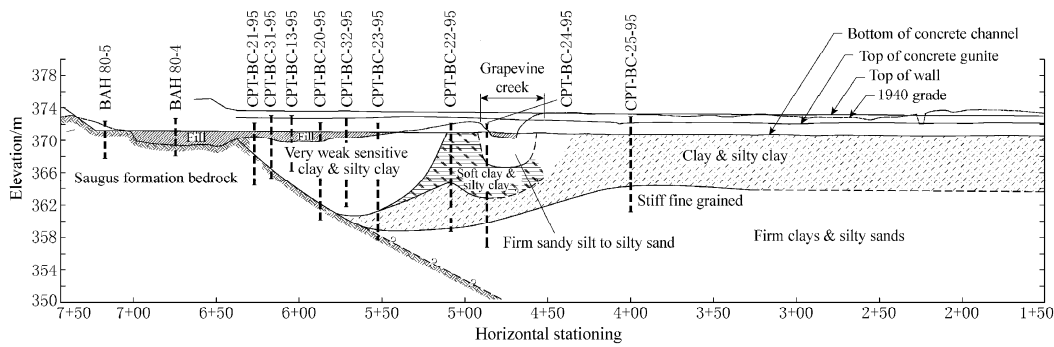
ground surface and is not shown in Figure 3. Seepage influences the groundwater elevation locally around both channels, causing a mound in the groundwater surface. Away from the channels the natural groundwater is approximately 6 m deep. Seepage from the BC influences natural water levels in the soft clay soils at distances greater than 18 m. Seepage from the HSC dissipates rapidly within 10 m of the channel, except for a localized condition in soft clay soils where the groundwater is observed to remain near the ground surface.

Figure 3 Bypass channel profile showing CPT locations and interpreted subsurface soil conditions (1 stationing = 50 m).

transits from bedrock having shallow fill cover to the weak clay soils at the station 6+40. Bedrock site $i=1$ has β_1 ranging from 263 m/s to 600 m/s (average 432 m/s) and $v_{PG1} = 130$ cm/s (estimated to be similar to station 10). Site $i=2$ is over the 12 m deep clay deposit at station 5+80 having $\beta_2 = 135$ m/s. Station 13 was recorded approximately over the deepest weak clay soils and is taken to represent motions at the station 5+80, providing $v_{PG} = 116$ cm/s. Evaluating sites 1 and 2 for $H = 12$ m gives $\Delta_2 = 3\Delta_1$. From the preceding information $\Delta_2 = 38$ cm at station 13, $L = 61$ m, and $\gamma = 0.41\%$. The strain resulting from differential ground motion is sufficient to cause major cracking. Similar results are expected for the HSC. This preliminary analysis assumes that the PGVs at sites 1 and 2 were in phase and occur at the same time. The transient ground strain may be greater or less than the average value depending on the phase of ground motion at sites 1 and 2. The purpose of this preliminary analysis is to assess if this simplified method can estimate channel performances during earthquakes. These initial results indicate this simplified analysis may be able to reasonably predict concrete channel performance; however, more advanced transient analysis is needed to reveal the actual ground strain condition under the shaking to confirm applicability of the simple method.

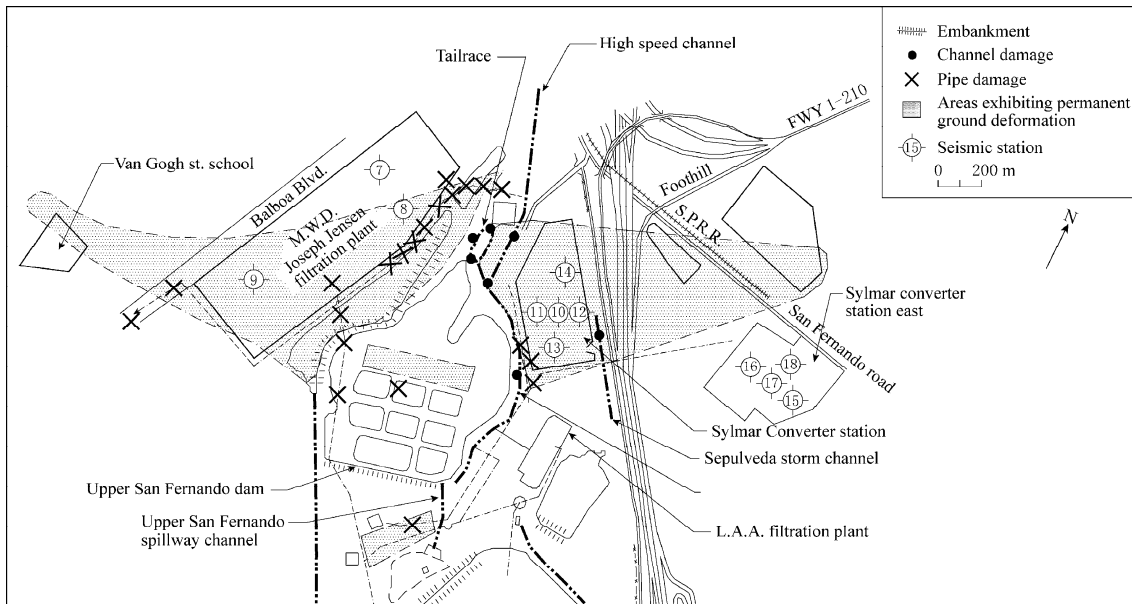
Figure 4 shows 1994 pipe and channel damage locations previously presented by Davis and Bardet (1995). As seen in Figure 4, most 1994 pipe and all channel damage occurred on the northern end of the Complex where the HSC and BC are located.

Figure 4 Northern Van Norman Complex area showing channel locations, seismic stations, and regions bounding observed permanent ground movement (shaded).

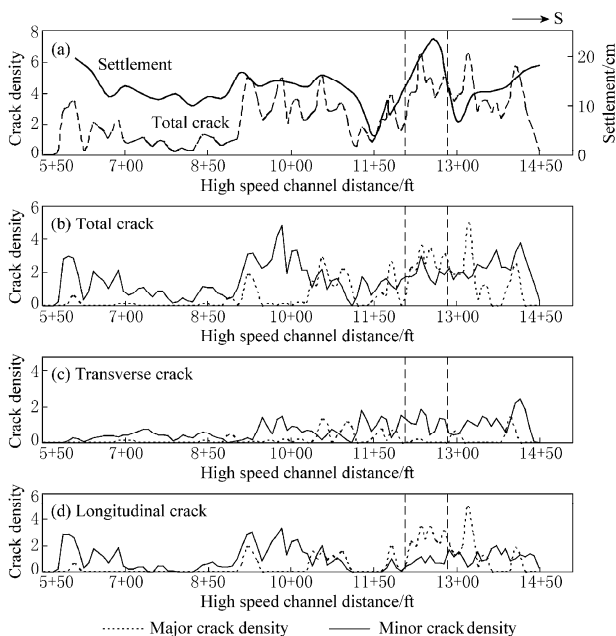
were mostly transverse (perpendicular) or longitudinal (parallel) to the channel axes. Some of the damage to both channels was due to the continued water flow across broken sections immediately following the earthquake. As shown in Figure 5c, the HSC sustained numerous transverse cracks. Many cracks extended through the original concrete liner and the gunite overlay that was placed in 1971. Most of the larger HSC longitudinal cracking identified in Figure 5d occurred at the top of the gunite overlay, indicating separation between the top curb and the channel.

Figure 5 High speed channel settlement and crack density where two vertical dash lines indicate the area of observed horizontal movement.

Figures 5a and 6a show settlement profiles of the HSC and BC, respectively. All settlement measurements were taken on the concrete surfaces. In zones of large settlement, the channels could bridge the movement and create voids between the soil surfaces. As a result, settlement measurements reported in Figures 5a and 6a are considered a lower bound of deformation in the underlying soil. As seen in Figures 5a and 6a, the channels underwent large soil settlements with the greatest settlement, resulting in the regions corresponding to soft clayey soils shown in Figures 2 and 3. BC measurements showed differential settlements across the channel width of up to 0.15 m, indicating the liner tilted down to the west. Figures 5 and 6 also show the approximate regions of observed greatest horizontal lateral permanent ground movement, which corresponds with the greatest settlement.

Figures 5a and 6a present the calculated crack density using all cracks and show a general correlation of increased cracking with settlement, but no consistent pattern over the entire channel lengths. Figures 5 and 6 also show that the crack density magnitudes for any crack subcategory are similar for the HSC and BC. Figures 5b to 5d and 6b to 6d present the major and minor cracks and show a reasonably good correlation of major cracking with settlement, but no correlation of settlement with minor cracking. Longitudinal cracks in the HSC and transverse cracks in the BC are very well correlated with settlement and horizontal movement in Figures 5d and 6c, respectively. However, the HSC transverse and BC longitudinal cracks do not correlate well with permanent ground movements.

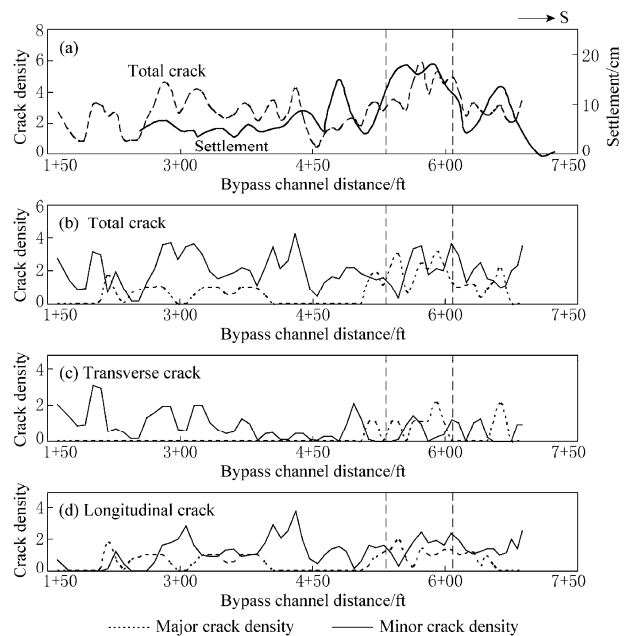
The BC cracked and separated in many locations and in some places the overlay began to delaminate from the original channel. Figure 6 identifies the BC sustained numerous cracks. Davis et al (2002) described seven transverse cracks greater than 0.63 cm wide. Two cracks over 0.63 cm wide occurred near the south end over soil fill. Many transverse cracks over the clay soils are measured in excess of 1.3 cm wide. The greatest transverse cracking resulted above soft clayey soils between stations 5+30 and 6+25 rupturing across the entire channel section displacing the lining and walls. The two transverse cracks between stations 6+10 and 6+25 had a noticeable vertical offset, down to the north, and left lateral offsets having a minimum movement of 7.6 cm.

Figure 6 Bypass channel settlement and crack density where two vertical dash lines indicate the area of observed horizontal movement.

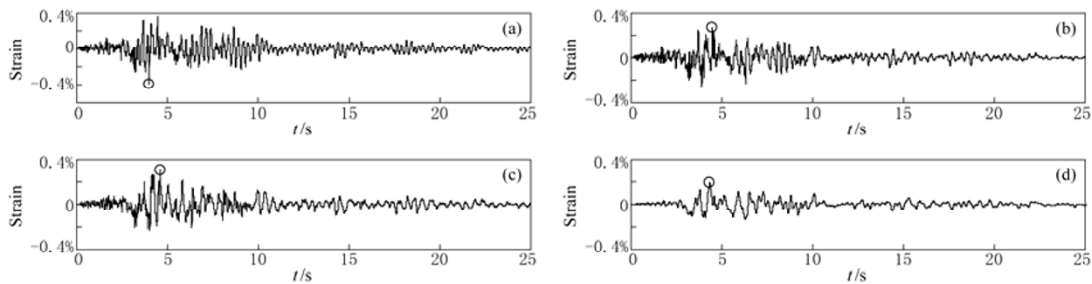
Figures 7 and 8 show horizontal transient shear strain results at different locations along the HSC and BC in a direction transverse to the channel axes. These shear strain time histories are calculated, neglecting soil-structure interaction effects, at the depth between the ground surface and the channel bottom. As shown in Figure 7, between BC station 4+80 and station 6+40, the maximum transient shear strains in the first 10 seconds of shaking exceed 0.2%, which is the assumed minimum strain to initiate concrete cracking (USACE, 1990). This correlates well with the observed major crack and settlements at this portion of the channel. It also indicates that some of the BC major cracks within the greatest

permanent ground deformation regions may have resulted from transient motions independent of permanent ground deformations. As shown in Figure 8, similar

Figure 7 Transient shear strain at bypass channel with stations 6+25 (a), 6+10 (b), 5+95 (c) and 4+90 (d).
