Comparison of the Failures during Cyclic Oxidation of Yttria-Stabilized (7 to 8 Weight Percent) Zirconia Thermal Barrier Coatings Fabricated *via* Electron Beam Physical Vapor Deposition and Air Plasma Spray

N.M. YANAR, M. HELMINIAK, G.H. MEIER, and F.S. PETTIT

The failures during oxidation of electron beam physical vapor deposition (EBPVD) and air plasma spray (APS) yttria-stabilized zirconia (YSZ) thermal barrier coatings (TBCs) on different bond coats, namely, platinum-modified aluminide and NiCoCrAlY, are described. It is shown that oxidation of the bond coats, along with defects existing near the TBC/bond coat interface, plays a very important role in TBC failures. Procedures to improve TBC performance *via* modifying the oxidation characteristics of the bond coats and removing the as-processed defects are discussed. The influence of exposure conditions on TBC lives is described and factors such as cycle frequency and thermal gradients are discussed.

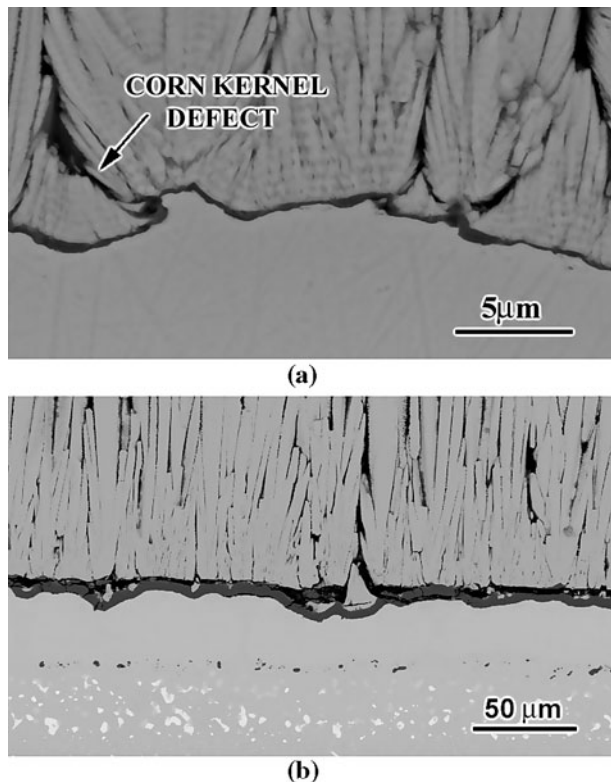
Fig. 13—Scanning electron micrograph of a typical heavy grit blasted TBC system with Pt aluminide bond coat with corn kernel TBC defects (a) in the as-processed condition and (b) after failure.

In this study, heavy grit-blasted Pt aluminide coatings with EBPVD TBCs subjected to 1-hour thermal cycles failed by the ratcheting mechanism. Figure 13 presents such a system in the as-processed condition and after failure. The interface became highly irregular, eventually causing failure. NiCoCrAlY coatings failed as a combined result of TGO growth and defects that were identified as TBC defects, transient oxides, surface defects, and reactive element-rich oxide protrusions. Examples of some of the defects are shown in the micrographs of as-processed coatings given in Figure 14. The details of the failure mechanisms for these two systems were discussed in an earlier publication.^[18]

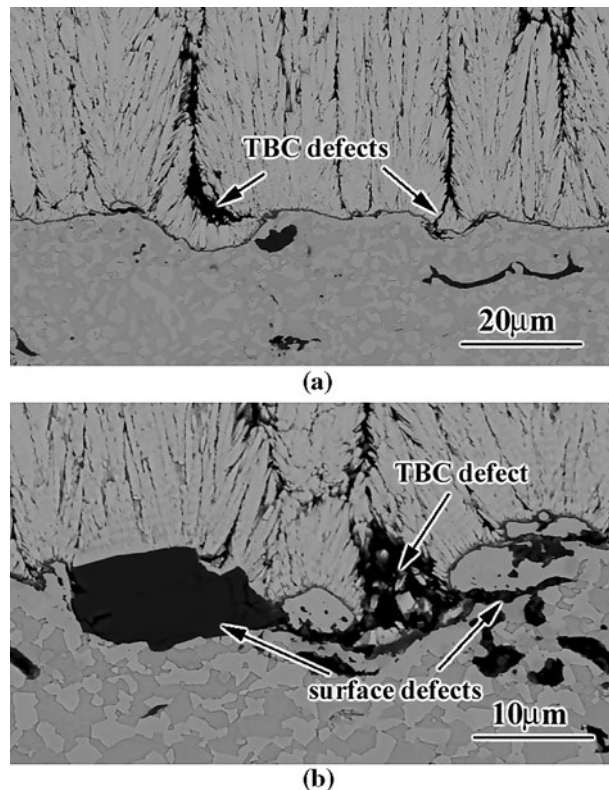
Fig. 14—Scanning electron micrographs showing the typical state-of-the-art TBC systems with NiCoCrAlY bond coats in the as-processed condition. Defects were present, such as (a) TBC defects (corn kernels) and (b) surface defects.

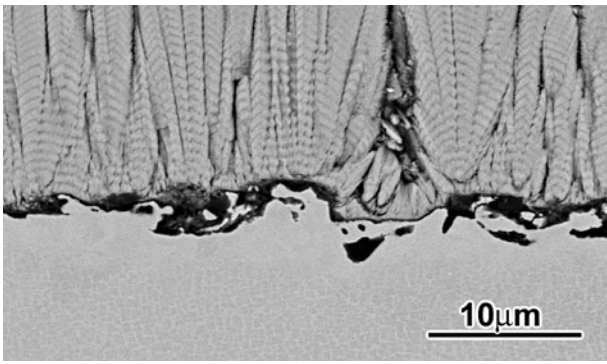
Fig. 15—Scanning electron micrograph of as-processed EBPVD on René N5. The TBC-N5 substrate interface is irregular and corn kernel defects are evident in the TBC at the TBC-alloy interface.

systems have surprisingly competitive TBC lives. An as-processed no bond coat TBC is presented in Figure 15. The TBC/superalloy interface is irregular and oxides are evident along this interface. A failure of such a no bond coat system is presented in Figure 16, and it is apparent that failure has occurred along the TGO/superalloy interface, but no rumpling or ratcheting has occurred. An as-processed TBC on René N5 with a diffused platinum layer is presented in Figure 17. The interface between the TBC and the substrate is irregular due to the electrolytic process used to deposit the platinum. The TBC on this type of bond coat did not fail after 7000 cycles, and a cross section of this

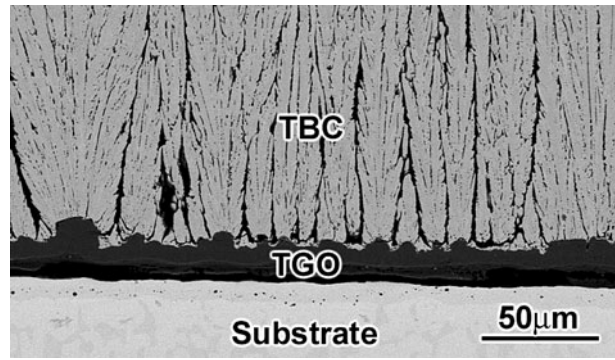
Fig. 18—Scanning electron micrograph of an EBPVD YSZ TBC on René N5 with a platinum overlayer. This specimen did not fail after ~7000 cycles of oxidation at 1373 K (1100 °C). (The TGO separated from the coating during metallographic preparation).

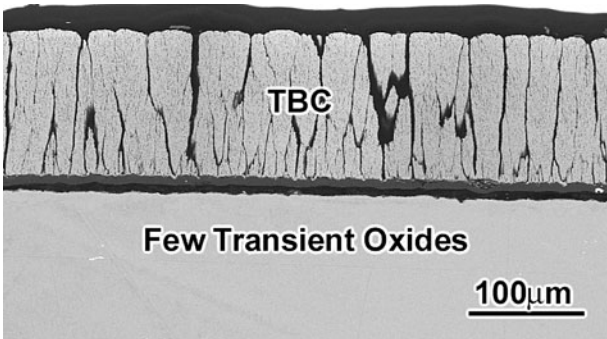
Fig. 16—Scanning electron micrograph of failed EBPVD YSZ TBC (second lot) on René N5 after 4100 cycles at 1373 K (1100 °C).

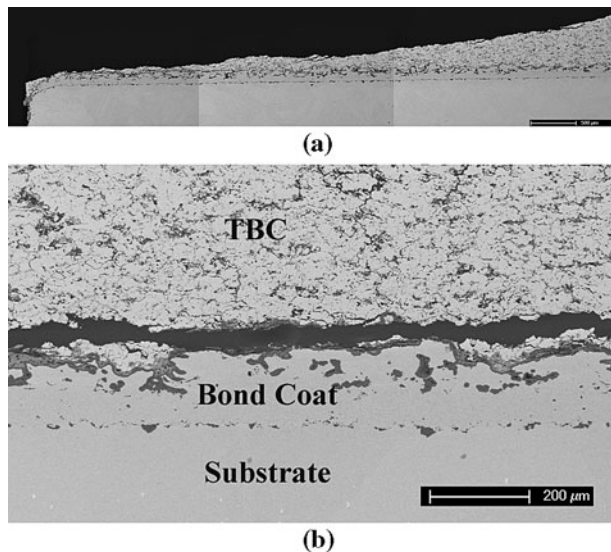
It has been found that the lives of APS TBC coated NiCoCrAlY coatings are strongly influenced by TBC thicknesses (Figure 19). Moreover, the failure modes can differ between thick and thin TBCs. For thick TBC (*e.g.*, 1125 µm), the failure is well into the TBC at splat boundaries (Figure 20(a)). As the TBC thickness is decreased, the failure moves toward the TBC/TGO interface and the failure mechanism is similar to that described previously for such TBC systems (Figure 20(b)). It has been found that APS TBC failures on NiCoCrAlY bond coats are also influenced by the alloy substrate (Figure 21).^[20]

Fig. 20—(a) In the case of thick (>1000 μm) APS TBCs, failure occurred in the TBC where the initial cracking initiated at the specimen edge. (b) For thinner thicknesses, the failure was along the TBC-TGO interface.

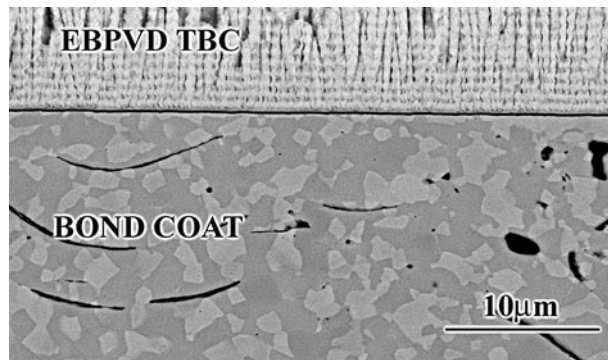
Fig. 22—Micrograph showing as-processed TBC on polished NiCoCrAlY bond coat. The TBC-TGO interface is very smooth and no defects are evident.

believed that the increased life of the EBPVD TBC is due to improved adherence and the development of pure and slow growing TGO on the platinum-coated NiCoCrAlY. In the case of hand-polished specimens, the improved lives were attributed mainly to the lack of defects along the TGO/TBC interface (mainly TBC defects and transient oxides).

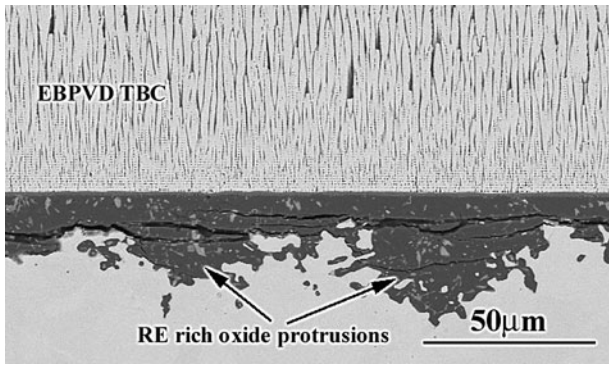
Figure 25. The TGO is thick due to reactive element oxides in the TGO, but the TBC/TGO interface is very smooth and free from most of the defects. The TBC system with the NiCoCrAlY bond coat with the Pt overlayer is presented in Figure 26. Cracks are evident in the TBC. The growth rate of the TGO is slower compared to the growth rate of the TGO on the state-of-the-art NiCoCrAlY systems (Figure 27).

Fig. 25—Scanning electron micrograph of a TBC with a hand-polished NiCoCrAlY bond coat after 1520 cycles of exposure at 1373 K (1100 °C).

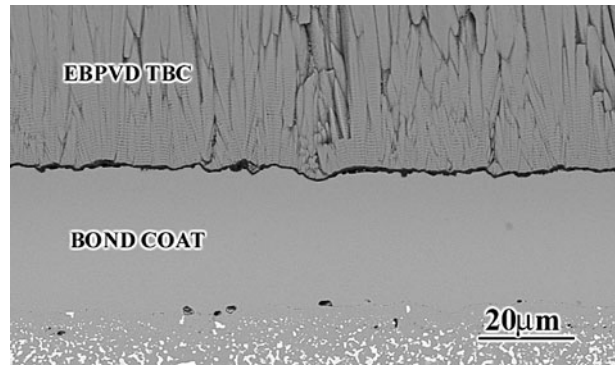
Fig. 28—Scanning electron micrograph of a typical TBC system with light grit blasted Pt aluminide bond coat in the as-processed condition showing the relatively smooth interface compared to the interfaces of heavy grit blasted Pt aluminide bond coats.

Surface condition also had a significant improvement in the lives of EBPVD TBCs on Pt aluminide coatings. An as-processed TBC with a light grit-blasted bond coat is presented in Figure 28. Few defects are evident and a TBC system with such a bond coat finish did not fail after 8000 cycles at 1373 K (1100 °C) (Figure 29).

Since rough surfaces are conducive to bond coat rumpling because defects exist in the TBC that permit the bond coat to recede, a light grit blast was used on Pt

aluminide coatings to attempt to produce a TBC system with fewer of these defects. Significant improvements in lives were observed, which are attributed to the inhibition of the ratcheting type of failure.

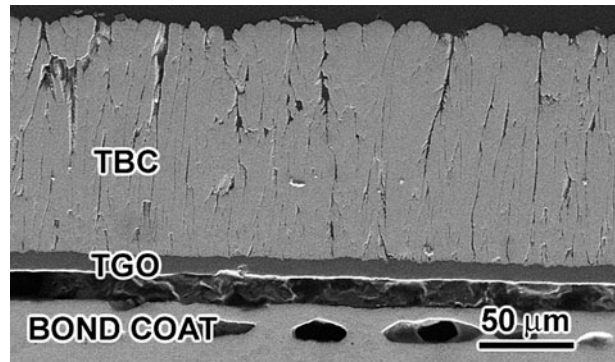
Fig. 29—Cross-sectional view of TBC on light grit blasted Pt aluminide bond coat. This TBC did not fail after 8000 cycles at 1373 K (1100 °C). Voids formed in the bond coat as a result of interdiffusion (the TGO detached from the bond coat during metallographic preparation).

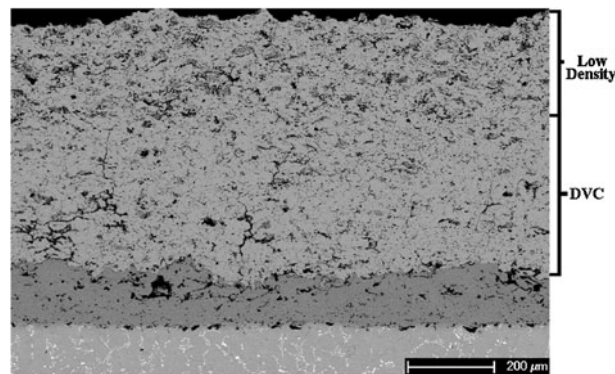
Fig. 30—Cross-sectional micrograph of an APS TBC system with DVC inner layers in the as-processed condition.

with vertical cracks and the upper layer is more porous. This type of microstructure is obtained by adjusting spraying parameters during deposition. Cracking was sometimes observed at the interface between the two layers of the TBC. Even though specimens without DVC layers for direct comparison were not available due to different substrates used, similar cyclic lives of systems

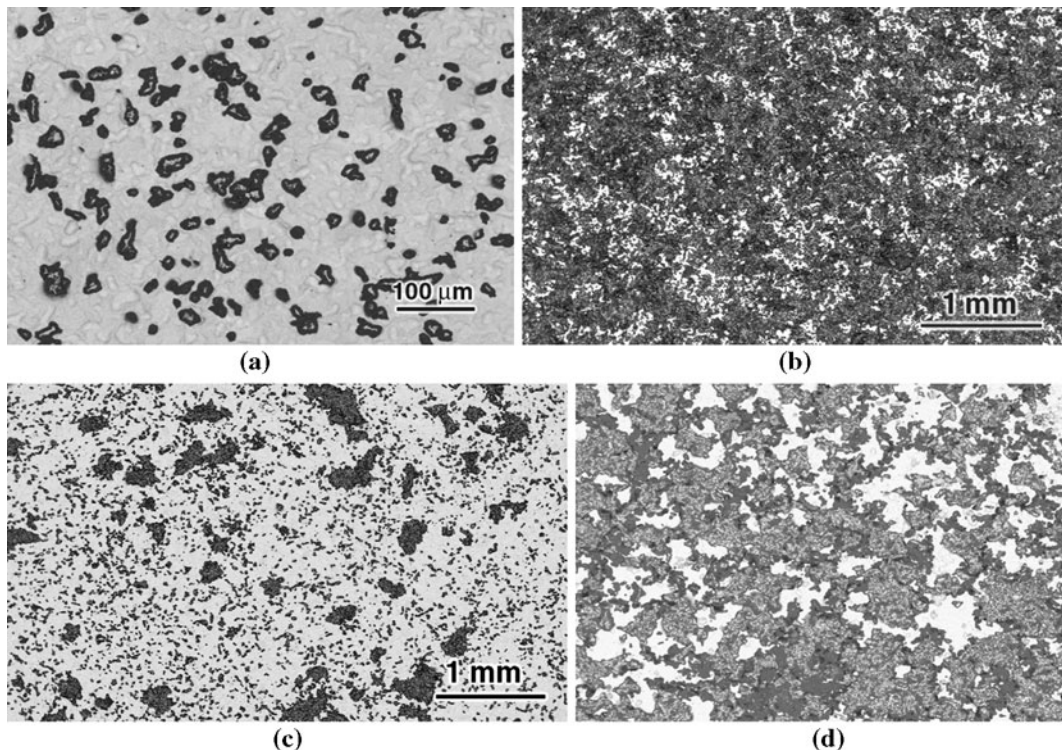
Fig. 33—Fracture surface exposed upon failure of EBPVD YSZ TBCs on platinum aluminide bond coats in cyclic oxidation for different cycle lengths and temperatures. (a) 100-h isothermal (1473 K (1200 °C), 1 cy), (b) 15-h cycles (1373 K (1100 °C), 88 cy), (c) 1-h cycles (1473 K (1200 °C), 120 cy), and (d) rapid cycles (1373 K (1100 °C), 6556 cycles).

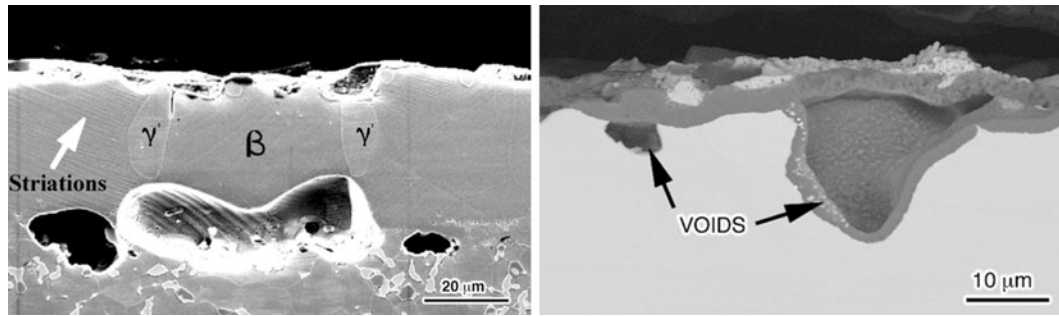
The microstructures of the failed specimens are also different for the two bond coats. Figure 32 shows that the fracture occurs mainly along the TGO/bond coat interface for the NiCoCrAlY bond coat regardless of cycle frequency. There is no evidence of rumpling for this bond coat. (Shi *et al.*^[22] reported rumpling for NiCoCrAlY bond coats when the cyclic exposures are carried out with a temperature gradient across the specimen.) Figure 33 indicates that the failure for Pt-aluminide bond coats occurs along the TGO/bond coat interface for isothermal exposures and by a ratcheting mechanism for 1-hour cycles (as described previously). The 15-hour cycles result in a mixed fracture surface, but much of the failure proceeds along the TGO/bond interface. The fracture surface for the rapidly cycled specimens actually shows more exposed bond coat than that for the 1-hour cycles. This is the result of profuse void formation in these coatings, as illustrated in Figure 34.

Fig. 34—Scanning electron micrographs showing voids that develop in platinum aluminide bond coats after rapid cycling at 1373 K (1100 °C).

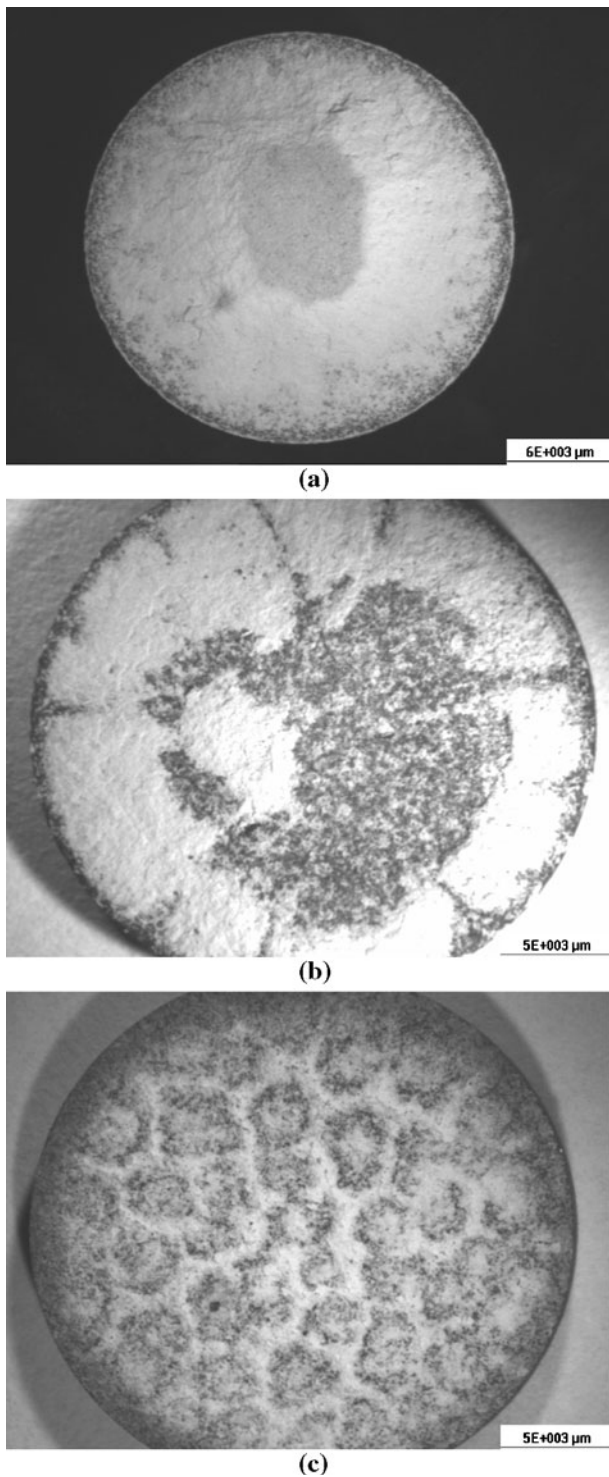
Figure 36 compares the fracture surfaces of the thickest (1.1 mm) topcoats in the three tests. Figure 36(a) corresponds to the cross section in Figure 20(a) for the FCT, and the surface appears to be comprised entirely of YSZ. The fracture surface of the specimen failed in the pseudo-isothermal test (Figure 36(b)) is similar to that for the FCT, except there is somewhat less YSZ remaining on the surface. The fracture surface of the FCT was completely covered by YSZ with very minimal amounts of TGO showing, whereas the surface of the pseudo-isothermal specimen was comprised of 75 pct YSZ and 25 pct TGO and bond coat. The JETS specimen failed by the spallation of portions of the YSZ top coat, which left a dimpled morphology at the fracture surface, as seen in Figure 36(c). The darker rim around the edge of the button shows an edge crack fully surrounded the button early in the test. The dark tint is caused by carbon deposited by the JETS flame, which has decorated the extent of the inward growth of the edge crack. The inward growth varied from about 1000 to 3000 μm at different locations around the circumference. Finally the YSZ layer completely spalled at the end of the test on final cooldown, since no carbon deposit is seen in the central area of the button. Each of the specimens examined contained roughly 40 dimples. The individual dimples had a raised outer YSZ edge, a flat YSZ/TGO inner ring, and occasionally a raised center YSZ peak. The average diameter of the dimples was 3.3 mm with a standard deviation of 0.5 mm. Given this statistic, the average number of dimples across the diameter of a single button is approximately seven to eight dimples. SEM analysis of the fracture surface revealed that fracture occurred mostly within the YSZ top coat, because there was relatively little TGO at the fracture surface. The fracture path appeared to be mixed between intersplat fracture and intrasplat fracture. Examination of thinner topcoats, which were in an earlier stage of degradation, indicated that the dimpled failure in the JETS test involved formation of horizontal cracks in the lower portion of the topcoat, followed by the formation of vertical cracks and finally linking of the horizontal and vertical cracks to remove a portion of the topcoat.

Fig. 36—Comparison of the fracture surfaces of TBC specimens with a 1.1-mm-thick topcoat and IN718 substrate after failure in (a) a furnace cycling test, (b) a pseudo-isothermal test, and (c) a JETS test.
