Corrosion of 1.4016 Ferritic Steel by Urea at High Temperature

Anastasiia Galakhova, Fabian Kadisch, Gregor Mori, Susanne Heyder, Helmut Wieser, Bernhard Sartory, Jaroslav Wosik, Sabine Schwarz, and Simon Burger

Submitted: 7 June 2022 / Revised: 22 August 2022 / Accepted: 19 January 2023 / Published online: 9 March 2023

The corrosion behavior of a ferritic unstabilized stainless steel 1.4016 during decomposition of aqueous urea solution at high temperature has been investigated. Corrosion was obtained from 100 h of cyclic heating (from room temperature up to 600 °C) and injection of aqueous urea solution on the steel plate in a laboratory-scale test bench. The evaluation procedure covered the metallographic analysis of corroded steel samples by high-resolution scanning electron microscopy (HR-SEM) and transmission electron microscopy (TEM). Uniform corrosion underneath deposits was found as one of the drivers for degradation of the steel. Damage happened by high-temperature depassivation of stainless steel due to the excess of the aggressive medium. Besides uniform corrosion, a nitridation layer underneath surface oxides together with chromium carbonitride particles precipitated

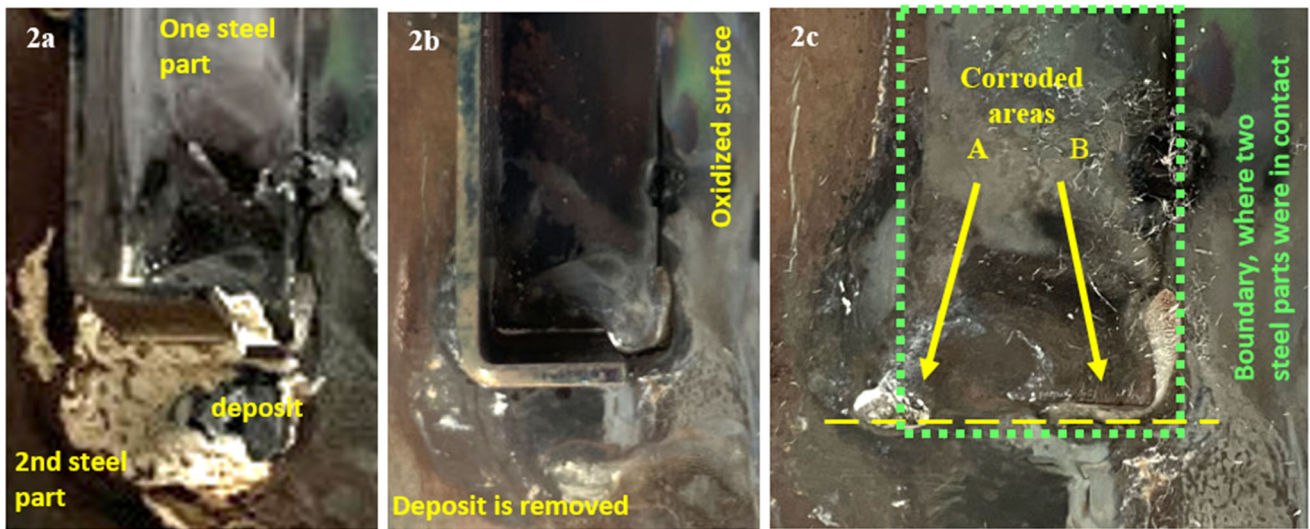
After 100 h of cyclic heating and injection of aqueous urea solution on the steel 1.4016, the material shows a differently colored, oxidized surface (Fig. 2a, b and c). The material loss is localized near the crevice where two steel design parts were in contact (Fig. 2c). There are also areas along the boundary (where two steel design parts were in contact, marked by green dotted line) with no material loss found, probably due to a more narrow crevice between them (Fig. 2c).

Fig. 2 Macroscopic image of corroded sample after 100 h experiment, 1.4016 grade. (a) Two steel design parts are in contact, not cleaned from urea-related deposits, (b) two steel design parts are in contact, cleaned from urea-related deposits, and (c) one separated steel design part with corroded areas shown by yellow arrows A and B along the yellow dashed line. Both corroded areas were subjected to metallographic analysis (Color figure online)

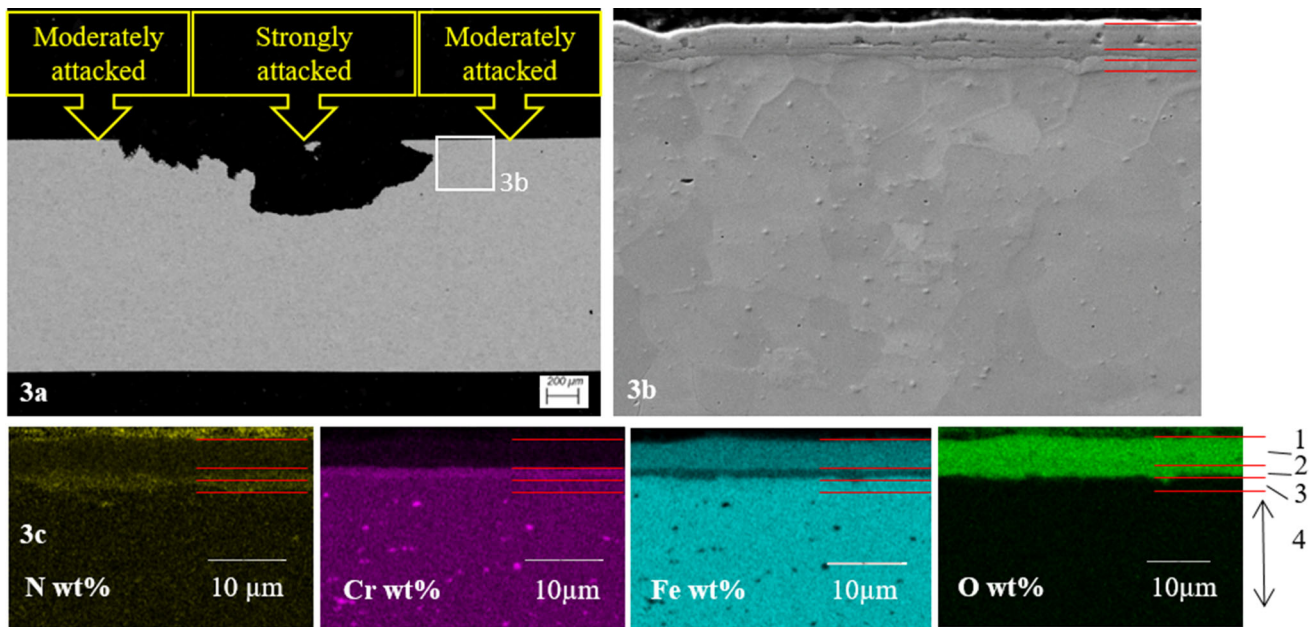
3.1.1 SEM Analysis. Examining the cross section of the corroded area A (microscopic image in Fig. 3(a), for macroscopic image look at yellow dashed line in Fig. 2c), one can observe parts that are slightly corroded and parts that are more attacked. The total wall thickness of the investigated steel sheet was 1.6 mm before testing and in the slightly corroded area after the experiment no reduction of wall thickness was detected with a caliper (caliper accuracy $\pm 10 \mu\text{m}$). In the center of the SEM image (Fig. 3a) can be seen the strongly attacked area, with an indication of attack along grain boundaries as well as uniformly. Here, the material loss is $650 \pm 50 \mu\text{m}$ and most of the grains tend to fall off. To the left

Fig. 3 FE-SEM image of the corroded sample in area A after 100 h experiment. (3a) BS detector, (3b) SE detector, (3c) EDS image by element distribution mapping shows three layers: 1— FeO_x with a bit of Cr_2O_3 ; 2— Cr_2O_3 ; 3—nitrogen and 4—matrix

and right from the strongly attacked area, a moderately attacked region is visible when looking under higher magnification. (The place of interest is highlighted by white frame in Fig. 3a, and magnified in Fig. 3b.) This region of interest indicates multilayers on the surface (Fig. 3b). The element mapping of multilayers between surface and matrix is shown in Fig. 3c. Additionally, the concentration profile of the involved elements of the same location is shown in Fig. 4. The EDS analysis revealed the presence of 3 different layers. Starting from the outside, the depth profile shows FeO_x with a bit of Cr_2O_3 at the

surface (layer 1), under which a chromium-rich oxide (Cr_2O_3) layer can be seen (layer 2). The inner chromium oxide layer also appears to contain some FeO . At the oxide/metal interface, a high level of nitrogen was found (layer 3). When looking at the whole width of the sample, it is noticeable that the nitrogen layer is not constant and sometimes drops. In small quantities, nitrogen was found in the oxide layers. The results of chemical analysis by element mapping are in full agreement with the concentration profiles of the involved elements. Neither a sign of nitrogen nor any precipitation of chromium-rich phases at

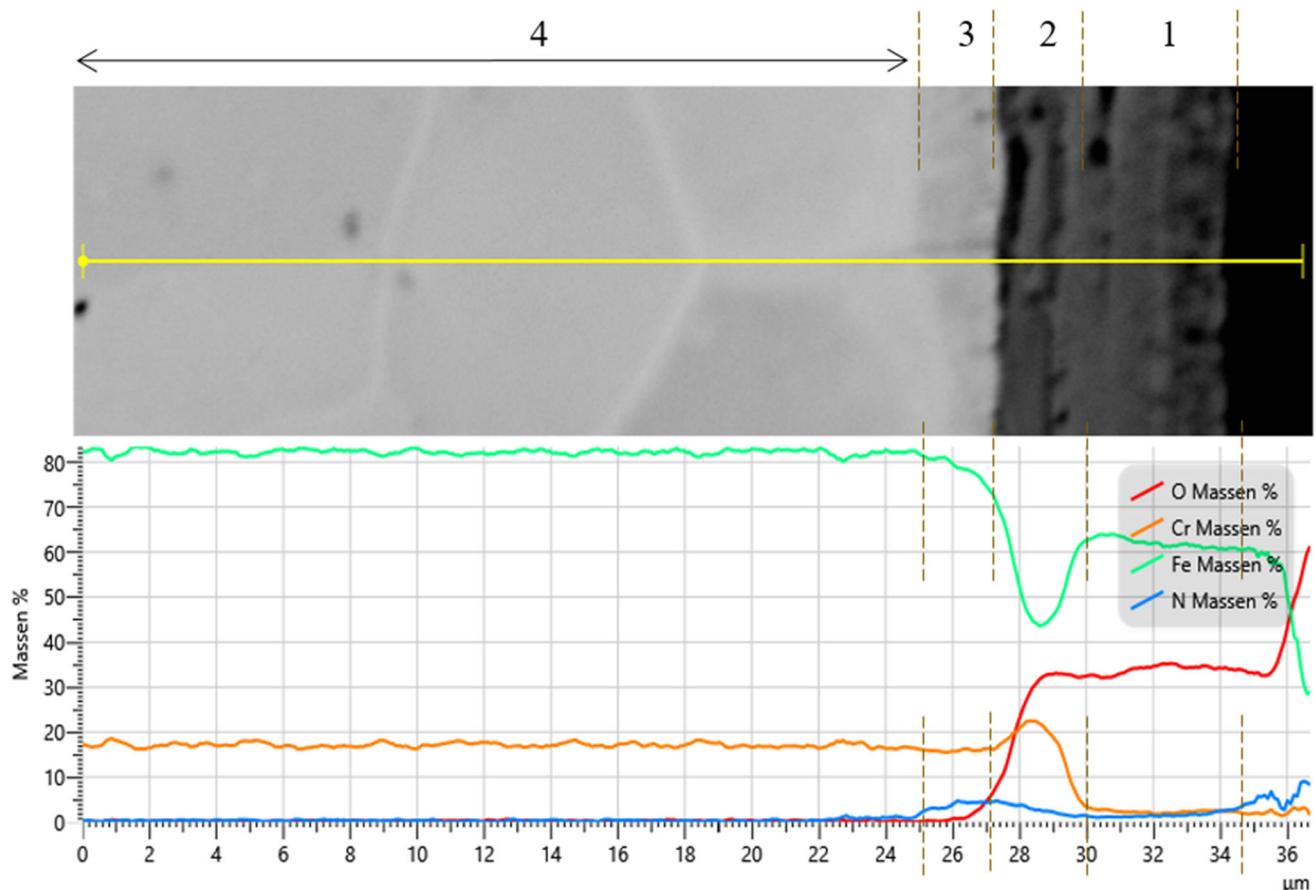
Fig. 4 Element concentration profile of the corroded sample in area A after 100 h experiment shows three layers: 1— FeO_x with a bit of Cr_2O_3 , 2— Cr_2O_3 , 3—nitrogen, and 4—matrix

the grain boundaries was observed by SEM-EDS. The total thickness of three O- and N-rich layers is $10\ \mu\text{m}$. The outer FeO-rich layer has a thickness of $5\ \mu\text{m}$, and the inner Cr_2O_3 and the N-rich layer has a thickness between 2 and $3\ \mu\text{m}$ each.

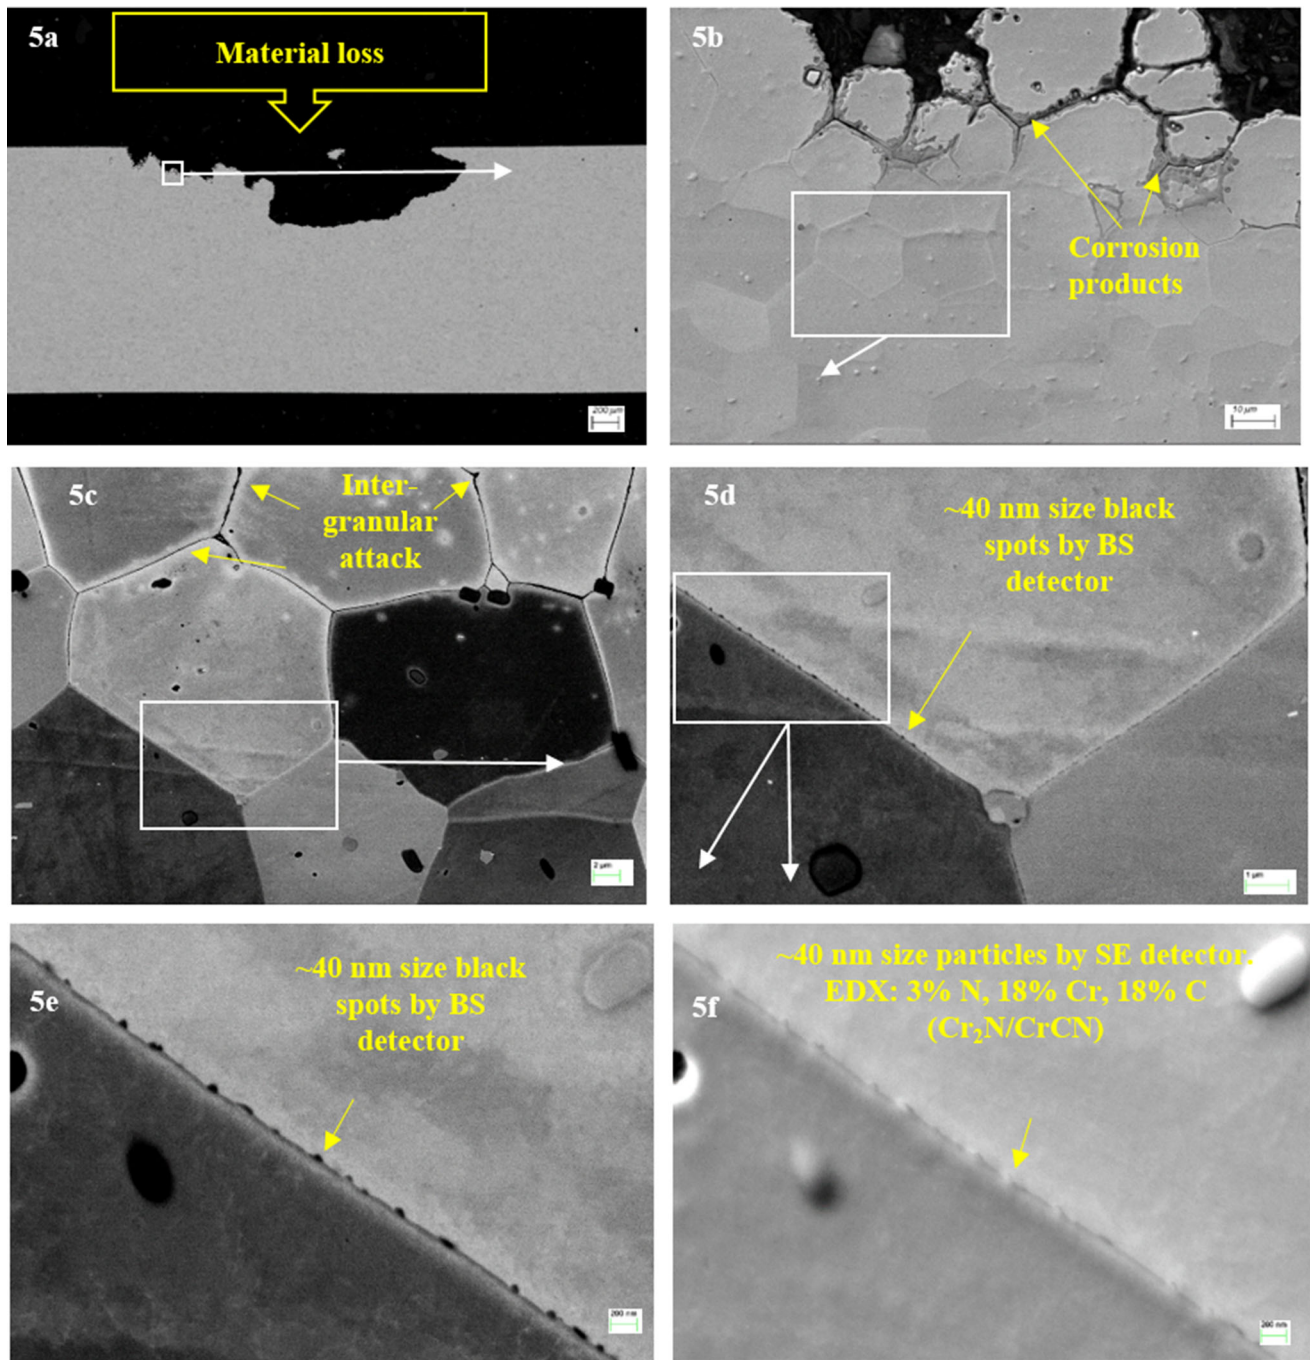
By help of SEM-EDS technique severe material loss, grain boundary attack and nitriding were identified. However, no any particles at the grain boundaries (as a prerequisite of intergranular corrosion) were detected, what could be a sign of low resolution of SEM-EDS technique. Thus, investigation on the same corroded area A was continued with high-resolution HR-SEM technique. In the place of material loss (Fig. 5a and b is a higher magnification of region of interest highlighted by white frame in Fig. 5a), it is visible that starting from the surface the grains are surrounded by corrosion products and till a certain depth level, all grains are attacked (Fig. 5c). HR-SEM analysis revealed circle-shaped precipitates with roughly $40\ \text{nm}$ size visible by BS detector as black spots (Fig. 5d and e). SE detector showed that there are no holes (Fig. 5f). These precipitates were identified by EDS technique as 3% N, 18% Cr and 18% C what could say for $\text{Cr}_2\text{N}/\text{CrCN}$. The precipitates along the grain boundaries were found at all depth levels of the sample (up to $1500\ \mu\text{m}$ depth). For comparison reasons, the analysis of the matrix revealed neither nitrogen nor a depletion of chromium. A more detailed TEM analysis on the nature of precipitates was done.

Fig. 5 FE-SEM image of the corroded sample in area A after 100 h experiment with a focus on corrosion products and precipitates on grain boundaries (**a, c, d, e** (BS detector) and **b, f** (SE detector): different magnifications)

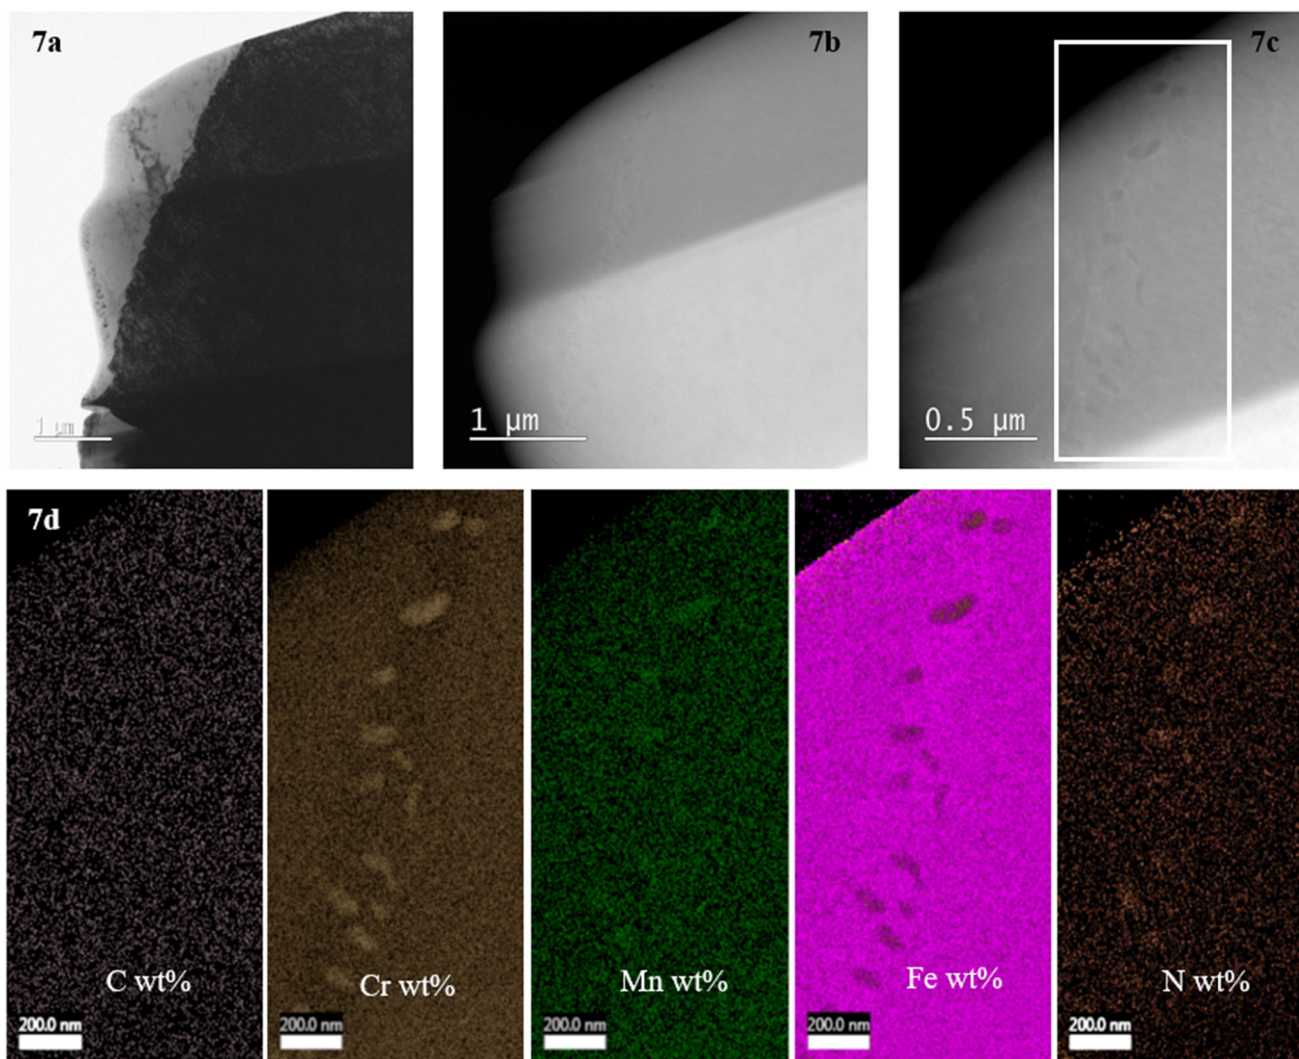
STEM HAADF analysis revealed precipitates on the grain boundary, some of them have a symmetric spherical shape with $20\ \text{nm}$ diameter, and another one shows an oval shape with $170\ \text{nm}$ length (Fig. 7b and c). By Z-contrast, it is visible that the heavy elements (Fe 26) are more light-colored, and the lighter elements (Cr 24, Mn 25) are darker-colored. According to EDS analysis, these precipitates are rich in Cr and slightly in N when comparing with matrix (Fig. 7d). The results of chemical analysis by element mapping are in full agreement with the qualitative concentration profile of the involved elements (Fig. 8a and b). Although nitrogen and, for instance,

Fig. 7 STEM image of the grain boundary with precipitates and EDX image by element distribution mapping (corroded sample in area A after 100 h experiment, 1.4016 grade). (a) Lamella in TEM, (b) STEM HAADF image, (c, d) EDS map

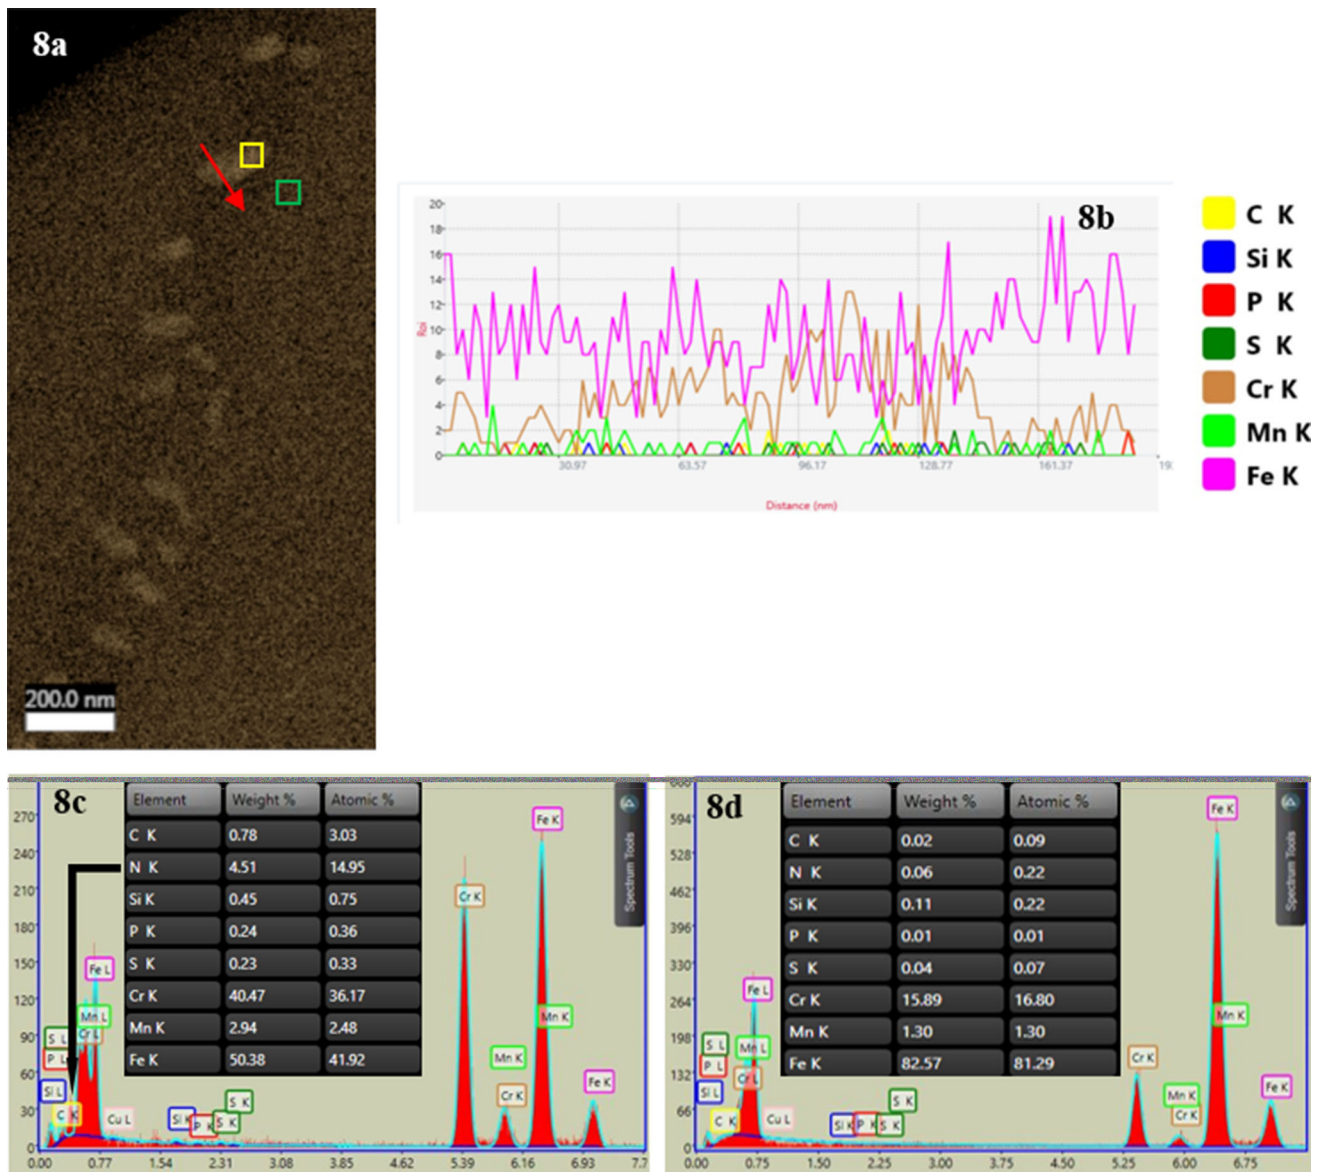
carbon were more difficult to detect by EDS analysis with the described EDAX detector (see chapter 2.3), the analysis was possible even quantitatively, and the results of calculation clearly showed the presence of these two elements in the particle (Fig. 8c) when comparing with matrix (Fig. 8d). Even when quantitative EDS analysis of light elements such as carbon and oxygen is not reliable, the analysis of Fig. 8c and d shows substantial differences in carbon content on the same specimen. This is a strong argument that the precipitate in Fig. 8a contains carbon. The absolute value given in Fig. 8c is not too important.

Fig. 8 (a) EDS image of the grain boundary with precipitates, (b) qualitative element concentration profile of one of the particles (marked by red arrow in 8a), (c) EDS measurement and quantification of elements in the area of particle (marked by yellow square in 8a), (d) EDS measurement and quantification of elements in the matrix (marked by green square in 8a)

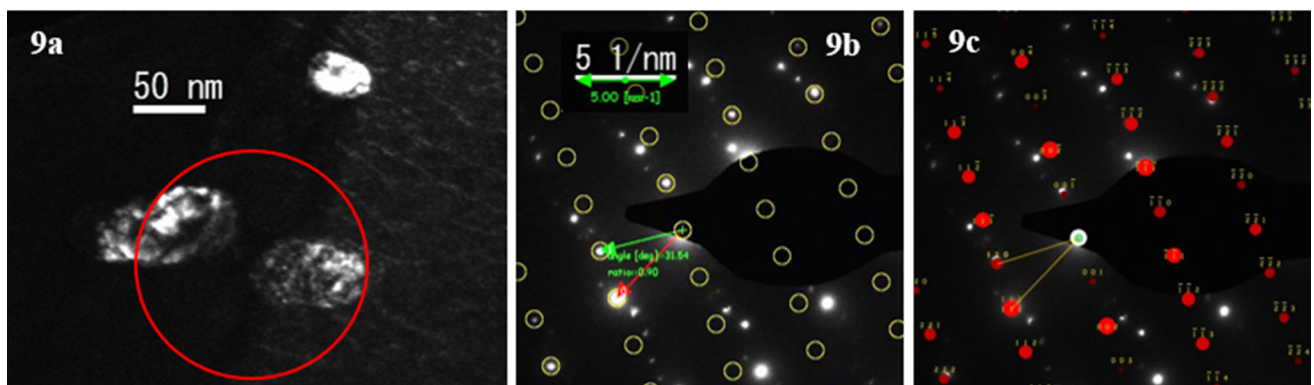
Electron diffraction was performed on a TEM specimen of the same corroded area A. The obtained diffraction patterns from crystal orientations revealed the ferrite matrix and Cr₂N precipitates on the grain boundary (Fig. 9). When considering the high carbon content of the precipitates in Fig. 8c, the precipitates are not pure nitrides, but carbonitrides with the structure CrCN. The selected area for diffraction pattern of the dark-field TEM image is shown in Fig. 9a (red circle), the diffraction pattern in Fig. 9b and the calculated pattern of crystalline Cr₂N in zone axis [1, -1, 0] in Fig. 9c, which is in good agreement to the masked spots in Fig. 9b.

Fig. 9 TEM dark-field image and electron diffraction of grain boundary precipitates in material 1.4016. (a) TEM dark-field image of chromium-rich precipitates with selected area aperture (red circle), (b) corresponding diffraction pattern of selected area from figure b, (c) calculated diffraction pattern of Cr_2N in zone axis $[1, -1, 0]$ compared to diffraction pattern in figure b

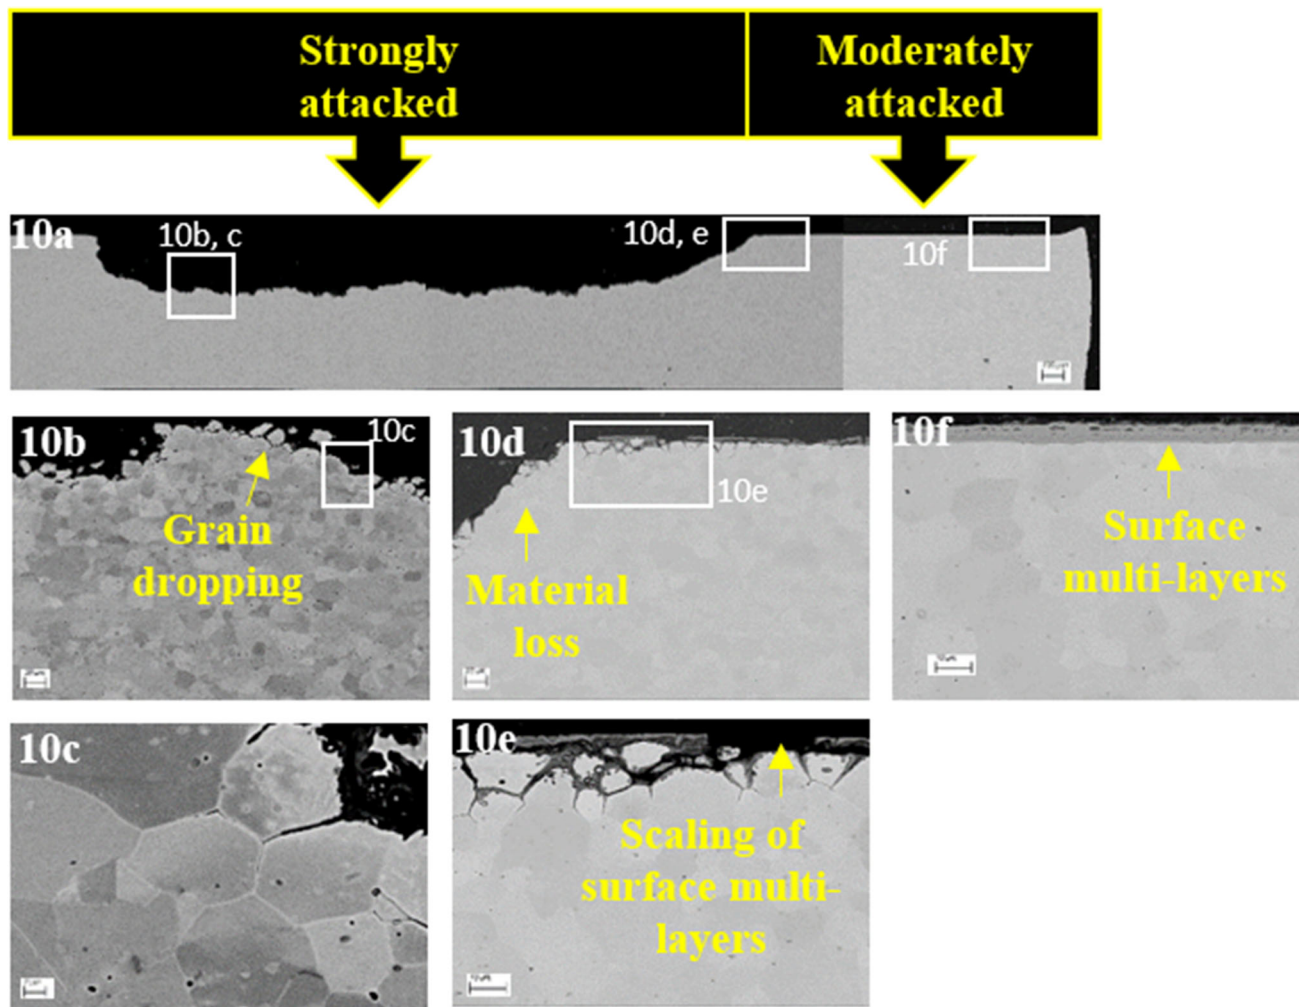
Next to the corroded area A is located another characteristically corroded area B (Fig. 2c—macroscopic image, Fig. 10a—microscopic image). The cross section morphology of corroded area B exhibits also a moderately attacked region together with the strongly attacked one. In Fig. 10a, three regions of interest were selected for observation under higher magnification. (They are marked by the white frame, and each white arrow points out at a corresponding magnified image.) In Fig. 10f, the moderately attacked area displays the surface multilayer. Figure 10d and e shows the section, close to the severe material loss, with partial scaling of the surface multilayer,

where the grains are surrounded by corrosion products and are subjected to intergranular attack. In the deeper attacked area in Fig. 10b and c, one can easily see grains dropping.

Fig. 10 FE-SEM image of the corroded sample in area B after 100 h experiment (a-f: BS detector, different magnifications and locations). (a) Global view about a corrosion sample showing strongly and moderately attacked areas, and here, three regions of interest were selected for observation under higher magnification (they are marked by the white frame), (b) grain dropping affected by IG corrosion and high corrosion rate, (c) local view of area 10b, showing intergranular attack, (d) global view about a material loss, (e) local view of area 10d about cracked oxide layers and IG attack, (f) global view of moderately attacked area (formation of multioxide layers)
