Failure of Multilayer Suspension Plasma Sprayed Thermal Barrier Coatings in the Presence of Na₂SO₄ and NaCl at 900 °C

Abstract The current investigation focuses on understanding the influence of a columnar microstructure and a sealing layer on the corrosion behavior of suspension plasma sprayed thermal barrier coatings (TBCs). Two different TBC systems were studied in this work. First is a double layer made of a composite of gadolinium zirconate + yttria stabilized zirconia (YSZ) deposited on top of YSZ. Second is a triple layer made of dense gadolinium zirconate deposited on top of gadolinium zirconate + YSZ over YSZ. Cyclic corrosion tests were conducted between 25 and 900 °C with an exposure time of 8 h at 900 °C. 75 wt.% Na₂SO₄ + 25 wt.% NaCl were used as the corrosive salts at a concentration of 6 mg/cm². Scanning electron microscopy analysis of the samples' cross sections showed that severe bond coat degradation had taken place for both the TBC systems, and the extent of bond coat degradation was relatively higher in the triple-layer system. It is believed that the sealing layer in the triple-layer system reduced the number of infiltration channels for the molten salts which

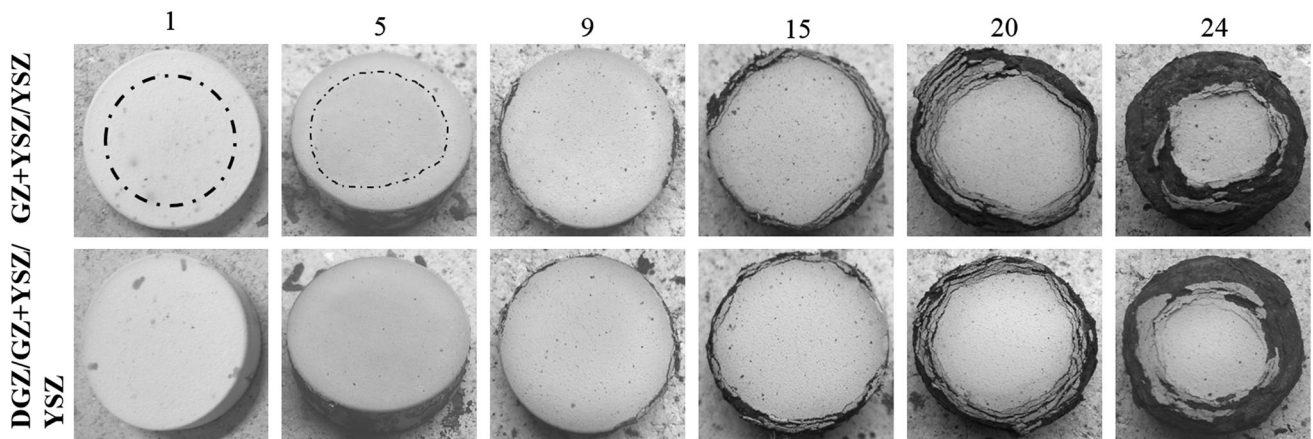
Figure 1 shows selected visual images of the double-(GZ + YSZ/YSZ) and triple-layer (DGZ/GZ + YSZ/YSZ) samples during the different stages of corrosion. The typical salt spread region after the first and fifth cycle is marked with the black lines in the double-layer system. As shown in Fig. 1, the salt coverage is roughly circular. For up to 9 corrosion cycles, the top surface appeared to be free from damage. After the ninth cycle, the damage started to increase slowly from the edges and started to propagate toward the center. After 24 cycles, for both the double- and triple-layer samples, the visible damage was estimated at about 75% of the topcoat surface and the tests were stopped. Just with the visual inspection, there appeared to be no significant difference in the extent of damage between the double- and triple-layer samples. It has to be noted that even though there is no significant difference in the radial direction during visual inspection, there could be difference in the Z-direction (thickness) of the damaged regions. This is very difficult to observe just with visual inspection. It is emphasized here that the purpose of visual inspection, through a camera, is to illustrate the damage development from the edge to the coating center with increased exposure time. Accurate and more in-depth analysis of the coatings' cross section was obtained from SEM analysis (discussed in the subsequent sections).

Fig. 1 Selected visual images showing the top surface of the two TBC systems after different corrosion test cycles. The salt spread region is approximately marked using a black dash-dot line after cycles 1 and 5

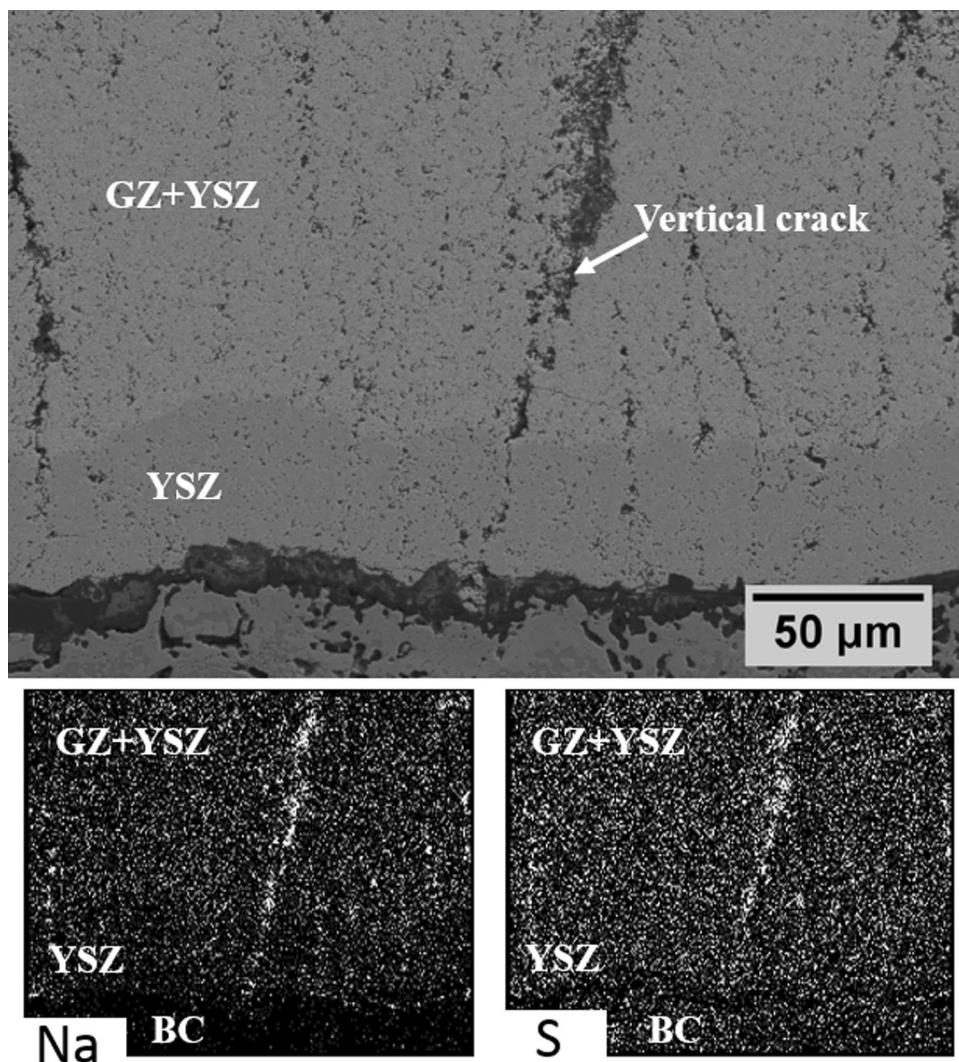
Figure 3 shows the infiltration of the molten corrosive salts through the columnar gaps along with the EDS maps revealing the presence of sodium (Na) and sulfur (S) in the columnar gaps. There is no reported direct chemical

Fig. 3 SEM image showing the infiltration of the molten salts through the vertical cracks (columnar gaps) in the topcoat along with the EDS maps for sodium (Na) and sulfur (S). It has to be noted that the boundary between the BC/YSZ/GZ + YSZ layer is not visible in the EDS maps

reaction between GZ and sodium sulfate at high temperatures (Ref 20). The molten salts infiltrate through the columnar gaps between the columns and reach and attack the bond coat material (represented by white arrow) as indicated in Fig. 3. At the same time, some molten salts overflow from the top surface to the edge and then to the side surface and react with the substrate material, as shown in Fig. 1. This results in the degradation of the substrate and substrate/bond coat interface from the side surface and will lead to damage that can start at the edge and subsequently propagate to the center of the coating.

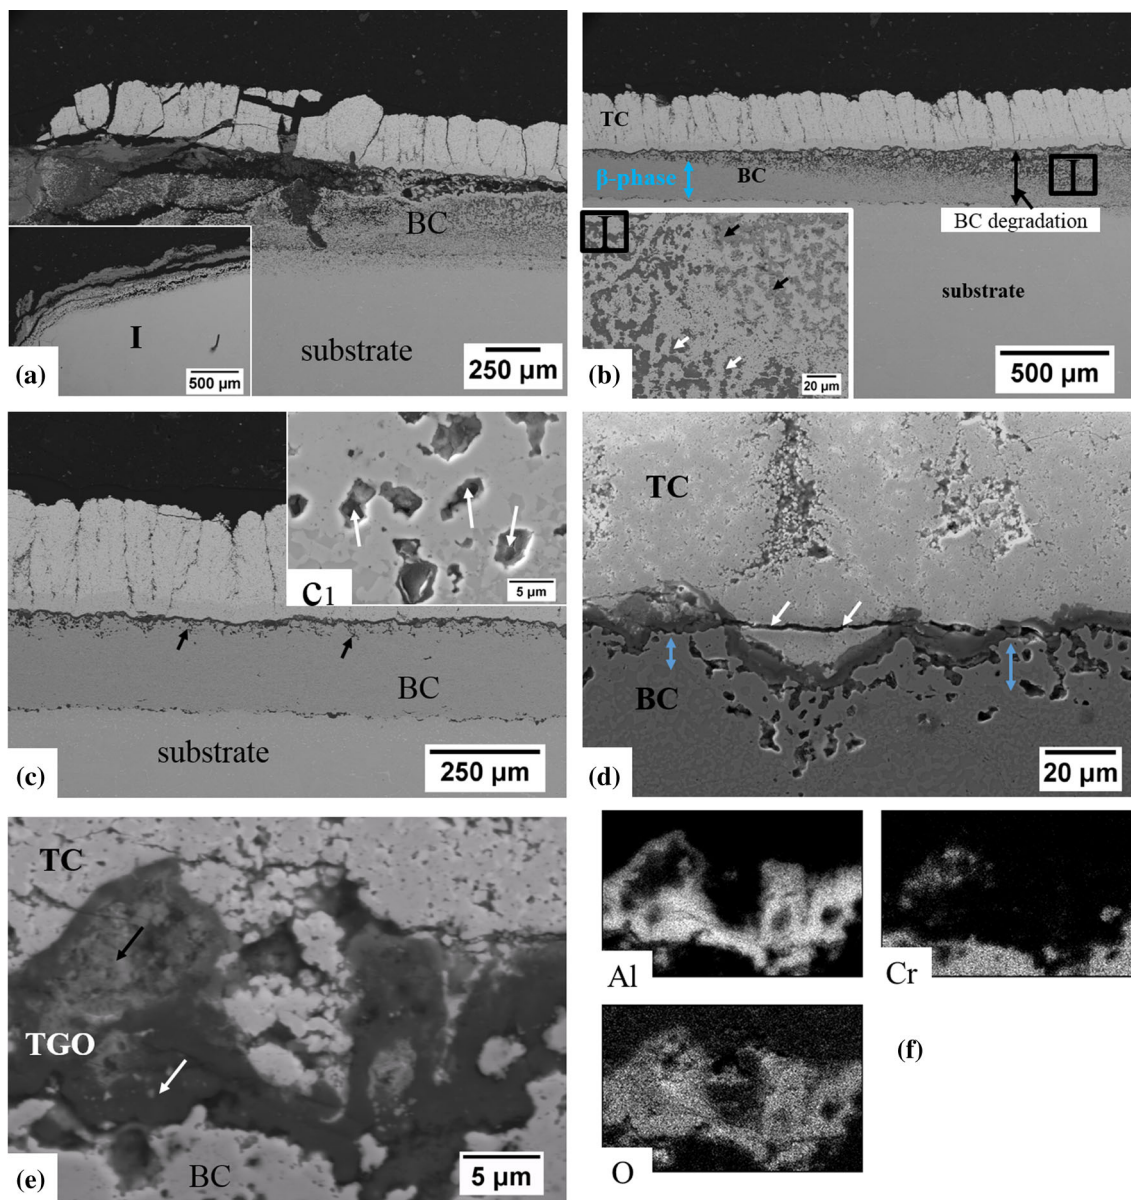
The cross-sectional SEM images of GZ + YSZ/YSZ coating after 24 corrosion cycles are presented in Fig. 4(a)–(f). The edge of the coating is shown in Fig. 4(a) along with a better view of the edge indicated by region “I” at the bottom left side of Fig. 4(a). Reaction of the molten salts with the substrate and the bond coat at the side surface resulted in severe damage at the edge and the damage started to develop in the bond coat from the edge toward the

center. This damage in the bond coat had resulted in the loss of integrity of the topcoat with the TBC system at the edge (see Fig. 4a). The bond coat degradation from the edge to the center can be observed from Fig. 4(b). The region denoted as “I” which is enlarged in the inset of Fig. 4(b), clearly illustrates the BC degradation with the formation of internal oxides of chromium and aluminum, indicated by the black and white arrows, respectively. The extent of bond coat degradation, in this context, is defined as the depth of internal oxidation expressed in terms of percentage of the total bond coat thickness. The depletion of the β (NiAl) phase roughly follows the bond coat degradation, i.e., the region to the left in Fig. 4(b) still has β phase remaining in the coating (indicated by the double-headed blue arrow). Figure 4(c) shows the microstructure at the center of the coating. The infiltrated molten salts stayed between the columns and resulted in the fluxing of the thermally grown oxide (TGO), alumina. Fluxing of the alumina scale damages the TGO and the salts reach the bond coat surface. The

Fig. 4 Cross-sectional SEM images of GZ + YSZ/YSZ (a) coating edge, (b) coating cross section from the edge to the center showing bond coat degradation, (c) coating center, and (d) TGO/topcoat

interface, (e) high magnification image of the TGO, and (f) corresponding EDS maps for (e)

attack on the bond coat resulted in the internal oxidation of alumina along with the presence of some voids indicated by the white arrows as shown in the inset at the top right of Fig. 4(c) (c1). The TGO layer was observed to be a mixture of aluminum and chromium oxides [for instance, see Fig. 4(e) and the corresponding EDS maps in Fig. 4(f)]. The black and white arrows in Fig. 4(e) correspond to chromium and aluminum oxides, respectively. The reaction between the corrosive salts and the TGO can cause a fast growth of the alumina scale due to fluxing. During the cooling part of the corrosion cycle, due to the coefficient of thermal expansion (CTE) mismatch, horizontal cracks as

shown in Fig. 4(d) with white arrows were observed all along the cross section. The depletion of β phase below the TGO is indicated by the double-headed light blue arrows. To summarize, the damage occurred from two fronts in the double-layer sample. First, the damage from the edge degraded the bond coat and damaged the integrity of the top coat. Second, the damage due to the molten salt infiltration caused the fluxing of the alumina scale and promoted rapid growth of alumina and a mixture of alumina and chromia at certain locations. This, in turn, increases the thermal stresses during cooling and promotes crack propagation at the TGO/topcoat interface.

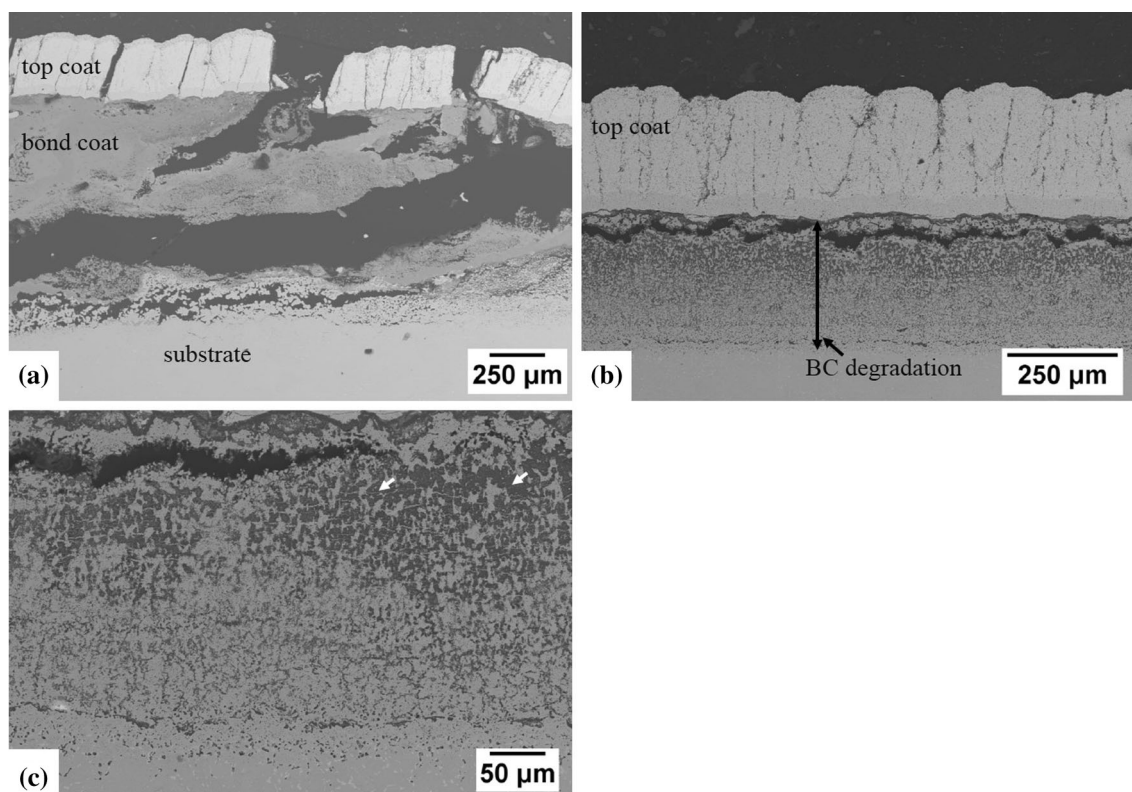
Figure 5(a)–(c) shows the cross-sectional SEM images of the triple-layer DGZ/GZ + YSZ/YSZ coating system after 24 corrosion cycles. The coating edge is shown in Fig. 5(a), where severe damage had occurred and resulted in the loss of the integrity of the top coat/bond coat with the TBC system. Figure 5(b) shows the microstructure at the center of the coating. Unlike the double-layer system (see Fig. 4c), the extent of bond coat degradation is throughout the coating cross section and also throughout the coating thickness. Figure 5(c) shows a high magnification SEM image at the coating center of the internal oxides (indicated by the white arrows) that are formed in the coating.

Fig. 5 Cross-sectional SEM images of DGZ/GZ + YSZ/YSZ (a) coating edge, (b) coating cross section at the center showing bond coat degradation, and (c) bond coat degradation at high magnification at the center

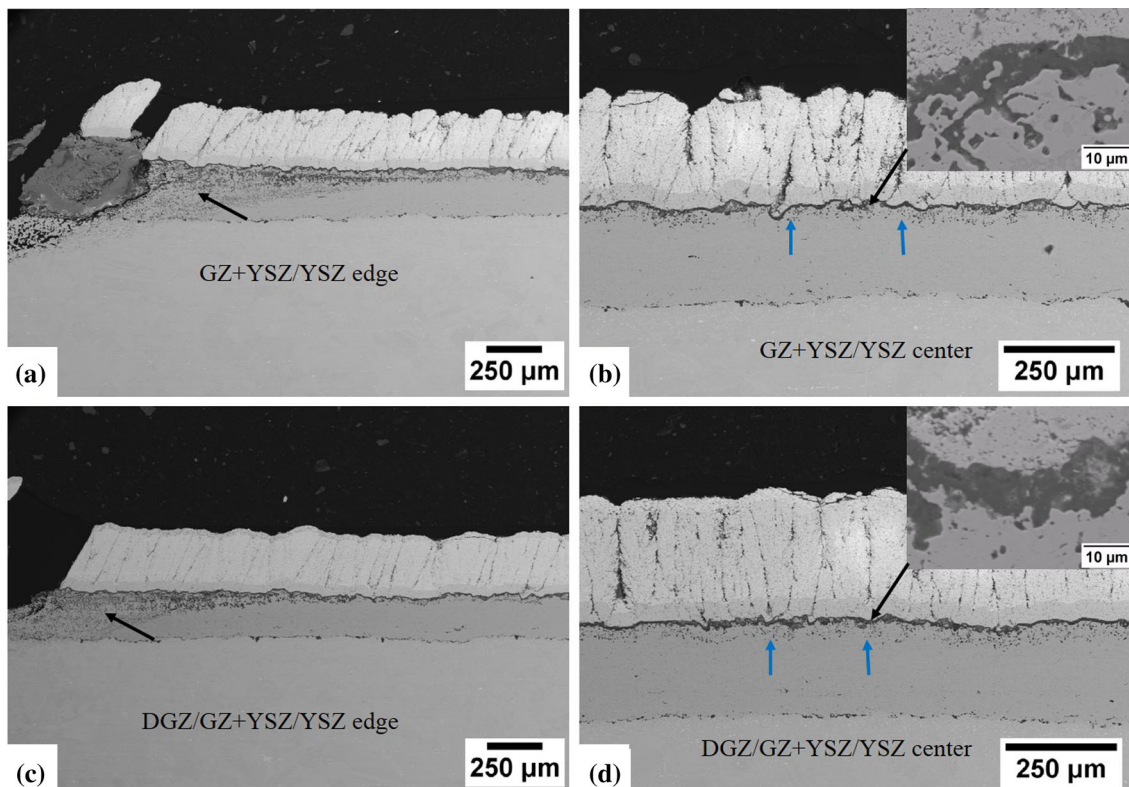
Figure 6(a)–(d) shows the cross-sectional SEM images after the interrupted corrosion tests at cycle 9. Damage development from the edge to the center was observed for both the double-layer (see Fig. 6a) and triple-layer (see Fig. 6c) coating systems. Damage is indicated by black arrows in both images. The microstructure of the coatings at the center is shown in Fig. 6(b) and (d) for the double-

and triple-layer systems, respectively. High magnification images of the TGO at the coating center are shown in the insets of Fig. 6(b) and (d). The extent of bond coat degradation is very low and similar for both coating systems. The formed internal oxides are indicated by blue arrows.

Fig. 6 Cross-sectional SEM images after 9 corrosion cycles showing (a) GZ + YSZ/YSZ edge, (b) GZ + YSZ/YSZ center, (c) DGZ/ GZ + YSZ/YSZ edge, and (d) DGZ/GZ + YSZ/YSZ center

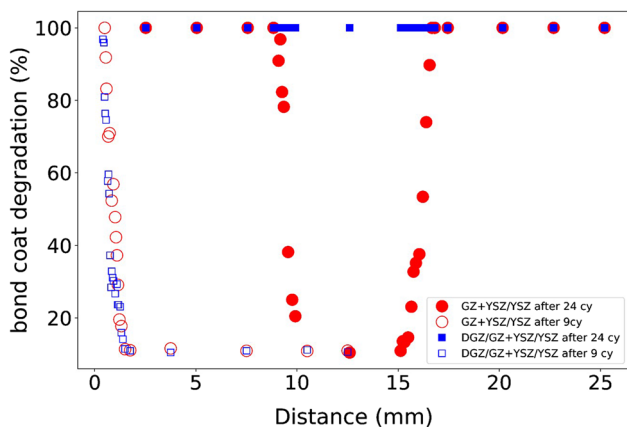
Figure 7 shows the extent of bond coat degradation along the diametrical cross section (edge to edge) for the double- (represented by solid red markers) and triple- (represented by solid blue markers)-layer coating systems after 24 corrosion cycles. For 9 corrosion cycles (hollow red and blue markers), the bond coat degradation is only shown from one edge till the center of the coating as the other edge exhibited a similar degradation profile. This was true for both coating systems. From Fig. 7, after 9 corrosion cycles, the degradation profiles were nearly identical for both the double- and triple-layer systems. The extent of degradation was 100% percent at the edge (the entire thickness of bond coat was damaged at the edges) and it dropped to ~ 10% about 1.5 mm from the edge and was then similar till the center of the coating. After 24 corrosion cycles, the bond

Fig. 7 Profile of bond coat degradation across the diameter (25 mm) in both coating systems after 9 cycles and 24 cycles, respectively

coat degradation in the double-layer system was 100% for about 10 mm from the edge and then it dropped to about 10%. The extent of bond coat damage at the center was observed to be similar after 9 and 24 corrosion cycles. One probable reason could be due to the retention of the molten salts in the columnar gaps, which then limited the exposure of the bond coat surface to new melt. However, the damage from the edge had developed almost to the center of the coating. For the triple-layer system, the entire thickness of

the bond coat had been degraded 100% along the cross section of the coating. As the damage at the center was similar after 9 corrosion cycles for both TBC systems, the contribution of damage from the edge is relatively higher for the triple-layer system. With continued salt exposure (an additional few corrosion cycles), the degradation profile for the double-layer system would be similar to the triple-layer system.

As such, discarding the edge effect by applying some kind of protective coating to the side surfaces may result in similar behavior for the two coating systems. This is the subject of future research. Furthermore, an inert sealing layer may not be the optimum solution for reducing the corrosion damage. A reactive topcoat can restrict the salt infiltration to the upper parts of the coating. The results from the present investigation can be used as a general guideline during the design of coatings about the suitability of an inert sealing layer in the presence of molten salts.

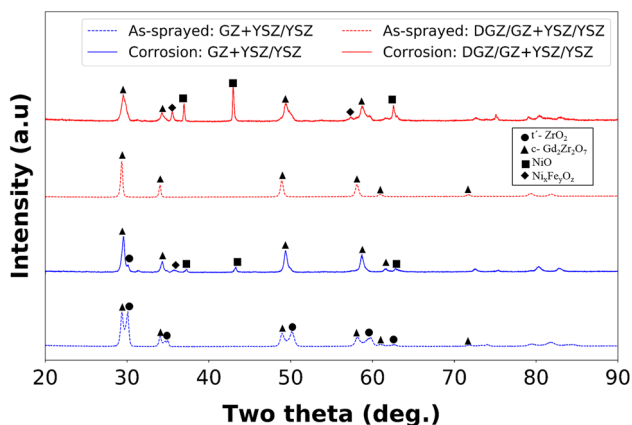
Figure 8 shows the x-ray diffraction pattern for both the double- and triple-layer systems in their as-sprayed state and after 24 corrosion cycles. The obtained peaks from the XRD were labeled using PDF standards. For the double-layer composite TBC, in its as-sprayed condition, both tetragonal YSZ and cubic defect fluorite gadolinium zirconate phases were observed. This is desirable as the purpose of the composite TBC was to achieve the best properties of both materials such as the fracture toughness of YSZ and low thermal conductivity of gadolinium zirconate. For the triple-layer system, the observed phase on the sealing top layer was defect fluorite of gadolinium zirconate. This phase is a disordered variation of the cubic pyrochlore phase of gadolinium zirconate and is a desired

Fig. 8 X-ray diffraction pattern for the samples before and after the corrosion tests

After the 24 corrosion cycles in the double-layer coating, parts of the original phases (tetragonal zirconia and cubic gadolinium zirconate) were retained in the top coat. The other observed phases were oxides of Ni (NiO) and other compounds of Ni ($\text{Ni}_x\text{Fe}_y\text{O}_z$). As most of the coating was damaged, these phases come from the damaged parts of the coating. The top surface at the center of the coating (see Fig. 1) appeared to be unaffected based on the color of the coating compared to the as-sprayed samples' top surface. At this location, the main phases of the original coating were still retained. This further proves that there is no direct reaction of the corrosive salts with both gadolinium zirconate and yttria-stabilized zirconia. Similar phases, although with different intensities, were observed with the triple-layer DGZ/GZ + YSZ/YSZ coating system. The higher intensity of the NiO signals in the triple-layer system could be because there was relatively more damage from the edge and this could have resulted in higher amounts of corrosion products at the edge compared to the double-layer system.
