The Effect of Phosphate on the Properties of Copper Drinking Water Pipes Experiencing Localized Corrosion

Darren A. Lytle · Colin P. White

Submitted: 31 December 2013 / Published online: 6 February 2014
© ASM International 2014

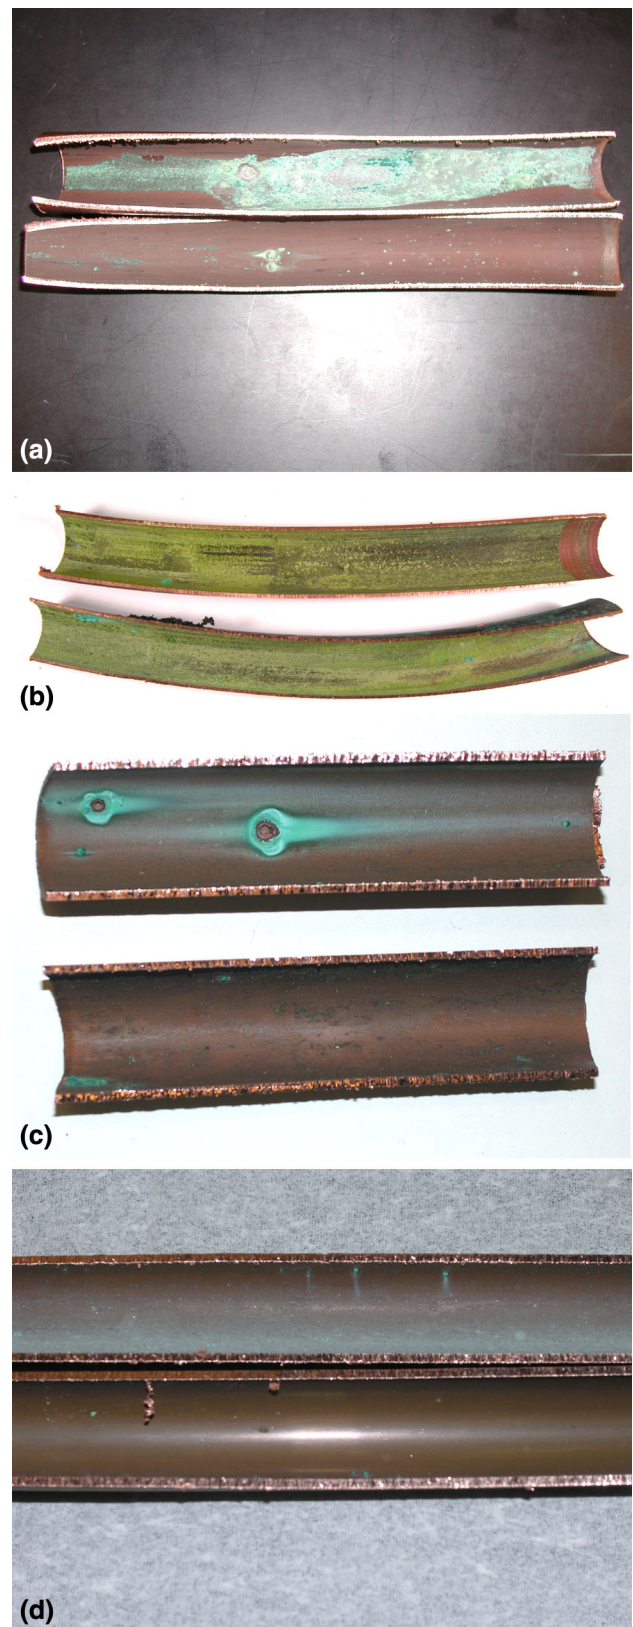
The interior base surface of the copper pipe section removed 1 year into orthophosphate treatment (sample ID dl00255) was dark orange in color. A large streak of white to cream-colored and various shades of green and blue solids were deposited on half of the pipe below where a pinhole leak had developed (Fig. 1a). There were also a number of randomly deposited dark green mounds of solids of various sizes, many of which were covered with a cream-colored deposit layer. Stereomicroscopic examination of the local deposits showed the extent to which the cream-colored material covered and surrounded the dark green (presumably copper corrosion by-product) mounds (Fig. S2a). Removal of a green mound revealed a light orange-colored and porous surface (Fig. S2b). The solid resembled the porous membrane typically associated with localized corrosion attack that separates the pit cap from the pit [1]. The presence of corrosion by-product mounds and a porous membrane does not necessarily indicate a location of pitting corrosion attack. Examination of the cross section of the corrosion mounds, however, confirmed that pitting corrosion was taking place in these areas (Fig. S2c). The cross section clearly shows the features commonly associated with pitting corrosion: pit cap, porous membrane, and pit.

Fig. 1 Internal surfaces of copper pipe sections: (a) dl00255, (b) dl00378, (c) dl00557, and (d) dl00510c

Pipe sections collected 1 month after the blended phosphate addition (orthophosphate had been added for 2 years) were analyzed (sample ID dl00378). The pipe sections were covered with a yellow to dark cream-colored solid (Figs. 1b, 5a, b). Green and blue corrosion by-product mounds were randomly spread across the surface. Some of the mounds were covered or partially covered by the cream-colored material (Fig. 5a, b). An image of a large and partially degraded pit cap (~ 8 mm in diameter) reveals the dark red crystalline contents of the pit around

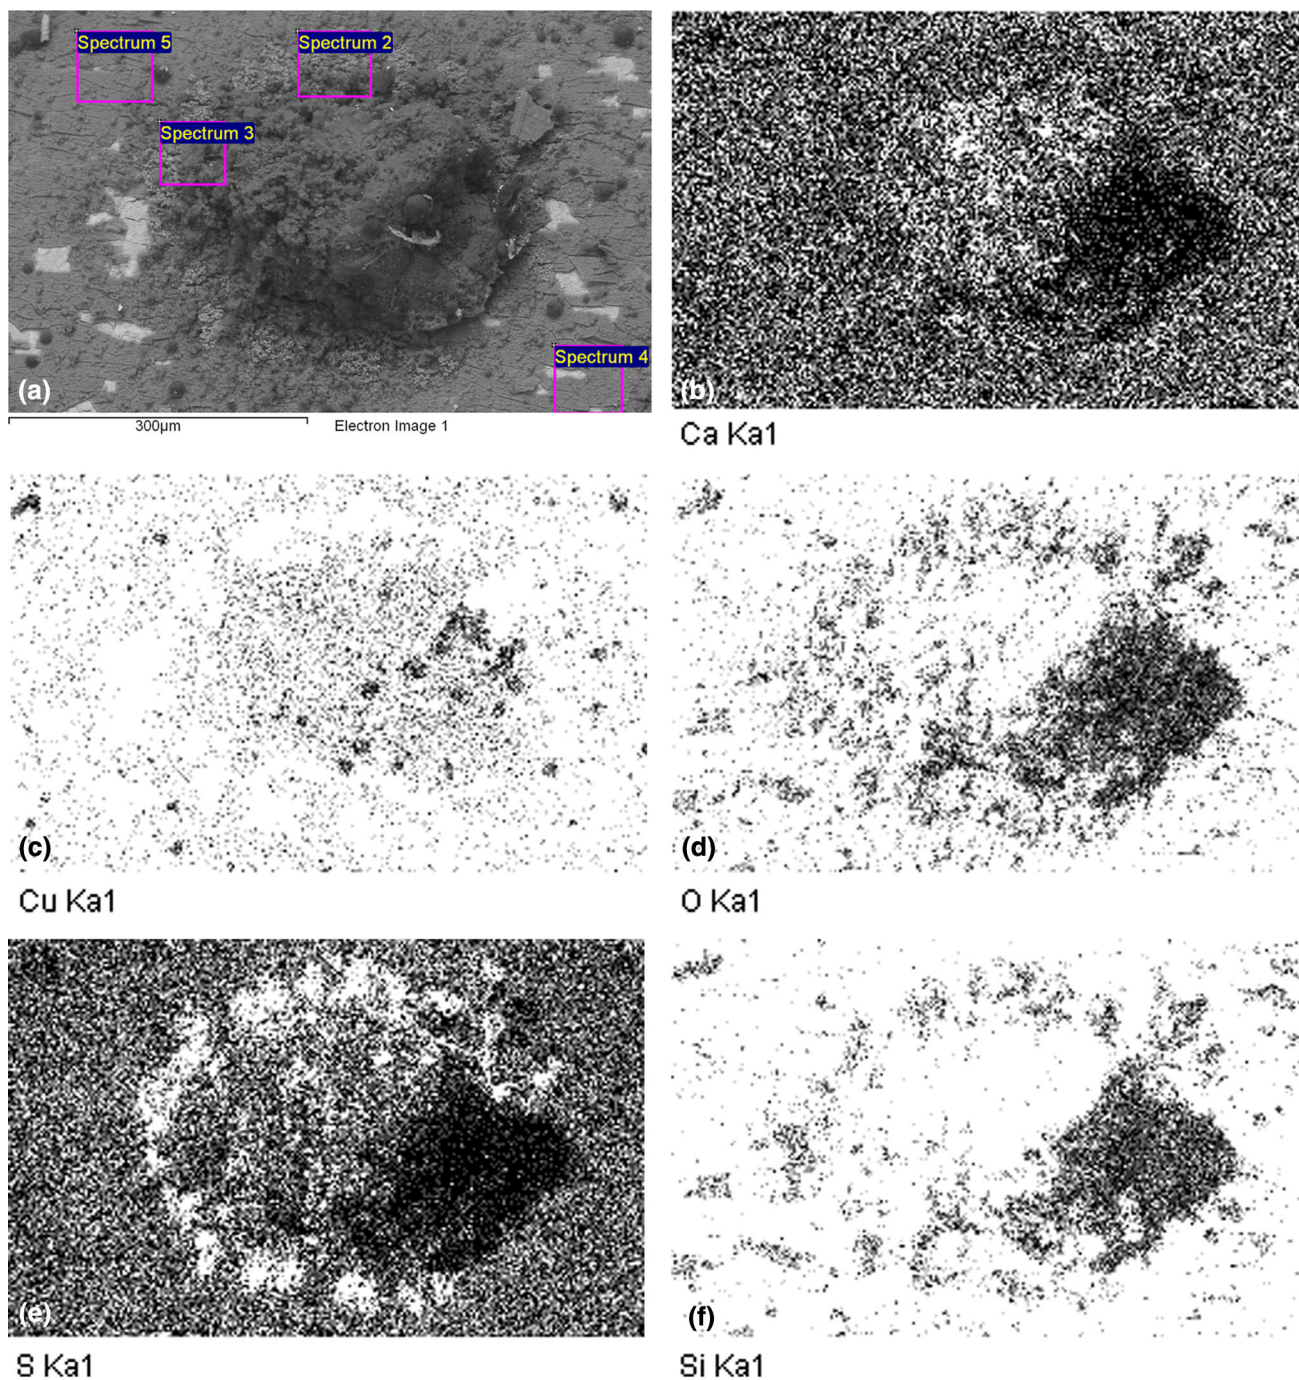
Fig. 2 SEM and corresponding energy dispersive x-ray elemental mapping analysis of the top of a pit cap and surrounding area of the surface of copper pipe section exposed to 1 year of orthophosphate (sample ID dl00255)

entire surface of the pipe including the pit caps (Fig. 2). Silicon levels in the “uniform” portion of the pipe surface (Fig. 2) averaged 11% (by weight) and 8% at the base of the pit cap (Fig. 2; Table 2). Relatively large amounts of sulfur (average 5.5%, Fig. 2) were detected as well, but only at the base of pit caps. The finding suggests that the pit cap is comprised of a sulfate-based solid. Significant levels

of iron (2.4–3.1%) and small amounts of aluminum (0.7%), calcium (0.6%), and magnesium (0.9%) were also detected in all spectra (Table 2). Phosphorus (<0.1%) was not detected on any portion of the analyzed pipe section area. A pit cap was carefully dislodged, and the side in contact with the pipe wall and underlying pipe wall itself were examined. The pipe wall was dominantly copper (average

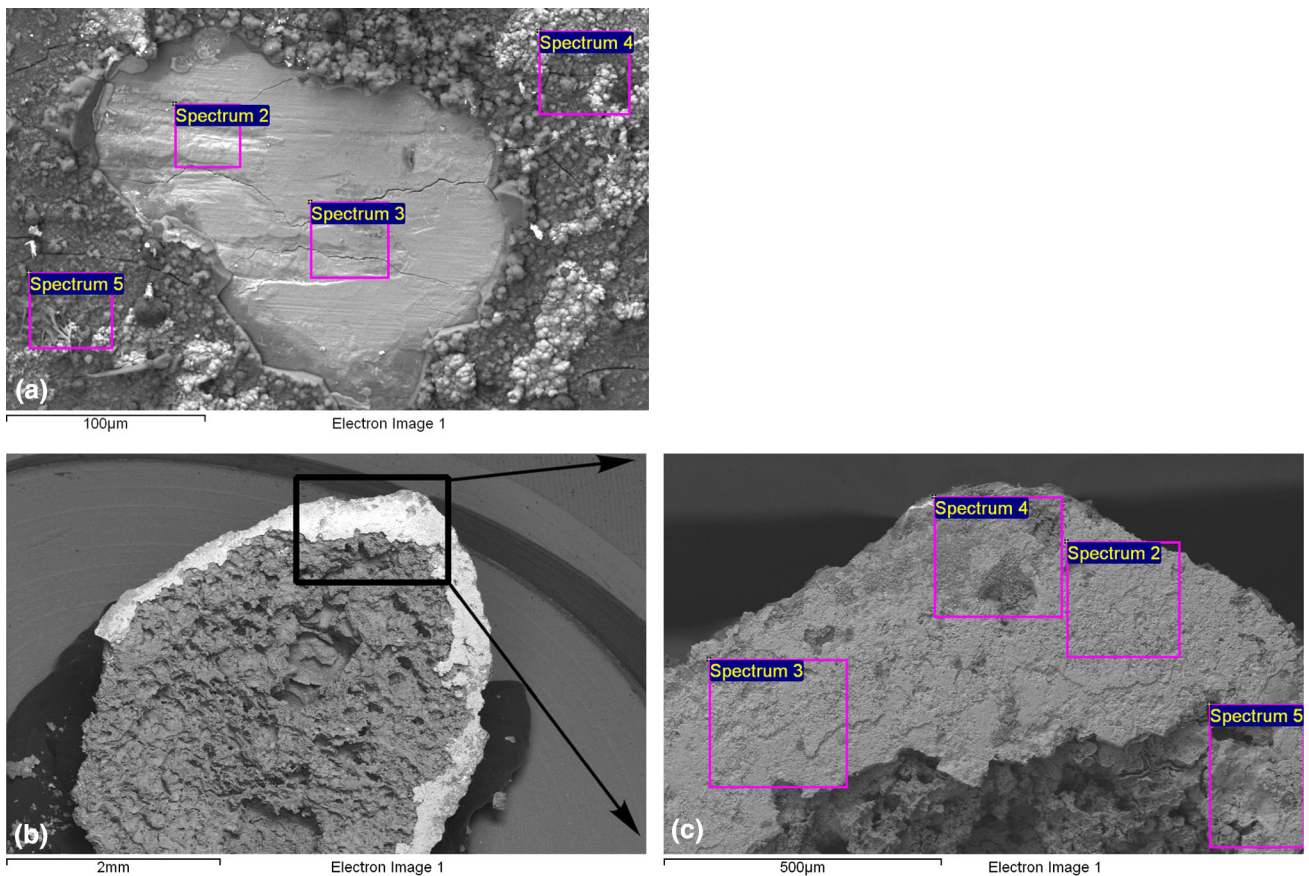
90.2%) with some oxygen (average 7.2%) (Figs. 3a, S3; Table 2) suggesting a layer of copper oxide (e.g., cuprite, Cu_2O). Silicon (average 1.4%) and chlorine (1%) were also detected in this area. The uniform deposits surrounding the removed cap region were consistent in composition with previous analysis (Fig. 2). The underside of the pit cap was hollow and dome-shaped, and consisted primarily of copper, oxygen, and sulfur (Figs. 3b, S4). Sulfur composed an average of 5.8% of the weight (Table 2) of the internal structure of the cap (Figs. 3b, S4) suggesting that the cap is largely a copper sulfate-based material(s). Aluminum and chlorine were detected as well, but concentrated on the edge suggesting they covered the cap. Phosphorus was not detected in either location. Finally, a cross section of a pit was examined (Fig. 4). The results showed a thin outer layer (layer in contact with bulk water) that was previously described as a uniform cream-colored deposit that was approximately 100 μm thick. The layer consisted dominantly of copper, oxygen, and silicon (10.8%) in composition with small amounts of sulfur, calcium, iron, and chlorine (Table 2; Fig. 4). The internal green and blue material that made up the bulk of the pit cap was comprised dominantly of copper, sulfur (3.8%), silicon (2.6%), and oxygen (Table 2; Fig. 4) supporting the previous conclusion that the pit cap was a copper–sulfate compound(s). The cap covered a thin layer or membrane (Fig. 4). The porous membrane, which separated the cap from the pit, was comprised of copper and oxygen which is, with the presence of cuprite, the material commonly reported to make up the membrane [1]. The pit was broad (~ 2 mm wide) and shallow (~ 0.5 mm deep) in the cross section (Figs. 4, S2c). The images clearly show that localized corrosion attack is occurring below the green and blue corrosion by-product mounds. Copper, oxygen, and elemental chlorine (i.e., chloride) dominated the contents of the pit (Table 2; Fig. 4). Chloride is often associated with pit initiation and growth [1]. It was not possible to ascertain whether the chloride was originally present in the aqueous form or as a copper chloride compound because of dehydration due to drying of the sample prior to analysis.

Fig. 3 SEM of (a) pipe surface below a pit cap and surrounding area, (b) the underside of a pit cap removed from a copper pipe section exposed to 1 year of orthophosphate (sample ID dl00255), and (c) an expanded view of (b)

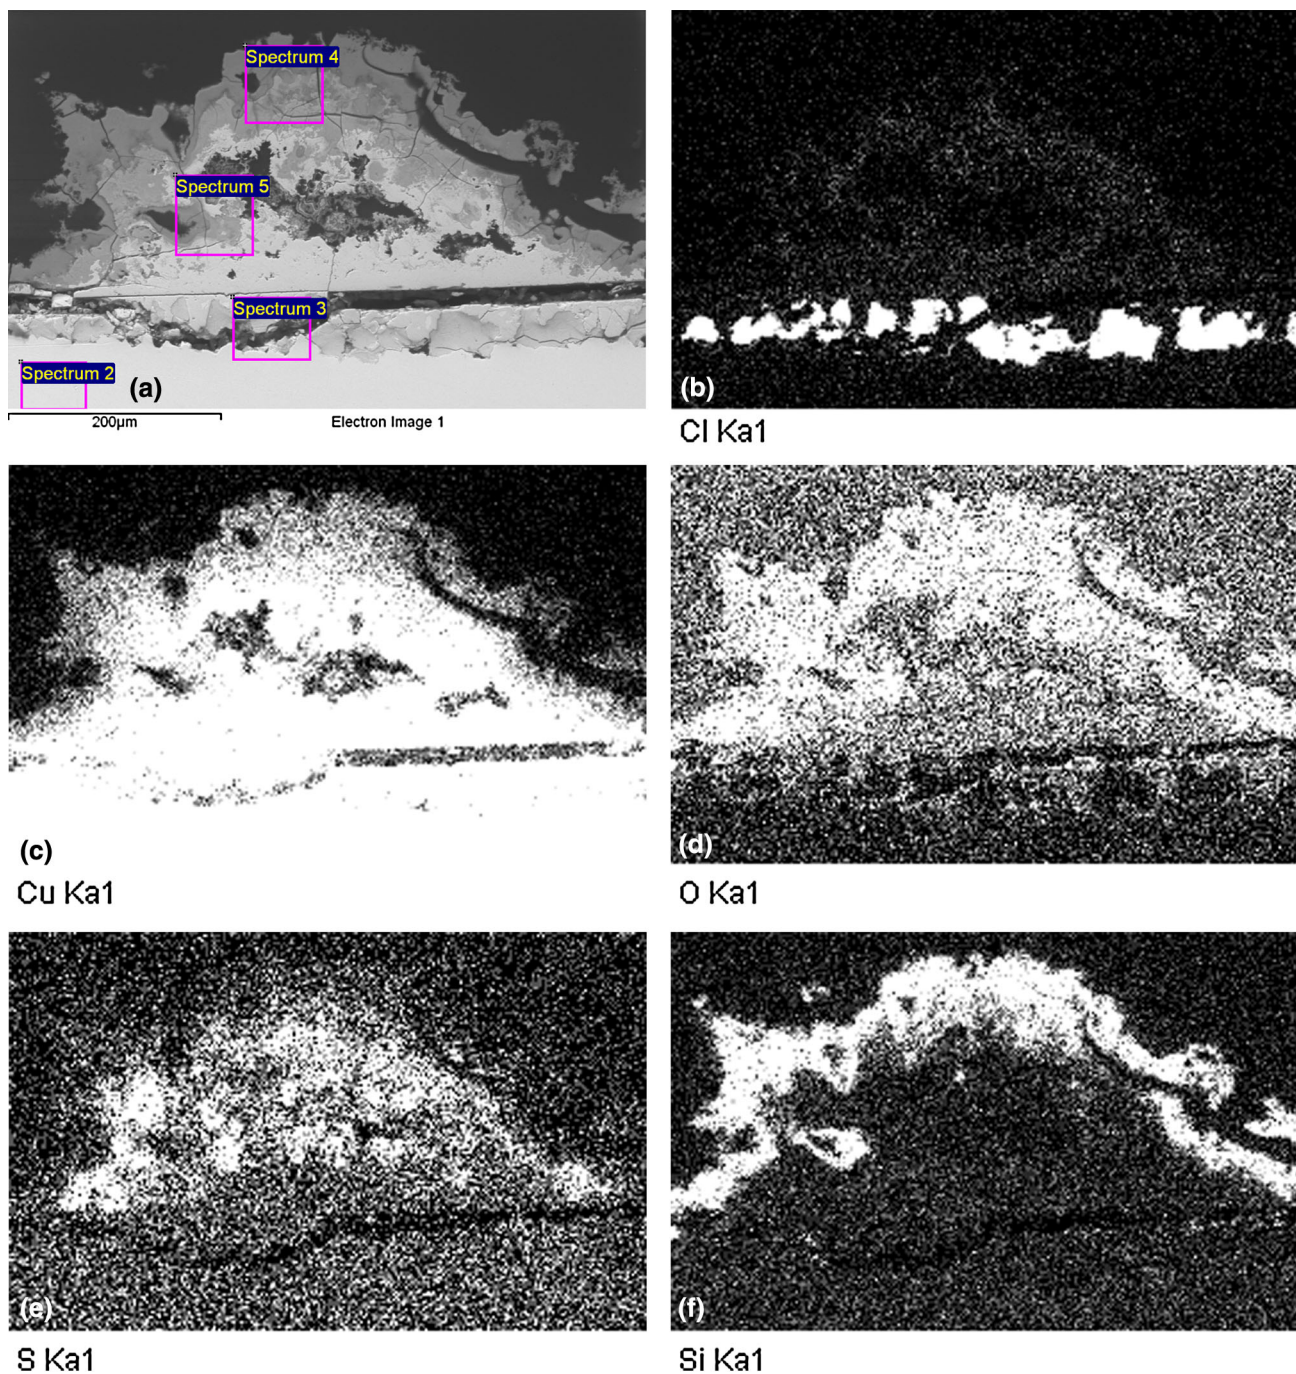
Fig. 4 SEM and corresponding energy dispersive x-ray elemental mapping analysis of the cross section of a pit from a copper pipe section exposed to 1 year of orthophosphate (sample ID dl00255)

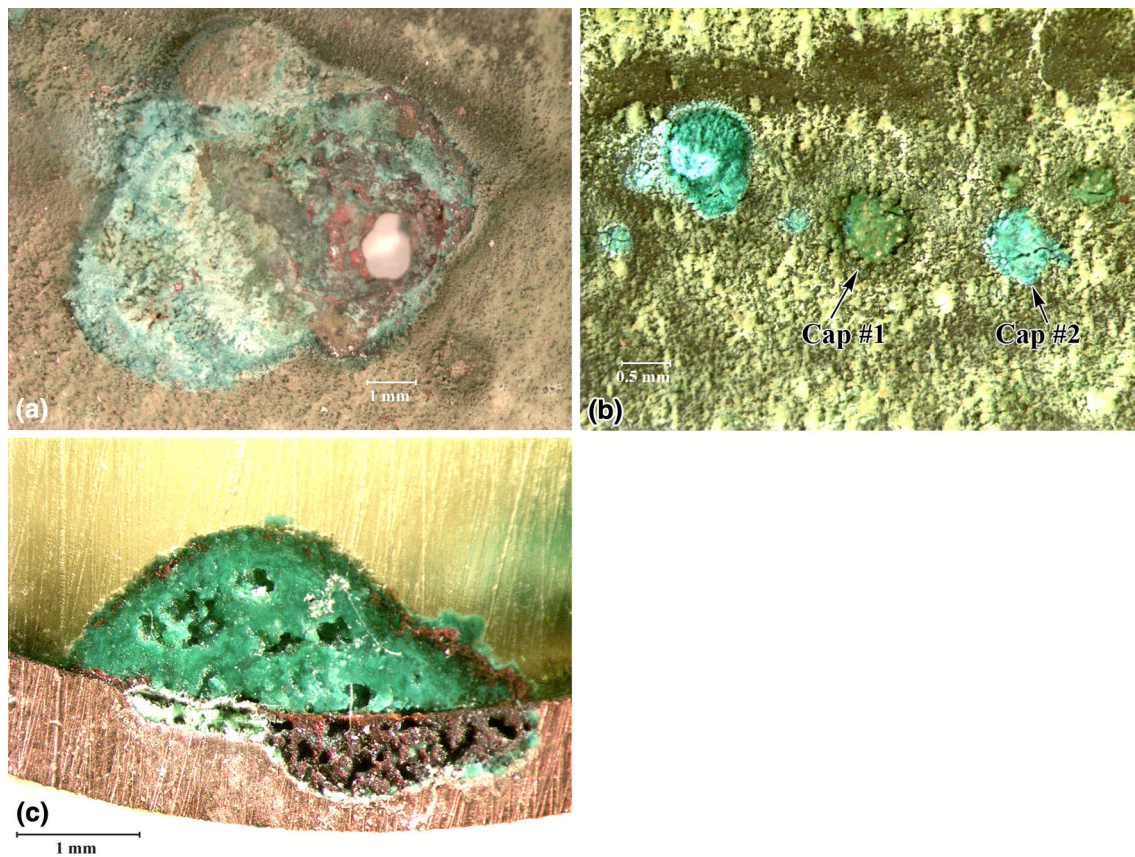
the failure hole that is approximately 1 mm in diameter (Fig. 5a). Figure 5b shows a patch of several corrosion by-product mounds that varied in appearance. Some of the mounds were light blue in color and others green, and some were covered to some degree with the material that made up the uniform portion of the scale. A cross section image of a cut through a pit cap and pipe wall reveals the extent of corrosion attack into the metal (Fig. 5c). The pit cap was approximately 2 mm thick and green and blue in color. At this cross section, the depth of the pit is approximately 2/3 the thickness of the pipe wall. All features of pitting corrosion are present; the pit cap, porous membrane, and pit full of large dark orange cuprite crystals.

Fig. 5 Features of pitting corrosion attack on pipe section exposed to 1 month of blended phosphate (sample ID d100378): **(a)** close-up of internal surface of pipe including a portion of the pit cap and view of

hole, **(b)** several local corrosion mounds on pipe surface, and **(c)** cross section showing pit cap, porous membrane, and pit

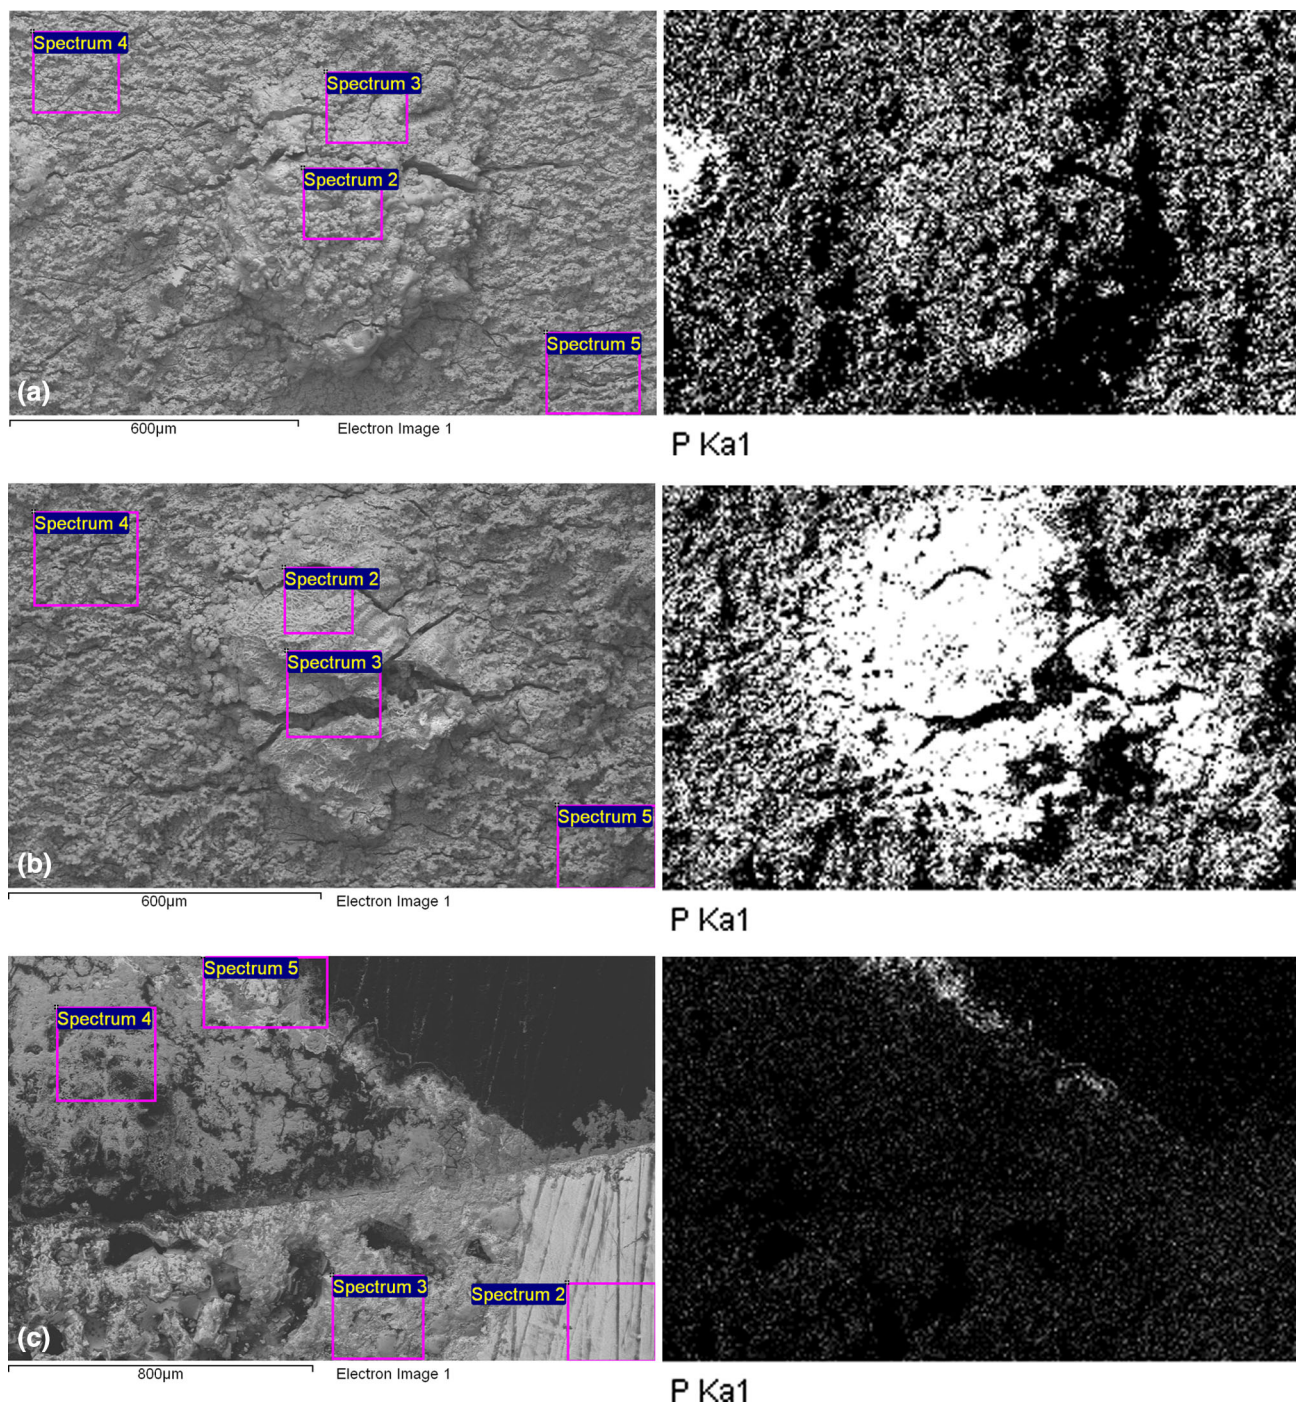
Elemental mapping of the surface of the copper pipe section, including a small pit cap (Figs. 6a, S5), showed that the surface was evenly distributed with silicon, oxygen, and copper. Silicon levels in the uniform portion of the pipe surface surrounding (Figs. 6a, S5) and covering the cap (Figs. 6a, S5) averaged 12.6 and 13.7%, respectively (Table 2). Significant levels of iron (2.9–5.3%), aluminum (1.7–1.9%), calcium (0.6–0.8%), and magnesium (1.3–1.5%) were measured in all spectra (Table 2). Also, measurable levels of phosphorus were detected (0.4–0.9%) across these areas showing that the corrosion inhibitor, with time, was being incorporated into the solids that cover the pipe with time. The elemental make-up of the material was similar to solids on the earliest pipe section, except for the presence of phosphorus. Because of the difference in visual appearance between some pit caps, other pit caps on the pipe surface were also examined. The results showed that the elemental composition of the surrounding uniform portion of the solids was nearly identical to previous analysis of other areas (Figs. 6b, S6; Table 2). Interestingly, the cap was covered with phosphorus (Figs. 6b, S6), and silica was nearly absent from the same area. The solid that covered the cap contained largely copper and oxygen, and an average of 7.4% P and 0.4% Si (Figs. 6b, S6). Phosphorus, likely as a copper phosphate compound, either covered or displaced the silicon material. Sulfur was also present at greater amounts (2.1%) than on the surrounding “uniform” portion of the scale. Other elements including calcium, iron, and aluminum (Table 2) were also present but at much lower levels. Phosphorus, presumably from the corrosion inhibitors, was highly concentrated over some pit caps suggesting that it was attracted to sites of localized corrosion.

Elemental analysis of a pit cross section (Figs. 6c, S7) showed that silicon, oxygen, and copper covered the “uniform” portion of the solids on the pipe adjacent to and partially covering the pit cap. The layer was approximately 0.2 mm thick in some areas. The silicon partially covered the pit cap, but was not a significant part of the pit. Phosphorus was found in small areas covering the top of

the pit cap. For example, one such region (Figs. 6c, S7; Table 2) contained 3.3% phosphorus which may be somewhat underreported given the area of analysis expanded outside the region of concentrated phosphorus. Phosphorus pockets were generally distinct from silicon, however, it was difficult to precisely determine whether phosphorus displaced or covered the silicon deposits. The bulk of the internal cap material was comprised of copper (56.1%), sulfur (10.1%), and oxygen (31.2%) (Figs. 6c, S7; Table 2). Elemental chlorine (i.e., chloride) (16.1%) and copper (70.1%) dominated the material in the pit.

Fig. 6 SEMs and corresponding energy dispersive x-ray mapping analysis of phosphorus on the surface of copper pipe section exposed to 1 year of orthophosphate (sample ID dl00378): (a) the top of a pit cap and surrounding area, (b) another pit cap, and (c) cross section through pit cap

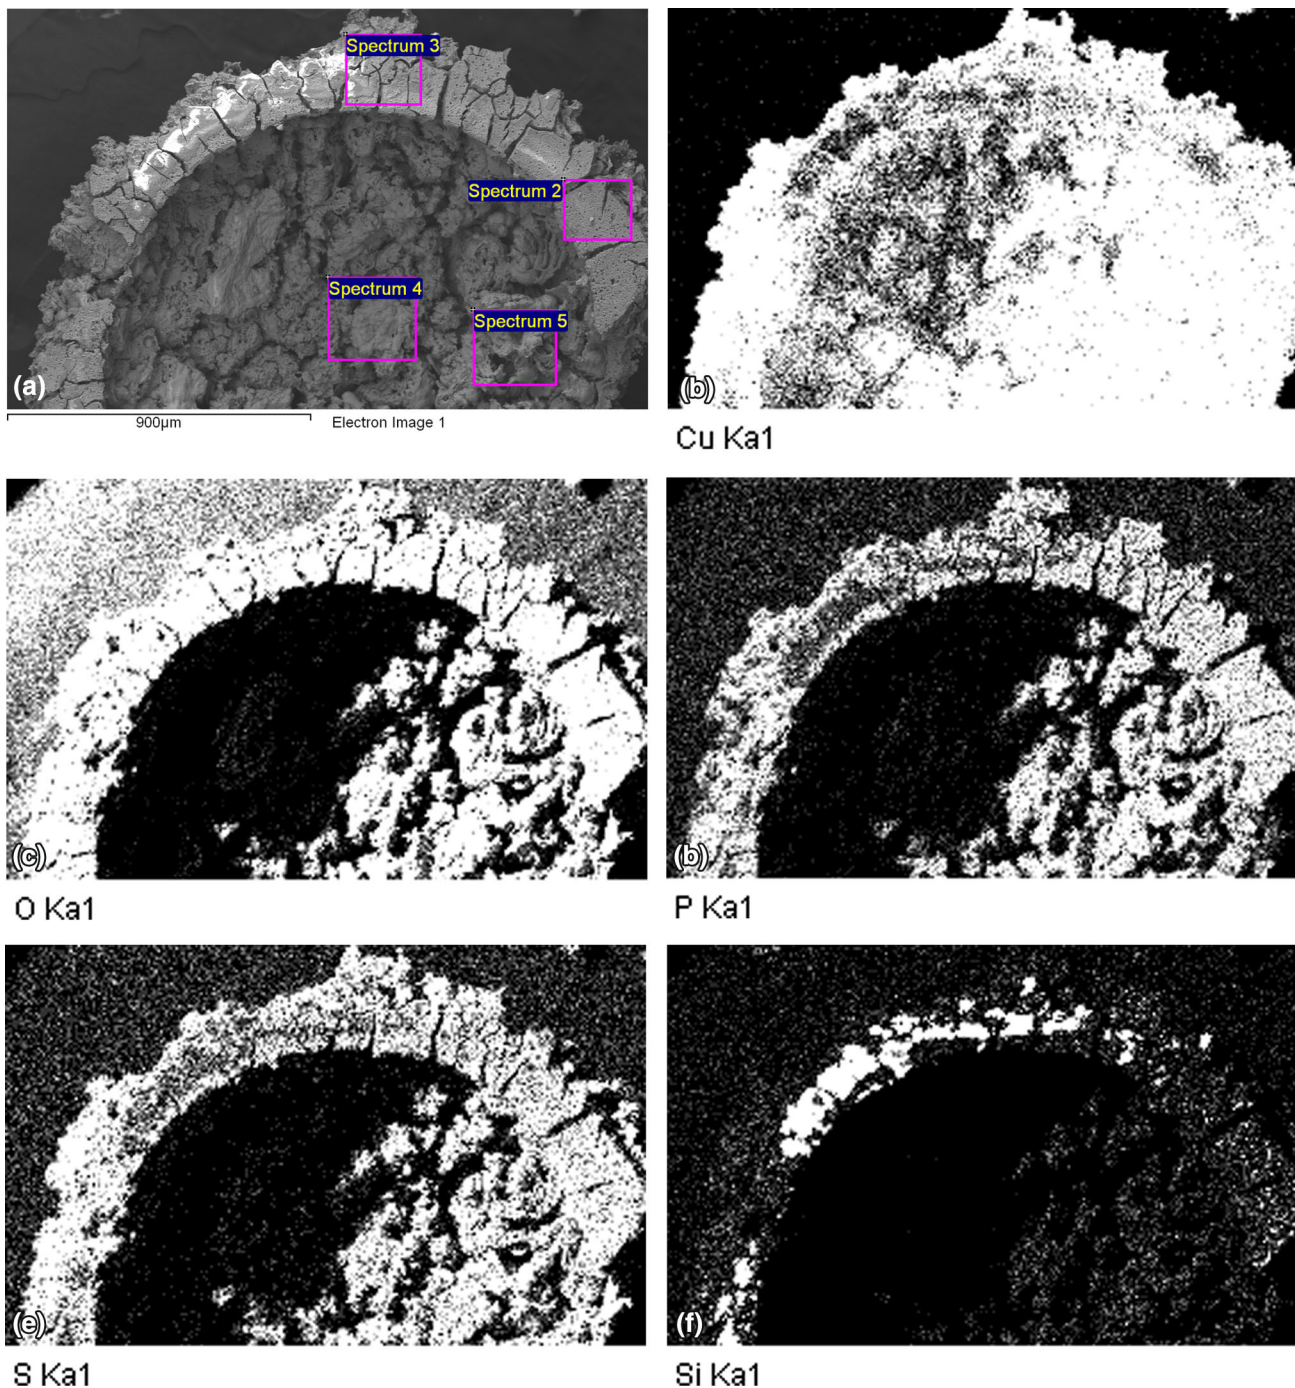
Visual and microscopic examination of the underside of the pit cap revealed the domed appearance of the cap that covers the pit, which is common with all of the caps examined in this work (Fig. 7). Elemental mapping shows that the band of material at the base of the cap that was in contact with the pipe wall is dominated by copper, oxygen, phosphorus, sulfur, and silicon (Fig. 7). Elemental spectra collected in the area in contact with the pipe wall (Fig. 7; Table 2) showed that the average copper, oxygen, and

phosphorus quantities were 54.5, 32.0, and 6.2%, respectively. Sulfur, silicon aluminum, and iron were all detected as well. The accumulation of phosphorus in this region is of particular significance because the region is at or near the cathode reaction that drives the localized corrosion and degradation of the copper pipe wall. The copper–phosphorus solid also covered the internal dome of the cap (Fig. 7; Table 2).

Fig. 7 SEM and corresponding energy dispersive x-ray analysis elemental mapping analysis of the underside of a pit cap removed from a copper pipe section exposed 9 months after blended phosphate addition (sample ID dl00557)

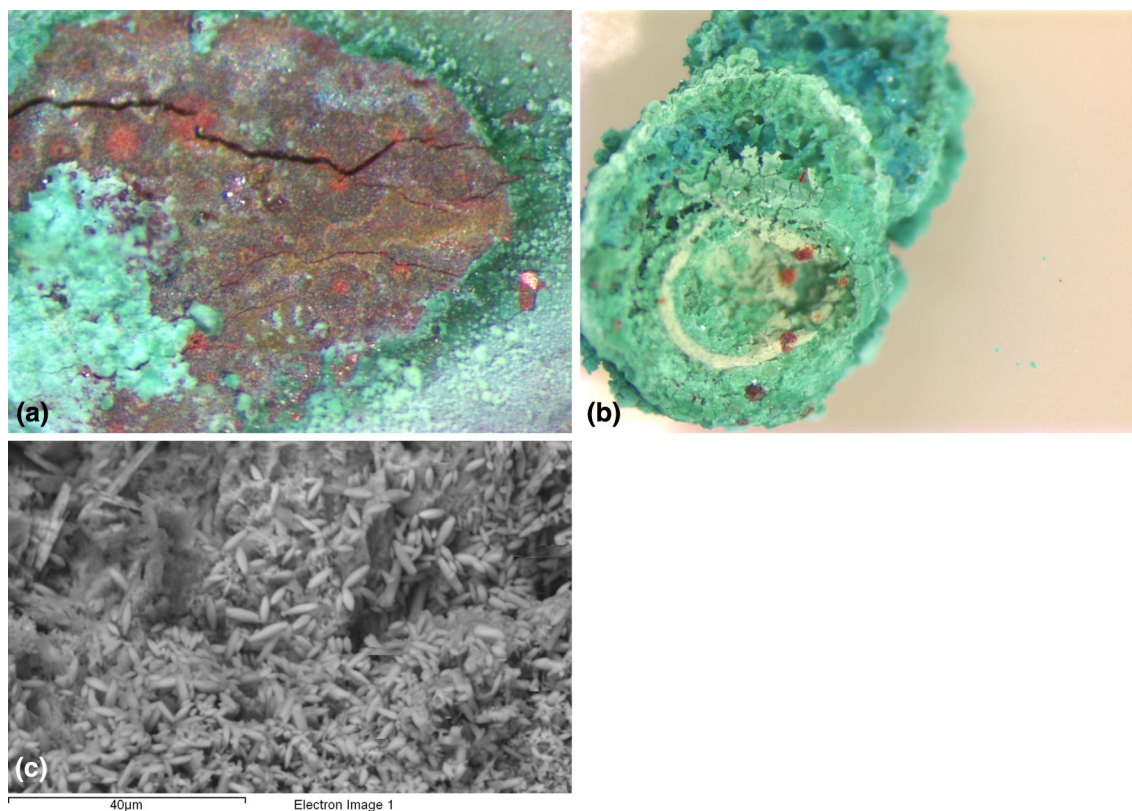
magnification and showed the well-defined shape of the solids in the band (Fig. 8c). Solids were long (3–4 µm) and elliptical in shape. Closer examination of the solids showed the ratio of Cu:P:O in the solid was almost exactly 2:1:3.4 and contained between 13 and 17% phosphorus.

Fig. 8 Stereomicrographs of (a) copper pipe surface below a pit cap and (b) the underside of a removed pit cap, and (c) SEM of white solid ring on underside of pit cap (sample ID dl00509c, approximately 1 year after ortho-polyphosphate blend addition)

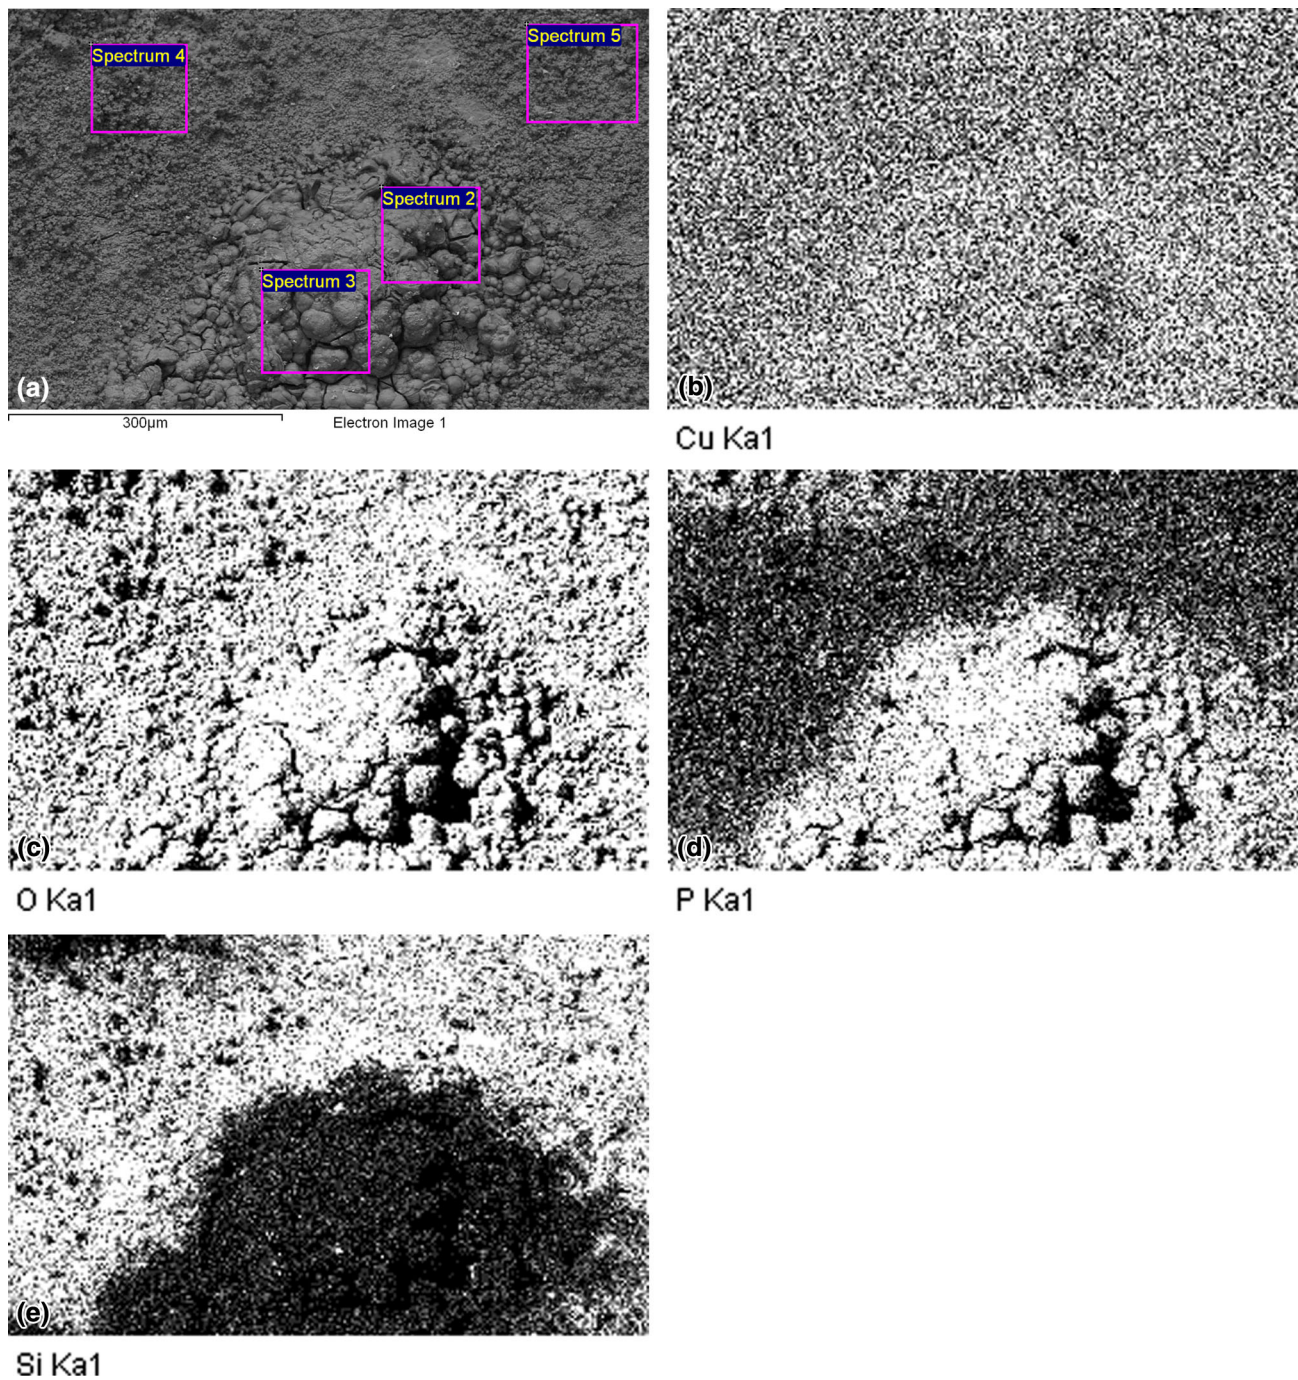
Elemental mapping analysis of the surface of the copper pipe section, including a small pit cap (Fig. 9), showed that the surface composition varied with location. The relatively uniform layer of material was dominated by silicon, oxygen, and copper. Silicon levels in the uniform portion of the pipe surface (Fig. 9) averaged 11% (Table 2). Significant levels of iron (3.8 and 5.1%), aluminum (2.0 and 2.1%), calcium (0.2 and 0.3%), and magnesium (0.6%) were also detected across uniform solid spectra (Table 2). This composition was very similar to the composition of the uniform material

in previous pipes except the amount of phosphorus increased to 2.6% on average with time. The pit cap was totally covered with a relatively concentrated layer of phosphorus (and copper and oxygen) (Fig. 9), and silica was either absent or covered by the phosphorus-containing material. Specifically, the material (Fig. 9; Table 2) contained an average of 13.0% phosphorus, which was higher than past samples, and only 0.5% silicon. It also contained copper and oxygen.

Fig. 9 SEM and corresponding energy dispersive x-ray analysis elemental mapping analysis of the cross section of a pit from a copper pipe section exposed to blended phosphate (sample ID dl00509c)

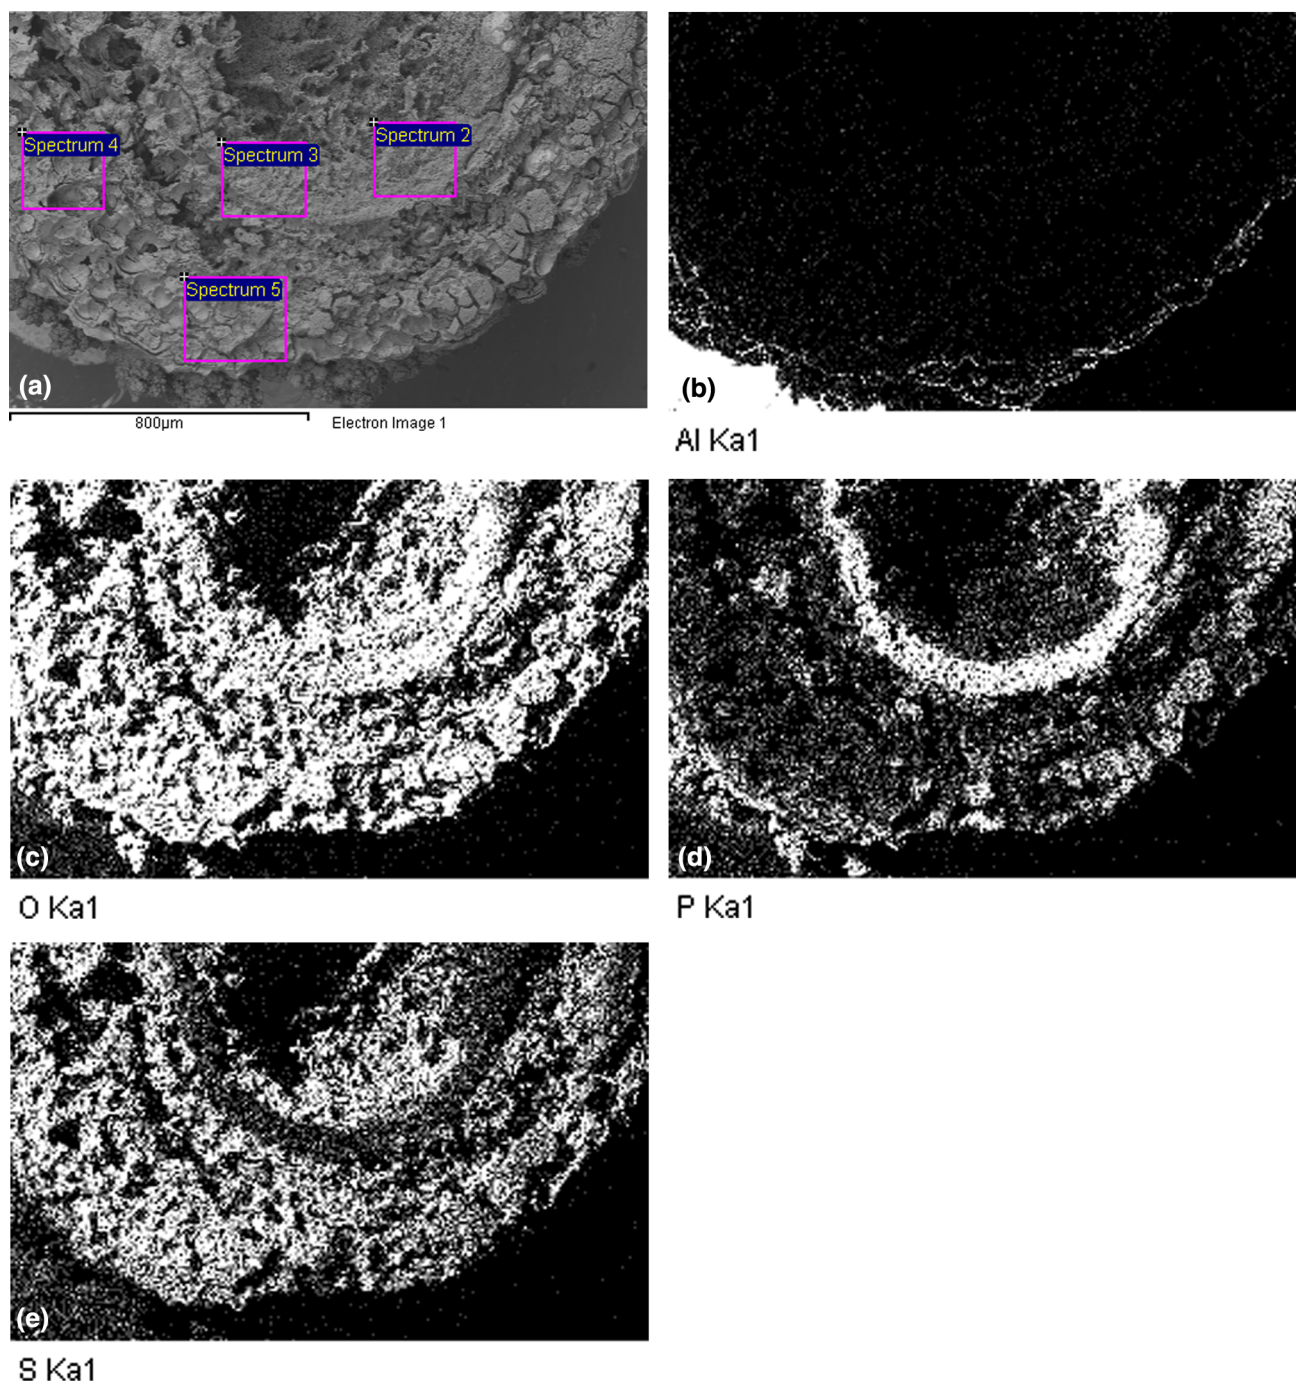
The underside of a pit cap was examined by SEM and EDXA analysis (Fig. 10). As with before, the cap was hollow toward the center—presumably in the region directly above the growing pit—which again suggests that the water was corrosive (e.g., low pH). Elemental mapping in this region provided details about the composition of the cap and the white ring at the base of the cap. Copper, sulfur, and oxygen with phosphorus in regions were identified throughout the base of the cap. Interestingly, the white ring was dominantly phosphorus, oxygen, and copper. Specifically, the white ring contained 7.0 and 5.5% phosphorus, respectively (Fig. 10; Table 2). The actual concentration of the ring is greater than the reported values because the scanned region is wider than the band. The white band was examined under greater

Fig. 10 SEM and corresponding energy dispersive x-ray analysis elemental mapping analysis of the underside of a pit cap removed from a copper pipe section exposed to 1 year of orthophosphate (sample ID dl00509c, 9 months after ortho-polyphosphate blend)
