CASE HISTORY—PEER-REVIEWED

# Failure Analysis of Premature Corrosion of HF Seam-Welded Steel Pipe in Central Heating System

Dorota Tyrła · Bogdan Pawlowski

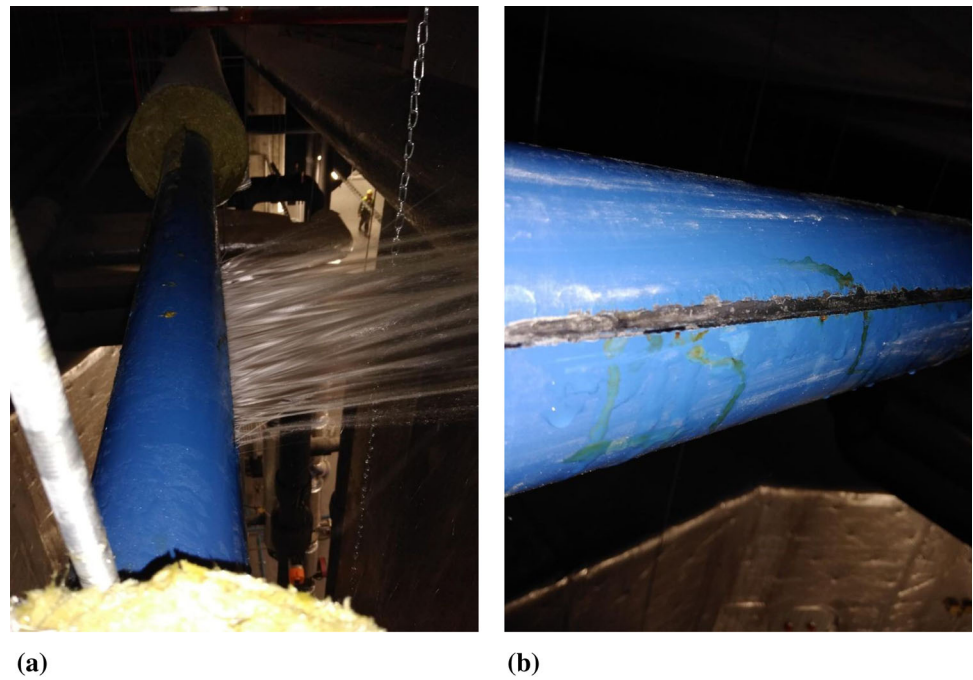
A 3" (fi 88.9 × 3.87 mm) high-frequency induction welded pipe made of S195 steel carrying hot water (70/50 °C at 4 bar pressure) failed by longitudinal cracking after just 24 months in service, as shown in Fig. 1.

Visual inspection of the failed pipe showed that the rupture is located within the seam weld line, similarly to the case presented in the work [1], which focused on longitudinal cracks in electric resistance welded (ERW) steel pipes immediately after quenching and tempering processes. As stated by Kaba et al. [1], the cracks in the quenched and tempered ERW steel pipes could be correlated with the combination of coarse manganese silicate type complex oxide formation in the weld seam and high

**Fig. 1** Macroscopic view of failed steel pipe

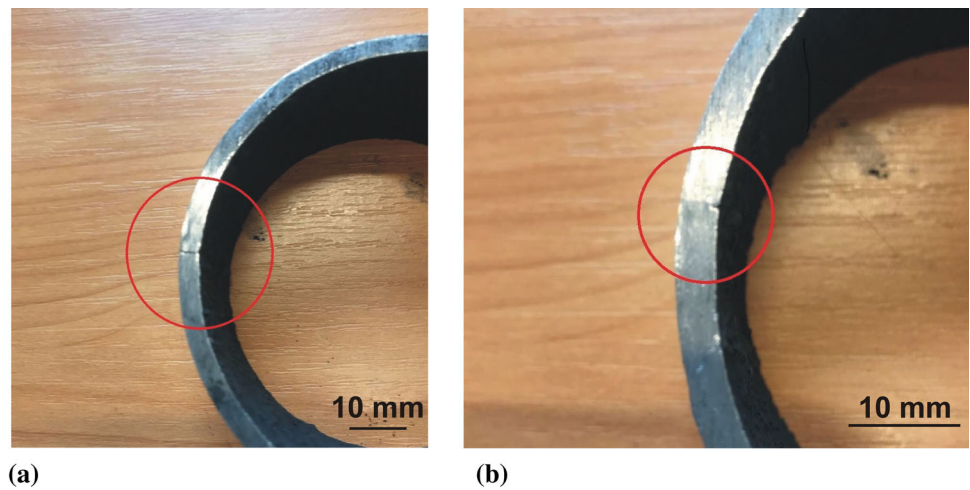
In the process of preparing metallographic samples, in the supplied pipe sections, macroscopic cracks were observed along the weld line (Fig. 2a) and there was a progressive

**Fig. 2** Crack (a) and a corrosion attack (b) along the weld line

corrosion attack along the weld line in the sample cut away from the leakage point (Fig. 2b).

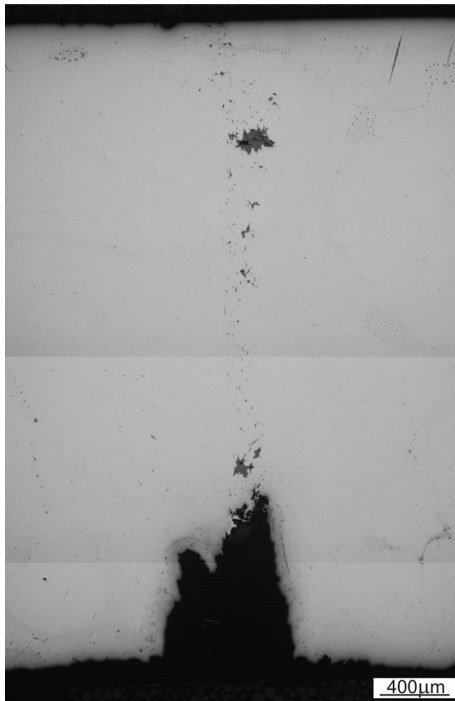
The microstructure of the sample taken from the place marked in Fig. 2b (corrosion attack along the weld line) is shown in Fig. 3 (non-etched sample).

As can be seen in Fig. 3, there are many inclusions along the weld line. These inclusions are also visible on

**Fig. 3** Corrosion attack along the weld line (non-etched sample)

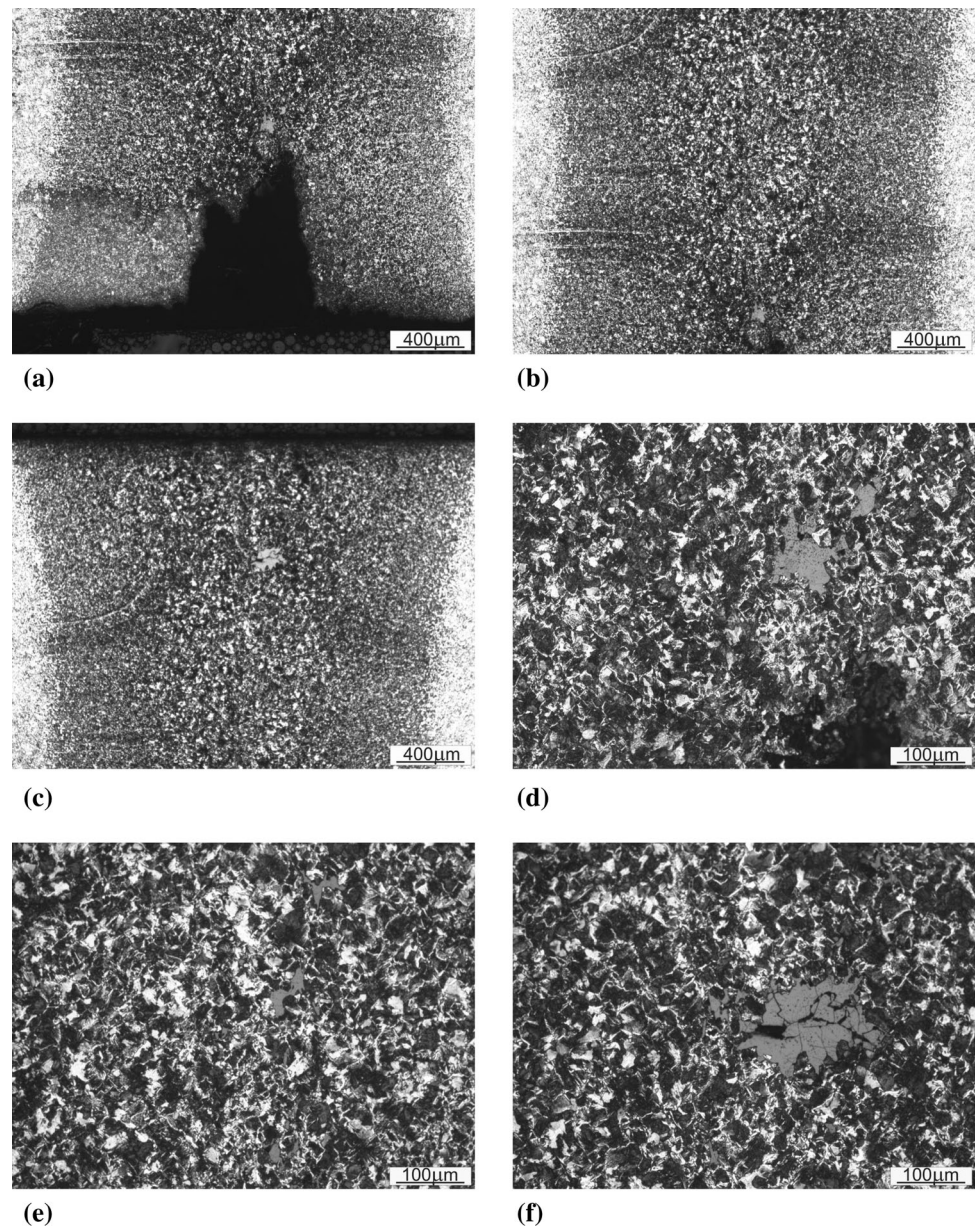
micrographs of the etched specimens (2% nital), shown in Fig. 4.

**Fig. 4** Corrosion attack along the weld line (2% nital)

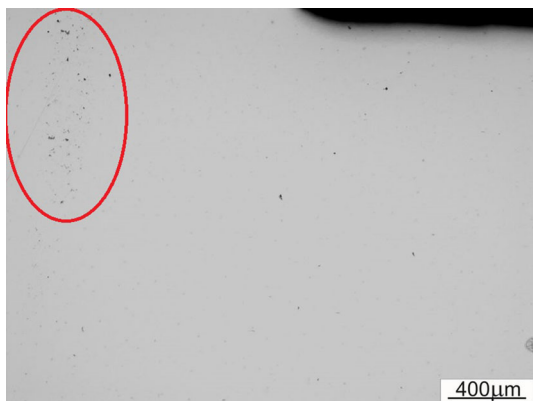
The presence of numerous inclusions in the weld line was also confirmed in an additional sample taken further away from the leak location, as shown in Fig. 5.

**Fig. 5** Inclusions in the weld line (non-etched)

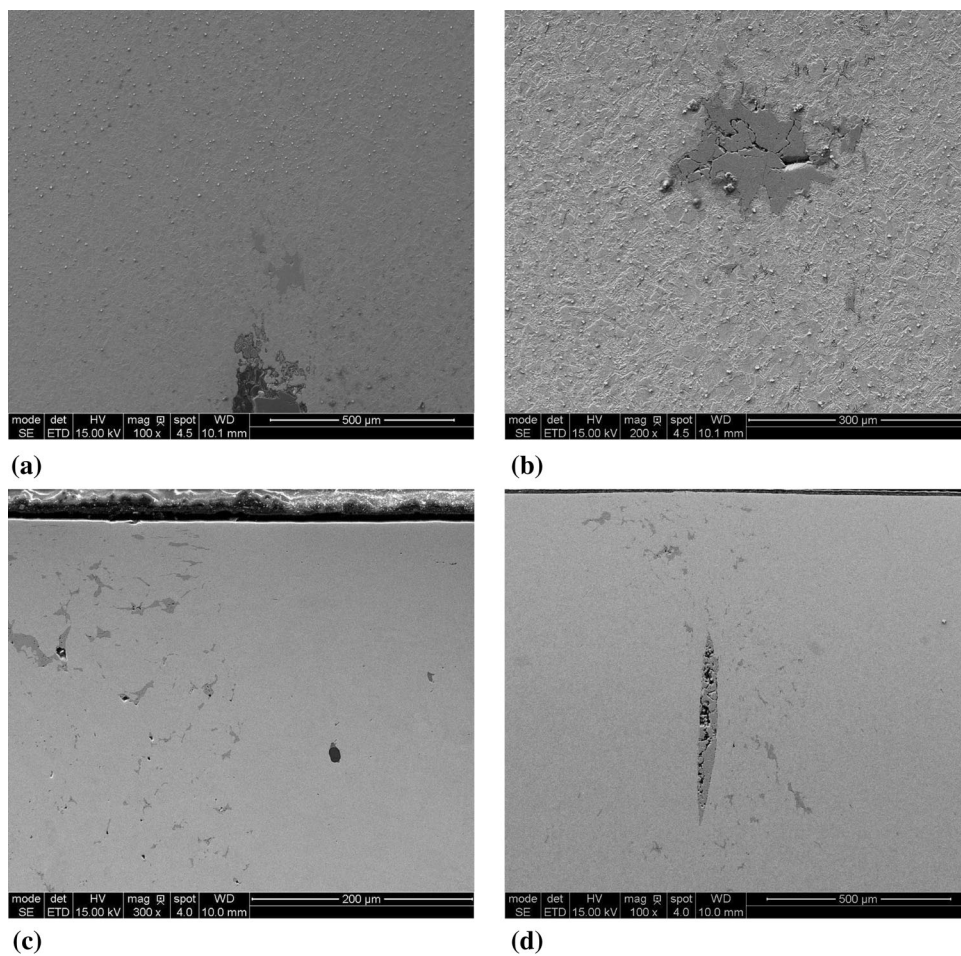
The nature of the numerous inclusions observed in the weld line was analyzed using a scanning electron microscope. Figure 6 shows the images obtained by scanning electron microscopy in the weld line.

**Fig. 6** Images of inclusions observed by scanning electron microscopy in the weld line

to pitting corrosion [7, 8]. Additionally, the clustered non-metallic inclusions (iron oxides in this study) significantly reduce the fracture toughness of the seam weld, leading to the formation of longitudinal cracks. This large amount of iron oxides observed in the weld line resulted in premature corrosion in the form of longitudinal cracking that can only be related to one of the high-frequency welding defects known as a *cast weld* [3]. A cast weld is the result of failure to eject all of the molten metal from the bond plane. The remaining cast metal on the bond plane likely contains metal oxides. Prevention of a cast weld is possible by increasing squeeze out or increasing the strip width.

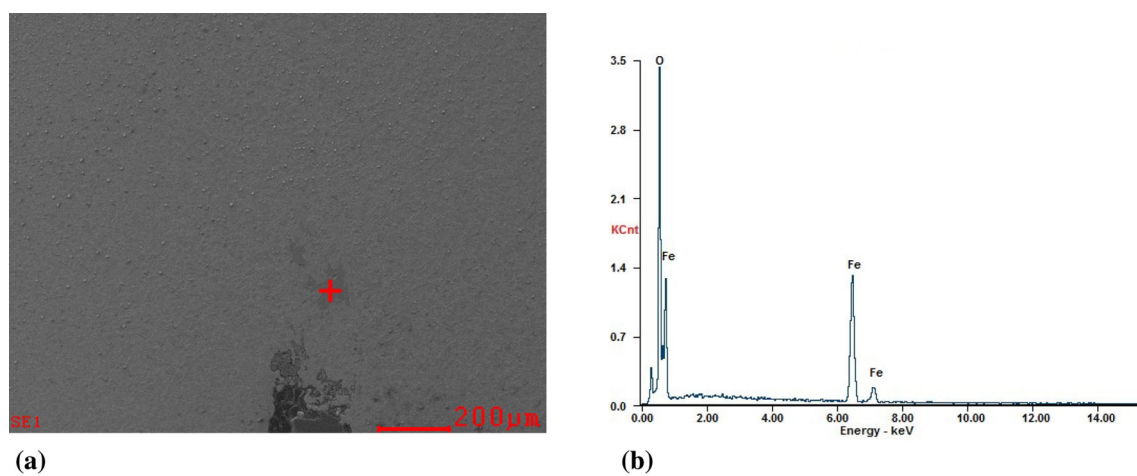
The results of energy-dispersive spectroscopy (EDS) microanalysis of the inclusions visible in Fig. 6 are presented in Figs. 7, 8, 9 and 10. The structural examinations conducted by use of EDS (Figs. 7b, 8b, 9b and 10b) show that inclusions observed in the weld line are iron oxides.

**Fig. 7** The results of EDS microanalysis of the inclusion visible in Fig. 6a

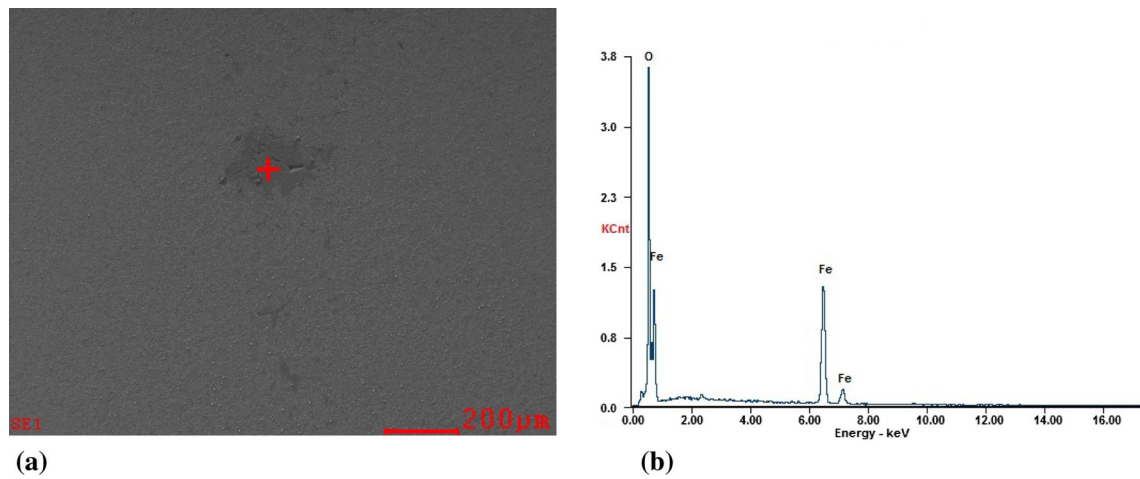
**Fig. 8** The results of EDS microanalysis of the inclusion visible in Fig. 6b

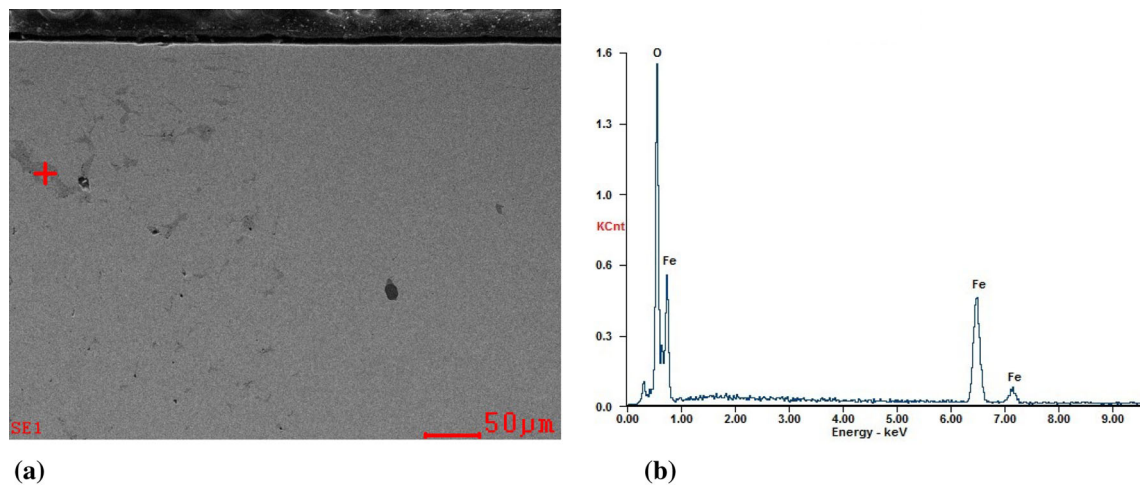
**Fig. 9** The results of EDS microanalysis of the inclusion visible in Fig. 6c

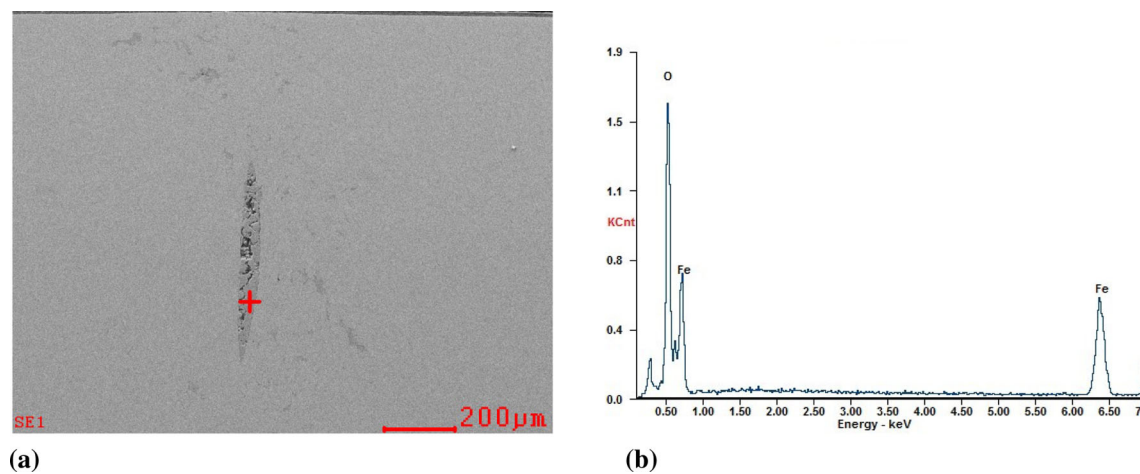
**Fig. 10** The results of EDS microanalysis of the inclusion visible in Fig. 6d
