Keystone Pipeline Rupture Investigation

Matthew R. Fox · Adrienne V. Lamm

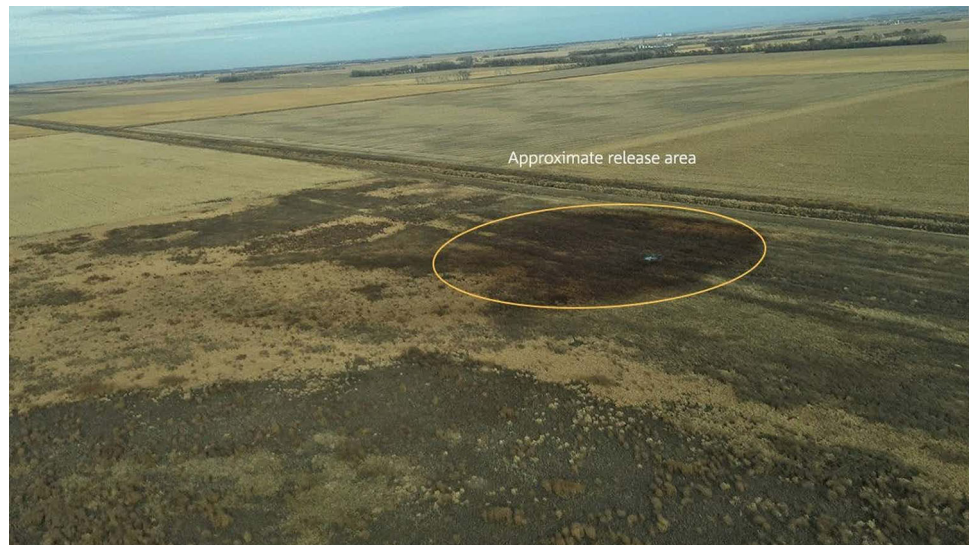
Fig. 2 Pipeline piece as received. Unlabeled brackets indicate the fatigue region near the middle of the rupture

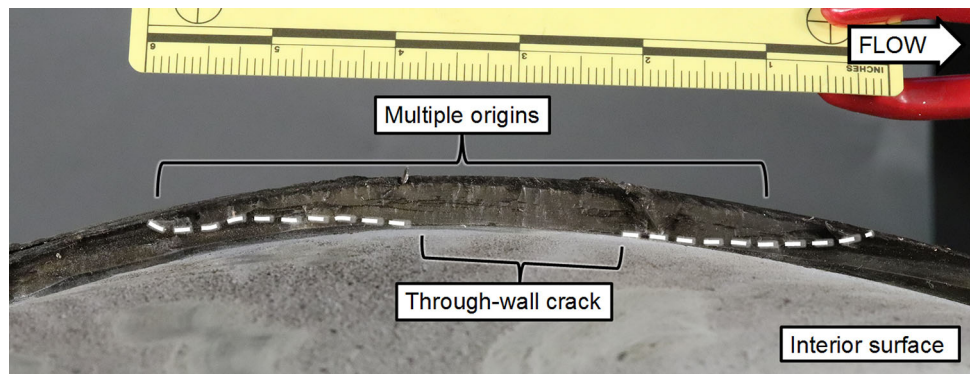
Fig. 4 Oblique view of the fatigue region on the left fracture face showing sliding contact damage bounded by the dashed line on the exterior surface adjacent to the fracture

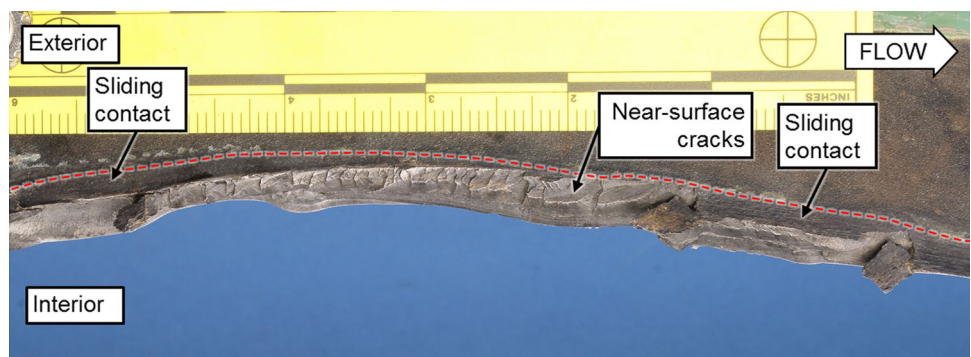
Fig. 5 Fatigue region in an area of through-wall penetration. A dashed line indicates the near-surface crack boundary, and unlabeled arrows indicate prominent fatigue crack arrest lines

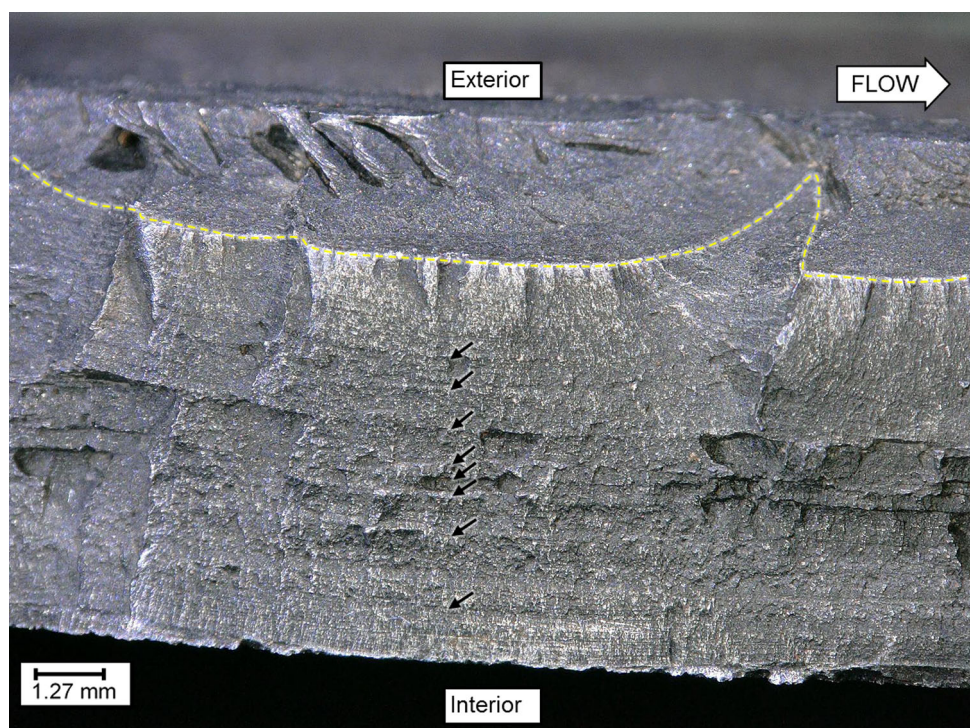
made after the longitudinal marks. Coating material was present intermixed with the sliding contact marks, and many edges of the remaining coating adjacent to individual contact marks were curled and rounded consistent with

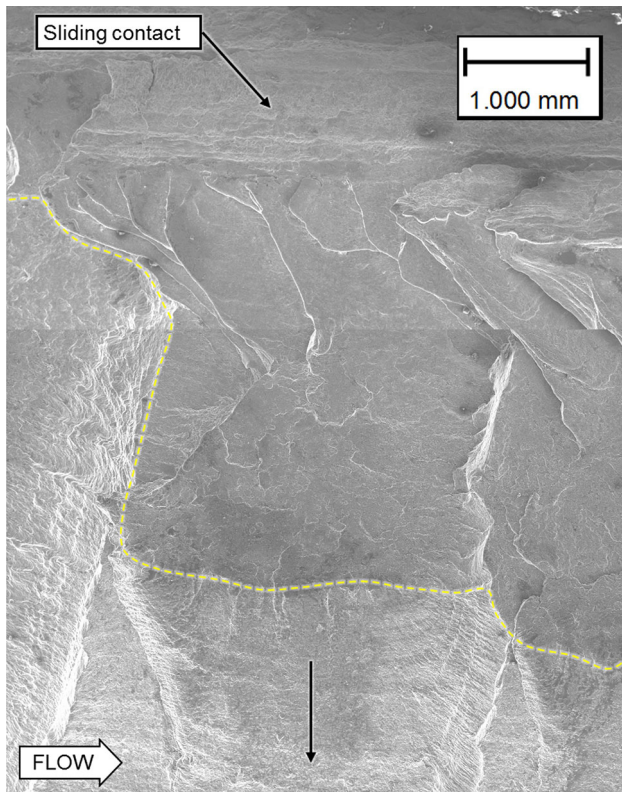
Fig. 6 SEM image of sliding contact features, near-surface cracks, and fatigue features. A dashed line indicates the near-surface crack boundary, and an unlabeled arrow indicates the fatigue crack propagation direction

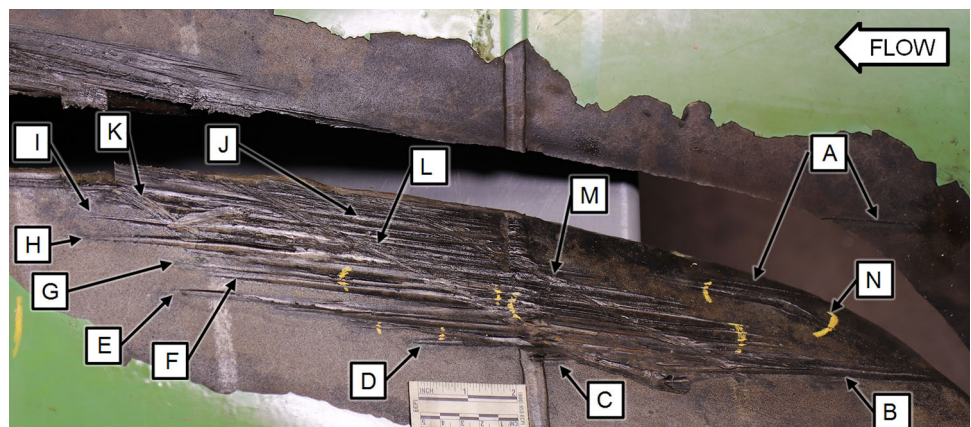
some areas of the pipe with intact coating and the weld bead associated with the girth weld.

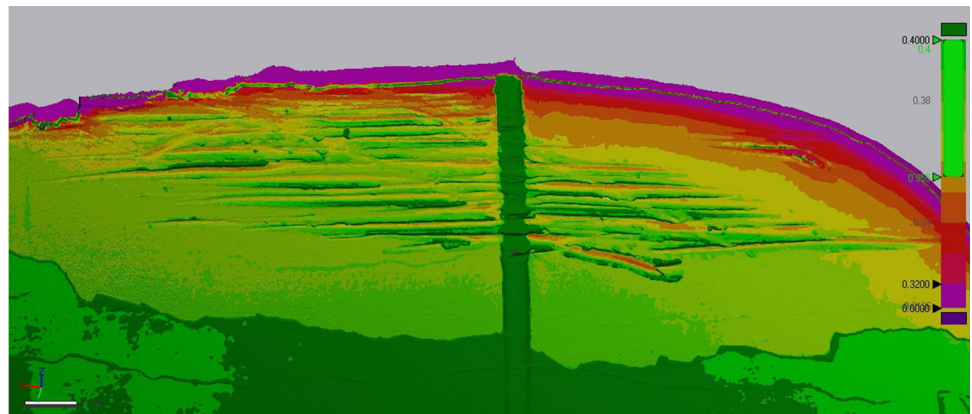
Fig. 9 Sliding contact groove radius measurements in the transverse plane

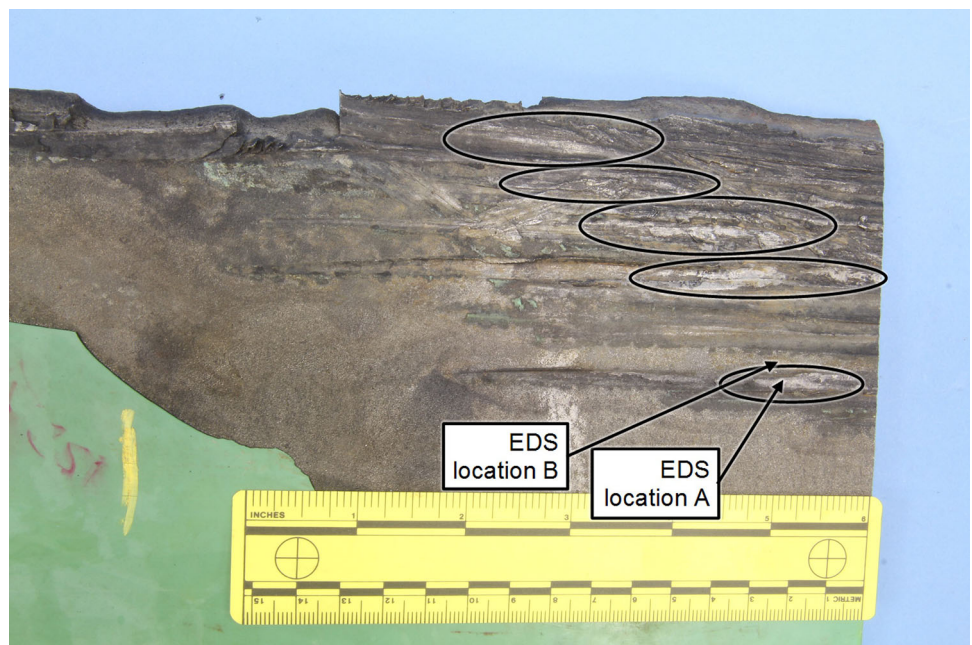
Fig. 10 Area of sliding contact marks after sectioning and cleaning. Areas of lighter gray material with higher chromium content relative to the pipe material are indicated

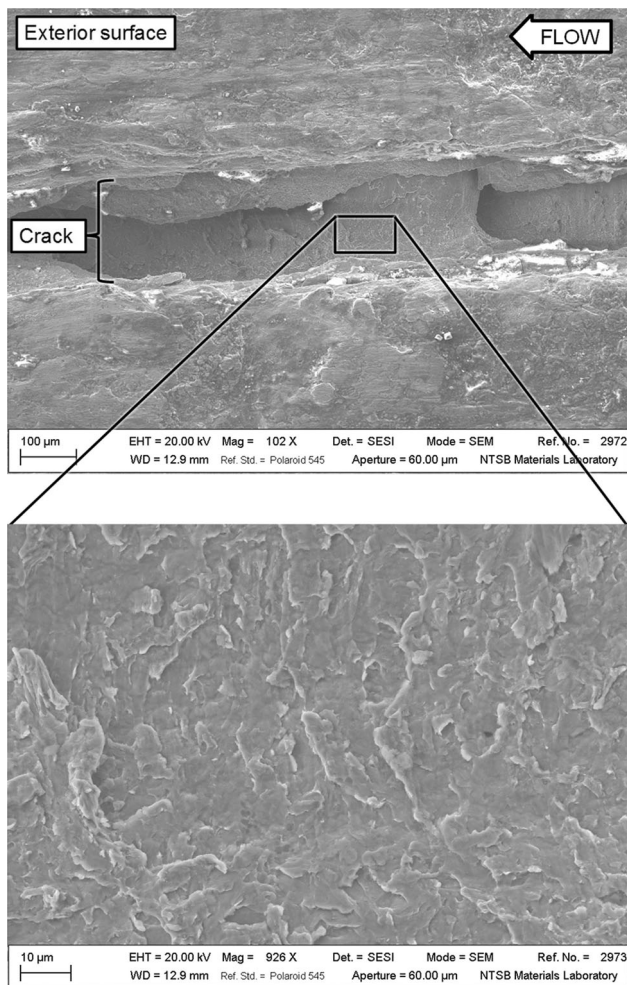
Fig. 11 Fracture features associated with a partially opened longitudinal crack observed in one of the sliding contact grooves

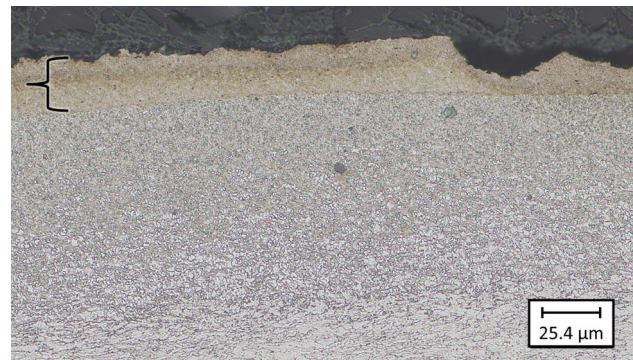
Fig. 12 Metallographic section through one of the grooves showing metal deposited on the surface as indicated with an unlabeled bracket (etched with 4% nital)

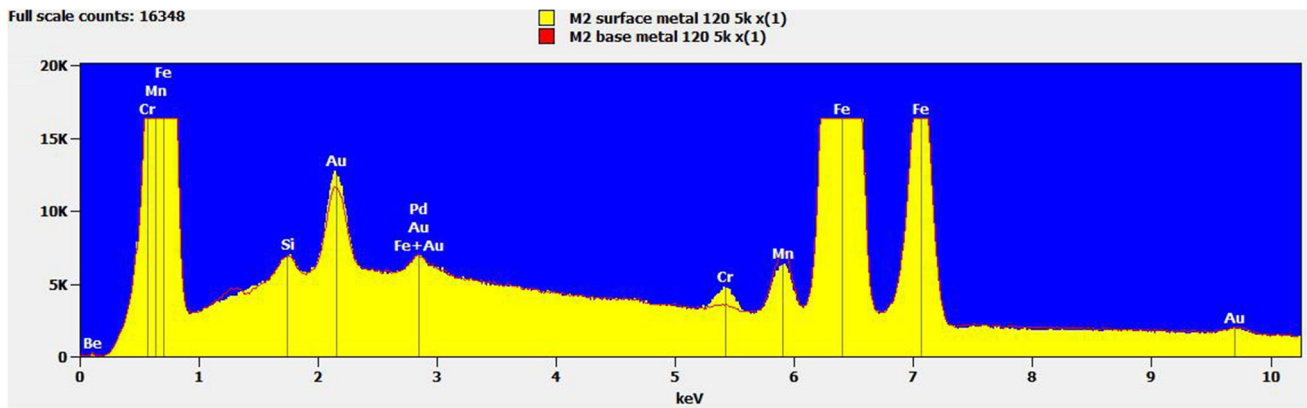
Fig. 13 EDS spectra of the gold palladium-coated metallographic section showing the deposited surface material spectrum in yellow, and the underlying pipe material spectrum outlined in red (Color figure online)

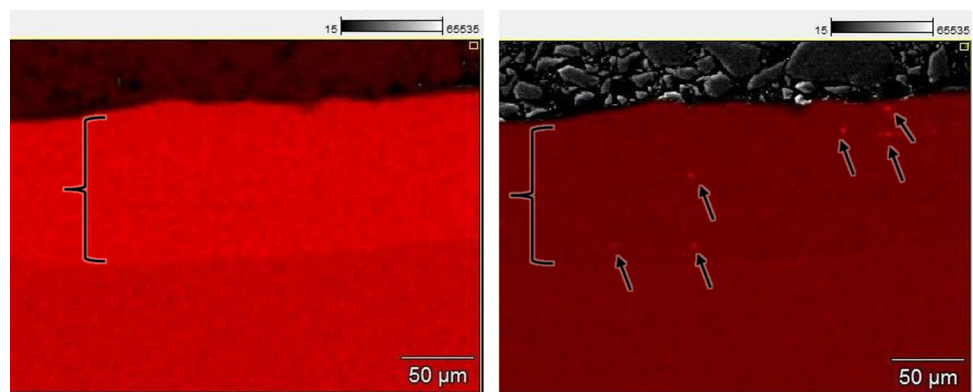
with another object. The contact pressures were substantial enough to locally deform the pipe metal to form the groove and cause near-surface cracks to develop within the damaged areas. The fatigue cracks then initiated and propagated from the near-surface cracks during subsequent pipeline operations.
