Liquid Metal-Assisted Cracking During Hot-Dip Galvanizing of Complex Structures: A Case Study

Abstract A pipe rack assembly uses hot-dip galvanized trusses joined together by screw connections. The welded trusses were manufactured with ASTM A572 gr.50 W steel profiles. Two of them fractured during the galvanizing bath. The fractures presented typical characteristics of the LMAC — liquid metal-assisted cracking mechanism. In both cases, the fracture was located in the structural element base metal and followed the fillet weld to the neighboring elements at a distance beyond the heat-affected zone. The trusses height was greater than the depth of the molten zinc vat, and double immersion is required for complete galvanization. The failed trusses had a particular geometry, distinct from the others. The design of the trusses was verified taking into account the thermal stresses generated by the partial immersion in the zinc bath. Among all, only the two broken trusses were exposed to stresses of thermal origin substantially higher than the material yield strength. Metallographic analysis revealed secondary intergranular cracks near the fracture surface. The crack roots contained zinc.

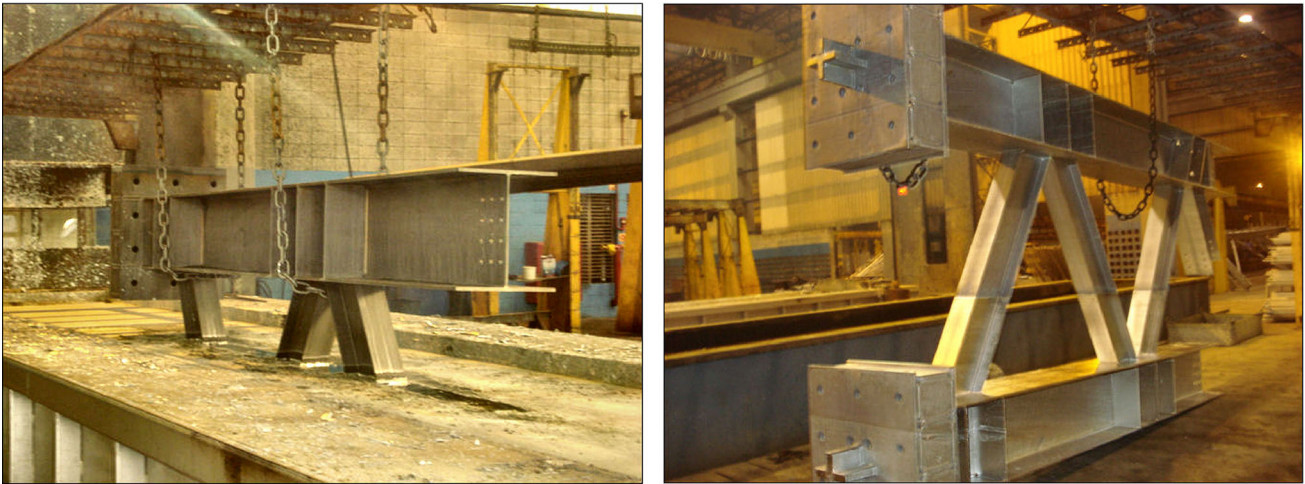
Fig. 1 Double immersion procedure used for the hot galvanizing of the 226 trusses for the assembly of the pipe rack

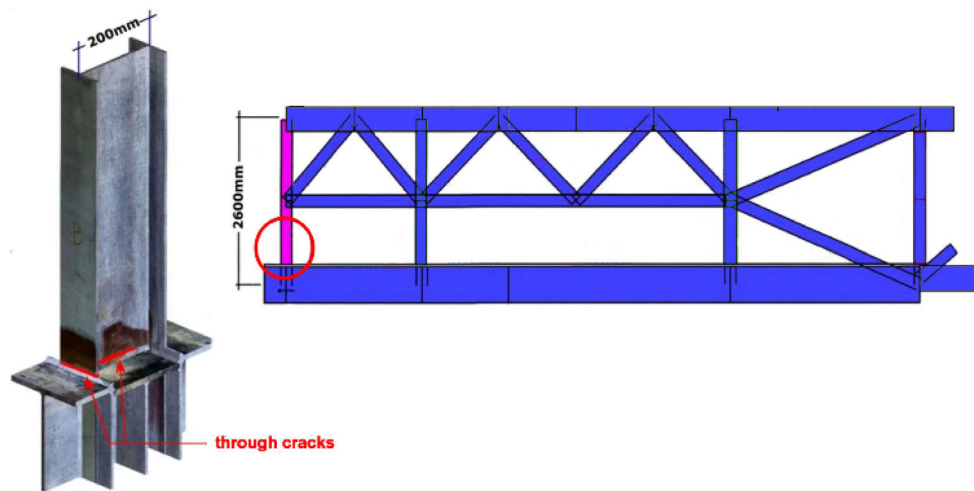
Fig. 2 Arrangement of one of the fractured trusses. The differences among these trusses are the resistant section dimensions of some elements. The detail highlights the relative position of the fracture in the broken element and the rest of the truss

other trusses of the pipe rack. Figure 2 shows the fracture location in one of these trusses.

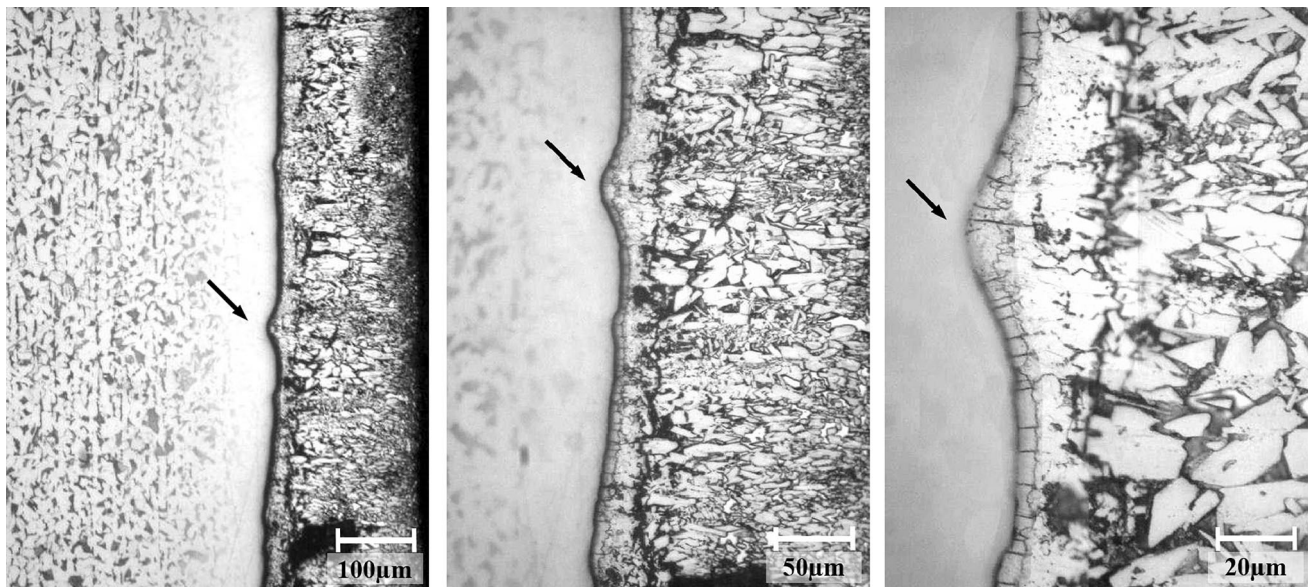
Fig. 4 Galvanizing layer in a region of the web next to the fracture. The nominal thickness of the deposited layer is 0.18mm. Mechanical polishing. Longitudinal section. Etching: Nital 2%. The zinc coating inhibits the action of Nital 2% on the carbon steel in its vicinity

The zinc bath used in the trusses galvanizing does not deviate from the current industrial practices recorded in Table 1. In the vicinity of the fracture, the deposited layer consisting of intermetallic compounds of the Zn Fe system and metallic zinc, Fig. 4, is compatible with the literature

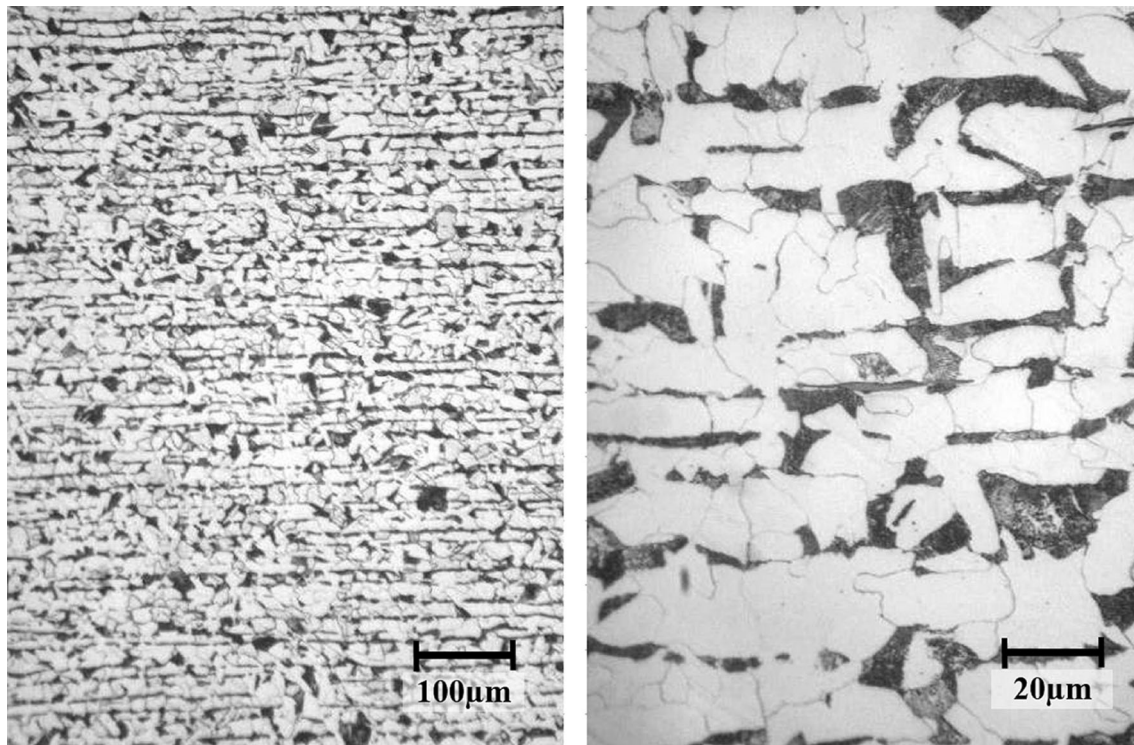
Fig. 5 Typical microstructure of the fractured truss during the galvanizing process. The average grain size is ASTM No 10. The properties are typical of a high-strength carbon steel laminated profile

intended for structural application. Mechanical polishing. Longitudinal section. Etching: Nital 2%

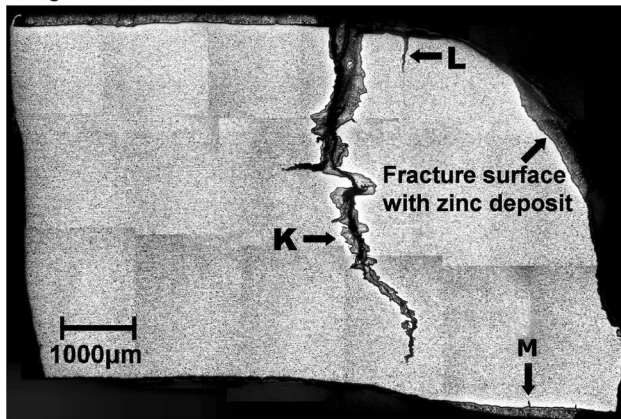
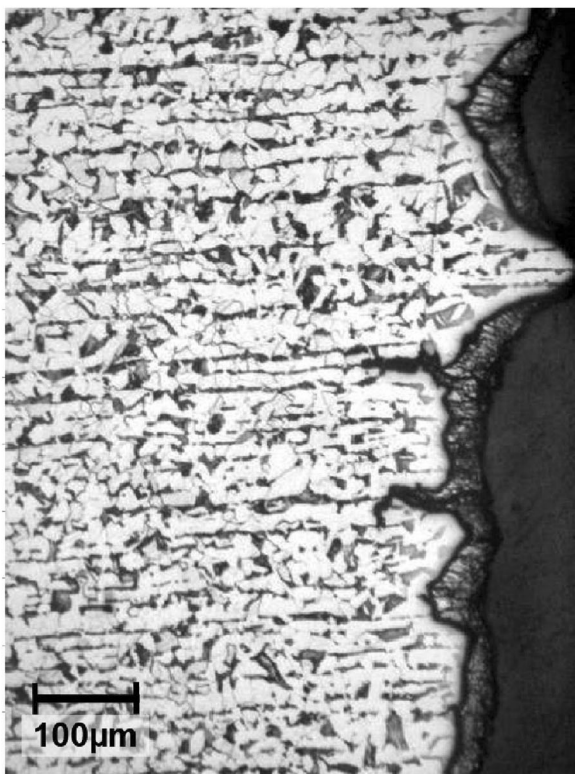
The morphology of the fracture and associated secondary cracks are typical of the LMAC mechanism. It is noteworthy: (1) the brittle nature of the fracture, Fig. 6, although the broken structural element presents ductile behavior in tensile after galvanizing, characterized by an area reduction in tensile test of 57%; (2) secondary cracks and microcracks present in the vicinity of the fracture, all with a large opening in relation to the depth, Figs. 6a and 7a; and (3) the presence of zinc on the fracture surface, as

well as on the root of the secondary cracks, Figs. 6 and 7. Note that these features are not consistent with defects resulting from welding or any other stage of manufacturing and of galvanizing prior to their contact with molten zinc.

Fig. 6 Fracture in the flange region. (a) Highlight aspects: (1) The fracture surface contains remnants of zinc; (2) detail K indicates a large secondary crack containing zinc; (3) details L and M show microcracks, all of which have a large opening in relation to depth. (b) The lamination bands keep the shape up to the edge of the fracture surface, indicating that it occurred without the material incorporating significant plasticization. The fracture surface contains zinc deposit. Mechanical polishing. Longitudinal section

This same model can explain the initial stage of nucleation of cracks by LMAC from sites where pre-existing imperfections favor the concentration of plastic strain. The multiple nucleation of cracks by LMAC observed in Fig. 6a reinforces this possibility.

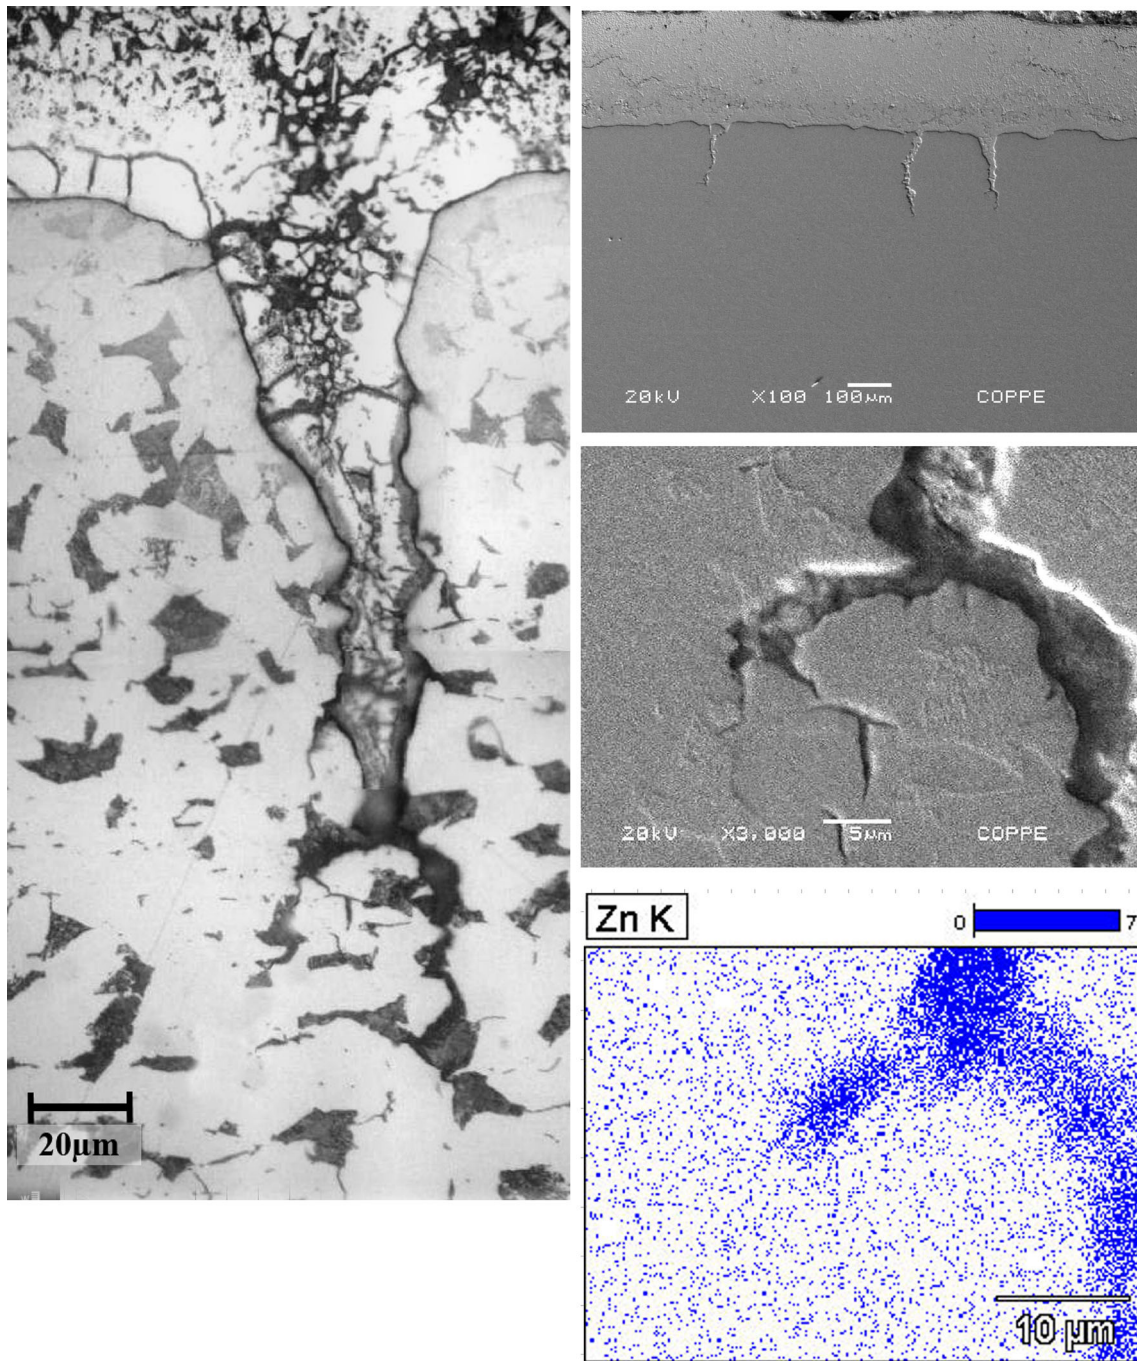
Fig. 7 Microcrack in the flange region and close to the fracture surface. Propagation is intergranular with branching. The opening is large in relation to the depth. Intermetallics are present at the root of the microcrack which denotes a high capacity for infiltration of the liquid through capillarity inside small openings. Mechanical

polishing. Attack by Picral. In B and C images by scanning electron microscopy, in D semi-quantitative chemical analysis by EDS

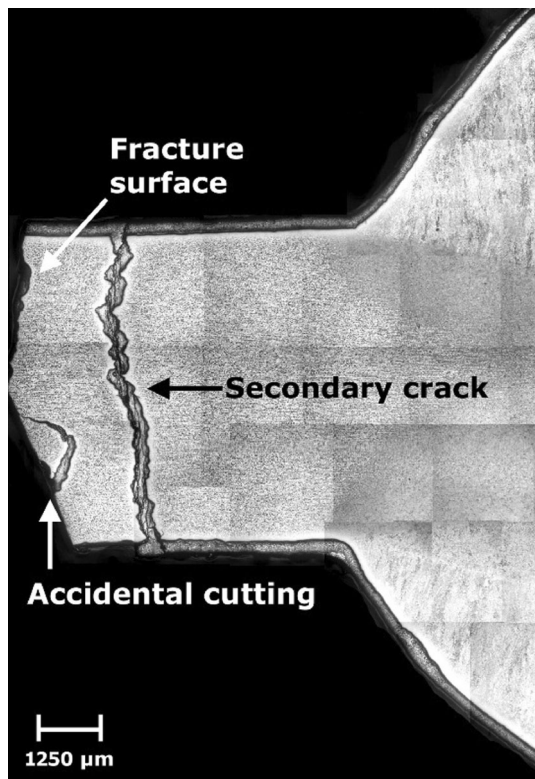
Fig. 8 Fracture surface in the vicinity of the welded fillet joint applied to the web of the broken structural element. It is noteworthy that the fracture surface and the secondary through crack are outside the heat-affected zone and outside the region subjected to the main residual welding stress. Mechanical polishing. Etching: Nital 2%
