# Booster Bearing Failure Reduction Through a Novel Thermodynamic Analysis

Philip Venter · Martin van Eldik

Submitted: 5 May 2021 / in revised form: 19 October 2021 / Accepted: 9 November 2021 / Published online: 2 December 2021  
© The Author(s) 2021

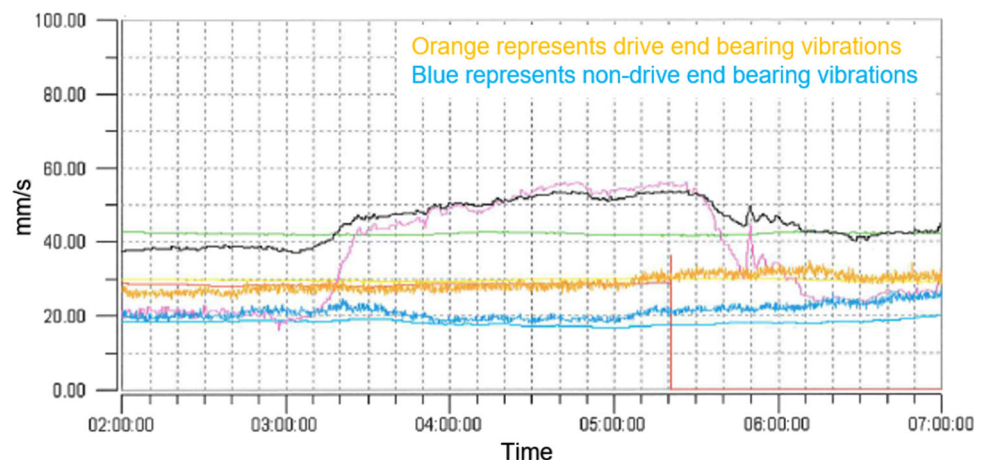
Figure 1 represents a typical condition monitoring graph for one of the boosters under investigation. Vibration measurements are represented by the fluctuating orange and darker blue trend lines for the drive- and non-drive end bearings, respectively. The vibration levels are provided on the y-axis in millimeter per second (mm/s). Time is given on the x-axis from 2:00 AM to 7:00 AM. From plant personnel's experience it follows that the bearings should experience vibration levels closer to 10 [mm/s]; however, historical data show that typical vibration levels around 20 [mm/s] are observed. Note, it is common for the drive end bearing to experience higher vibrations, as depicted on the graph.

After 5:00 AM a slight increase in vibration levels is observed from Fig. 1 for both bearings. It is not uncommon for the bearings to experience slight increases and decreases during normal operations. Important to note, the vibration levels as depicted within this graph were observed over a sufficiently long period of time, where only a few hours are depicted in Fig. 1 for demonstration purposes. Based on the graph and this information, it is not necessarily possible to predict if the bearing will fail in near future, i.e., allowing planned proactive maintenance.

Figures 1 and 2 represent a typical bearing failure where condition monitoring could not have been used to allow for preventative maintenance. Even though the failure was evident from 7:00 AM onward, realistically there was not an opportunity to plan a bearing change.

**Fig. 1** An operational graph indicating high bearing vibrations (orange and blue). (Color figure online)

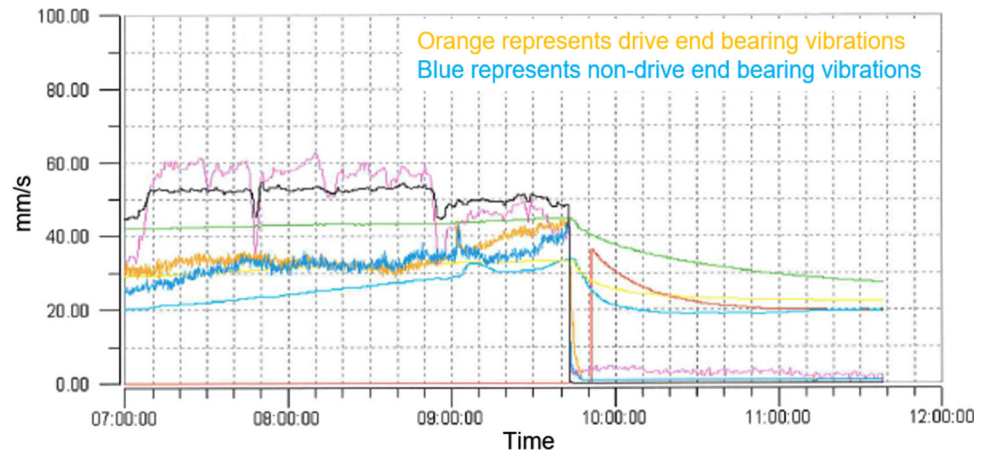
Further increases in the vibration levels can be seen from 7:00 AM onwards as depicted in Fig. 2. A bearing failure is observed (Fig. 2) in the proximity of 9:40 AM,

whereafter the booster tripped. The black line is a representation of the electrical currents drawn by the unit, which can be seen decreasing to zero around 9:40 AM. Note from Fig. 2 how the vibration levels slowly increased prior to the bearing failure over a period of less than three hours.

**Fig. 2** An operational graph indicating high bearing vibrations (orange and blue). (Color figure online)

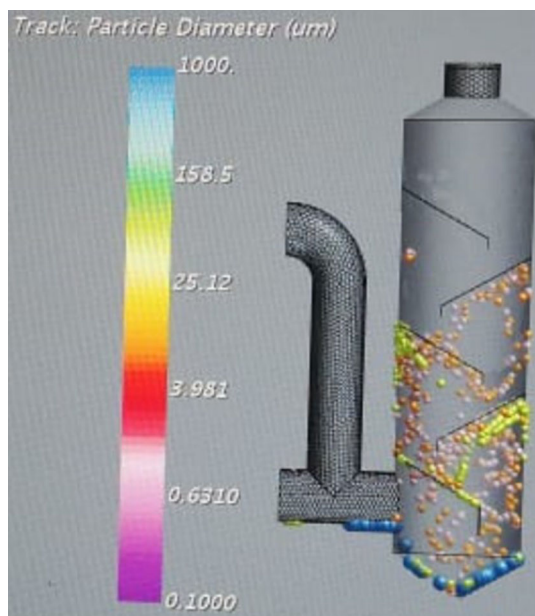
Figure 3 depicts results from a computational fluid dynamics (CFD) simulation that was independently done to demonstrate the extraction of impurities by the designed structure. Due to the demonstrative nature of this figure, only impurities are displayed. Note that none of the exiting flow (vertically upwards) contains impurities. The technicality of this CFD simulation does not fall inside the scope of this paper and will be presented in future work, since it is only provided for demonstrative purposes.

**Fig. 3** A CFD simulation demonstrating the extraction of impurities within the COG during operation

To reduce booster bearing failures, energy wastages and excess NG utilizations, impurities within the COG need to be removed. An innovative solution was developed that entailed the design of an in-line impurity collector. The solution integrates thermal-fluid modelling with structural design. This structure will be referred to as *the collector*. The detail design of this collector, however, falls outside the scope of this paper.

By taking all the decision-making variables into consideration, a specific flow pattern was computed to separate the impurities from the COG. The collector is a vertical structure where COG enters near the bottom and exits on

top. Impurities fall to the bottom and are collected in a seal drum below the collector.
