Failure Analysis of a Welded AISI321 Steel Bleed Air Connector of an Aircraft Engine

Abstract Failure investigation was conducted on a bleed air connector of an aircraft engine that developed an opening during service. The connector was a fabricated tubular structure wherein the flanges were circumferentially welded to a bent pipe on both the ends. The flanges and the pipe were made of austenitic stainless steel AISI 321. Fractography study confirmed that the connector had failed by fatigue mechanism. Fatigue crack had initiated at one of the weld joints. The exact location of the crack initiation was at the weld-to-tube interface. After initiation, the crack had propagated into the pipe resulting in loss of material by fracture. Investigation revealed that the primary cause of fatigue crack initiation in the connector was stress concentration at the weld joint resulting from improper weld joint design. Inferior quality of weld was another factor that contributed to the failure. A detailed analysis of the failure is presented in this article and remedial measures suggested for preventing recurrence of similar failures.

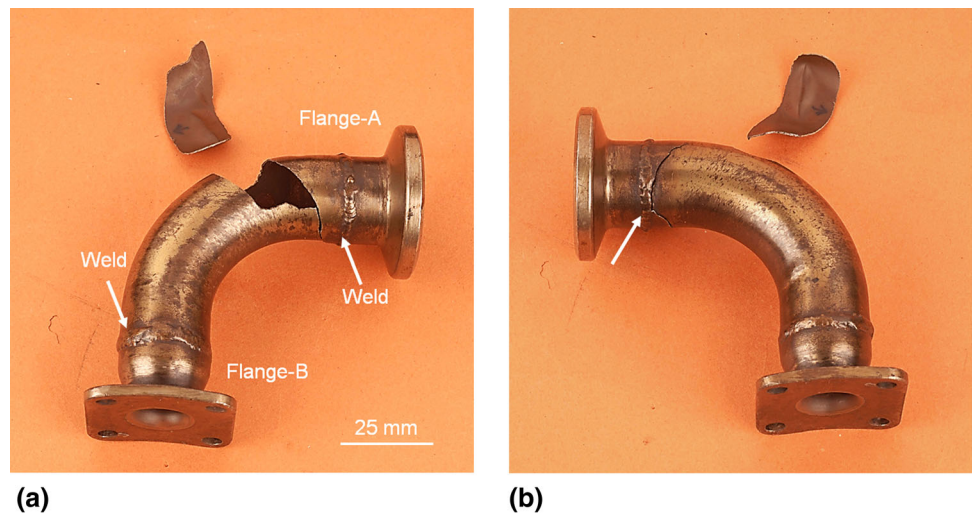
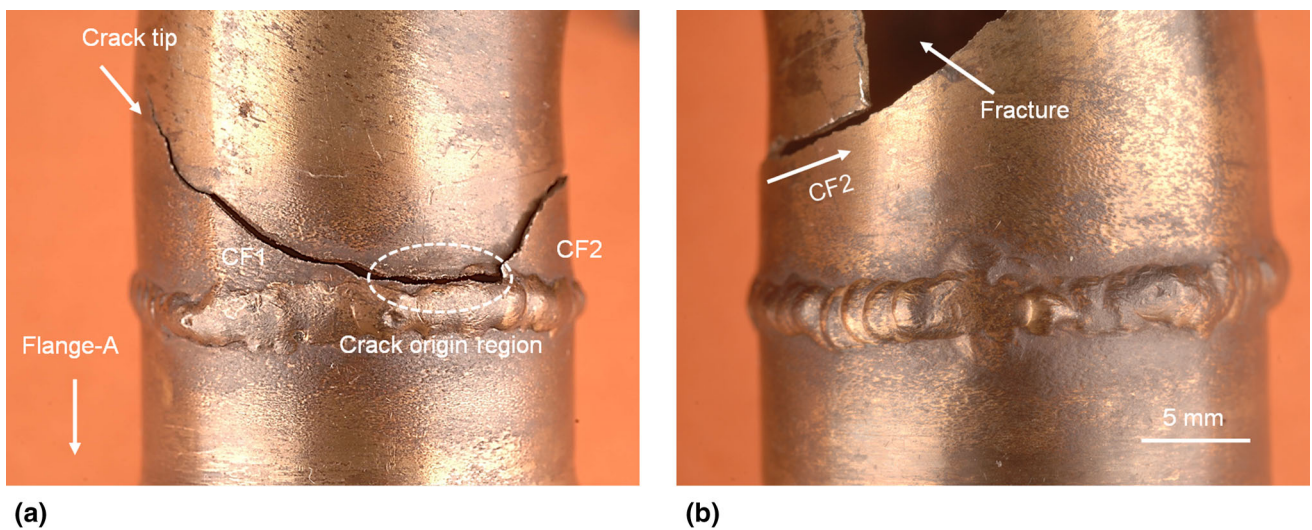
Fig. 1 (a) Fractured bleed air connector and the detached fragment of the pipe, and (b) view of the connector looking from opposite side of that in (a)

The bleed air connector was fabricated by welding two flanges (designated as Flange-A and Flange-B in Fig. 1) to a bent pipe. The connector was found to have developed an opening close to Flange-A due to loss of material by fracture. Fracture occurred on the convex side of the bent pipe and the dislodged fragment exhibited roughly a rectangular shape of approximate size 35 mm × 15 mm.

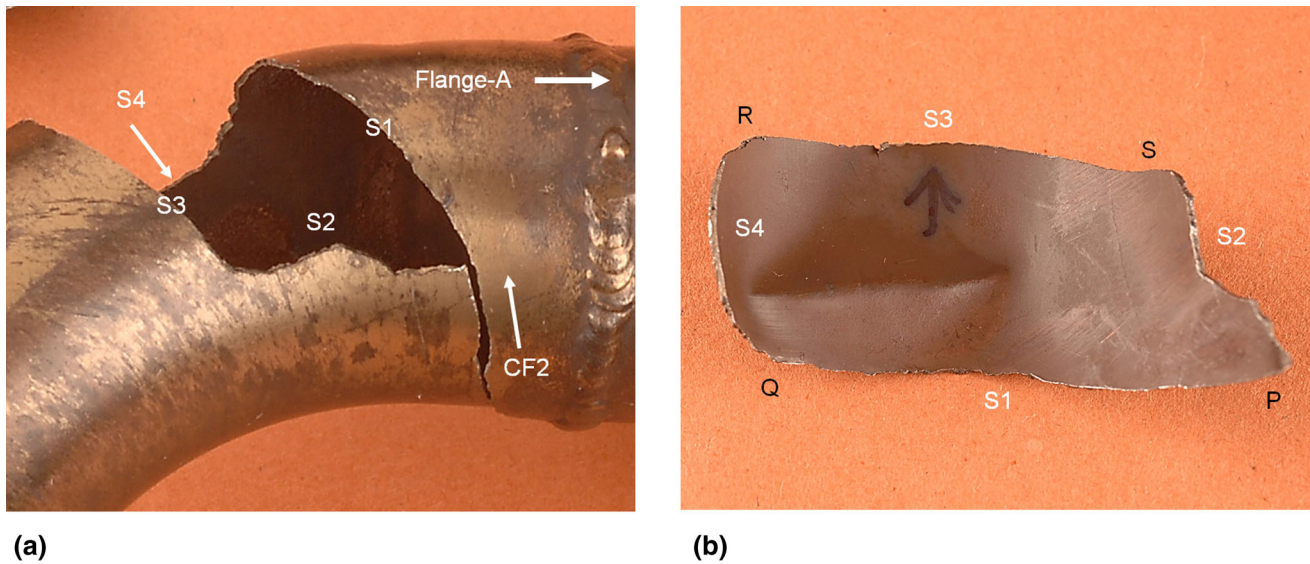
Fig. 3 (a) Identification of fracture surfaces on the pipe of the connector, and (b) corresponding mating fracture surfaces on the fragment looking from the inner surface of the pipe

Figure 2a shows the close-up view of concave side of the connector, diametrically opposite to the fractured region. Examination revealed presence of a U-shaped crack in the pipe; the bottom of the crack being located at the weld. This typical profile of the crack indicated that most probably, the crack had initiated at the weld. It also appeared that after initiation, the crack had propagated on either side of the crack origin (marked as CF1 and CF2 in Fig. 2a). Further, while CF1 was still propagating into the pipe, CF2 culminated in fracture and detachment of a fragment from the pipe (Fig. 2b). Mating fracture surfaces on the pipe and the detached fragment were identified and they are marked S1 through S4 in Fig. 3.

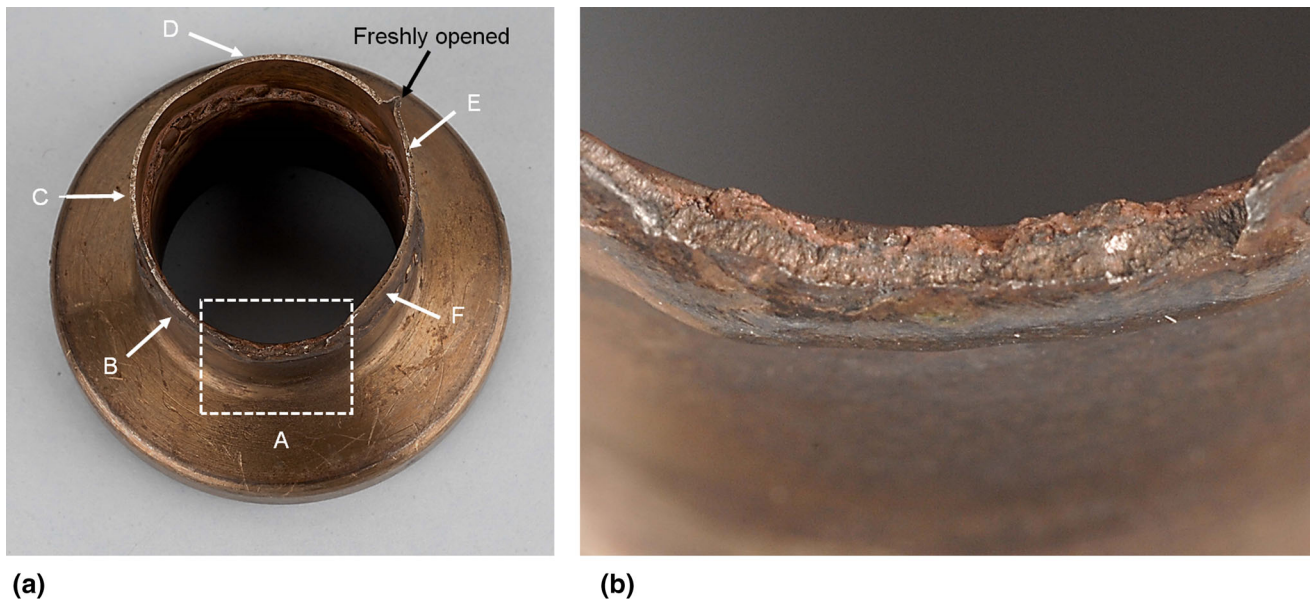
Fig. 4 (a) Fracture surface with Flange-A, and (b) magnified view of the suspected crack origin region marked in (a)

The pipe of the connector was held together with a thin ligament between tip of CF1 and the fracture. In order to examine the fracture surface, the crack shown in Fig. 2 was pulled open and the resulting fracture surface with Flange-A is shown in Fig. 4a. Probable location of crack origin region has been marked as ‘A’ in Fig. 4a and close-up view of the same is shown in Fig. 4b. At this region, fracture occurred in the weld and the surface was uneven in nature. The rest of the fracture surface had a flat and relatively smooth appearance.

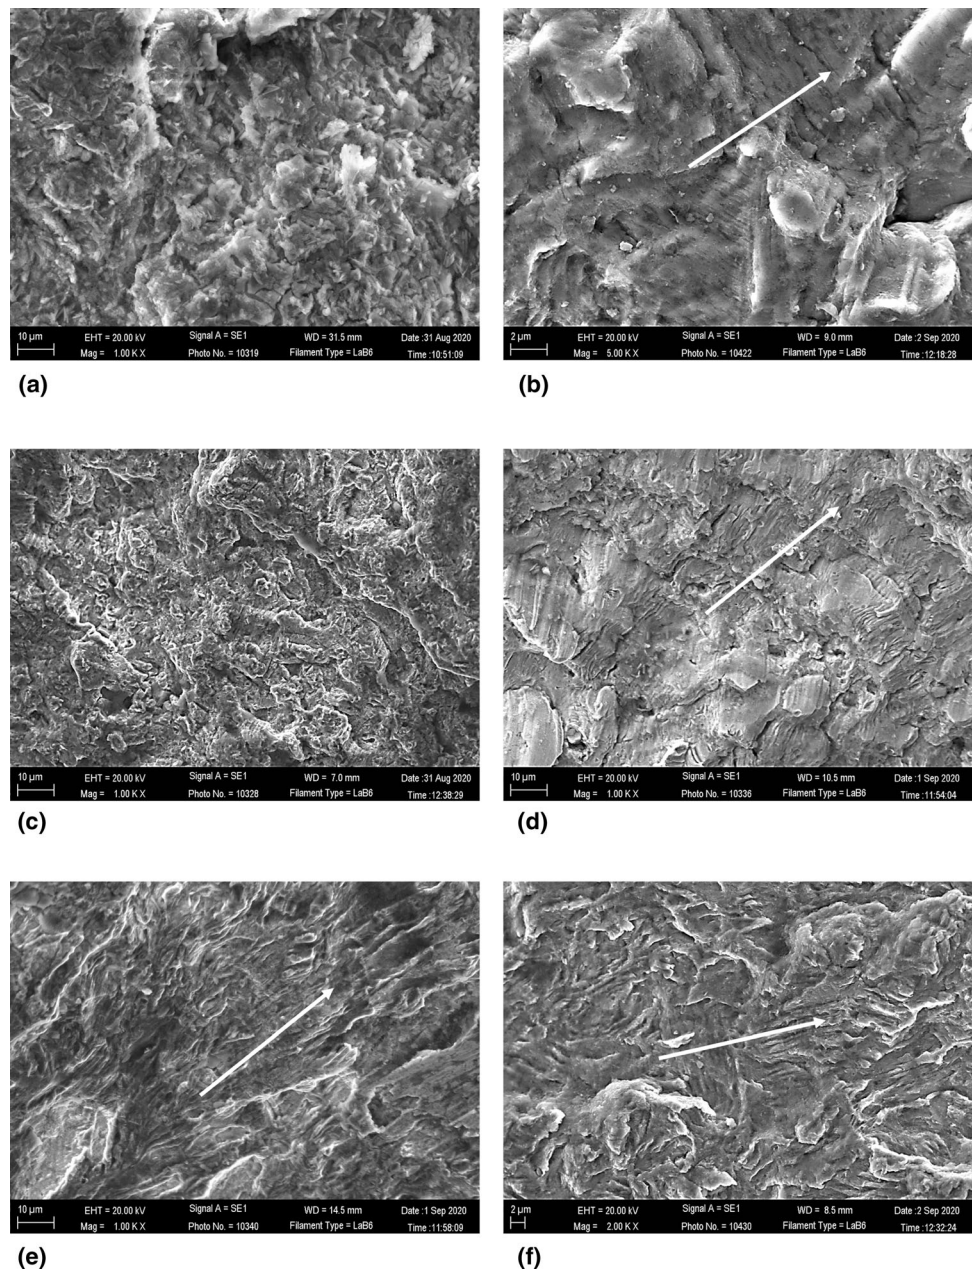
Fig. 5 (a–f) Secondary electron (SE) fractographs recorded on the regions marked ‘A’ through ‘F’ respectively in Fig. 4a showing crack arrest marks or beach marks and fatigue striations; crack propagation directions shown by arrows

The entire fracture surface with Flange-A was examined under a scanning electron microscope (SEM) for identification of the crack origin and mode of crack propagation. Figure 5 shows the fractographs at locations marked ‘A’ through ‘F’ in Fig. 4a. Micro fractographic features on the fracture surface were found mostly obliterated either due to

oxidation or rubbing between the mating crack surfaces. However, in isolated places, fracture features were relatively preserved, and examination of these regions confirmed fatigue mode of crack propagation; evident from the presence of crack arrest marks or beach marks and striations (Fig. 5). From the orientation of the crack arrest marks/striations, local crack propagation directions could be identified, and these have been marked by arrows on the fractographs. On superimposition of these directions on the fracture surface in Fig. 4a, it was established that on the left, crack propagation was along $A \rightarrow B \rightarrow C \rightarrow D$ and on the right, it was along $A \rightarrow F \rightarrow E$. This also confirms fatigue crack initiation at the weld region shown in Fig. 4b. Fractography studies were also conducted on the detached fragment of the pipe (Fig. 3b). Fractographs recorded on all four sides of the fragment are shown in Fig. 6 and 7.

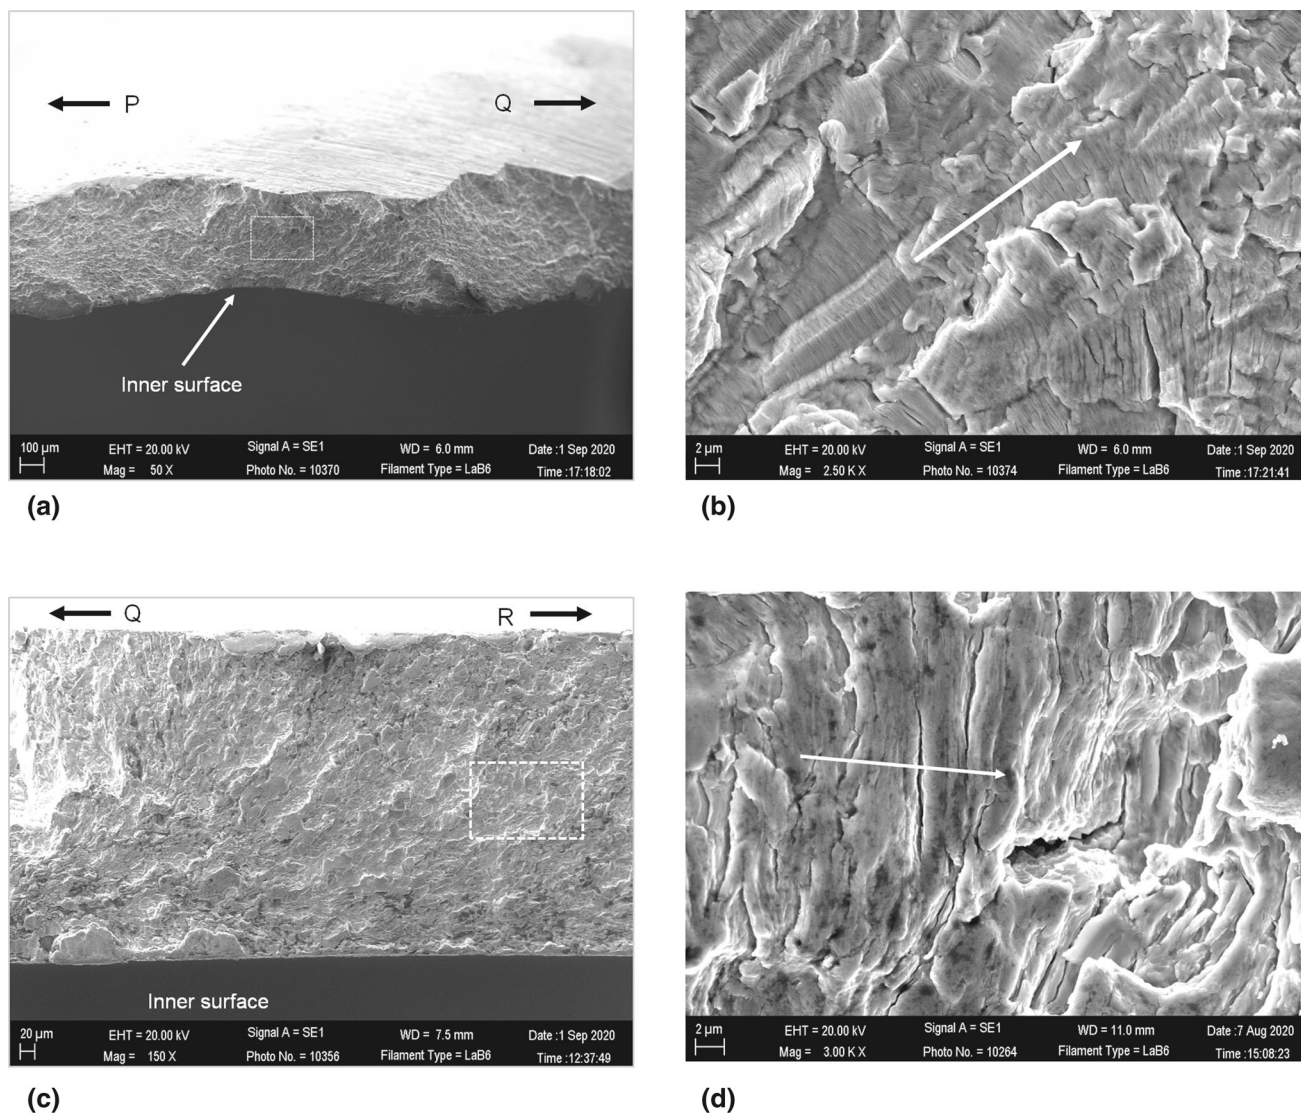
Fig. 6 SE fractographs recorded on the adjacent sides S1 (a–b) and S4 (c–d) respectively (Fig. 3b) showing crack arrest marks/beach marks, fatigue striations and local crack propagation directions; (b) and (d) magnified views of the regions marked in (a) and (c) respectively

propagating cracks, one along P → Q → R (Fig. 6) and the other along P → S → R (Fig. 7).

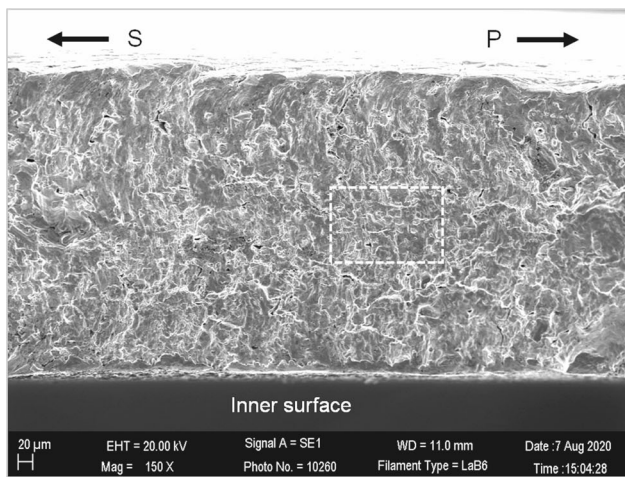
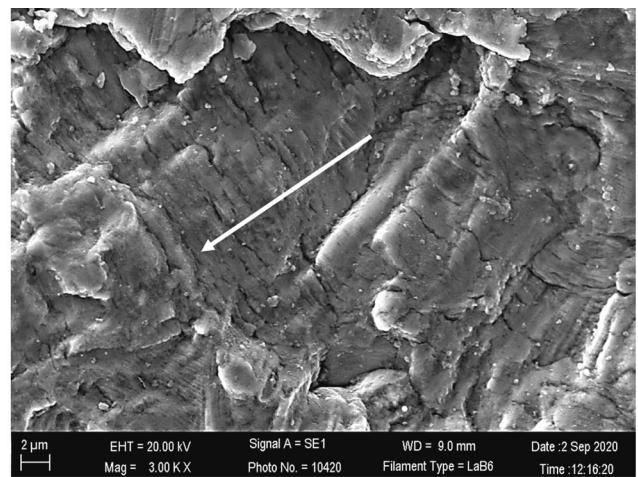
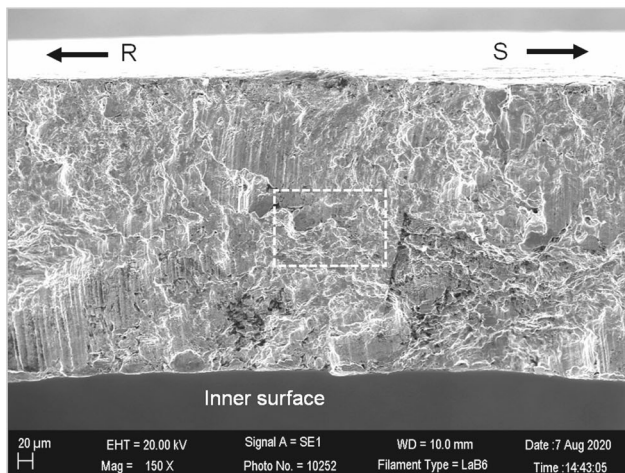
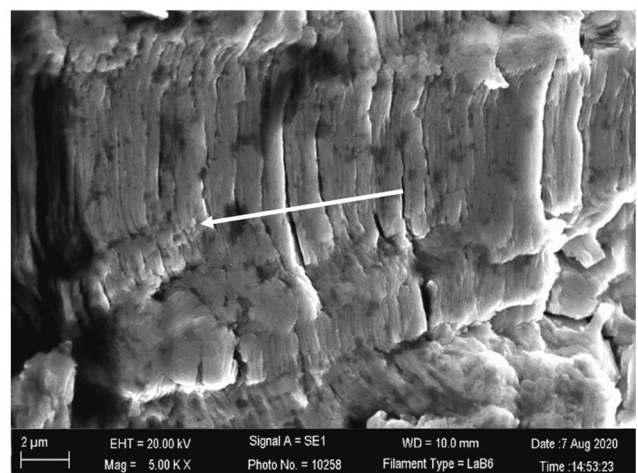
Fig. 7 SE fractographs recorded on the adjacent sides S2 (a–b) and S3 (c–d) respectively (Fig. 3b) showing crack arrest marks/beach marks, fatigue striations and local crack propagation directions; (b) and (d) magnified views of the regions marked in (a) and (c) respectively

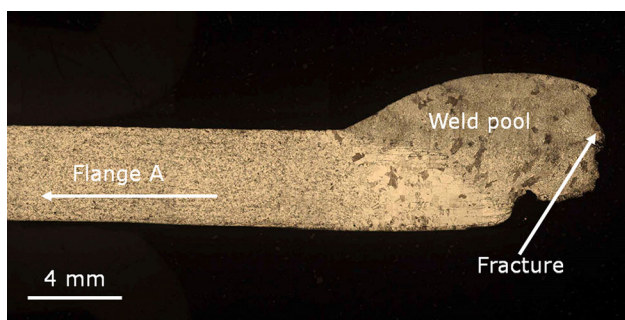
Fig. 8 Optical micrograph of a longitudinal section of the connector through fatigue crack origin showing fracture in the weld

Figure 8 shows longitudinal section of the connector through the crack origin region. The micrograph confirms initiation of fatigue crack in the weld pool. Figure 9 shows another longitudinal section of the connector containing flange-A, weld and pipe. The tubular section of the flange was joined with the pipe by butt welding. At the joint, wall-thicknesses of the flange and the pipe were approximately 4.2 mm and 1.4 mm respectively. Welding was performed in two passes. Examination revealed misplaced weld with inadequate fusion with flange-A, and excess weld penetration and fusion with the pipe.

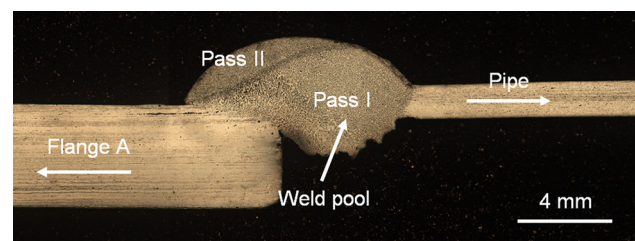
Fig. 9 Optical micrograph of a longitudinal section of the connector containing Flange-A, weld, and pipe showing misplaced weld and excess fusion zone and weld penetration

stress concentrator at the joint arising from sudden change in geometry/dimensions (Fig. 9). Therefore, the fatigue strength of the joint reduces significantly rendering it extremely susceptible to fatigue failure [9]. When such welded structures are superimposed with assembly stresses and vibration/cyclic load, which are inevitable in the

Metallography study showed that the weld joint between the flange and pipe of the connector was inferior in quality. The weld was misplaced resulting in inadequate fusion with the flange, and there were also defects in the form of excess weld penetration and fusion in the pipe. As a result, there was undesirable weld profile at the joint resulting in severe stress concentration (Fig. 9).

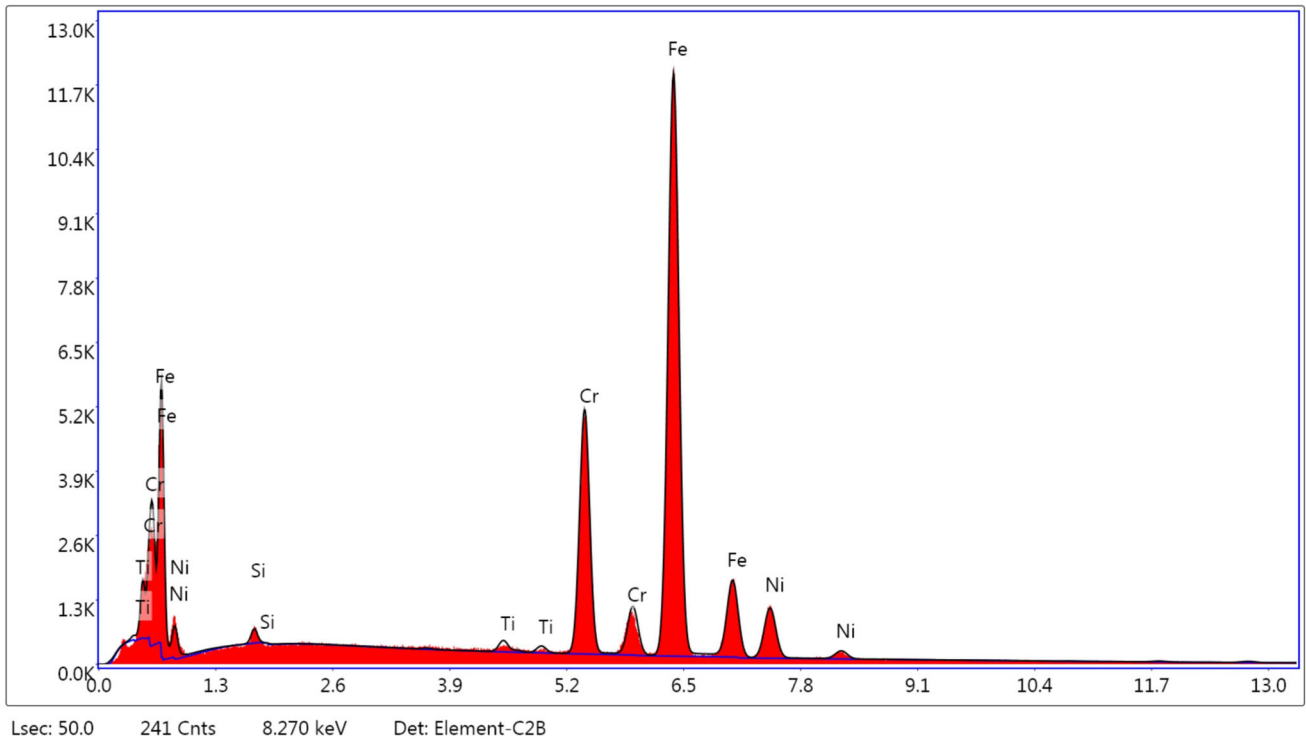
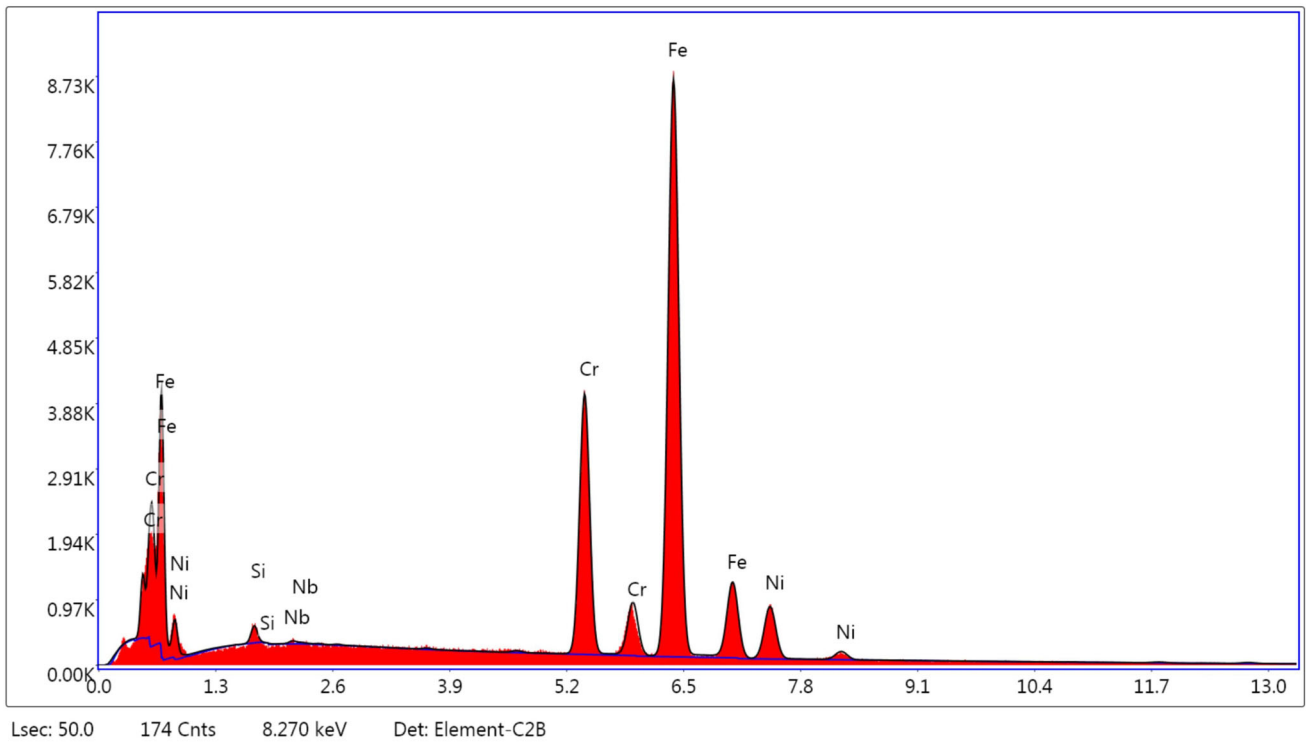
Chemical composition of material of construction of the connector was determined by EDX analyser on metallographically prepared specimens. The EDX results are given in Table 1. The EDX spectrums from the pipe and weld material are shown in Fig. 10a and b respectively. Results showed that the flange and the pipe were made of austenitic stainless steel of specification AISI 321. The composition of the weld was found conforming to AISI 347 stainless steel.

Fig. 10 EDX spectrums recorded on the (a) pipe and (b) weld region of the bleed air connector

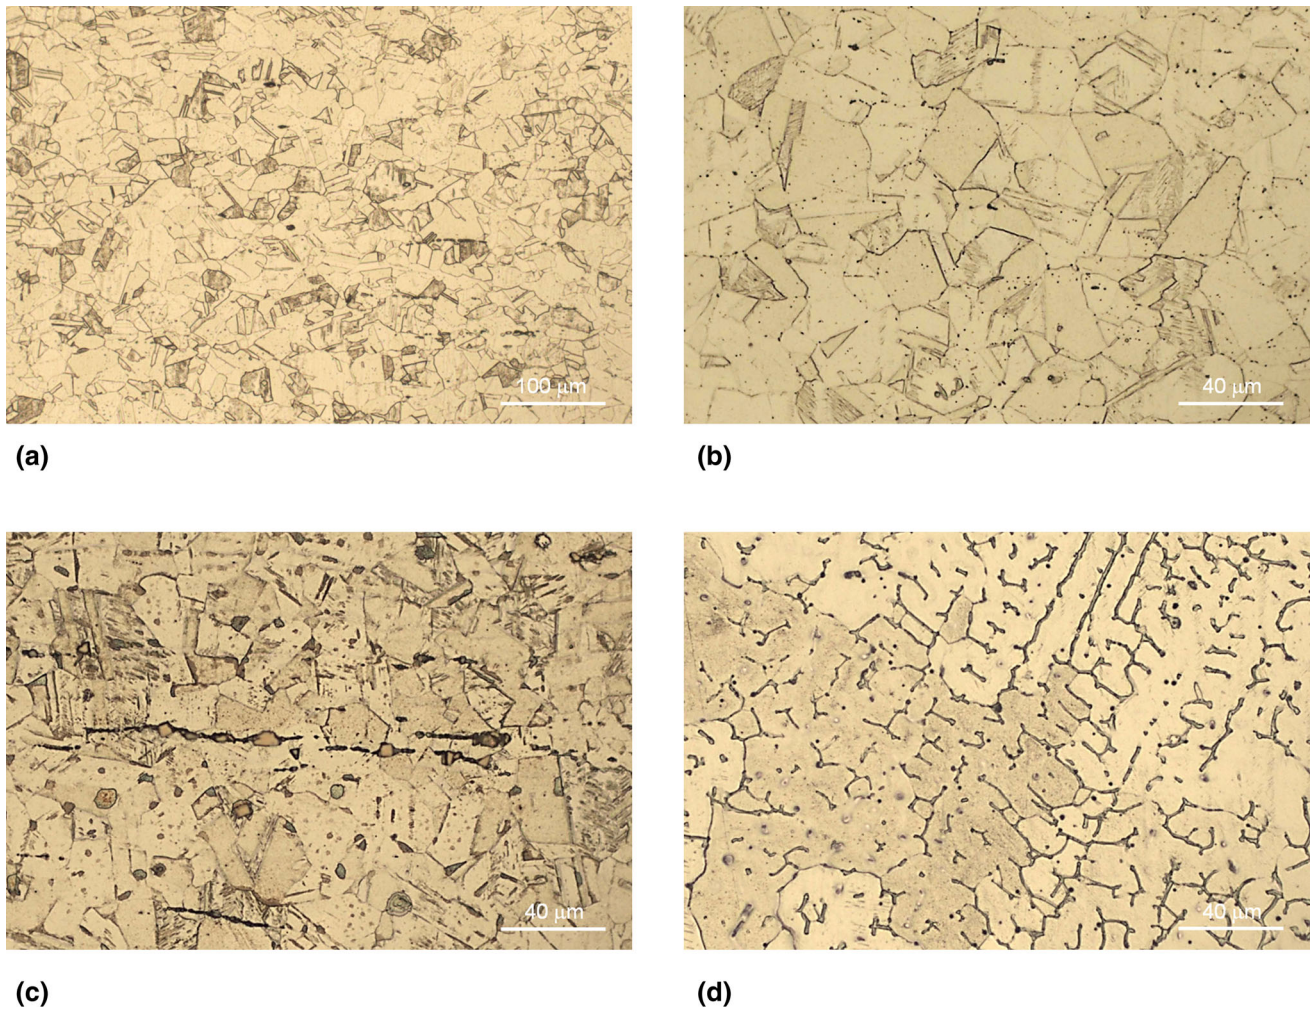
Figure 11 shows microstructures of the flange, pipe, and the weld. Microstructures of flange and pipe consisted of twinned austenite grains, typical of wrought AISI 321 steel (Fig. 11a–c). The weld pool showed presence of dendritic structure, typical of molten and solidified material (Fig. 11d). The weld structure did not show presence of any weld defects such as porosity/voids or deleterious phases. Metallurgically, no deficiencies were observed in the microstructures of flange, pipe, and weld.

Fig. 11 Optical microstructures of material of construction of flange, pipe, and weld: (a–b) flange, (c) pipe, and (d) weld

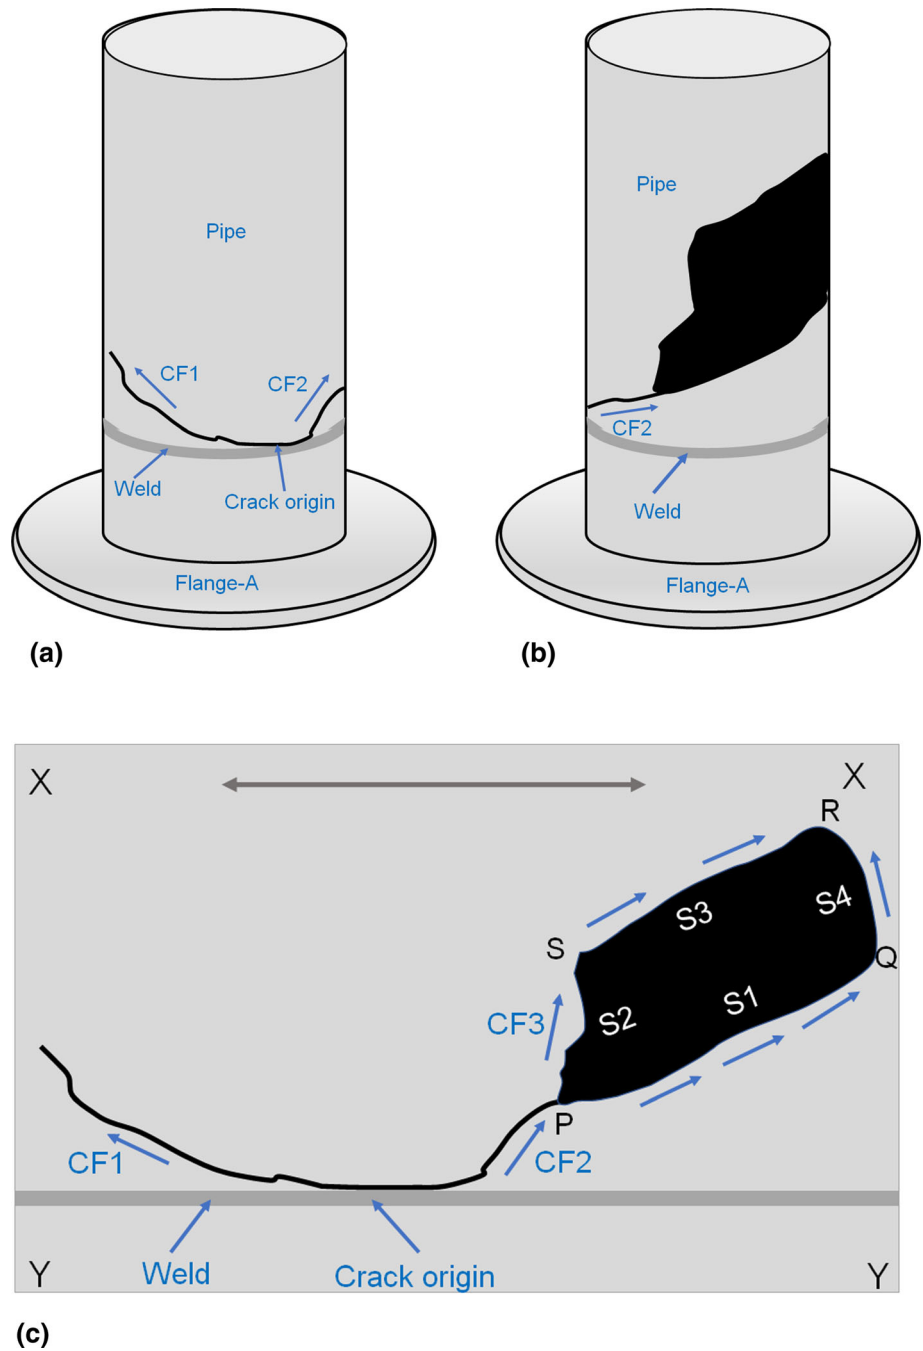
Entire process of crack initiation, propagation, and fracture in the connector has been explained through schematics in Fig. 12. Fracture analysis showed that the bleed air connector has failed by fatigue mechanism. A fatigue crack had initiated at the weld between Flange-A and the pipe. After initiation, the crack had propagated through the thickness of the weld giving rise to two crack fronts. Subsequently, these two crack fronts (CF1 and CF2) had propagated into the pipe in opposite directions (Fig. 12a). The fracture and detachment of a fragment from the pipe was associated with CF2 (Fig. 12b). At some point in time during propagation of the cracks CF1 and CF2, another crack had initiated from propagating CF2 at location P (Fig. 12c). After initiation, the new crack, designated as ‘CF3’, had propagated along the axis of the pipe, marked as fracture plane S2. After propagating to certain distances, CF2 and CF3 had deviated their paths along fracture planes S4 and S3 respectively and formed a close loop leading to fracture and loss of a fragment from the pipe of the connector.

Fig. 12 Schematics showing (a) crack initiation at the weld joint, (b) extension of crack leading to fracture in the pipe, and (c) representation of crack initiation, propagation, and fracture on the cylindrical surface of the pipe

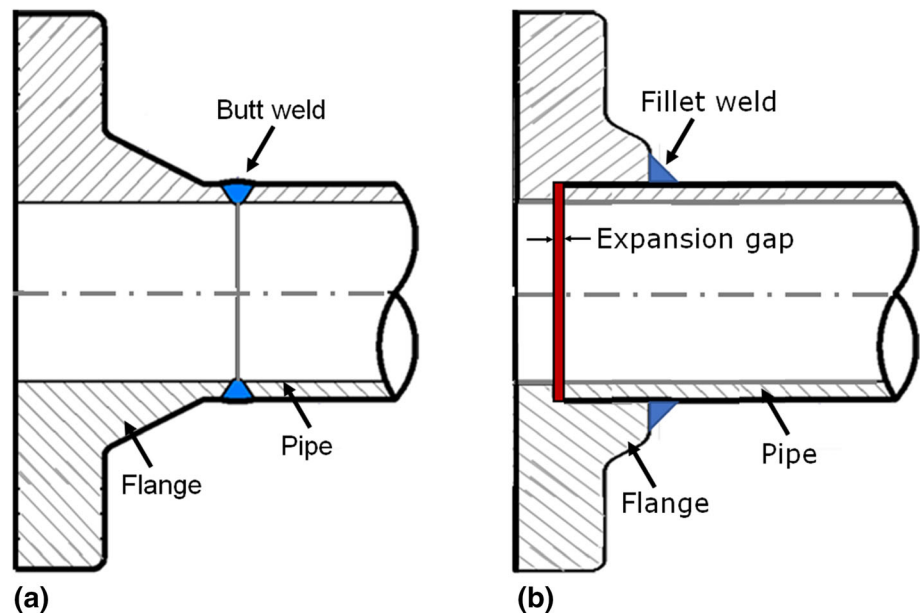
Fig. 13 Recommended practices for joining of flange and pipe having wide difference in thickness: (a) butt weld, and (b) fillet weld

present application, the vulnerability of failure by fatigue mechanism increases many folds. To overcome this problem, the recommended practice for butt welding of two parts with a wide difference in thickness, has been beveling of the thicker part so that the slope of the surface from one part to the other is not steep. In accordance with this, the recommended fabrication scheme for bleed air connector is as shown in Fig. 13a. If not practicable, the alternative scheme is as shown in Fig. 13b.
