Fan Blade Fatigue Fractures in CFM56-7B Engines

M. R. Fox · W. R. Rossey Jr. · M. Raguet

Abstract The National Transportation Safety Board investigated two accidents involving fan blade fatigue fractures in CFM International CFM56-7B engines. Fatigue cracks developed in the Ti-6Al-4V blades in an area of high contact stresses in the dovetail. Additional cracked blades were found using nondestructive inspections developed after the first accident. Although the blades had been shot peened, many of the blades had relaxed compressive residual stress profiles at the surface, making them more susceptible to fatigue crack initiation under the combined effects of loading/friction changes over time, coating condition, surface condition, and engine operational differences. Flight cycle estimates based on striation counting on the fracture surfaces revealed that blades with normal residual stress profiles had been overhauled after cracks had initiated, masking the original surface condition. As a result of investigation findings, new procedures were developed, including more frequent dovetail lubrications, improved visual inspection procedures, and new ultrasonic testing and eddy current pr

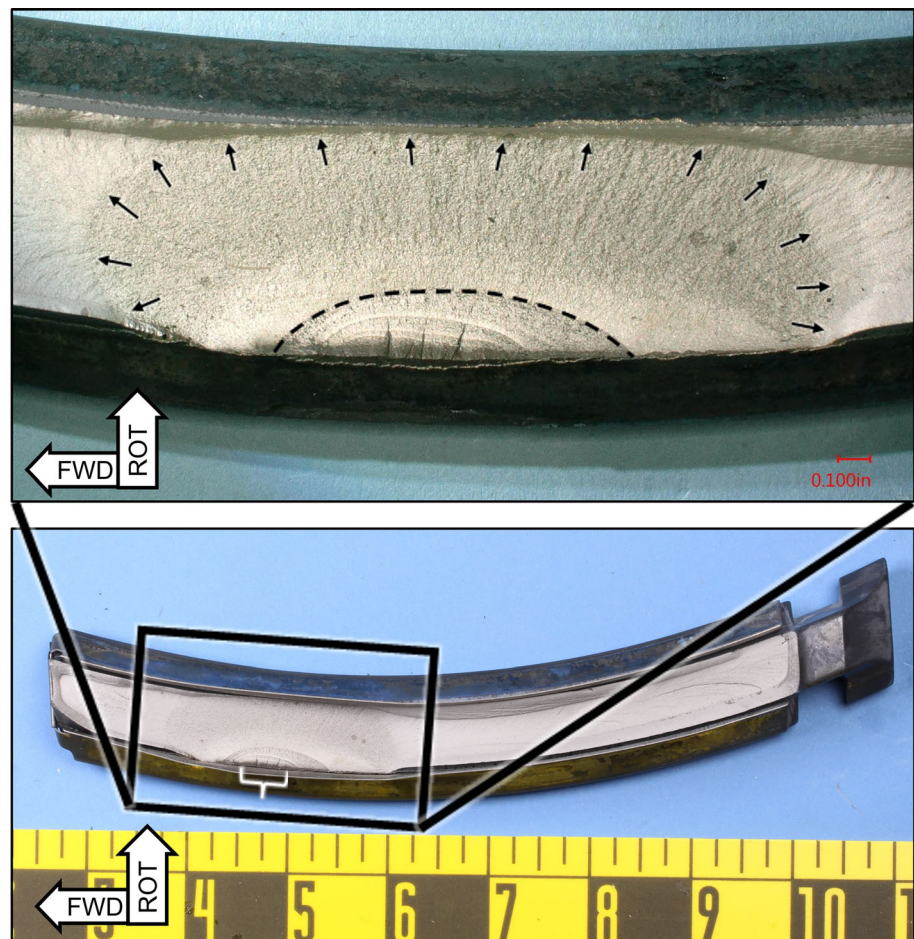
The fracture surface on the dovetail piece from blade 23 had indications of a progressive crack that existed before fracture (Fig. 3). A portion of the fracture surface

intersected the dovetail surface at a 90-degree angle and had a curving boundary, features consistent with a progressive fracture mechanism in ductile materials. Unlabeled arrows in the upper image in Fig. 3 indicate the extent of progressive crack growth, which measured up to 2.28 in (57.8 mm) axially and 0.695 in (17.7 mm) deep. The remainder of the fracture surface had matte gray fracture features with prominent shear lips along the edges, features consistent with ductile overstress fracture.

Within the progressive crack growth region, four crack arrest lines were identified in the region bounded by the dashed line in Fig. 3. Ratchet marks were also observed, indicating the crack had initiated from multiple origins along the convex side of the dovetail near the dovetail leading edge. The crack arrest lines were numbered sequentially starting with the line closest to the origin (Fig. 4). The region measured 1.14 in (29.0 mm) long axially at the dovetail surface and extended up to 0.217 in (5.51 mm) deep as measured projected on a plane parallel to the root end face.

Fig. 3 Dovetail for fan blade 23 showing the fracture surface. Unlabeled arrows indicate the extent of progressive crack propagation, and a dashed line indicates the location of the last crack arrest line associated with well-defined fatigue crack striations. A bracket indicates the fatigue origin area at the convex side of the dovetail. (Ruler in inches.)

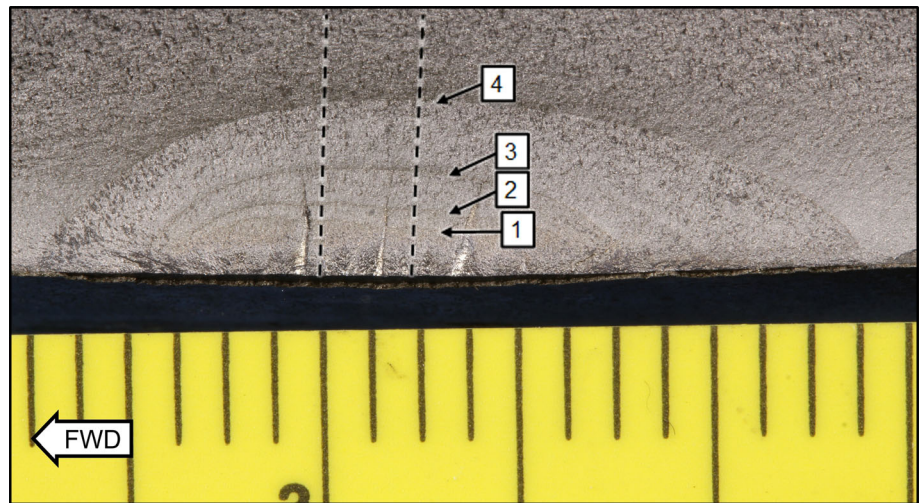
Fig. 4 Fatigue origin area on blade 23. Numbered call-outs indicate locations of crack arrest lines, and dashed lines indicate paths where fatigue striation densities were measured. (Ruler has 1/16-inch increments.)

In the next stage of the SEM examination, the fatigue striation linear density was measured at locations across the fracture surface along two separate paths (Fig. 4). At each location, the distance in the fracture plane from the dovetail surface was recorded, and an image was taken at a resolution sufficient to resolve approximately 10 to 20 sequential striations within the image frame. The striation linear density, ρ , in terms of number intersected per unit length in the direction of crack growth for that image was then determined using the following equation,

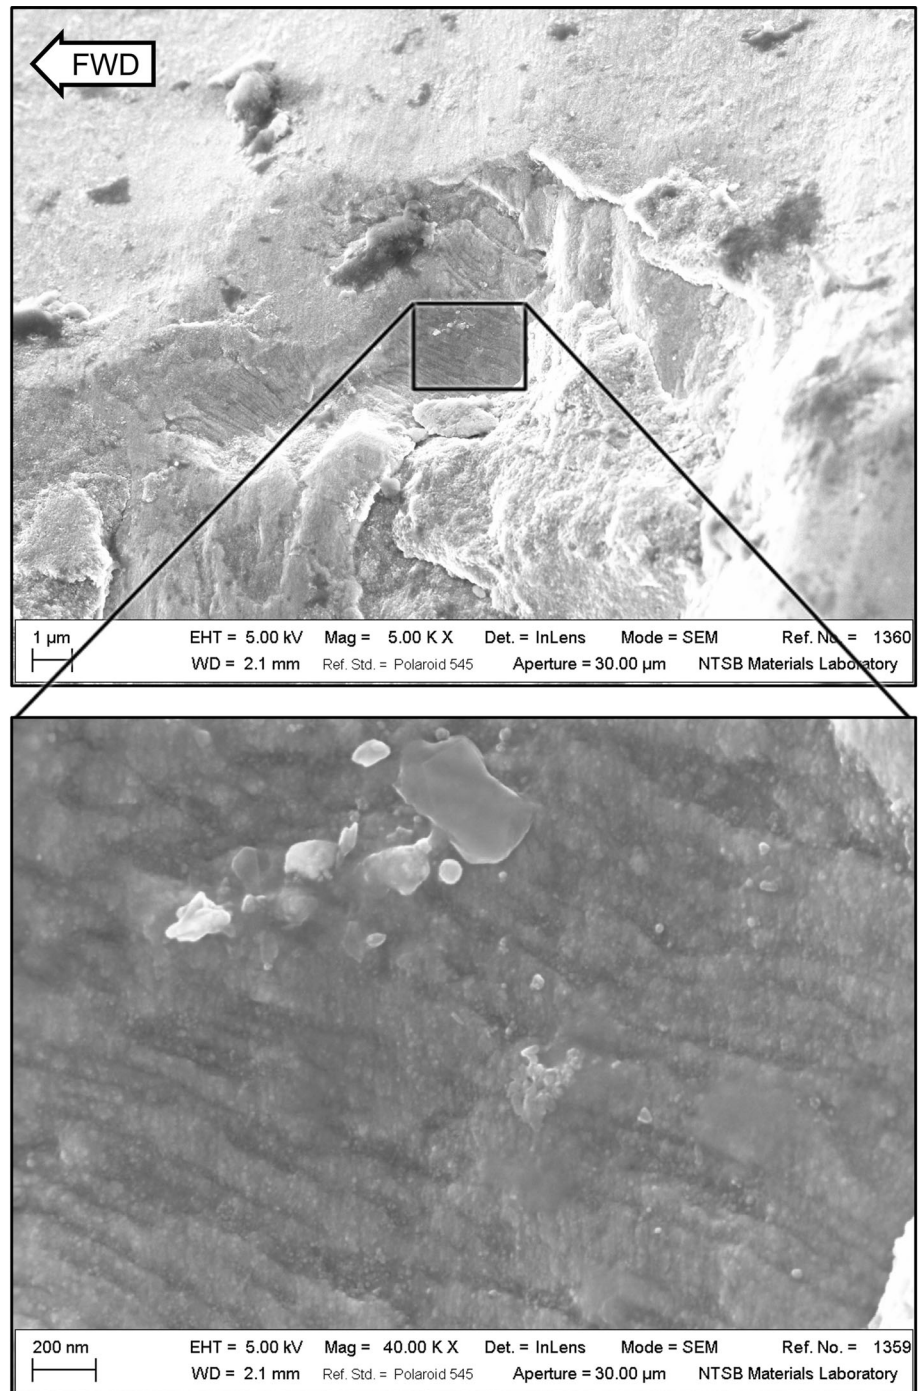
Fig. 5 Typical fatigue striations observed at 208 micrometers from the convex dovetail surface

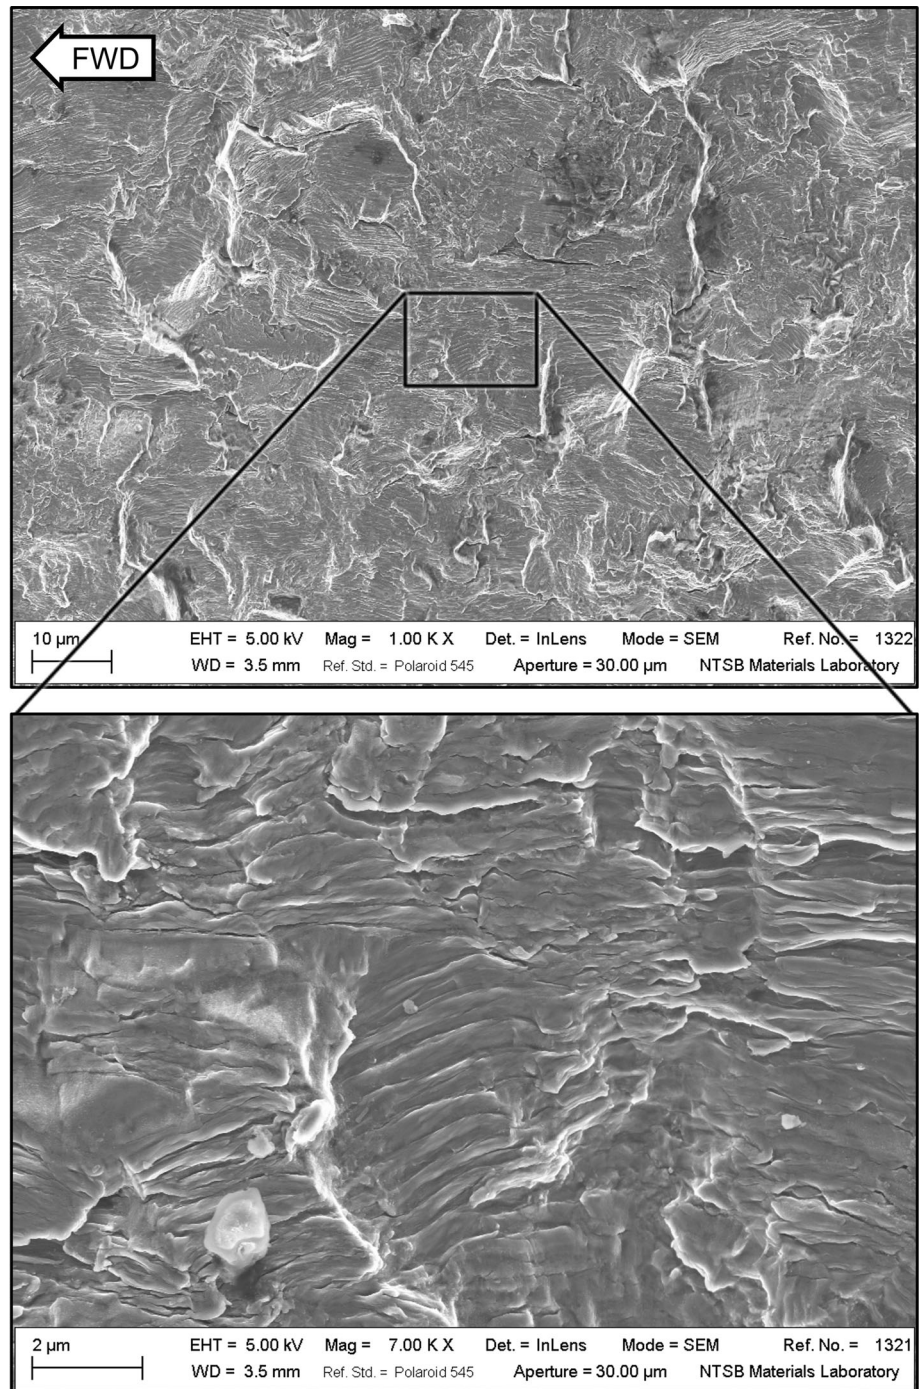
Fig. 6 Typical fatigue striations observed at 2.49 millimeters from the origin.

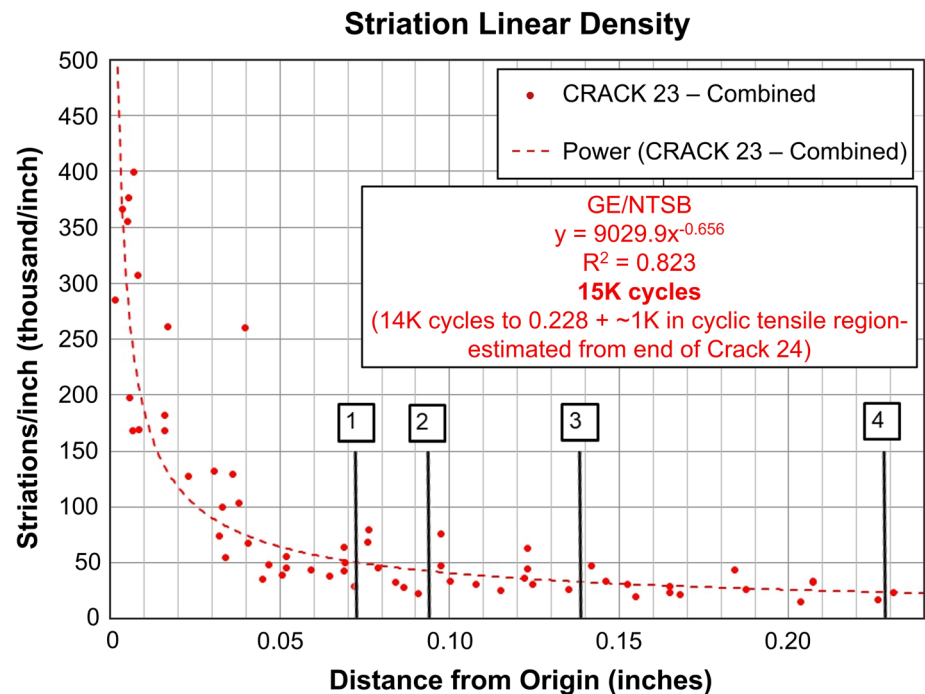
Fig. 7 Striation linear density data collected from the SEM examination of the blade 23 fracture surface. Locations of crack arrest lines are indicated, and the equation for the curve fit to the data is shown.

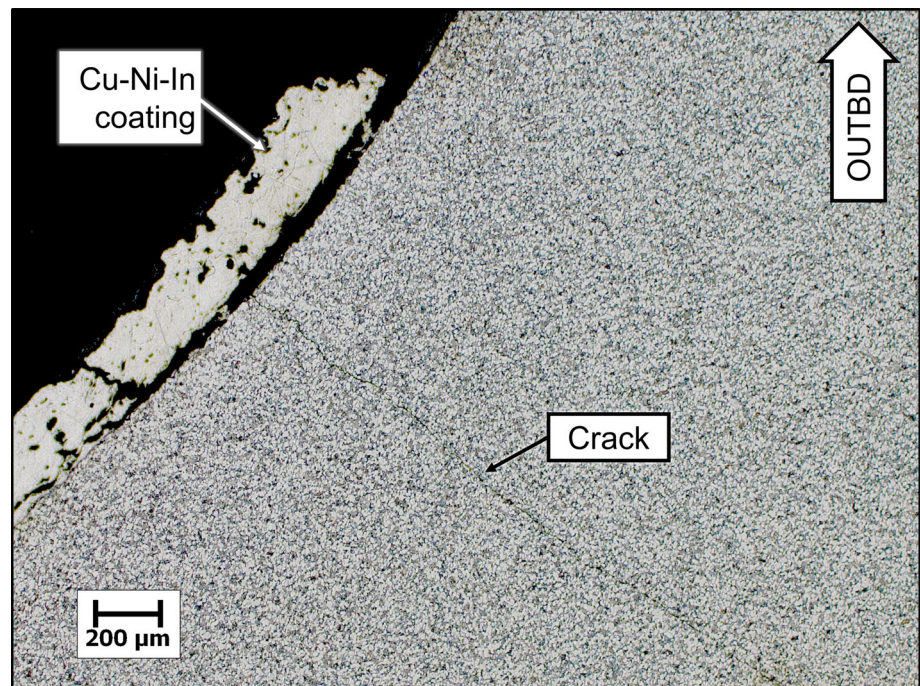
cracks emanating from the grit-blasted surface of the dovetail in an area that was covered by the intact dovetail coating (Fig. 8). The etched microstructure appeared uniform with an even mix of alpha and alpha plus beta grains as expected for the specified material. No surface anomalies such as distorted grains or alpha case were observed on the surfaces.

Fig. 8 Micrograph of the blade 24 cross section through the dovetail showing a crack emanating from the convex dovetail surface under the dovetail coating. Etched with Kroll's reagent

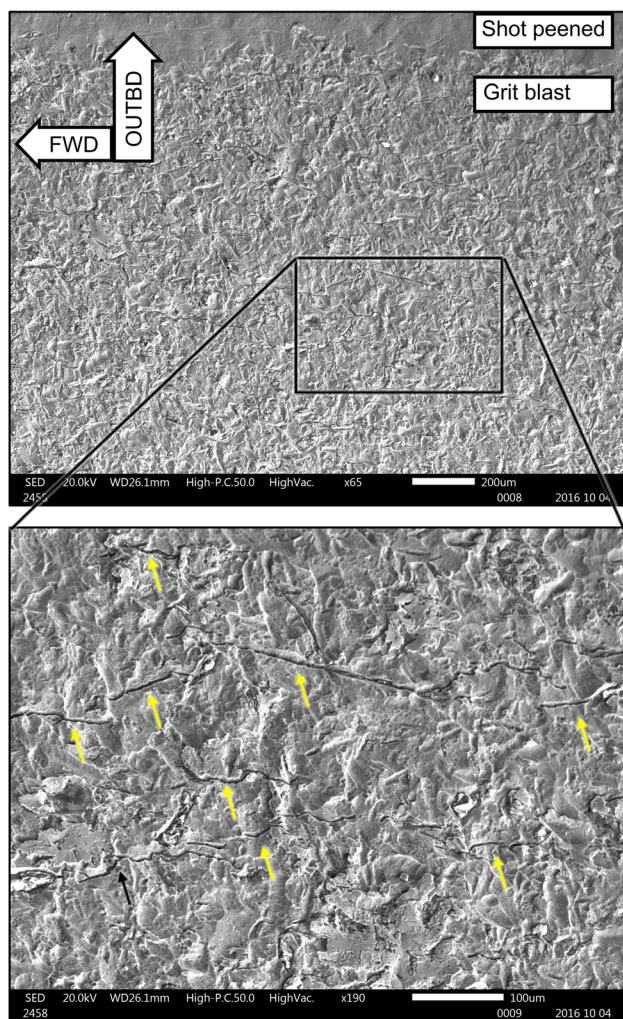
Fig. 9 Network of parallel microcracks (indicated by yellow arrows) observed on the grit-blasted surface of a blade with an intact dovetail after the dovetail coating was removed. No cracks were detected by NDI

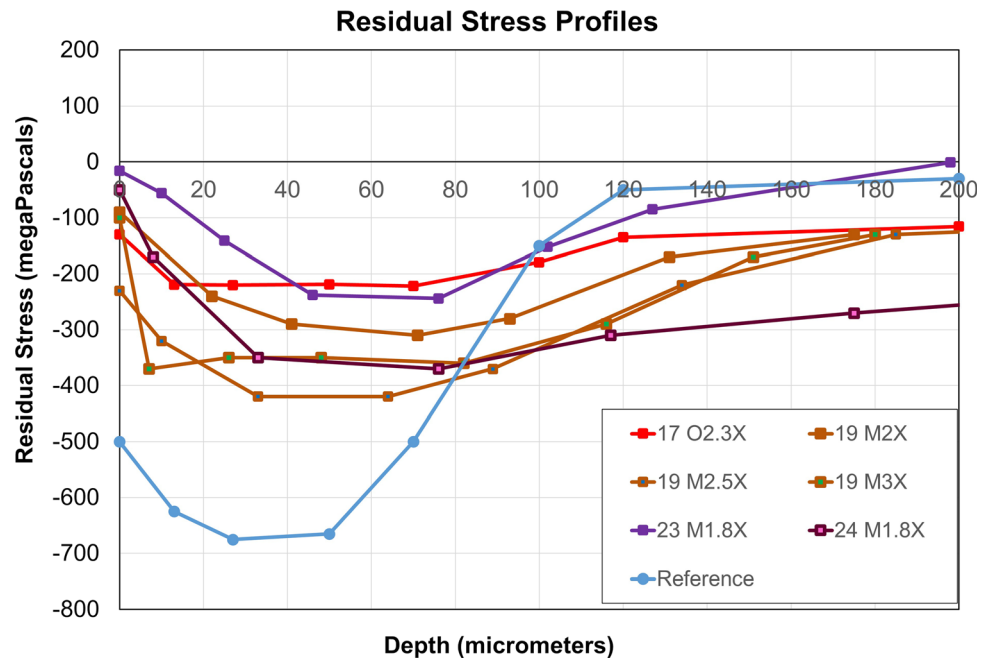
Residual stress profiles were measured on six of the first seven cracked blades found during inspections. Three of the blades had residual stress profiles with a peak compressive stress that was less compressive than the reference profile. The remaining blades with normal profiles and the untested blade had been overhauled in the time since the cracks had initiated.

Fig. 10 Residual stress profiles of fractured and cracked blades measured on the convex side near the area of cracking. The blue line shows a reference profile of a shot-peened surface for comparison

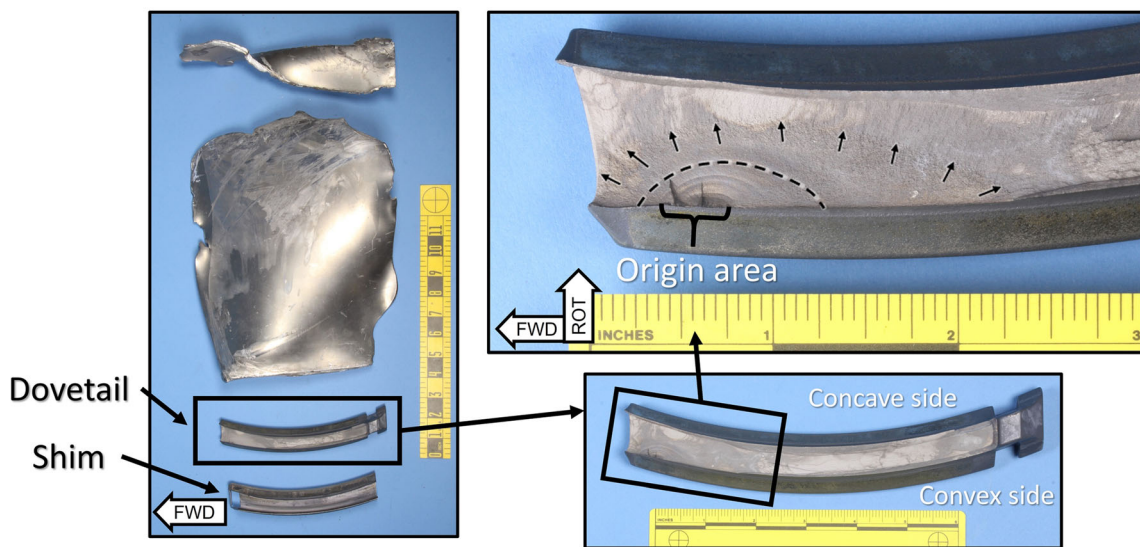
multiple origins were located at the convex contact face but further forward near the leading edge (Fig. 11). SEM examination of the fracture surface confirmed the fracture features were consistent with LCF. Six crack arrest lines were identified on the fracture surface, and striation count estimates between crack arrest lines corresponded closely with the flight cycles associated with the relubrication intervals. The total number of flight cycles associated with crack growth from 12.7 μm (0.0005 in) to fracture was approximately 20,000 cycles.

Fig. 11 Overall view of the blade 13 fracture from the 2018 accident (left image) with closer views of the fracture surface on the dovetail (right images). Arrows in the upper right image indicate the extent of

progressive crack propagation, and a dashed line indicates the last of 6 crack arrest lines
