# The Synergy Between Corrosion and Fatigue: Failure Analysis of an Aerator and a Cooling Tower

Luciano da Rocha Magalhães · Rodrigo Freitas da Silva Alvarenga · Flávio Augusto Coelho Resende · Leonardo Rosa Ribeiro da Silva

**Abstract** Corroded points can act as stress concentrators, usually resulting in the component failure at fewer cycles than was initially projected. Aerators are widely used in waste treatment units for chemical and biological control. Due to the chemically aggressive environment to which these components are subjected, they usually fail due to corrosion in one or more components. Cooling towers are one of the most applied equipment for temperature control in industrial processes. Due to generally hostile environments and operating conditions, this equipment is subject to failures which almost always lead to system imbalance followed by the catastrophic failure of the component. This work investigates the synergic effect of corrosion and fatigue in two separate case studies. In the first, the wear of the mixing shaft of an aerator was investigated. It was observed that the root cause of wear was the corrosion of the dissimilar welded joints in the mixing bl

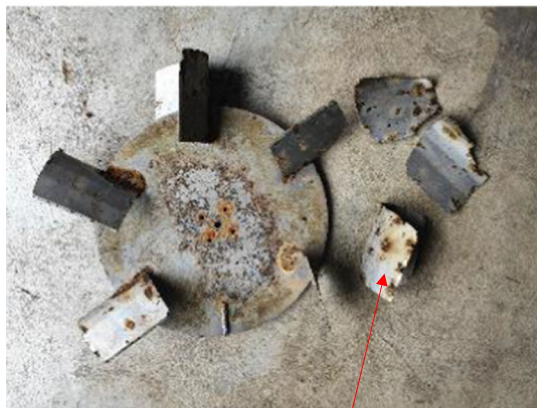
**Fig. 4** Mixer plate highlighting the blades that were already broken and the advanced corrosion in the welded joint

broken blades

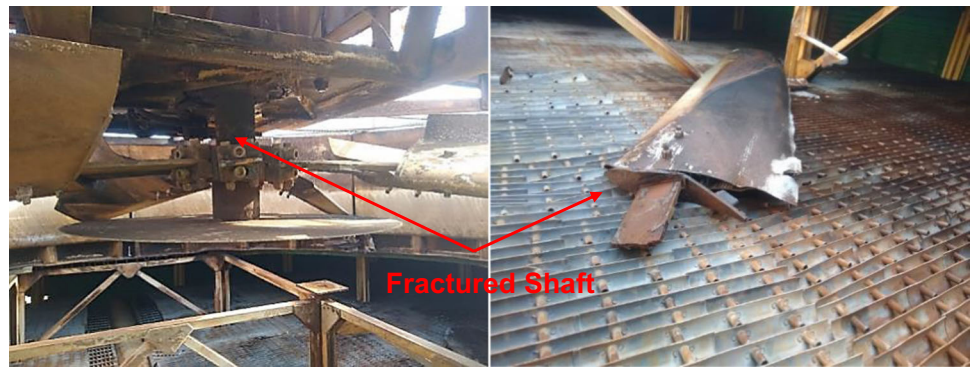
**Fig. 9** Photographs of assembled propellers (left) and fractured components (right)

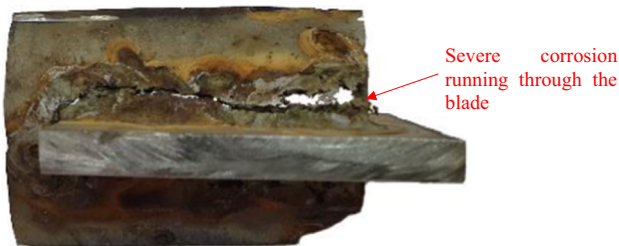
Figure 14 illustrates a section cut according to Fig. 7a, where it is possible to observe an advanced state of corrosion in the mixer paddle (the process is concentrated in the paddle and not in the plate) and, more severely, in regions close to the weld (called heat affected zone—HAZ).

**Fig. 14** Junction point between mixer plate and paddle

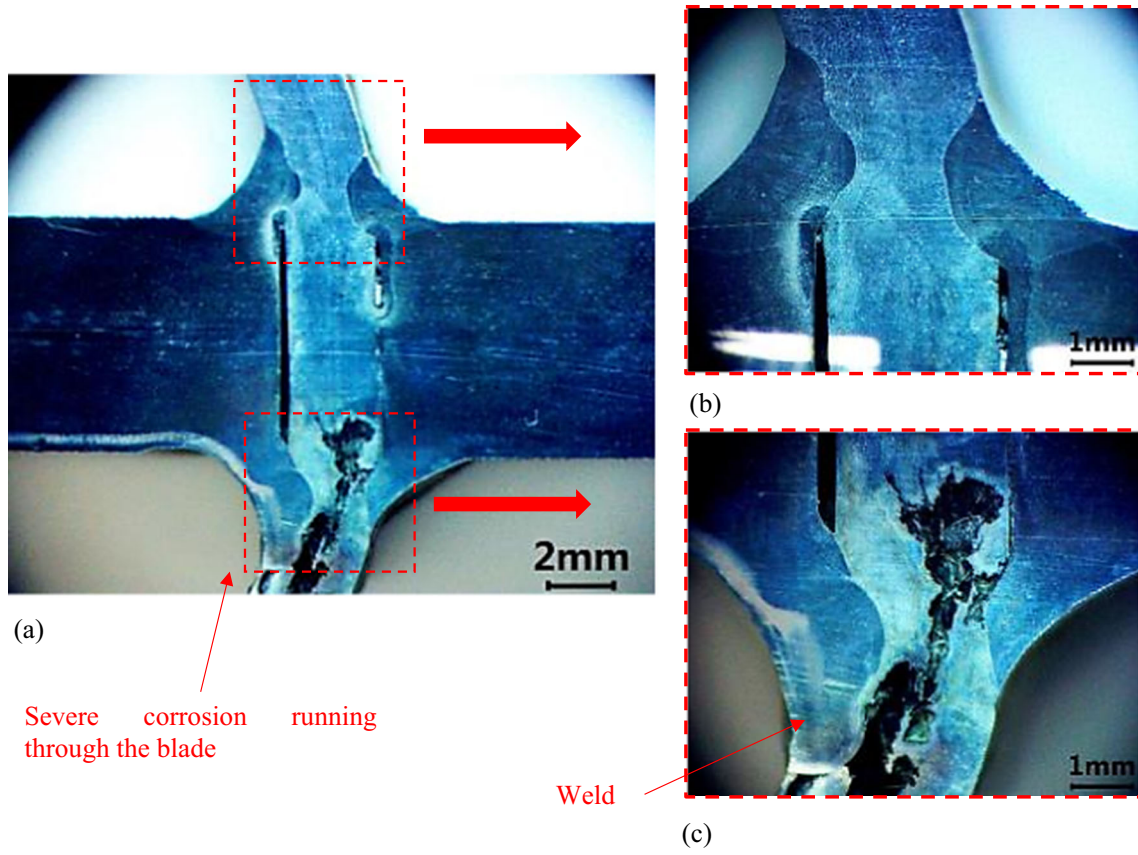
It is also possible to note that the plate and the weld do not show corrosion. This is because the highest kinetics of formation of  $\text{Cr}_{23}\text{C}_6$  carbides occurs at temperatures of approximately 450 to 550 °C. This condition was observed for all other upper and lower welds mixer blades (Fig. 15).

The macrograph of the weld bead cross section can be seen in Fig. 9. It is possible to observe severe corrosion starting at the bottom of the blade and advancing toward the interior (point of union with the plate), according to what is shown in Fig. 8. This is indicative that in certain regions close to the weld, the blade was largely sensitized (as will be discussed later).

**Fig. 15** Macrograph of the cross section of the union between the paddle and the plate

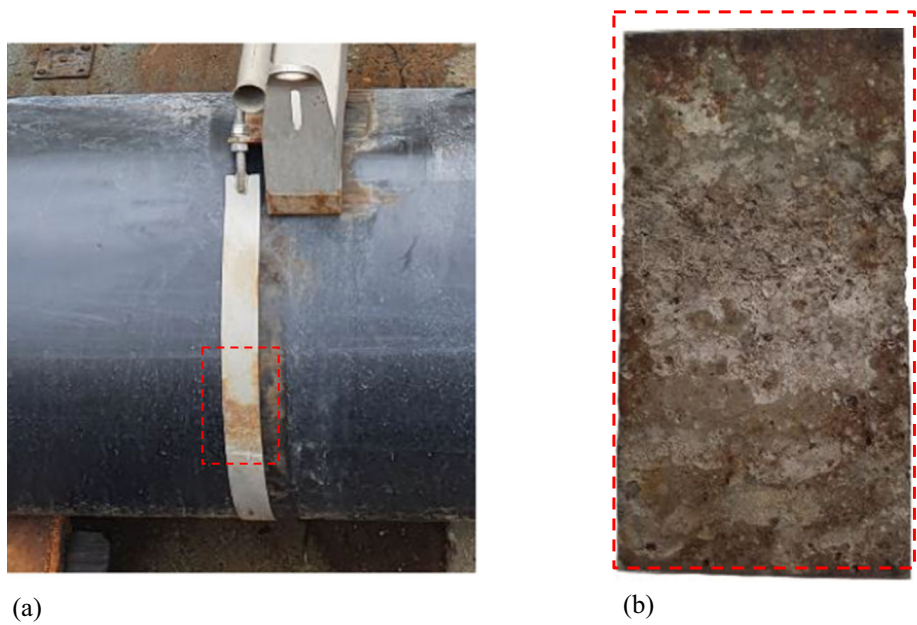
Figure 16 shows the corrosion of the float straps. Figure 10a shows the specific region where the corrosion manifests itself, which corresponds precisely to the position of the water sheet. Figure 10b shows the details of the corrosive process suffered.

This phenomenon is known as differential aeration corrosion. According to Roberge (2008), the oxygen content of any solution is at the top of the list of factors that influence the corrosion of iron and several other metals. Areas lacking oxygen are anodic, while areas with free access to oxygen are cathodic. Oxygen not only allows for a corrosion reaction by maintaining a cathodic reaction, but it can also promote it. This occurs when there is a difference in dissolved oxygen (DO) concentration between two points on the same metallic surface.

**Fig. 16** Fastening strap with detail for differential aeration corrosion just below the surface

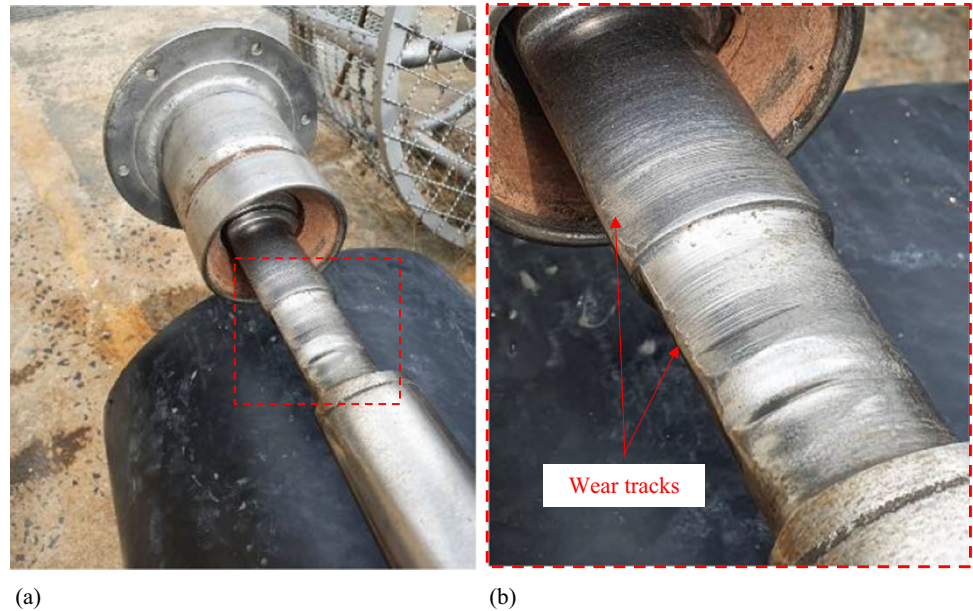
Shaft wear was also analyzed (Fig. 17) close to the attachment point of the mixer plate. As can be seen in Fig. 17b, there are deep marks of abrasive wear. However, as the assembly shows (Fig. 17a), there is no part that, under normal operating conditions, comes into contact with this region since the plain bearing (which has an internal

**Fig. 17** Detail of the axle assembly, highlighting the wear suffered

Celeron coating) ends immediately before the point where the diameter reduction begins.

- The problems presented in the shaft (ovalization and reduction of diameter) occurred due to the unbalance of the plate, which, in turn, was caused by the breakage/corrosion of the blades. This corrosion was due to the inadequacy of the blades' steel for the environment in which they are used.
- For the above, it is recommended that the failure of the protective coating against corrosion be avoided, thus avoiding the formation of pits that can act as stress concentration points and, thus, regions of facilitated nucleation of cracks.

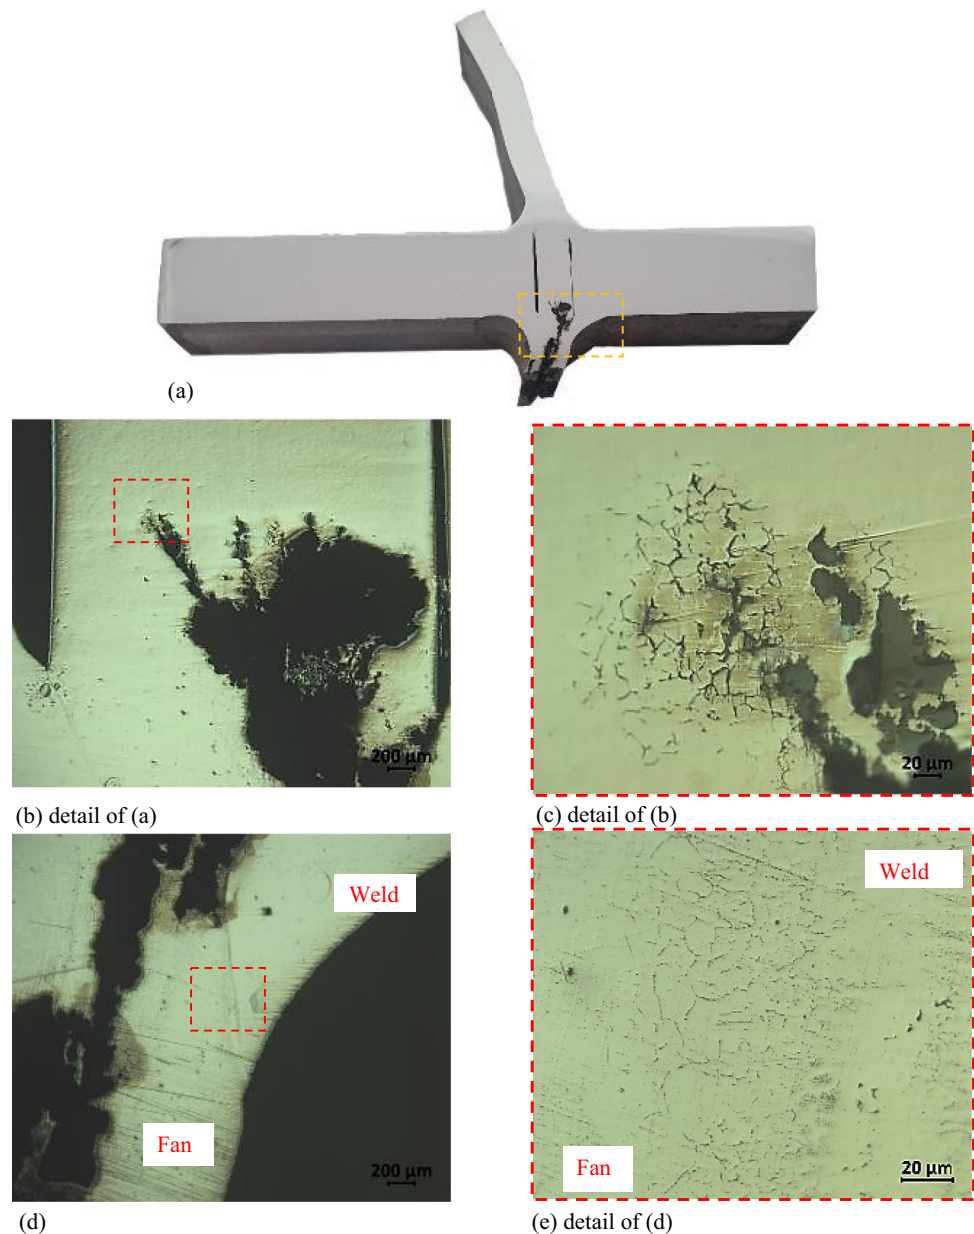
Figure 18 shows the polished surface of the sample previously shown in Fig. 7b. Analyzes via optical microscopy allowed to observe advanced intergranular corrosion, both in the center of the blade plate (Fig. 18c) and close to the weld (Fig. 18e). In addition to this steel’s susceptibility to intergranular corrosion, the sensitization phenomenon also contributed to the decrease in corrosion resistance observed in Fig. 18d.

According to Dak et al. [24], austenitic stainless steels are subject to precipitation of a constituent at the grain boundary when heated to temperatures between 400 and 900 °C (a phenomenon known as sensitization). This temperature range is commonly reached in the HAZ of welded joints under inadequate cooling conditions (slow cooling).

The most common constituent is Cr<sub>23</sub>C<sub>6</sub> for non-stabilized alloys (without the presence of Nb or Ti), and its formation depletes the regions neighboring the grain boundaries in chromium, which favors intergranular corrosion. According to Song and Guan [22], recommendations to avoid failures caused by sensitization are:

**Fig. 18** Micrographs of the bead of the joint between the plate and blade highlight the intergranular corrosion suffered

- The mixer shaft and plate were made of AISI 304L stainless steel. No signs of corrosion were found in these materials, which ensures the suitability of this alloy for the processes used to manufacture the equipment (welding) and the environment where it is used;
- The float fastening strap was made of AISI 304 steel. Due to differential aeration corrosion, it is suggested that steel with greater corrosion resistance, such as AISI 316, be used;
- The mixer paddle was made of manganese austenitic stainless steel, whose susceptibility to intergranular corrosion was increased due to the sensitization phenomenon during welding on the plate. It is recommended that, for its manufacture, the same material as the plate (AISI 304L) is used, and the

welding process is carried out with the appropriate procedures to avoid sensitization;

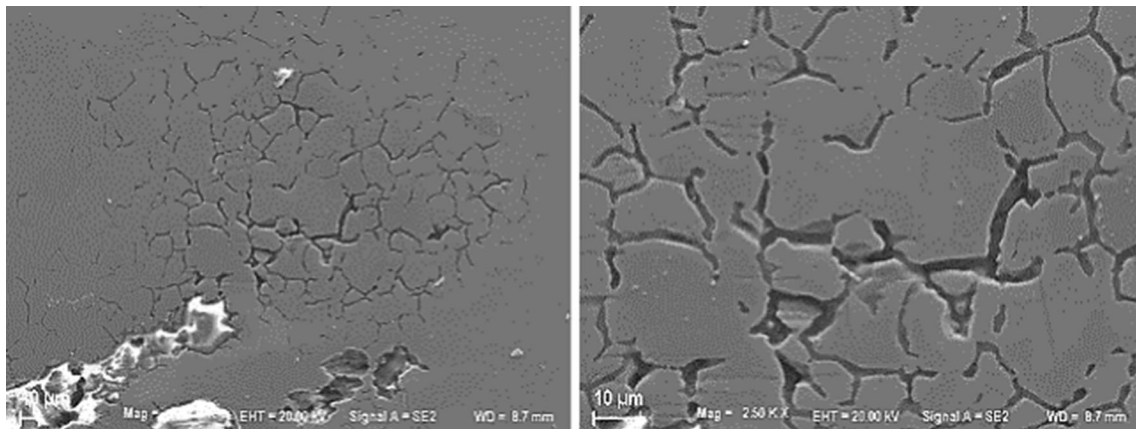
Figure 13 shows intergranular corrosion, obtained via SEM, where corrosion is observed in regions close to the grain boundaries due to the formation of Cr<sub>23</sub>C<sub>6</sub> carbides at the grain boundaries, leading to a reduction in chromium content in these regions. This makes these regions susceptible to intense corrosion, loss of efficiency, and blade breakage. These failures lead to unbalance in the agitation system and, consequently, high stresses on the shaft bearings, which, in turn, accelerate shaft wear (Fig. 19).

**Fig. 19** Scanning electron microscopy images of intergranular corrosion on the mixer paddle (manganese austenitic stainless steel)

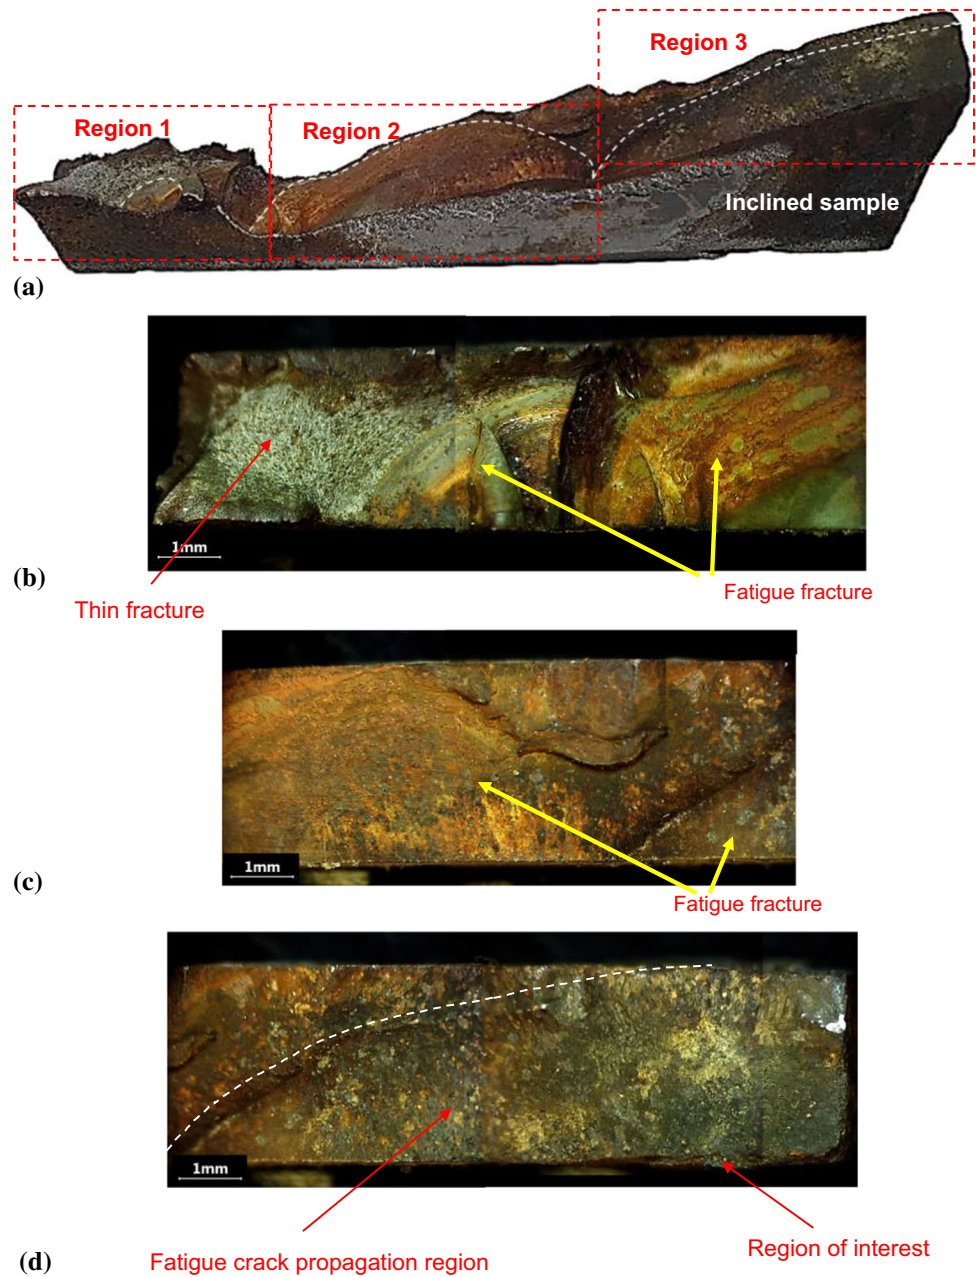
The fracture surface can be seen in Fig. 23. Figure 23a shows the surface divided into regions of interest. White lines demonstrate the fatigue crack propagation fronts in each region.

Figure 23b shows a fracture region during the part rupture’s last stage and some fatigue cracks that started (yellow arrows) on the surface of maximum tensile stress. Figure 23c shows region 2, where it is also possible to observe crack propagation (white line in Fig. 23a).

Figure 23d, in turn, shows a smooth-looking region characteristic of fatigue fracture. The crack nucleated in the upper part of the rod (in the figure, it corresponds to the lower part), which was subjected to cyclic tensile stresses (due to its weight) and the drag force due to the upward flow of air). Comparing the areas of fatigue crack

**Fig. 23** Macrographs of the fracture region were observed using stereomicroscopy. (a) fracture region with emphasis on regions of interest for failure analysis; (b) macrographs of region 1; (c) macrographs of region 2; (d) macrographs of region 3

propagation and the area corresponding to the final fracture, it can be concluded that the loads were of low amplitude.

- Based on fractography, it is possible to state that the failure occurred due to fatigue under low-amplitude loads that caused the nucleation of cracks facilitated due to the presence of corrosion pits in the upper part of the stem;

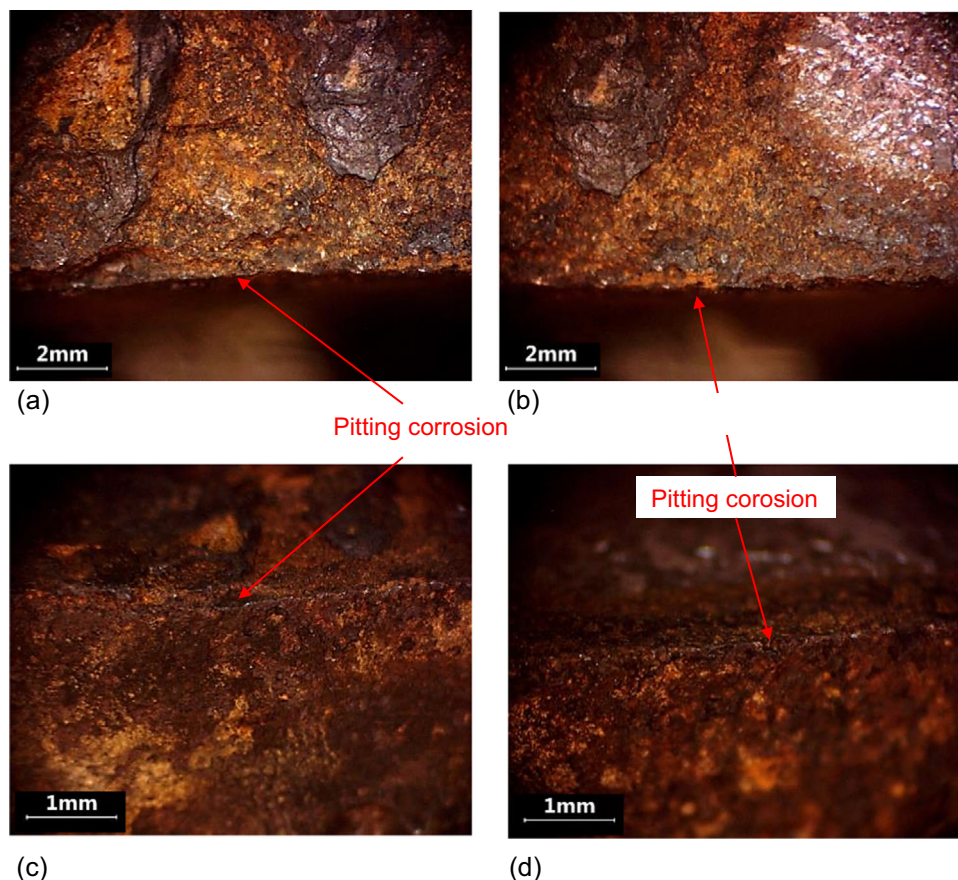
Figure 24 shows the fracture region, highlighting the region of interest 3. Figure 24c and d shows the edge inclined at 45° to show the corrosion pits.

As shown in Fig. 24, several corrosion pits have formed on the top of the stem. These corrosion pits probably functioned as nucleation points for one or more cracks, which evolved to abrupt rupture since the cross section was reduced so that it did not support the loads involved in the component’s operation.

**Fig. 24** Macrographs of the region of interest 2 (see Fig. 10d) showing the cross section (a and b) and the 45° angled edge (c and d)

- For the above, it is recommended to avoid the failure of the protective coating against corrosion, thus avoiding

the formation of pits that can act as stress concentration points and, thus, regions of facilitated nucleation of cracks.

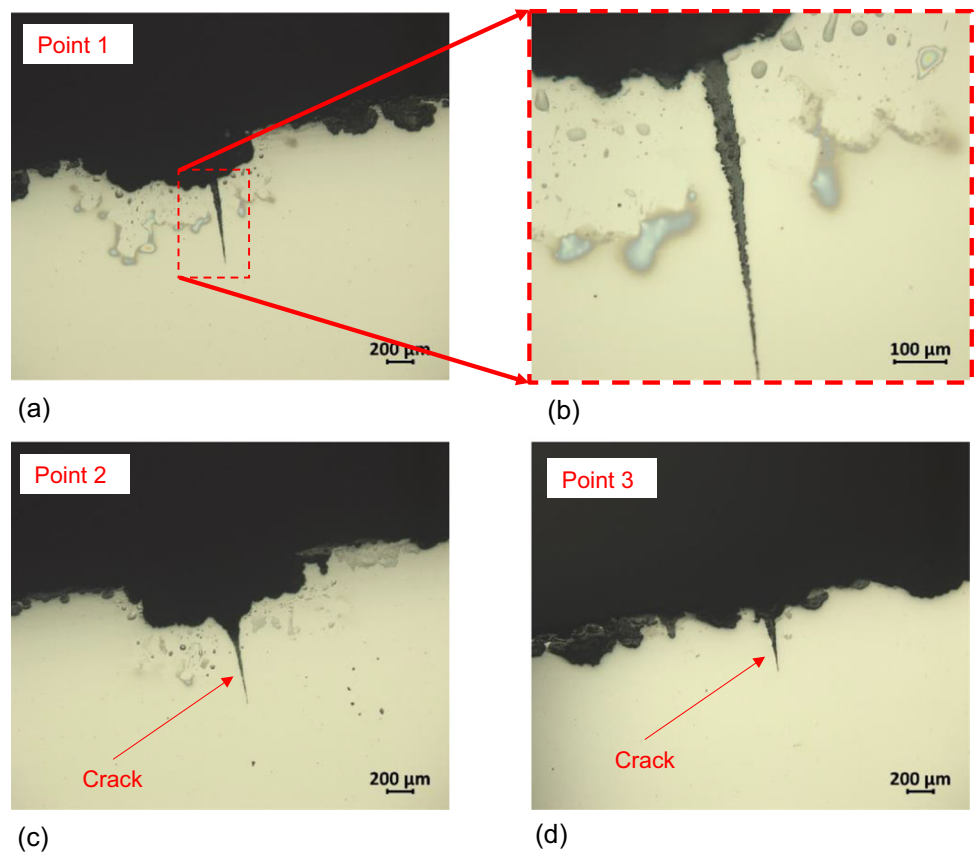
As can be seen in Fig. 26, cracks at the beginning of propagation were found in at least three different points of the fractured nail, with lengths between 0.3 and 0.65 mm. All cracks observed started from corrosion points.

**Fig. 26** Micrographs of the cross section of the fractured nail highlighting the cracks observed

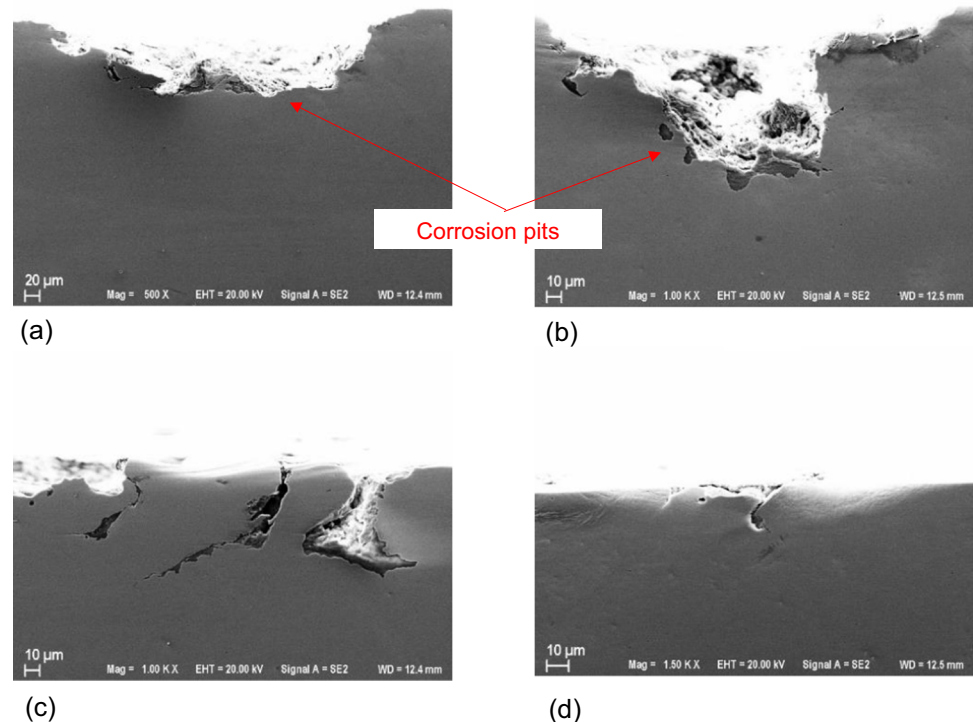
No cracks of the same type or size were found for the intact stem, but images obtained via SEM (Fig. 27) showed several points of localized corrosion. It is important to note

that before being sent for analysis, the intact stem was blasted to remove corrosion products and paint and this process may have masked surface effects such as those observed for the fractured stem.

Figure 27a and b shows corrosion pits of the same type found via light microscopy for the fractured stem (Figs. 25 and 26). Figure 27c and d shows surface defects (from corrosion or porosity of the material) that could evolve into cracks and eventually generate the same type of failure presented by the fractured stem.

**Fig. 27** Electron microscopy of the intact stem, highlighting the effects of surface corrosion and surface defects
