Failure Analysis of Low-Pressure Evaporator in Heat Recovery Steam Generator with 200 ton/h of Capacity

Tri Sigit Purwanto · Diki Ismail Permana · Meilinda Nurbanasari · Abdurrachim · Muhammad Pramuda Nugraha Sirodz

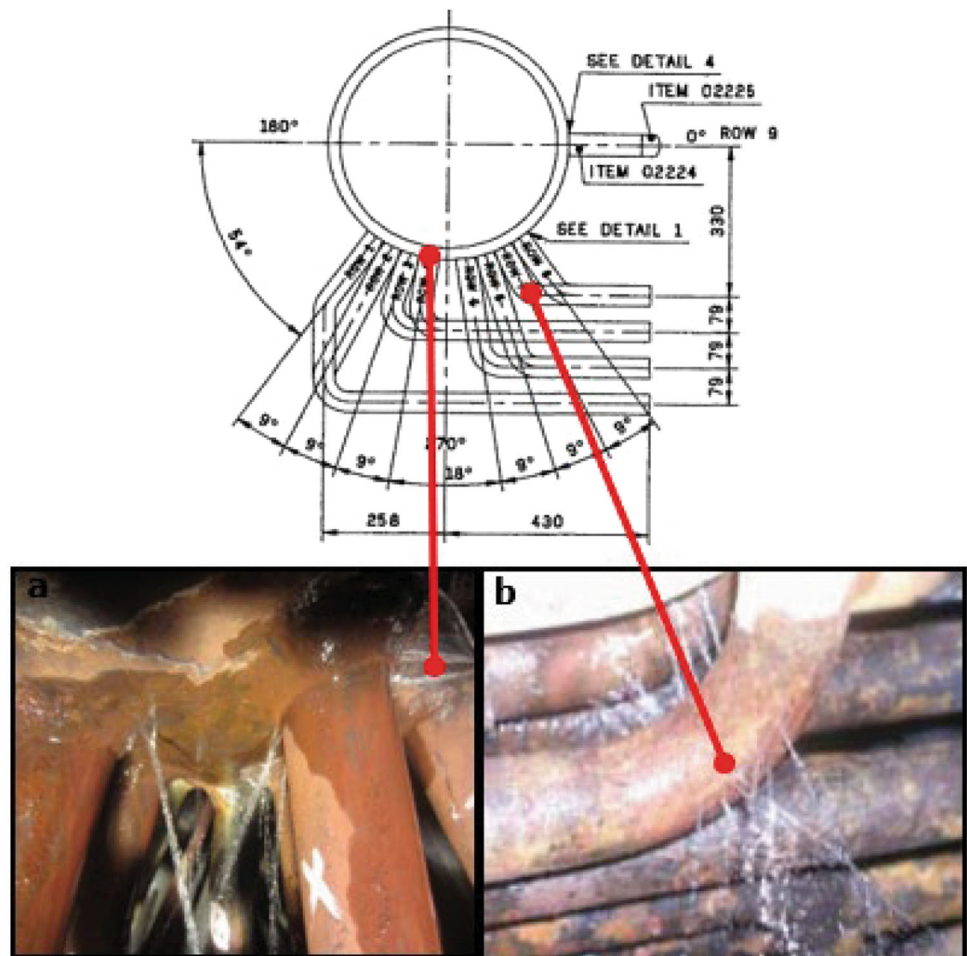
In Fig. 3, it is apparent that there was a leak in the LP evaporator pipe that had been in operation for over four years. The leak was located on the side of the pipe, while the connection with the header was leaking on the inner side of the pipe. This investigation aimed to determine the mechanism and cause of the low-pressure evaporator failure in HRSG pipes with a capacity of 200 ton/h at SGPP to prevent it from happening again in the future. Additionally, this study aimed to provide useful maintenance information and minimize unplanned downtime incidents.

Fig. 3 Failure location: (a) leak on pipe and header joint and (b) leaks on the pipe bend

The investigation found cracks and leaks in the bends and joints between the evaporator pipe and the evaporator header of the steam outlet side (see Fig. 3a). The LP evaporator pipe material is ST37.8 CL1, with a diameter of 44.5 mm and a thickness of 2.9 mm. The evaporator header material is ST35.8, with a diameter of 508 mm and a thickness of 25 mm. The LP evaporator system uses 80 pipes with three passes. The repeated weld repair of the header and pipe joints in the east, as depicted in Fig. 3b, indicated that these failures have occurred frequently. The welding is necessary due to the pipe connection to the header, which frequently leaks, and as a result, the weld can increase the brittleness and induce cracks in the header.

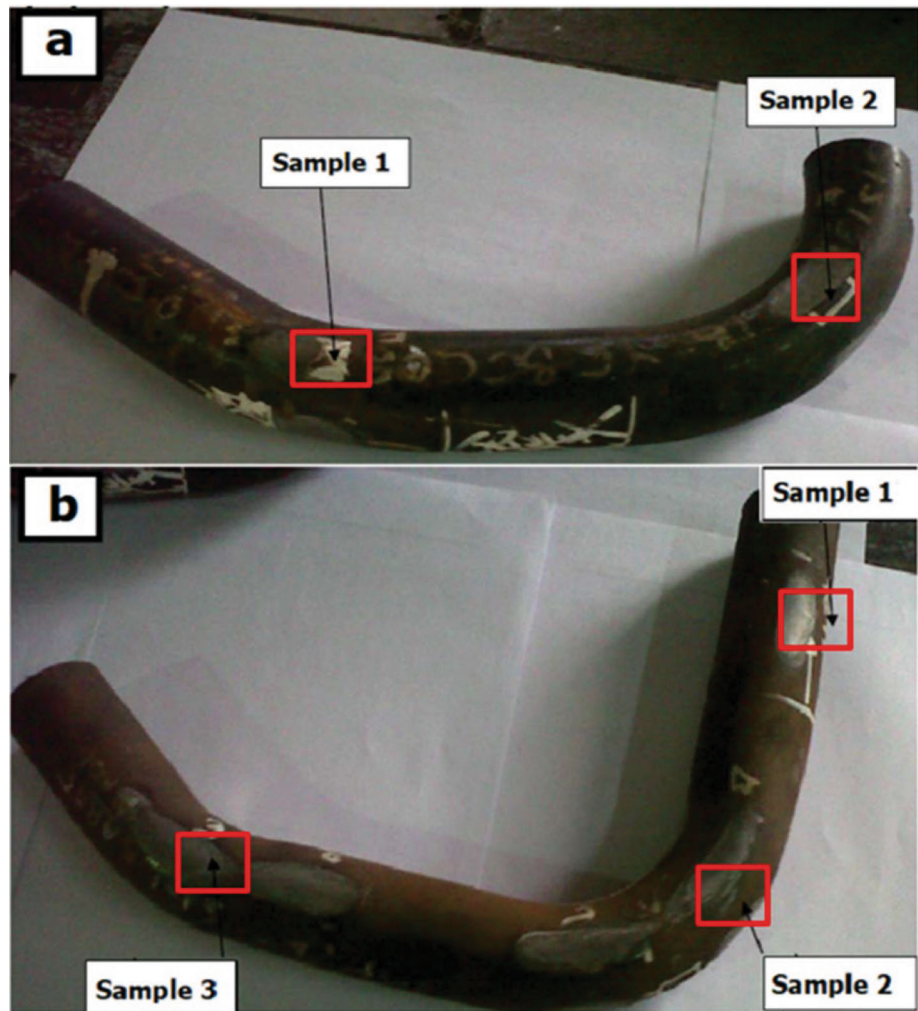
Fig. 5 Specimen test sample: (a) east side pipe and (b) west-side pipe

Furthermore, the hardness test conducted on the failure zone of both the east and west sides of the LP evaporator pipes revealed an average value of around 131.3 HB and 133.5 HB, respectively. This indicates a change in hardness near the lip rupture (samples 1 and 2 in Fig. 5) compared to the area away from the lip rupture (Sample 3 in Fig. 5). Therefore, according to ASTM A178 [16] grade A for carbon-steel welded boiler tube material hardness, which has a value of 139, the significant drop in hardness around the lip rupture indicated that creep damage and material softening occurred during operation.

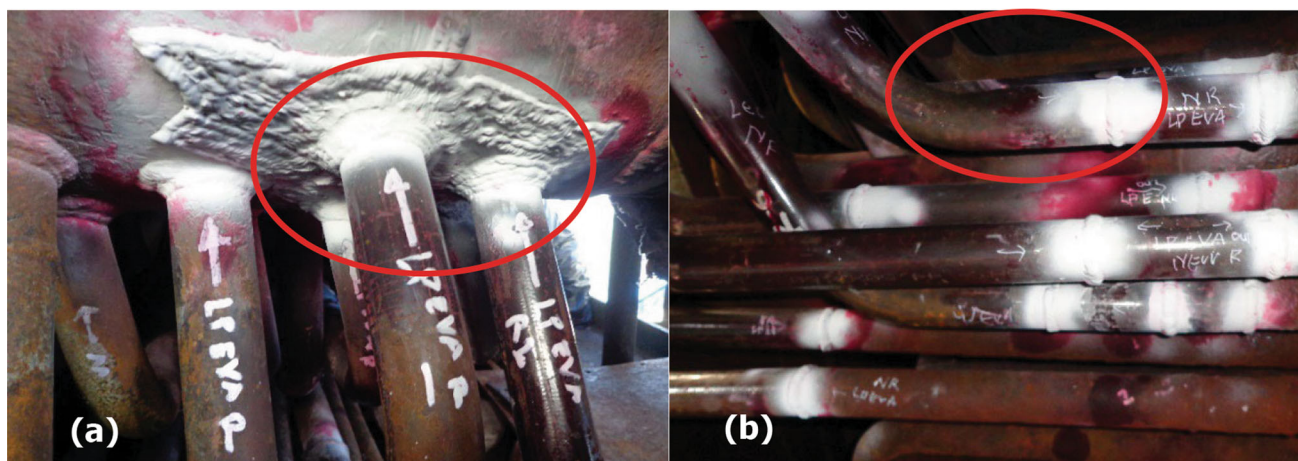
Non-destructive testing (NDT) was conducted to enhance the visual inspection and identify the reason behind the LP evaporator pipe's failure. As shown in Fig. 6, NDT revealed a red area in the tube joint and the LP

Fig. 6 NDT of the LP evaporator outlet: (a) header and (b) pipes

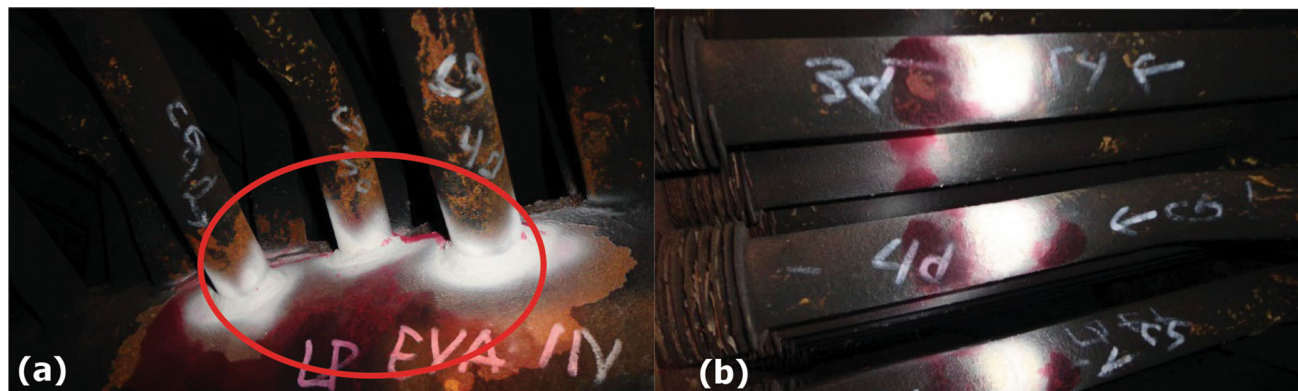
evaporator pipe's outlet, suggesting a potential leak in that region. Additional findings presented in Fig. 7, indicated the same occurrence in the inlet side of the welded connection area between the header and pipes, with a red hue around the zone, indicating some sort of failure.

Fig. 7 NDT of the LP evaporator inlet: (a) header and (b) pipes

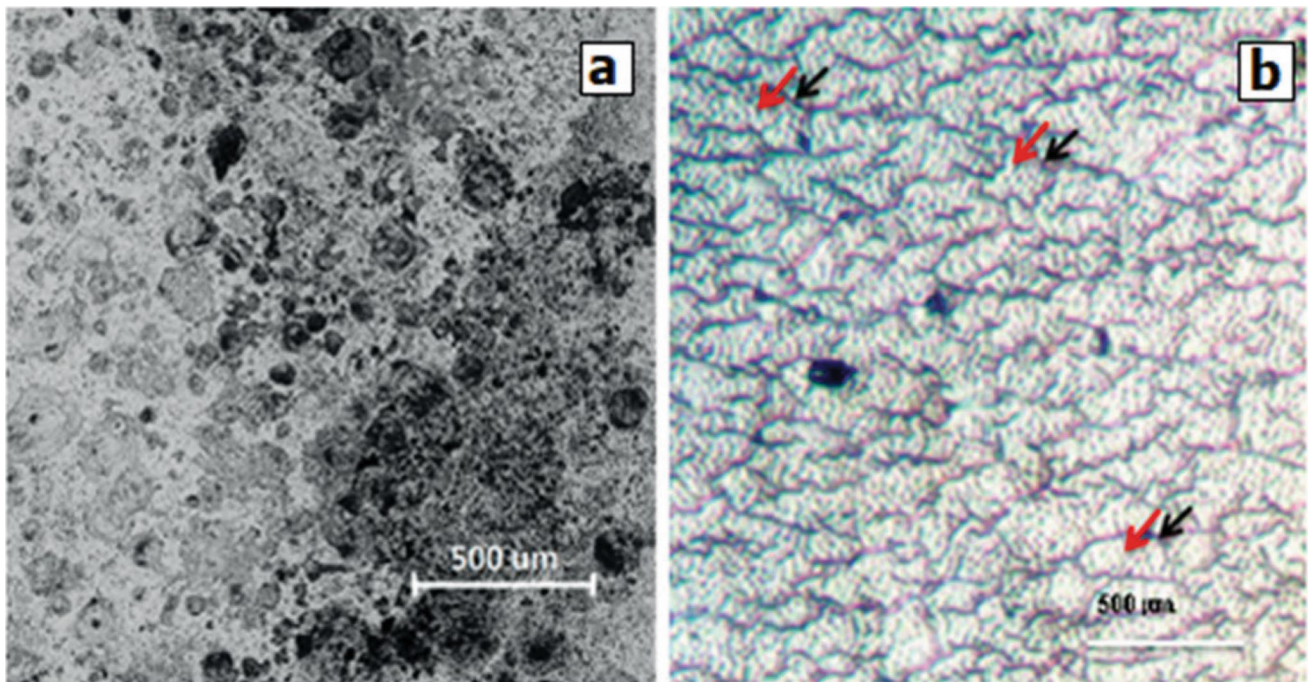
The base material’s microstructure is that of an LP evaporator pipe made of ST37.8 CL1, as shown in Fig. 8. The inspection results (Fig. 8b) align with an ASTM A178 [17] standard (Fig. 8a), as both indicate the presence of ferrite phase (indicated by a red arrow) and pearlite (indicated by a black arrow). No significant changes in the macro or microstructures were detected, and the grain shape appeared coarse.

Fig. 8 Metallography result: (a) ASTM A178 and (b) inspection result with 500x

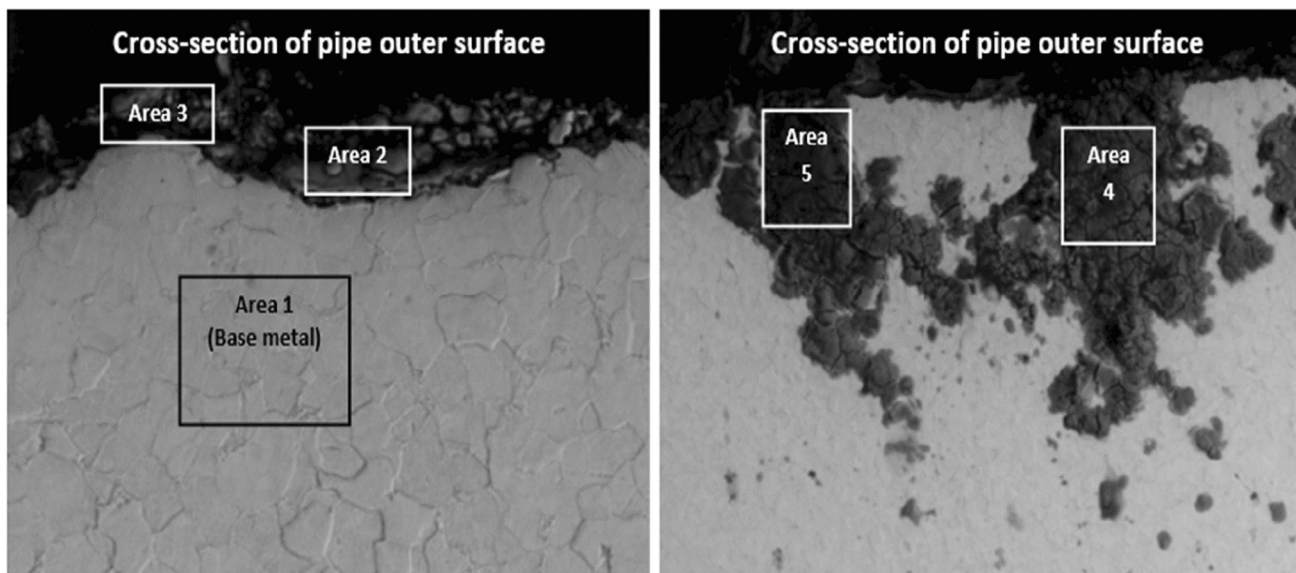
Sample 1 was a segment of the LP evaporator pipe’s eastern section, displaying general corrosion and pitting corrosion on the outer surface caused by sulfur (refer to area 3 in Fig. 9 section of the cross-section of the outer surface of the pipe). An oxide corrosion layer is also observed on the pipe’s outer surface. The sulfur content in the outer material originates from the flue gases generated during fuel combustion. The base metal’s grains reveal a composition of ferrite and pearlite with large grain sizes, a characteristic that allows the eastern pipe to endure high temperatures for maximum grain development. However, the presence of large grains implies a reduction in the pipe material’s strength. The tensile testing conducted in this area resulted in a range of 25 kg/mm². The SEM outcomes did not identify grain boundary cracks, creep, precipitates, or inclusions in the material grains.

Fig. 9 SEM images: Cross-section of the pipe's outer surface (Sample 1)

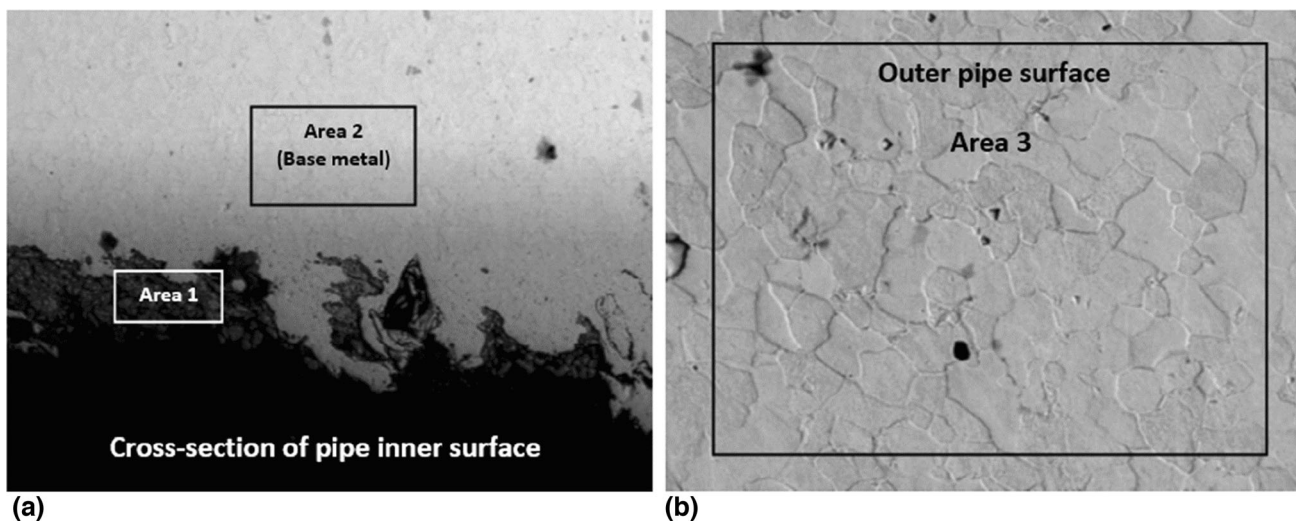
Fig. 10 SEM image of Sample 1: (a) cross-section of the pipe's inner surface and (b) outer pipe surface

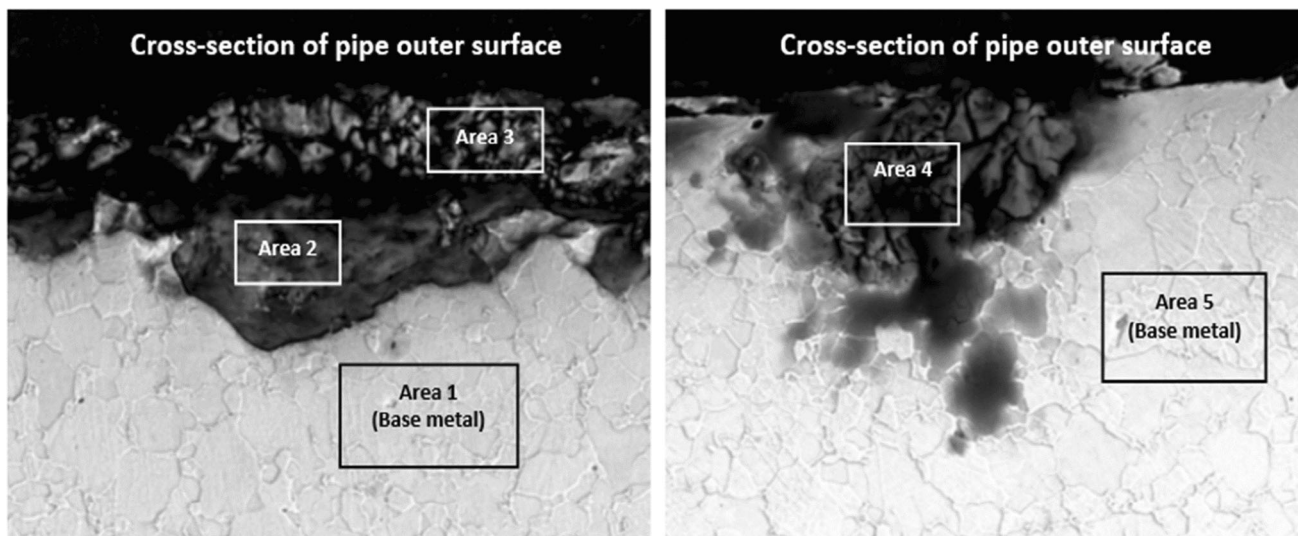
Sample 2 represents the west-side pipe and exhibited generally acceptable grain conditions, indicating a reasonably high strength. Its tensile strength, was measured to be around 35 kg/mm². Upon examining the pipe’s outer and inner surfaces, there was evidence of pitting corrosion on the outer surface in area 4. In addition, there is a possibility of stress corrosion cracking (SCC) on both the outer surface (area 4) and inner surface (area 1). Cracks that propagated in the longitudinal direction were observed on the pipe’s inner surface. Furthermore, there was evidence of pitting corrosion and erosion in area 3 of the inner

Fig. 11 SEM images of Sample 2: Cross-section of the pipe’s outer surface

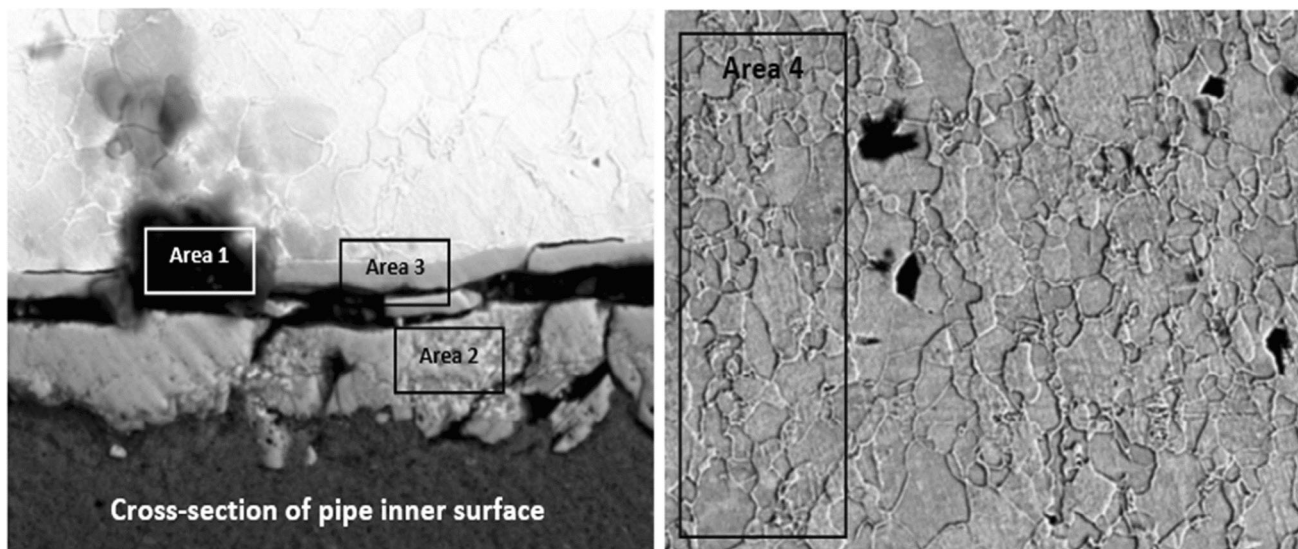
surface, which allowed for the occurrence of flow-accelerated corrosion (FAC).

Fig. 12 SEM image of Sample 2: Cross-section of the pipe’s inner surface

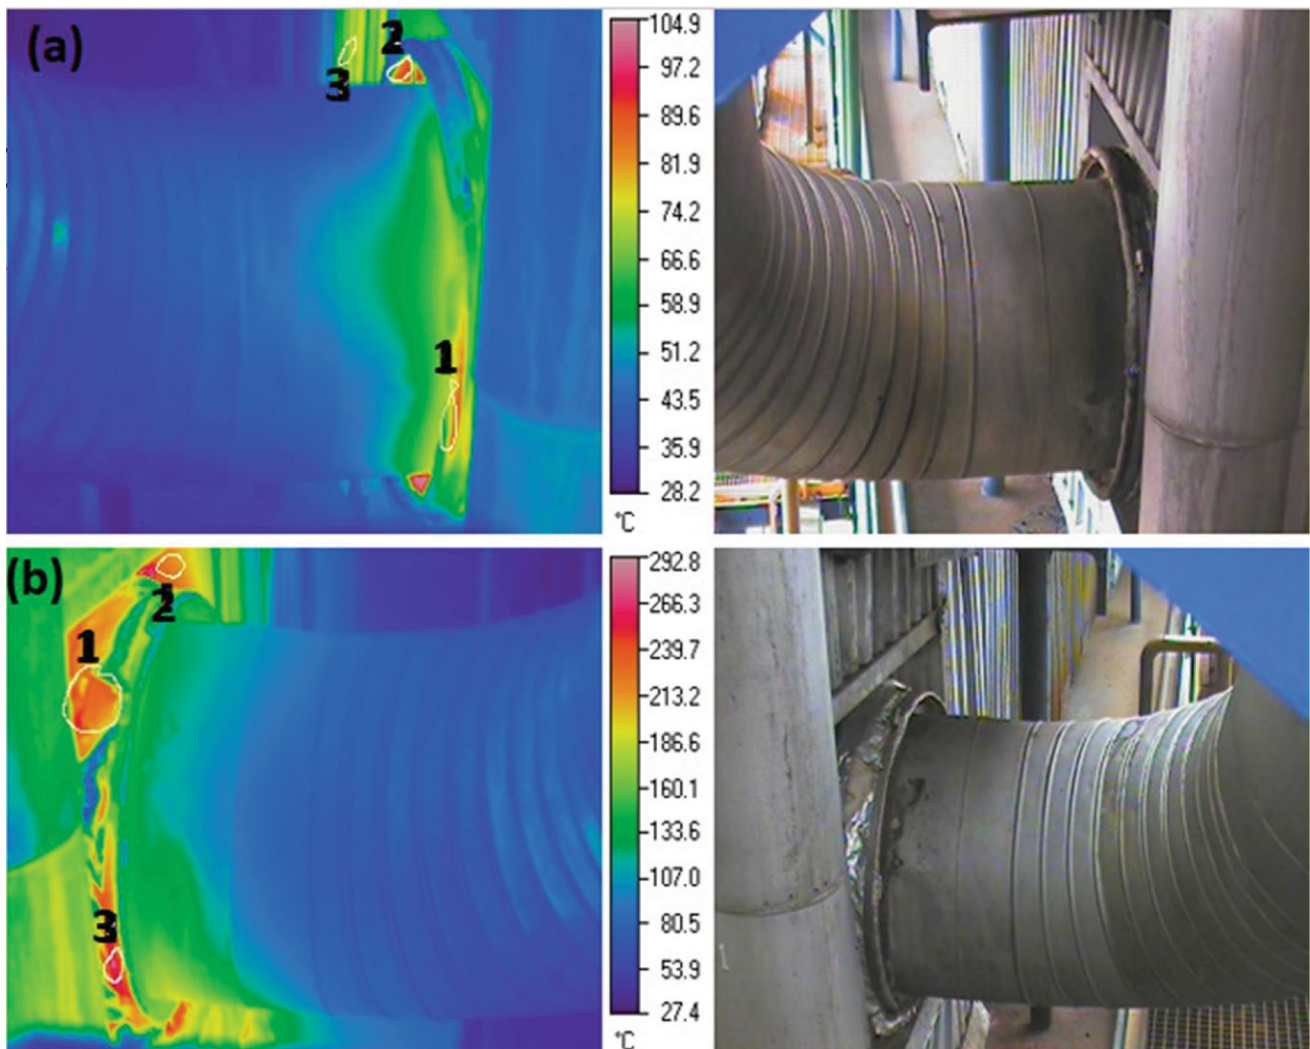
Table 7 presents calculation results based on the equations presented in the preceding subsection to determine the flexibility of both sides of the LP evaporator due to excessive thermal stress. From the results, the flexibility criterion ($\frac{(D.Y)}{(L-U)^2} < 0.03$) of the eastern LP evaporator pipe is slightly higher than that specified ($\frac{(D.Y)}{(L-U)^2} = 0.04$), with a difference of 0.01, suggesting that the risk of thermal-induced failure was significant. To demonstrate this, we conducted thermographic measurements on the east and west sides of the LP evaporator pipe to determine the difference between the actual and design inlet temperatures. Figure 13 shows the results of these measurements. In the recorded image (Fig. 13a), the east side appears significantly warmer than the west-side. By translating the thermographic images into temperature values, we determined that the maximum temperature on the east side wall is about 280.3 °C (Region 3), while the maximum temperature on the west-side wall is about 90 °C (Region 2), as seen in Fig. 13b. This indicates that the outlet section is exposed to higher heat levels than the inlet section. The uneven gas flow pattern is responsible for this difference, which often leads to damage at the outlet. Region 3 on the east side of the outlet is the hottest area, with an average

temperature of approximately 240 °C. This is because the weld in this region has a larger mass than the welds in other regions, such as Region 2 and Region 1, which have

average temperatures of around 218.1 and 208.6 °C, respectively. Additionally, the average temperatures of the LP evaporator on the west and east sides showed a significant difference from the design temperature, as shown in Fig. 1. The largest difference was found on the west-side, with a 100 °C variance between the actual and design temperatures. This temperature difference caused non-uniform expansion of the evaporator pipes, resulting in the east side pipe being longer than the west-side pipe and causing thermal stress in the LP evaporator pipe system (Table 8).

Fig. 13 Thermography result of the LP evaporator: (a) west-side and (b) east side

- Monitoring of flue gas flow in HRSG. It is advisable to install temperature gauges on the wall of the evaporator pipe at multiple locations to monitor flue gas flow in the HRSG. If the temperature readings are inconsistent, it indicates significant pipe fin deposition, resulting in blockage of gas flow in certain areas. In this case, operations must be immediately halted, and the pipe wall cleaned. The use of a thermocouple is a reliable and cost-effective alternative to a flue gas flow sensor.
- Replace the header pipe support with a support system that enables freedom of movement for the header pipe end both transversely and parallel to the pipe axis.
- Check the silencer before the HRSG for any damage that may be causing non-uniform gas flow. If repairs are needed, they should be promptly carried out.
