CASE HISTORY—PEER-REVIEWED

# Multiple-site Fatigue Cracking of Fuselage Structure Due to Improper Rivet Installation

Frank Zakar

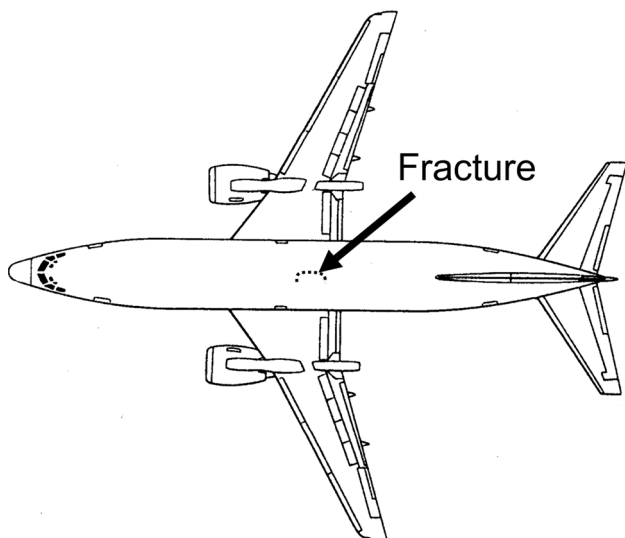
An airplane carrying 117 passengers experienced a rapid decompression after departing the airport [1]. The airplane made an emergency landing. Two passengers sustained minor injuries. Post-accident inspection of the airplane upon landing revealed that a section of fuselage skin about 60 in. long × 8 in. wide (152 cm × 20 cm) had fractured and flapped open on the crown portion of the fuselage.

Fig. 1 Location of the fractured skin panel

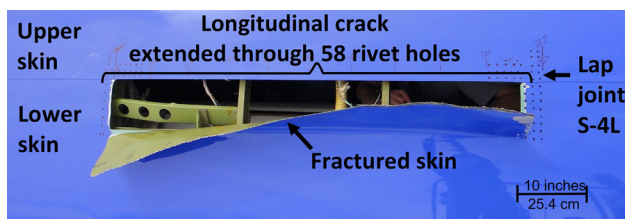
Figures 1 and 2 show the fractured skin panel on the top portion of the fuselage.

Fig. 2 Fractured skin panel as viewed from outside of the airplane

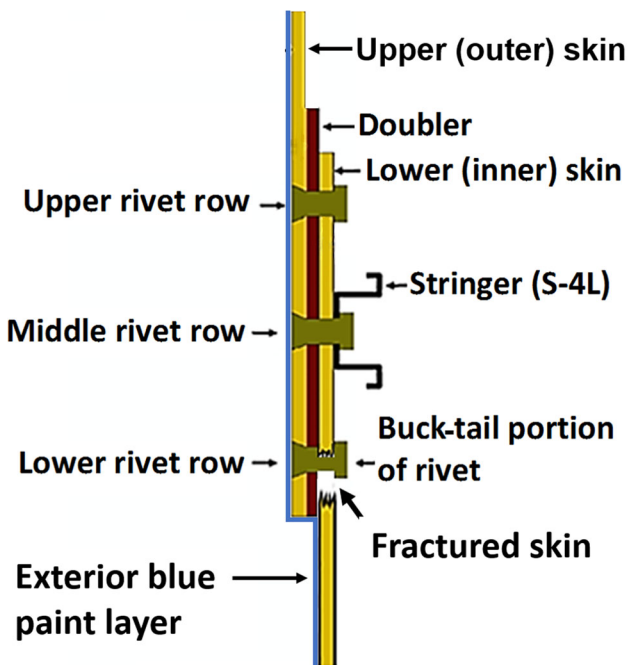
The exterior shell portion of the fuselage is made from many overlapping aluminum skin panels and where they overlap is called a lap joint. These lap joints are connected to stringers that run the length of the fuselage. Fracture of the fuselage skin occurred at the location of stringer number S-4L. Stringer number S-4L refers to the fourth stringer from the top side of the fuselage on the left side of the airplane. Figure 3 shows the cross section of the lap joint in stringer number S-4L. Adhesive sealant was applied at the factory between the three layers of skin panels. The adhesive sealant serves as a weatherproofing barrier and during flight keeps pressurized air inside of the passenger cabin. The lap joint was fastened by three rows of rivets (upper, middle, and lower). The fracture was through the lower skin of the lap joint and intersected the lower rivet row, as shown in Fig. 3.

Fig. 3 Cross section diagram of the lap joint and fracture area (not to scale)

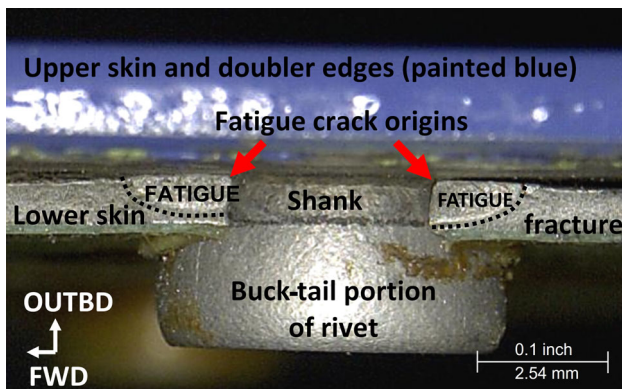
Stereo microscope examination of the lower skin fracture face (viewing the fracture face head on as shown in Fig. 4) revealed thumbnail fracture features typical of fatigue cracking emanating from 54 rivet holes. Fatigue cracking started on the forward and aft sides of each rivet hole. Figure 5 shows an example of one of the smaller fatigue cracks that did not intersect fatigue cracks from adjacent holes. Specifically, fatigue cracking started at the area where the rivet hole intersected the outer surface of the lower skin. The fatigue cracks in Fig. 5 emanated from diametrically opposite sides of the rivet hole, propagated forward and aft, and terminated in the areas indicated by a dashed line.

Fig. 5 Lower skin fracture face showing fatigue cracks (outlined by dashed lines) that emanated from the rivet hole

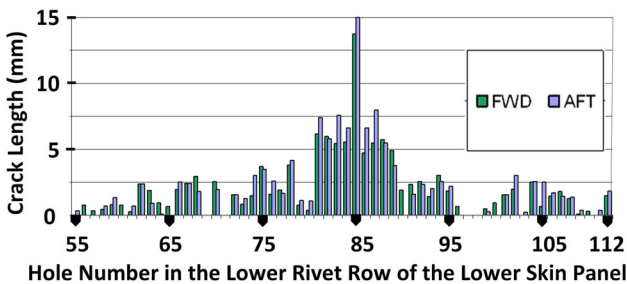
Fig. 6 Graphical representation of the rivet hole locations and length of respective fatigue cracks

Figure 6 shows a graphical presentation of the length of each fatigue crack. The rivet hole numbers were arbitrarily labeled on-site. The distance between the centers of each rivet hole was about 1-inch (2.5 cm). Typically, the longest fatigue crack represents the oldest fatigue crack and is the origin of fatigue cracking. The longest fatigue crack was located on the aft side of rivet hole “85” and it measured about 0.60 in. (15 mm). This observation gave us the first clue that fatigue cracking started on the aft side of rivet hole “85”. As seen in Fig. 6, the length of a fatigue crack decreased as one moved away from the longest fatigue crack in rivet hole “85”. The longer fatigue cracks penetrated through the wall of the lower skin, and they intersected the fatigue cracks at the adjoining rivet holes. In the aircraft industry, multiple fatigue cracks that emanate from a row of fastener holes is referred to as multiple site damage (MSD). The areas located outside of the fatigue regions exhibited micro-void coalescence features typical of overstress separation.

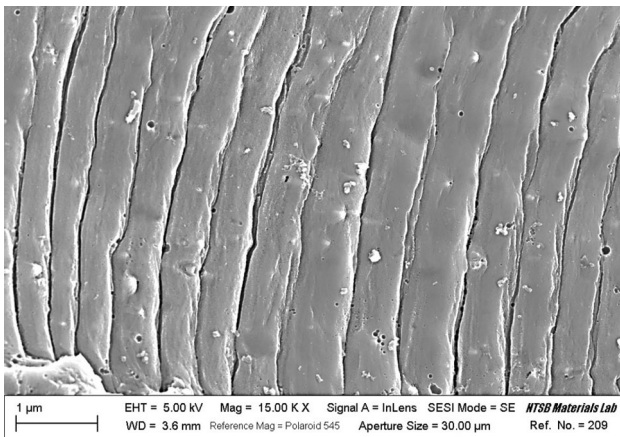
**Fig. 7** Scanning electron micrograph of fatigue striations found on the aft side of rivet hole “85”

cleaning aluminum alloys [6]. This cleaning procedure exposed the fine fatigue crack features, see example in Fig. 7. Striation counting was performed at various intervals along length of the fatigue crack, in regions that contained continuous fatigue striations (having stable crack growth rate). A plot of accumulated flight cycles versus the crack length is shown in Fig. 8. The plot in Fig. 8 shows that the crack length increased with the number of cycles. The average crack growth rate at a specific distance from the origin was determined by adding the crack growth rate at a specific distance (point) to the crack growth rate at the previous point and then dividing those figures by two. The number of cycles was calculated at specific intervals of the fatigue crack path. The cycles for each interval were added to obtain the accumulated flight cycles. The total striations count on the fracture surface added up to 38,261 cycles [7]. At the time of the accident, the airplane logbook showed the airplane flew a total of 39,786 flights (cycles). The accumulated cycles obtained by the SEM quantitative fractography method was nearly as great as the accumulated service cycles on the airplane. When comparing these two pieces of information, the investigation concluded that the fatigue crack started approximately when the airplane entered service.

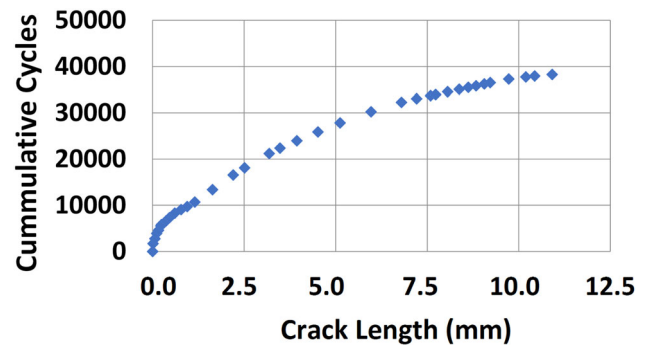
**Fig. 8** Plot of cumulative cycles versus crack length for the fatigue crack that emanated from the aft side of rivet hole “85”

[8]. Another source indicated that failures in very low cycle fatigue (VLCF) are in the order of 10, say below 20 cycles; LCF applies to failures between  $10^2$  and  $10^4$  cycles; and HCF applies to failures greater than  $10^5$  cycles [9]. The accumulated cycles count obtained from SEM quantitative fractography work was consistent with LCF (closer to the LCF regime rather than the HCF regime). As indicated earlier in this paper, the origin of the fatigue cracks emanated from irregular drilled holes (origin was not free of damage). The irregular holes acted as stress raisers. The fast transition from crack nucleation to stable crack growth, as shown in the early part of the plotted curve in Fig. 8, most likely was due to stress raisers (irregular drilled rivet holes).

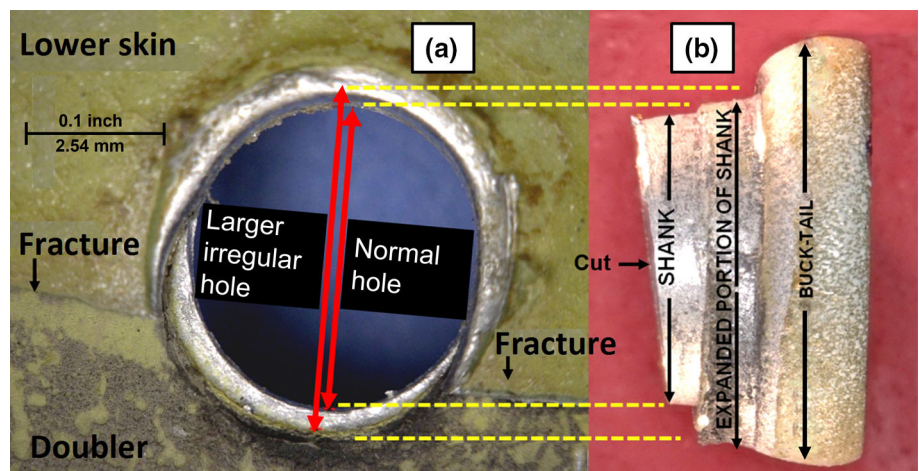
In contrast, many of the rivet holes associated with fatigue cracking deviated from a round shape (they were referred to as irregular holes). Irregular holes result from improper drilling. Figure 10a shows the outer face of an irregular hole prior to peeling apart the skin panels. To further assess the condition of the irregular holes, the skin panels were peeled apart from each other (recall skin panels were held together by adhesive sealants), and each skin panel was examined separately as a single piece. Examination of the disassembled skin panels revealed many of the holes that contained fatigue cracks appeared like the outline of a figure eight, often referred as a double-

**Fig. 10** (a) Exposed irregular hole prior to disassembly of panels and (b) side profile of removed corresponding rivet

drilled hole. Double drilled holes indicated that more than one drilling operation was performed at the same hole location. Double drilled holes are not permissible in the airplane manufacturer specification.

Rivets removed from irregular holes showed evidence that the diameter of the shank in the area adjacent to the bucked tail portion for most rivets was larger (expanded) compared to the diameter of the remaining portion of the shank, see Fig. 10b. The expanded portion of the shanks confirmed that the irregular holes in the lower skin were slightly larger compared to those in the doubler and upper skin.

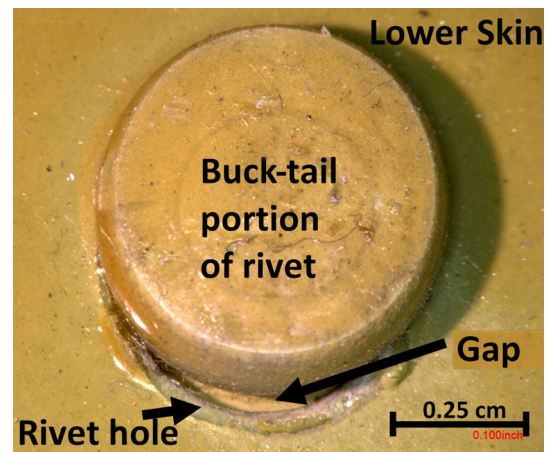
Two worse-case examples of improperly driven rivets were found such that the buck-tail did not entirely cover the irregular hole in the lower skin, and they are shown in Figs. 11 and 12.

**Fig. 11** Improperly installed rivet showing partially exposed hole (gap)

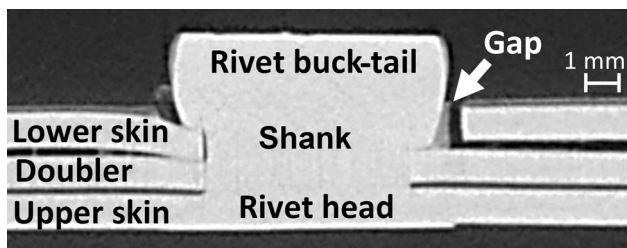
Fig. 12 X-ray computed tomography reconstructed image showing the cross section of an improperly installed rivet
