Radon levels and indoor air quality after application of thermal retrofit measures—a case study

Abstract

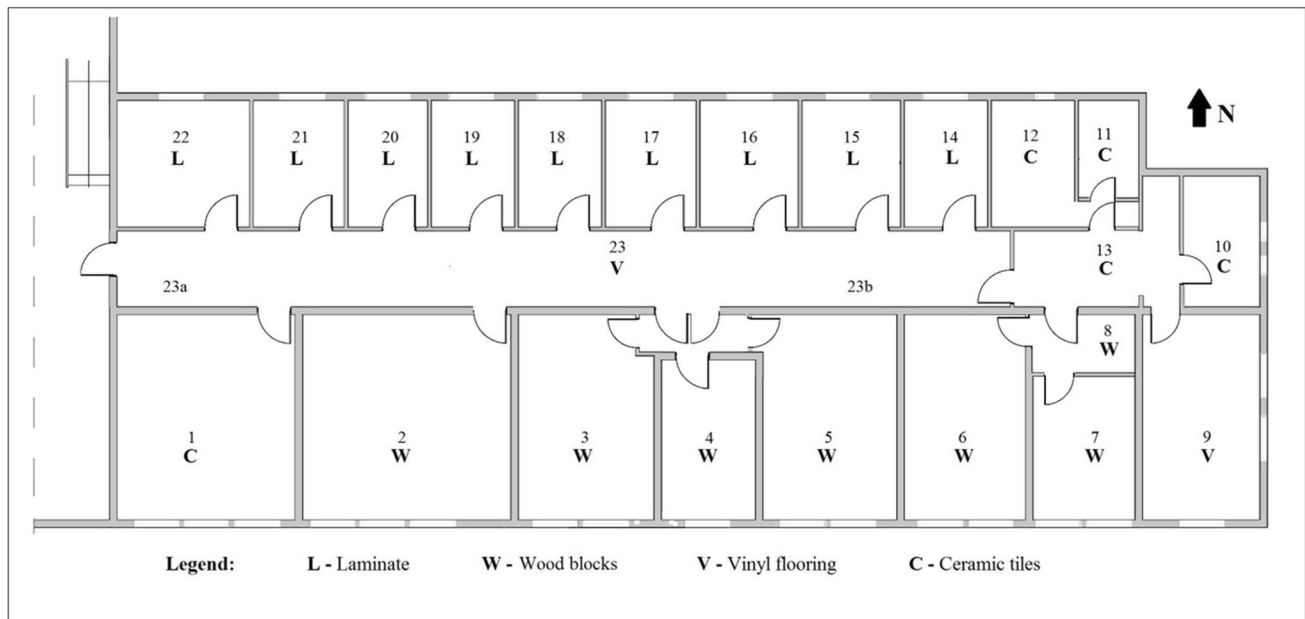
Fig. 2 Scheme of the building and floor characteristics of studied workrooms

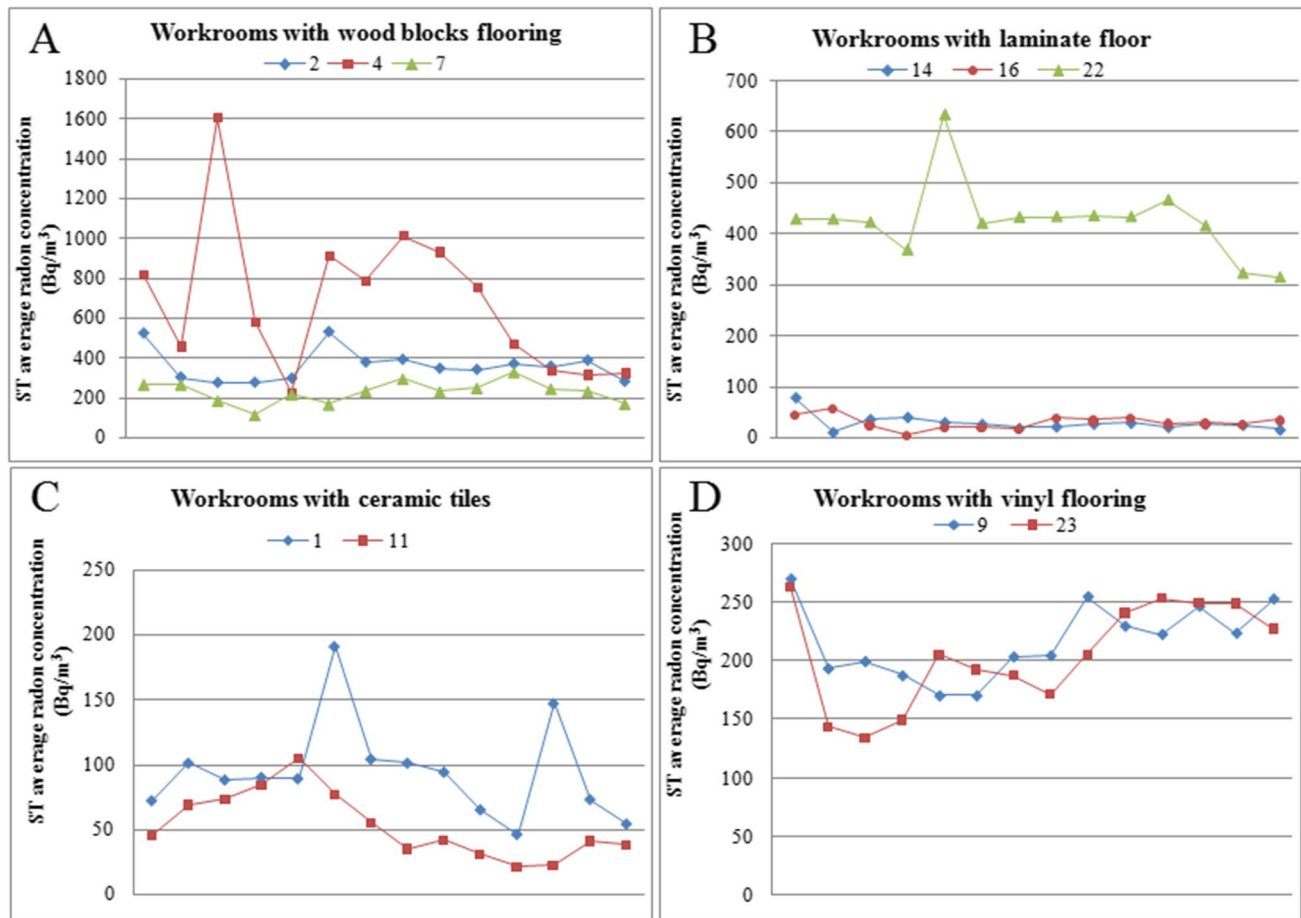
ST radon measurements followed by hour-to-hour changes (which are daily updated) showed variations from 6 to 1603 Bq/m^3 ; these radon variations were presented for different flooring types (Fig. 4). A coefficient of variation based on ST values for workrooms varied from 14.5 to 55%. Correlation of ST radon concentrations with the outside temperature was investigated. The correlation was positive and ranged from negligible (Spearman's $\rho = 0.033$ for workroom 4) to moderate ($\rho = 0.470$, workroom 14). Some contradictory results can be found in literature regarding this issue. According to Rey et al. (2022), temperature

Fig. 4 Short-term (ST) average radon concentration (Bq/m^3) in workrooms with different flooring types: wood blocks (A), laminate (B), ceramic tiles (C), and vinyl (D)
