High inspired carbon dioxide levels due to a faulty absorber engagement pin on a Dräger Fabius® GS machine

Andrew D. Milne, MD · Dan Cashen, RRT

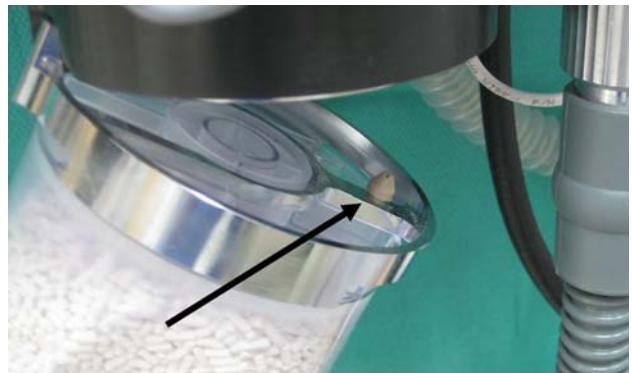
Fig. 1 Photograph of mushroom-shaped engagement pin on “CLIC” adaptor mechanism. Arrow points to an undamaged engagement pin

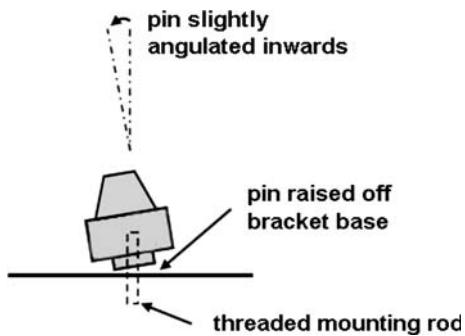
We wish to report the failure of the carbon dioxide (CO_2) absorber engagement pin on a Dräger Fabius® GS anesthetic machine (Dräger Medical Inc., Telford, PA, USA), which resulted in increased inspired CO_2 levels during a recent case at our institution. Our machines are fitted with an optional absorber attachment system, Drägersorb® CLIC Adapter (Dräger Medical Inc., Telford, PA, USA), which permits the use of disposable canisters of absorbent and allows canister replacement during operation. The “CLIC” mechanism utilizes a hinge design to remove the disposable canister and a mushroom-shaped pin to lock it in place when it is engaged (Fig. 1). During a recent case under general anesthetic, the anesthesia staff noted that the inspired CO_2 level was rising. Changing the CO_2 canister (Amsorb® Plus, Universal Bubble Can® Absorber, Armstrong Medical Ltd, Coleraine, Northern Ireland) and a routine check of the anesthetic machine for likely causes failed to diagnose the problem, thus our hospital biomedical technicians were notified to resolve the issue. The machine was quickly replaced and the patient suffered no adverse effects. Further examination of the CO_2 absorption system revealed that the engagement pin located on the “CLIC” connection ring was bent slightly inwards (Fig. 2). The angulation of the pin was quite subtle; the plastic tip was raised and it appeared as though the CO_2 canister was properly engaged with the anesthetic machine. However, gentle side to side pressure applied on the canister resulted in a rocking motion and formation of a small gap at the machine-canister interface. This incomplete connection resulted in a bypass of the CO_2 canister

Fig. 2 Diagram depicting pin migration and angulation that caused CO_2 absorber bypass

and subsequent increase in CO_2 due to re-breathing. Replacement of the pin completely resolved the issue. Close inspection of the remainder of our fleet revealed that four other machines had this defect and were also at risk of incomplete CO_2 canister connection. Discussion with the manufacturer revealed that this engagement pin should be

replaced on a yearly basis as part of preventative maintenance. This had not been done on our units due to a communication issue with a third party distributor of the machine. We wish to alert other users of this system of this subtle, yet preventable defect, which may be difficult to
