Complete obstruction to flow in a three-way stopcock due to a manufacturing defect

Andrew D. Milne, MD · Paul A. Brousseau, BEd

Received: 29 August 2013 / Accepted: 9 September 2013 / Published online: 27 September 2013
© Canadian Anesthesiologists' Society 2013

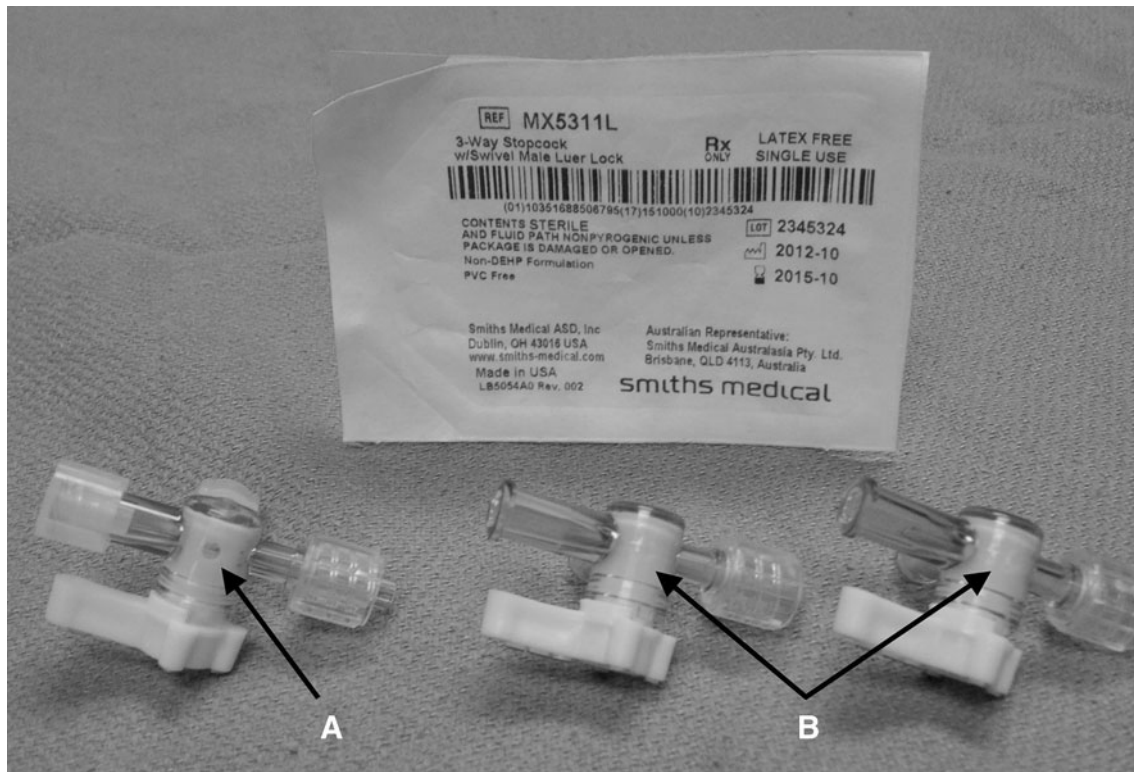
the clear plastic housing showed an incomplete perforation of the “through hole” in the valve body that blocked the passage of fluid (Figure). We immediately notified our staff, Biomedical Engineering, our Quality Control Department, and the local supplier and then performed a full search of our inventory to isolate any other defective units and locate a sample within its packaging to identify the lot number. One more defective three-way stopcock was found during this search, but unfortunately, our technicians had already disposed of its packaging. Despite an exhaustive search, we were initially unable to find a defective unit within its packaging to identify the specific lot number. Our inventory at the time was found to contain 30 different lot numbers, obscuring our search for the defective lot.

Figure Photograph of three-way stopcocks with the valve body rotated 90° clockwise to show the defect. The normal sample on the left (A) has a complete “through hole” to allow passage of fluid, whereas the two defective samples to the right (B) have an incomplete

or absent perforation on the inflow side of the valve body. The packaging shown is for identification purposes only and does not represent the defective lot

Similar three-way valves have been reported to fail after exposure to propofol infusions;¹ however, in this case, the units were faulty before usage. Response from the manufacturer indicates that the defect was identified by the number “39” stamped on side of the white valve body and tracked through the maintenance records at their facility, and the inventory was isolated and inspected for further problems. We have notified Health Canada of this issue through the Canadian Medical Devices Sentinel Network (<http://www.hc-sc.gc.ca/contact/dhp-mps/hpfb->
