# Monitoring the changes in the dynamic properties of an RC building experiencing column loss

Fuat Aras<sup>1</sup> · F. Necati Çatbaş<sup>2</sup>

In this study, an existing six-storey reinforced concrete building with an asymmetric structural plan and soft storey irregularity was used as a test specimen and subjected to three-step progressive structural damages to detect the variations in its dynamic properties. Mode shapes and dominant frequencies of the undamaged building were determined by the ambient vibration survey (AVS) and it was seen that its first three modes were torsion coupled. Besides, soft storey irregularity was evident due to the lack of masonry infill walls on its ground floor. Later on, three-step progressive damages were applied to the building. The first step targeted three columns and one beam of the building, located on a corner region of its ground floor to peel off their clear covers. The second step razed two adjacent corner columns which were already moderately damaged in the first step, while the third step knocked the third moderately damaged column down. After each damage step, AVS was repeated with the same details as applied for the undamaged buil

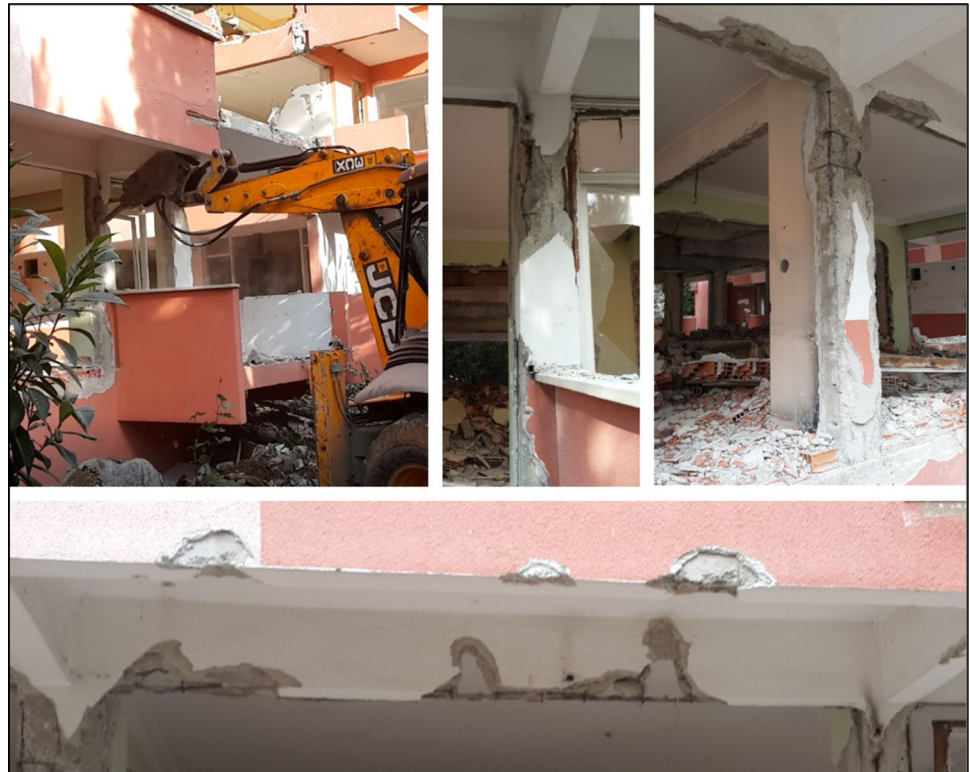
In this stage, two corner columns located on the right front (corner *B*), the column on the middle-front region of the building, and the beam connecting the middle-front column to the left-front corner columns were damaged by a construction-demolishing machine. Until the peel-off of the clear cover concrete, vibrational impacts were applied. Locally in some regions, longitudinal bars accidentally separated from the core, but no cracks developed in the core concrete of the columns. Besides, the beam experienced more damage than intended due to the difficulty of the application

of the impacts caused by the overhangs. Figure 7 shows the damaged members.

**Fig. 7** Three damaged columns and one beam for moderate damage (MD)

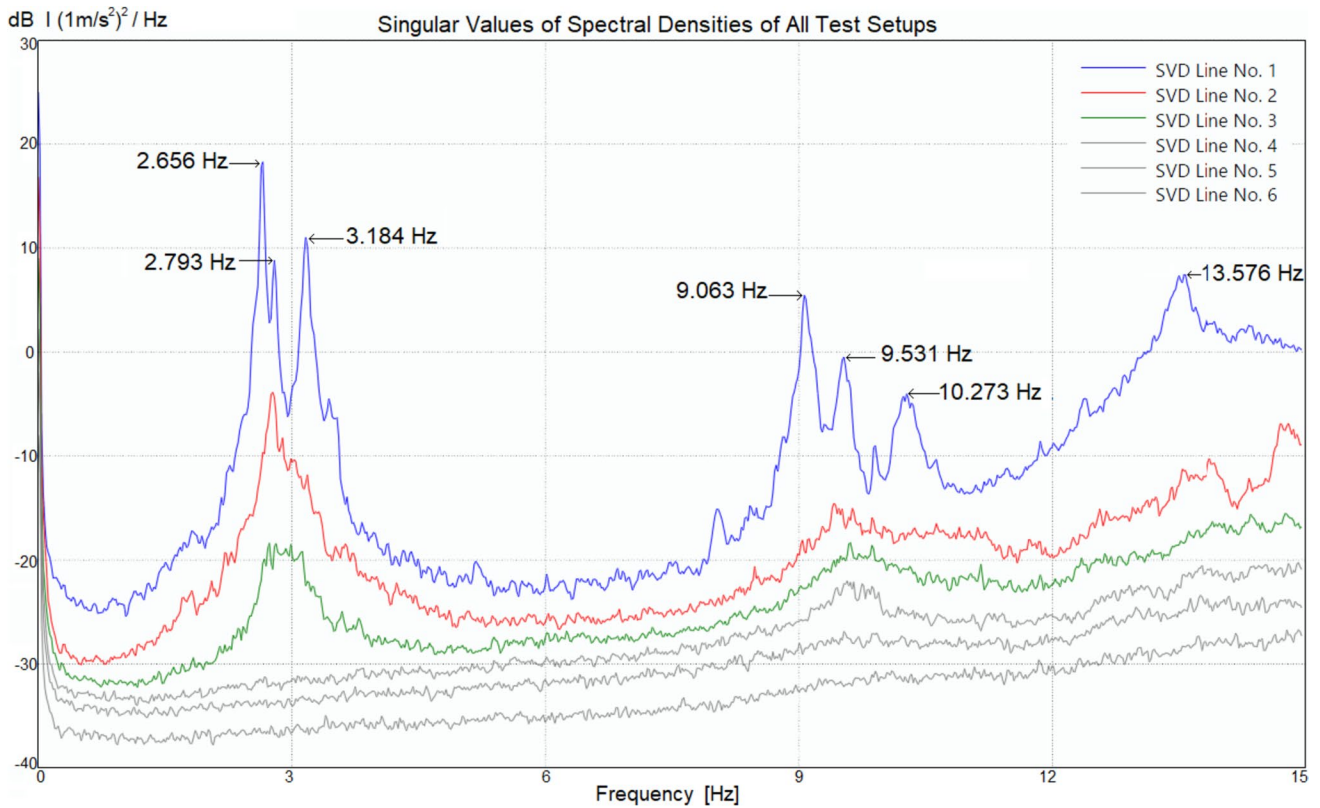
AVS was applied to the building with the same principles explained before. The first three dominant frequencies of the building were determined as 2.656, 2.793, and 3.184 Hz (Fig. 8). The general mode shape definitions of the building remained the same as those determined for the undamaged building. Concerning the previous phase, a slight decrease in the dominant frequencies was noted. The same conclusion is valid for the higher modes except for the fifth mode.

**Fig. 8** Singular values of spectral density for the MD phase of the building

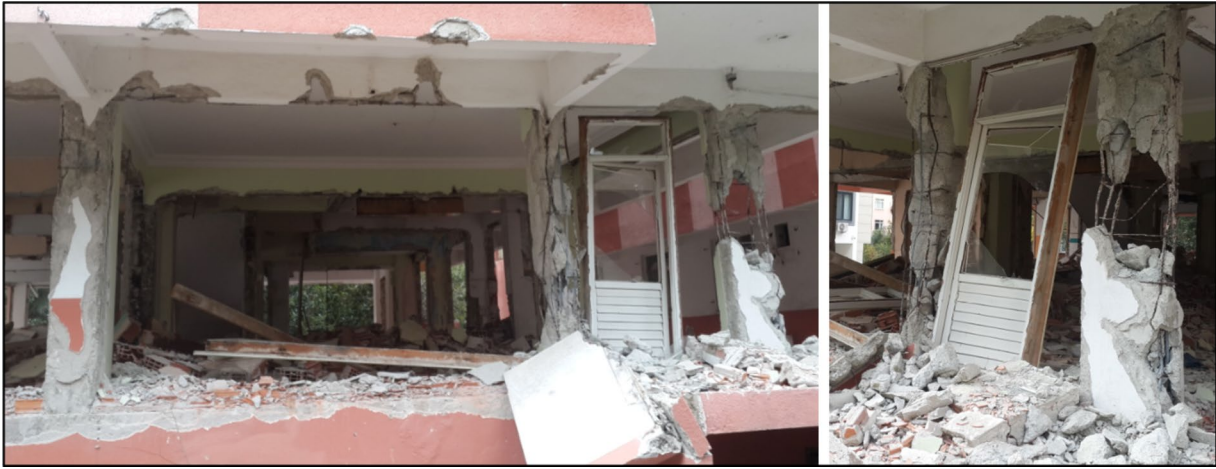
In this phase, two corner columns were heavily damaged. They were razed, and Fig. 9 shows the damaged elements in this phase. Figure 10 shows the singular values of spectral density illustration. The first three dominant frequencies of the building were determined as 2.578, 2.793, and 3.164 Hz, proving that the second mode frequency did not change, but the frequencies of other modes decreased slightly. Mode shapes visually remained the same as those for the undamaged building. One distinct difference concerning the previous case was the dominant frequency seen at 12.168 Hz. The mode shape evaluation pointed out that this mode did not

Fig. 9 Two heavily damaged corner columns for HD-I

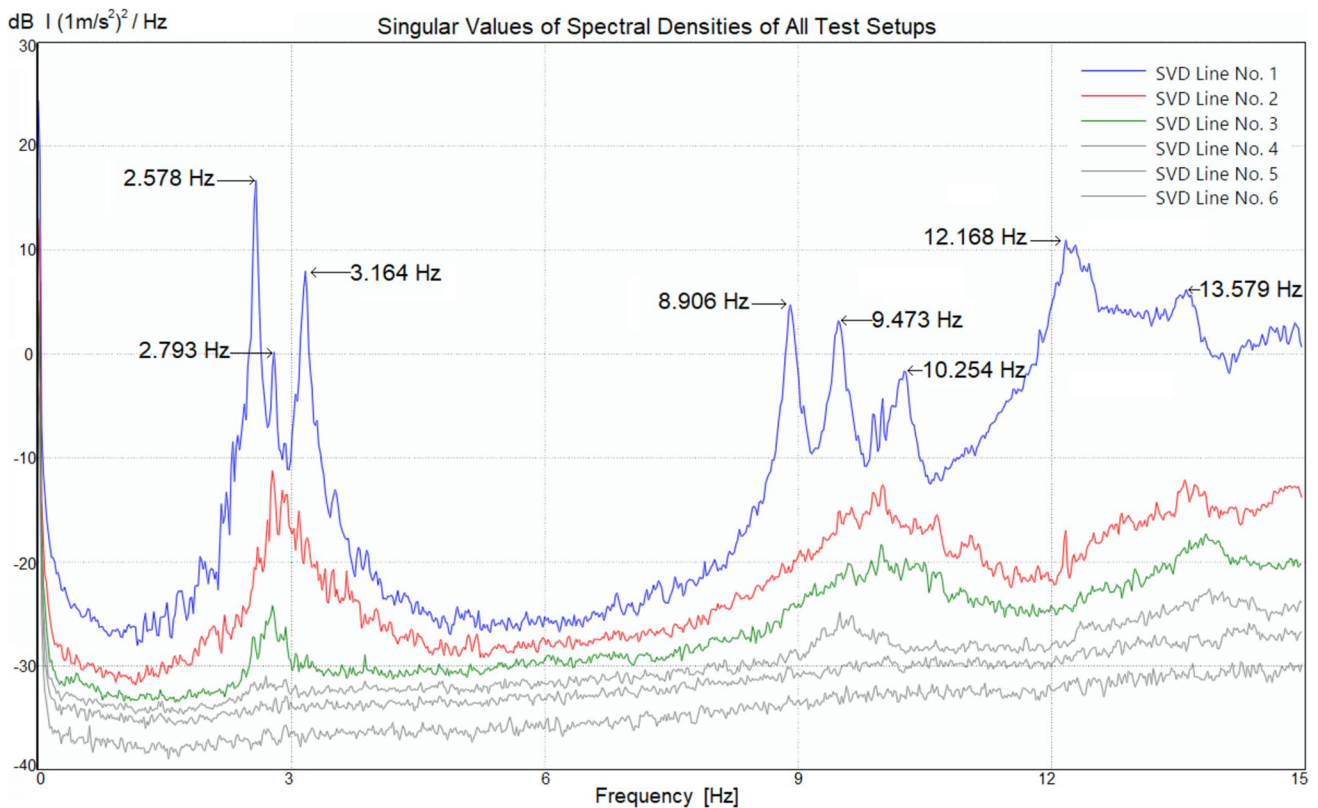
Fig. 10 Singular values of spectral density for HD-I

exist for the previous cases and it was formed by the vertical movement of corner *B*, where column damages existed on the ground floor. In other words, the given damage created a vertical mode.

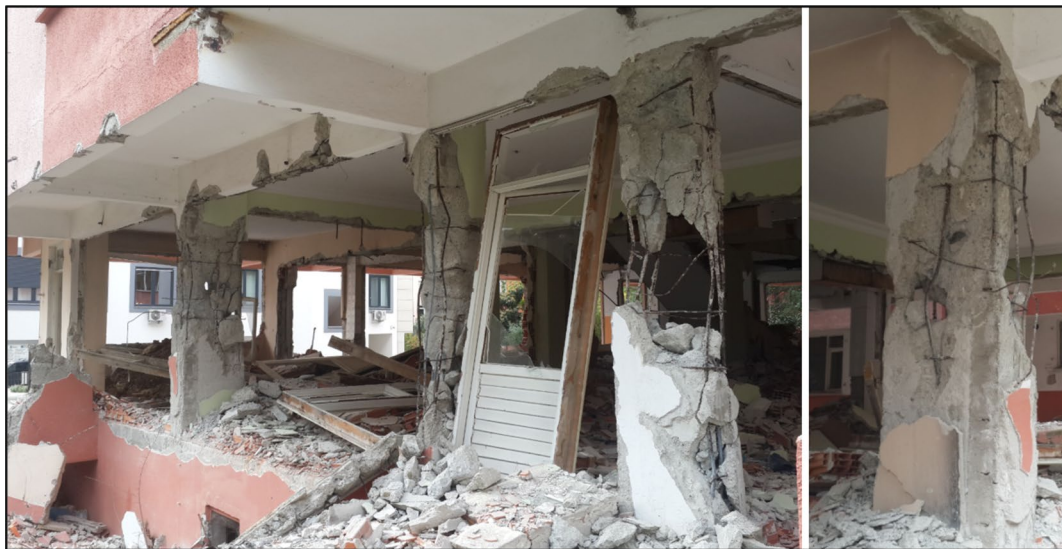
The moderately damaged column was heavily damaged in this phase. Figure 11 shows the damaged elements and Fig. 12 shows the singular values of spectral density illustration for the HD-II phase of the building. The dominant frequency of the second mode did not change again, but those

Fig. 11 Heavily damaged three columns for HD-II

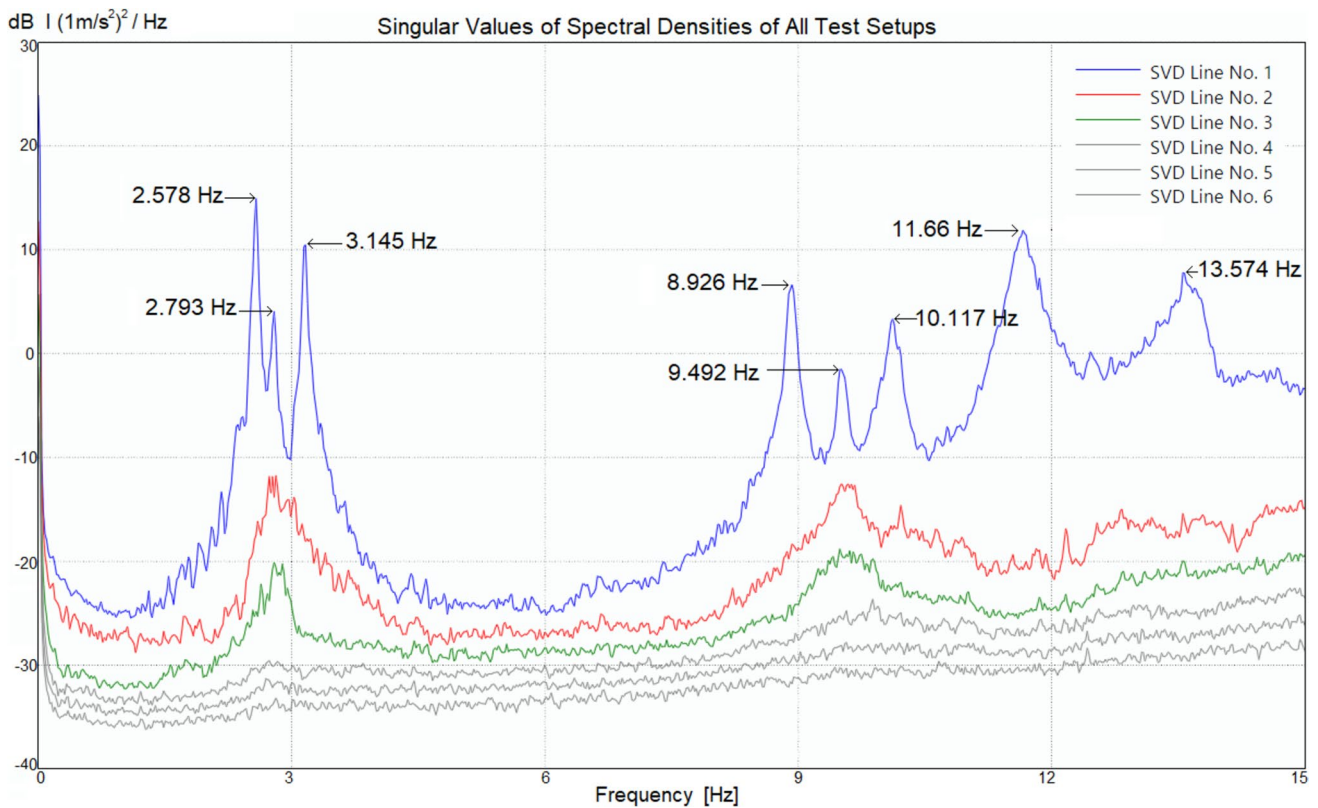
Fig. 12 Singular values of spectral density for HD-II

of other modes decreased slightly. Mode shapes remained the same as those for the original building. The vertical mode induced by the heavy damages had a dominant frequency of 11.66 Hz.

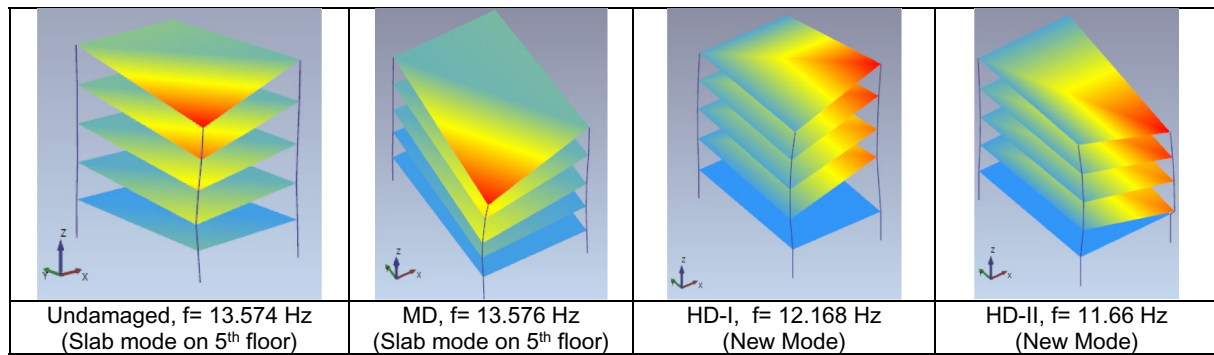
Figure 13 has been prepared to evaluate high-frequency modes and present the formation of a new dynamic mode for the HD-1 and HD-2 stages. For the undamaged and MD phases of the building, the seventh dominant frequency is seen at around 13.57 Hz and represents the mode shape

**Fig. 13** Seventh mode of the building for its different phases

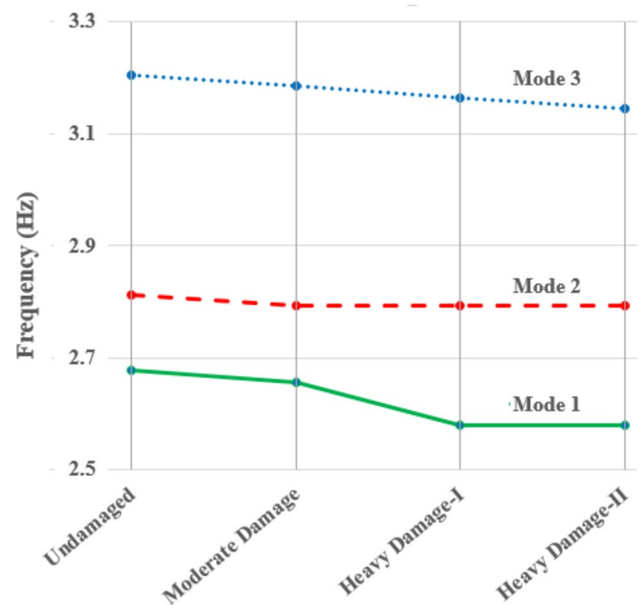
**Fig. 14** The first three modal frequencies of the building through the sustained damage levels

The first mode frequency of the building decreased with the experienced damage. Unexpectedly, the decreases for the HD-I and HD-II phases are the same. The obtained second mode frequencies of the building are the same for all damage stages and it is 0.71% less than that of the undamaged building. The third mode frequency decreases with the increase in the severity of the damage. The complete loss of three columns (out of 32) on the ground floor caused a decrease of less than 4% in the dominant frequency of the first mode. Such a small amount of decrease can be regarded as an insignificant change to worsen the dynamic behaviour of the building. For the decision-makers working on the assessment of partially damaged buildings, the result can favour the repair or retrofit of them.

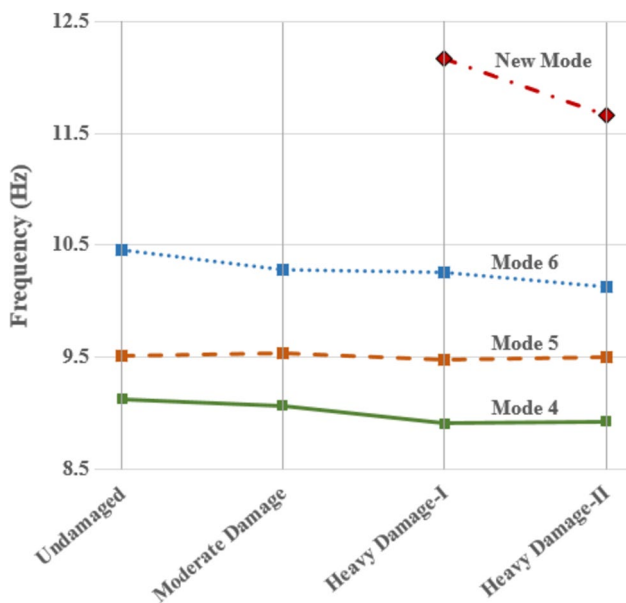
**Fig. 15** The variation of the modal frequencies of higher modes through the sustained damage levels

The loss of two corner columns in the HD-I phase makes the corner  $B$  unsupported in the vertical direction. For this reason, a new mode, which did not exist for the undamaged and moderately damaged building, was created with a dominant frequency of 12.168 Hz. When the building lost one more column, the dominant frequency of the new mode decreased to 11.66 Hz. In this study, numerical analyses were also employed for the validation of the experimental results.
