A case study of apparently spontaneous fracture

F. A. Veer

Abstract Spontaneous failures in thermally toughened glass are frequently reported, although the actual percentage is quite small, suppliers in the Netherlands reporting one or two cases a year while thousands of tempered panels are supplied. These cases are rarely investigated in the Netherlands because the broken thermally toughened glass is usually not in one piece and can thus not be sent for analysis. In 2015 several sliding thermally toughened glass single curved vehicle roof windows failed within several months. A butterfly pattern was seen and NiS failure was suspected by the window manufacturer. As a coloured adhesive foil had been applied during manufacturing the glass shards were kept together. The broken glass was shipped back to the supplier and was together with several non-broken roof windows sent to Delft University of Technology for analysis. The compressive surface pre-stress in the intact roof panels was measured with a SCALP 5 device. It was found that the compressive surface pre-stress varied, as bands of low compressive surface pre-stress alternating with bands of high compressive surface pre-stress

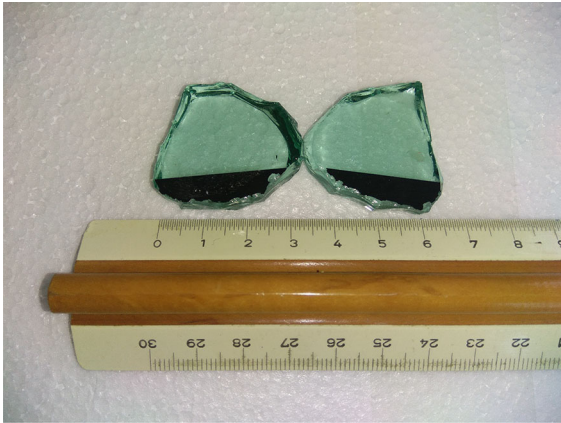
Fig. 2 Butterfly fragments removed from “spontaneously” failed window

The butterfly specimens of the two available spontaneously failed windows were carefully removed.

On one set no clear fractographic information was visible with a microscope. However, if the two pieces were put together it was clear that a small piece was missing. Presumably the piece of glass where the fracture originated was separated from the butterfly pieces and not recovered.

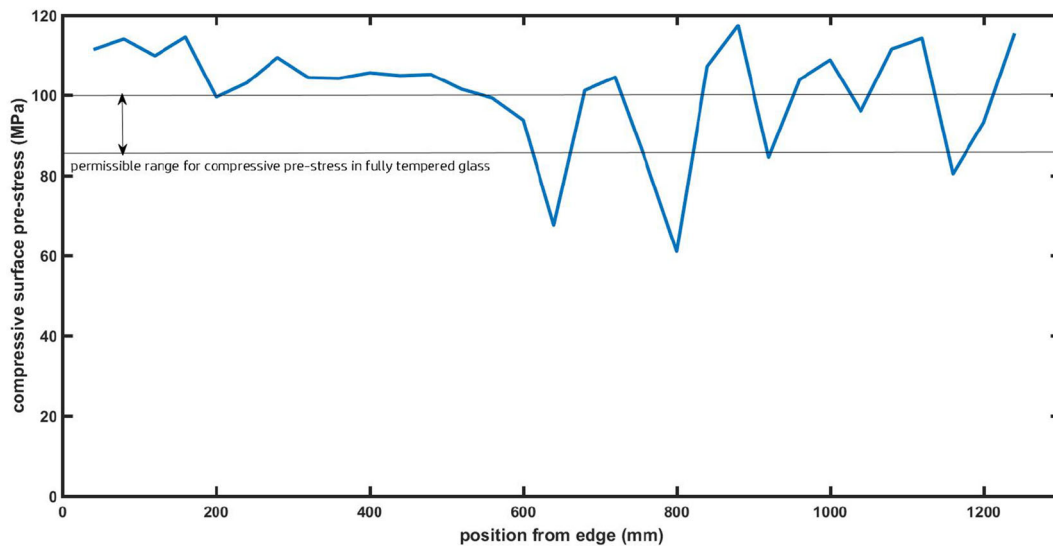
Fig. 3 Measured compressive surface pre-stress at the centre of the length of the window, measured across the width of the window from left edge to right edge for specimen 1

The compressive surface pre-stress was found to vary considerably across the width of the window forming bands similar to the bands of shards visible in the spontaneously failed specimens. As the variation is far greater than the 5% measuring error, the differences must be assumed to represent physical differences in the compressive surface pre-stress.

Figure 3 shows a typical variation in compressive pre-stress as measured with the SCALP 5 device. It should be noted that at the centre of the specimen, where the highest bending stresses occur, the compressive surface pre-stress is significantly lower. Depending

on the specimen, local values for the compressive surface pre-stress as low as 20 MPa were measured. This is in sharp contrast with the values of 100 MPa measured in the properly thermally toughened zones.

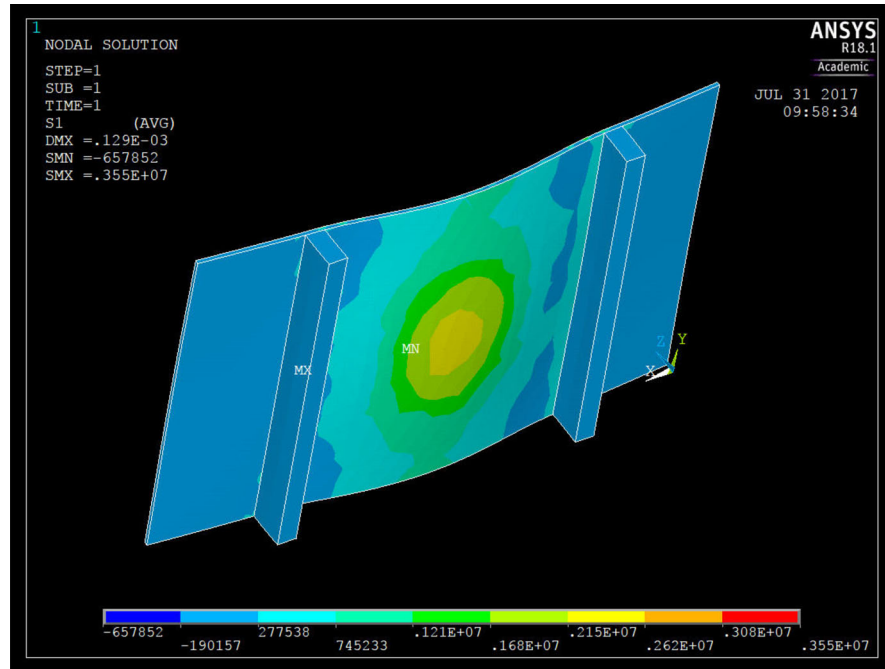
Fig. 6 Stress distribution according to ANSYS model

and illustrated in Fig. 7. All failures originated in the area with the highest applied stress shown in Fig. 6. The bands of large and small shards visible in Fig. 7 corresponded to the bands of lower and higher compressive surface pre-stress measured with the SCALP 5 device.
