# Investigation and diagnosis of a reinforced concrete reservoir with intense crack formation from several sources

**Abstract** This article presents an investigation of the pathological condition of a wastewater reservoir, characterized by leaks, severe cracking—typically due to expansive reactions of the concrete—and deterioration of the protection system. The investigation was based on a visual inspection, anamnesis, national and international literature review, project analysis and implementation of tests to determine the corrosion potential, chloride content, resistance to axial compression and modulus of elasticity of the concrete, as well as the occurrence of expansive reactions by petrographic analysis and scanning electron microscopy, etc. The contribution of various phenomena towards the development of the reported condition were detected, the main ones being the thermal shrinkage of the concrete, the limit of opening of cracks adopted in the project and the premature use of the structure. Based on the diagnosis developed, we studied the prognosis of the structure and prepared recommendations for recovery, mitigation and protection of the elements that make up the reserv

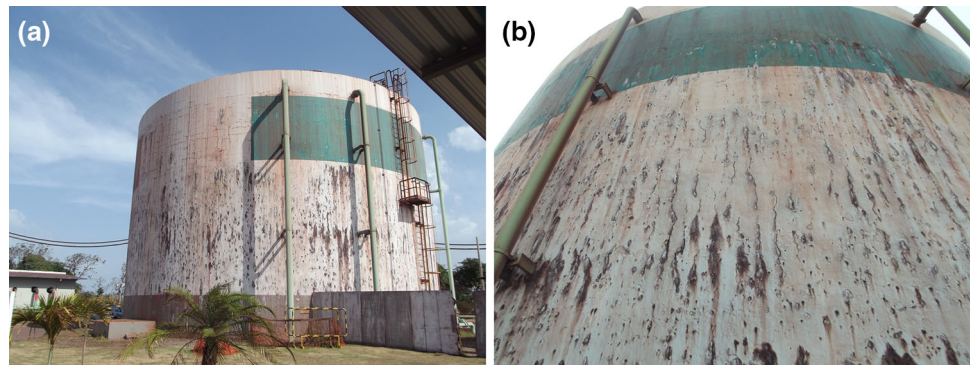
The structure under study was, in the period of inspection, severely cracked, and leaking, as shown in Figs. 1 and 2.

**Fig. 1** Overview (a) and partial view (b) of the reservoir—2013

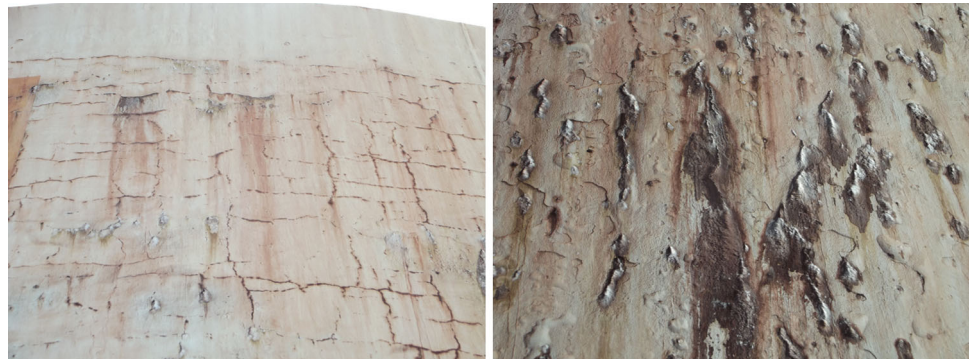
**Fig. 2** Fissuration details on the reservoir wall. Note also the presence of failure in water-tightness and deterioration of the coating

Through the visual inspection, it was found that the structure presents a condition of generalized fissuration on the reservoir wall, with percolation of water, efflorescences and concretions. The cracks have a maximum opening of 0.5 mm. On the upper face of the beam, one could see the occurrence of transverse cracks with systematic distribution.

It is also essential to clean the structure, to replace the internal waterproofing, to repair the cracks by means of injection, sealing and/or crystallization and the replacement of the outer face protection system by a system that is open to the diffusion of water vapor, allowing the reduction of humidity inside the elements, thus slowing down the expansive reactions.

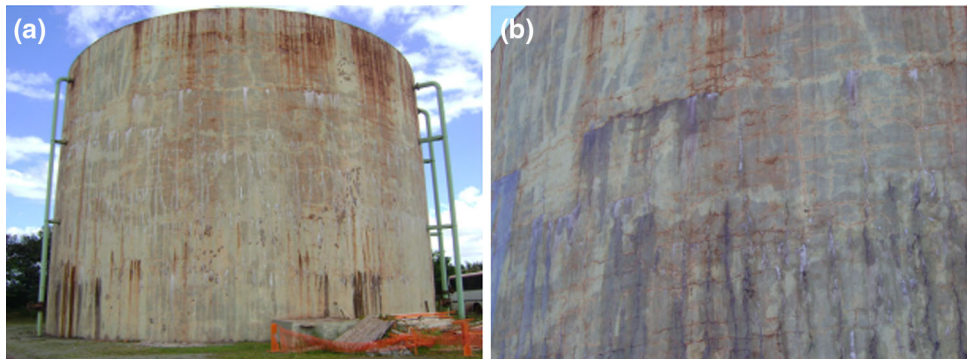
**Fig. 3** Overview (a) and partial view (b) of the reservoir—2009

Later, in 2009, the reservoir underwent an inspection that evaluated the pathological manifestations present in the structure and replacement of the waterproofing system was recommended. Figures 3 and 4 show the reservoir in 2009, 5 years after its construction.

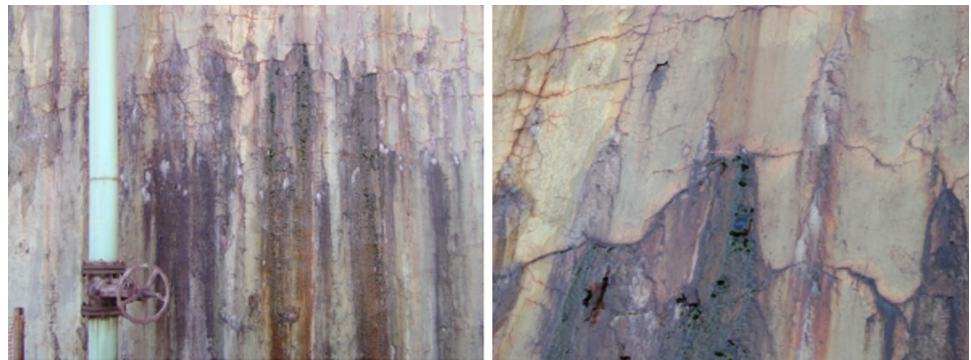
**Fig. 4** Details of the reservoir wall presenting fissuration and water percolation

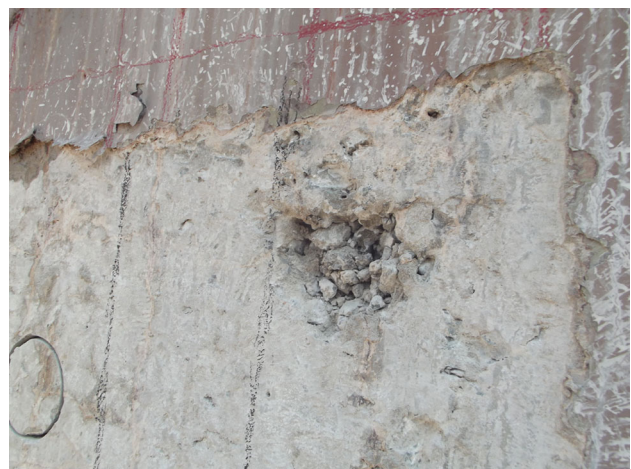
The presence of points of segregated concrete under the coating was found, as shown in Fig. 5.

**Fig. 5** Segregated concrete point visualized after a partial removal of the coating

The segregation of the concrete that was observed results from failures in the vibration and the densification of the material. This process may have been hindered by the reduced workability of the material, also influenced by the concrete mix and by the temperature of the material and the environment.

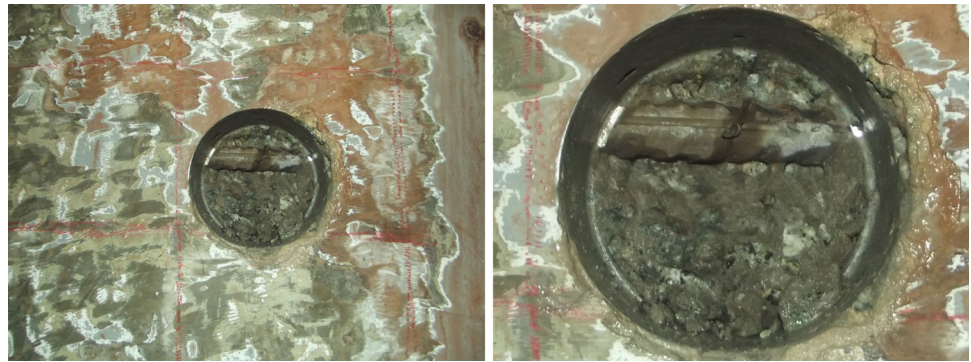
It is necessary to highlight that the presence of red spots at points affected by infiltrations was not considered indicative of the presence of oxides and corrosion of embedded rebars, given it is the same coloration as the wastewater stored in the reservoir. The structure does not show evidence of the corrosion of the rebars, such as the disgregation of the concrete. For confirmation, prospecting for rebars at intervals along the wall was performed. In all the regions analyzed, the rebars was in good conditions, as shown in Fig. 6.

**Fig. 6** Detail of rebar built into the concrete

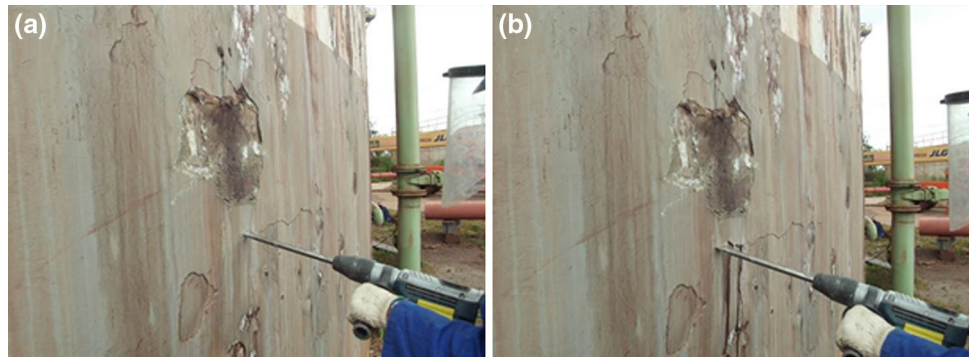
**Fig. 7** Wall detail immediately before (a) and after the commencement of drilling (b), at which time one may observe the percolation of water trapped between the coating and the structure

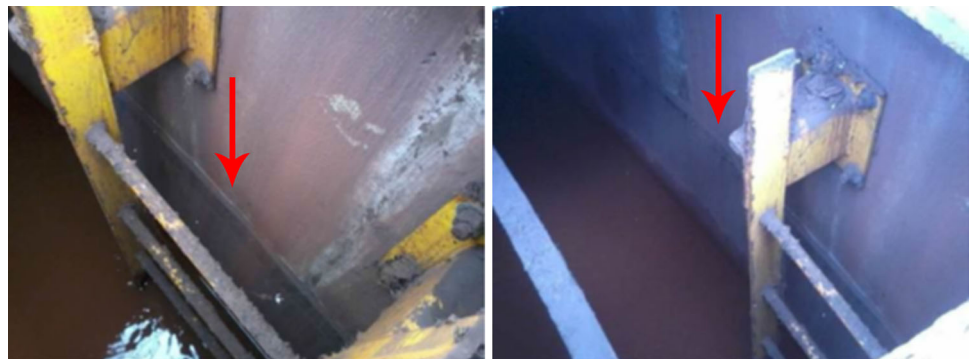
**Fig. 8** Limit of the internal waterproofing approximately 60 cm below the top of the structure. We also observe the color of the water
