Structural performance of impact damaged and repaired concrete bridge girder using GFRP rebars

Nur Yazdani¹ · Maria A. D. L. F. Montero²

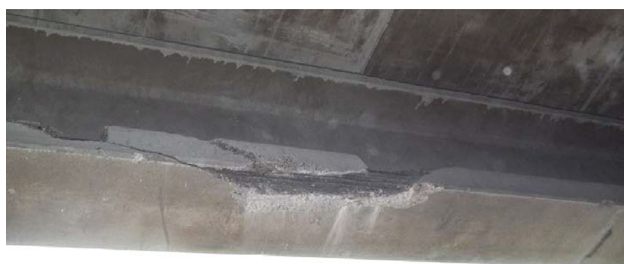
Fig. 3 Damaged girder photograph

The vehicle impact resulted in severe damage on the girder (Fig. 3), causing a 4.3 m long damage along the bottom flange with spalled concrete and three rows of exposed but undamaged strands (total of nine strands exposed). The center of the damaged area was at 6.7 m from the left support. A sketch of the damaged section is presented in Fig. 4.

NCHRP 20-07/task 307 report is a widely accepted source for classifying girder damage and associated repair needed [22]. Based on the NCHRP damage classification, because the exposed strands on the damaged girder were not severed, the damage was categorized as “moderate”. Although there was no structural damage, an adequate repair was required to prevent further deterioration and the corrosion of the strands. The repair process used three different materials: an adequate bonding agent, embedded

The repair procedure consisted of the following steps: (1) remove all loose concrete; (2) chip existing concrete to provide a rough surface; (3) drill holes for GFRP rebar placement; (4) place GFRP rebar after cleaning all surfaces; (5) apply bonding agent; (6) install formwork; (7) fill with repair mortar; and (8) remove formwork after 12 h of curing. Chipped concrete had a minimum depth of 38 mm. The GFRP rebar placement scheme is shown in Fig. 5. The rebars were arranged both longitudinally and transversally. The length of the transverse rebars was 203 mm, embedded 101 mm inside the girder section, and spaced at 152 mm along the damage and located at 216 mm from the bottom. The longitudinal rebars were placed along the damage above and below the transverse rebars with a length of 4.3 m. These rebars enhanced the flexural capacity of the repaired section and supplemented the mortar strength that was lower than the girder concrete strength.
