Failure analysis of ring die of a feed pellet machine

Abstract: The severely worn position and failure mechanisms of the ring die of a feed pellet machine were investigated. The macroscopic and microscopic morphologies of the failed surface, the chemical composition and mechanical properties of the collected samples were analyzed using scanning electron microscopy, energy disperse spectroscopy, optical emission spectrometry, and a universal testing machine. Results show that the dip angle at the entrance of the ring die hole between the roller and ring die was severely worn. The feed powder could not be fully extruded through the dip angle at the entrance of the ring die holes, thus the density of the feed particles produced could not meet the requirements. Therefore, abrasive wear under high stress is the main reason of failure at the entrance of the ring die holes under the action of feeding powder; and cutting and fatigue spalling lead to substantial material loss. In addition, a high damp-heat environment aggravates abrasive wear on the die hole internal surface.

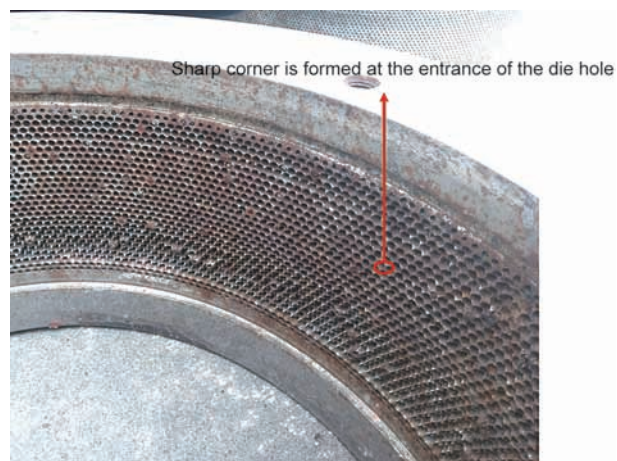
The studied ring die was made of 4Cr13. A scrapped ring die of a feed pellet machine was analyzed in this work. When the failures occurred, the total service time of the ring die was around 760 h, which was less than the ring die design service time. As displayed in Fig. 3, the surface of the scrapped ring die was filled with rust, and a sharp corner had formed at the entrance of the die holes. As shown in Fig. 4, the entrance of ring die holes was worn off and the ring die hole became larger, which was the cause of the failure. The specimen taken from the ring die along the direction of the ring die-hole depth was prepared for the follow-up experiments. The working condition of the ring die appeared to include severe mechanical stresses and a high damp-heat feed powder environment.

Fig. 3: Scrapped ring die

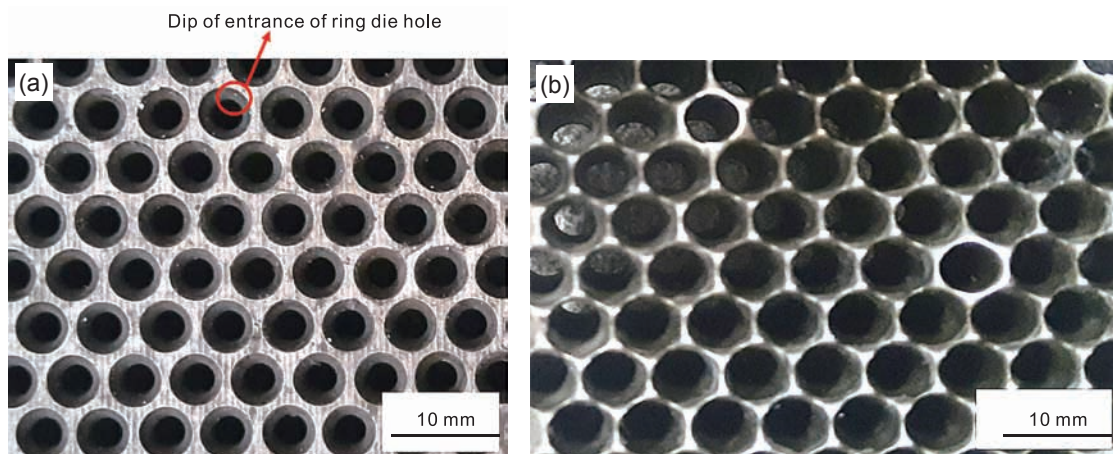
Fig. 4: Image of the entrance of the ring die hole: (a) In-service; (b) Scrapped

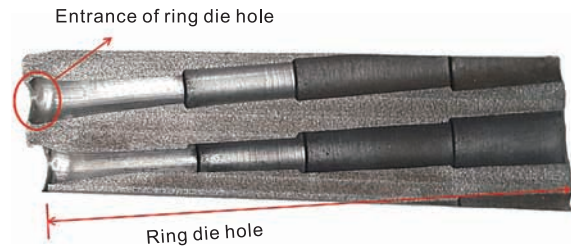
As shown in Fig. 5, the entrance of the ring die hole is worn more severely than the inner surface, and many wear scars are visible at the entrance. It can be basically determined that the entrance of the ring die hole is the most severely worn position of the ring die.

Fig. 5: Cross-sectional view of the ring die holes

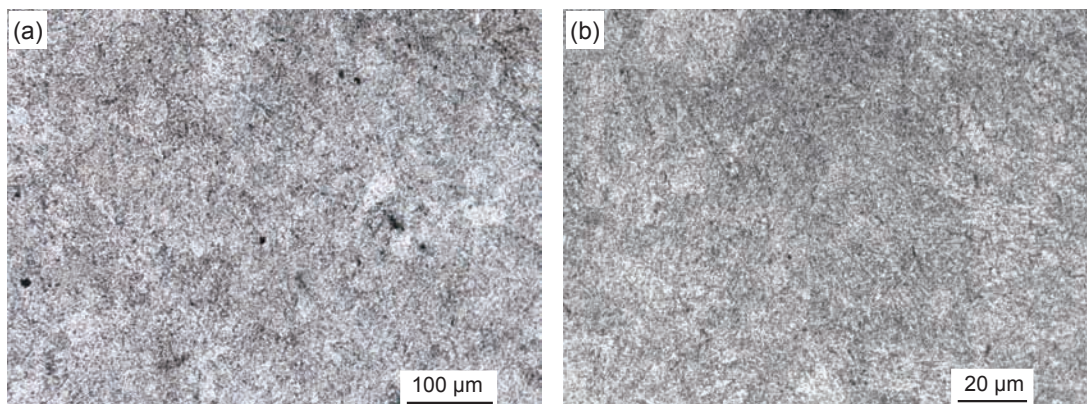
Figure 6 shows the microstructure of the ring die. It can be observed that the structures are mainly composed of tempered

sorbites, which are dispersed with a eutectic mixture of ferrite and carbide particles [9]. These structures are in line with those of 4Cr13 stainless steel after quenching and tempering, and display the typical microstructure of normalized high carbon steel. The tempered sorbite microstructure provides this component with excellent mechanical strength.

Fig. 6: Microstructure of the ring die

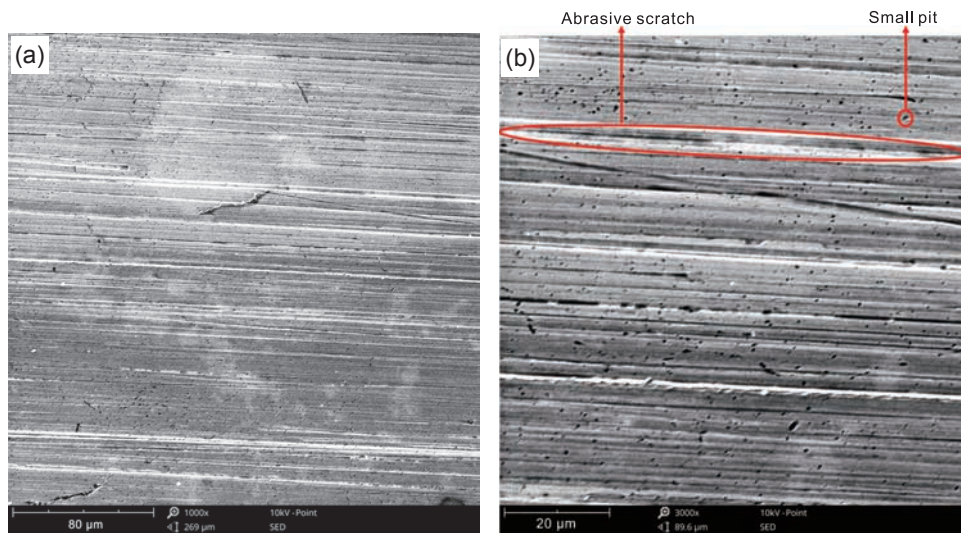
SEM analysis of the surface of the ring die hole was carried out to determine the wear mechanism. Figures 7 (a) and (b) show the microscopic morphologies of the inner surface of the failed ring die hole under SEM. Minor parallel abrasive scratches are found on the worn surface. Meanwhile, many small pits are found distributed on the worn surface.

Fig. 7: SEM micrographs of the inner surface of the ring die hole

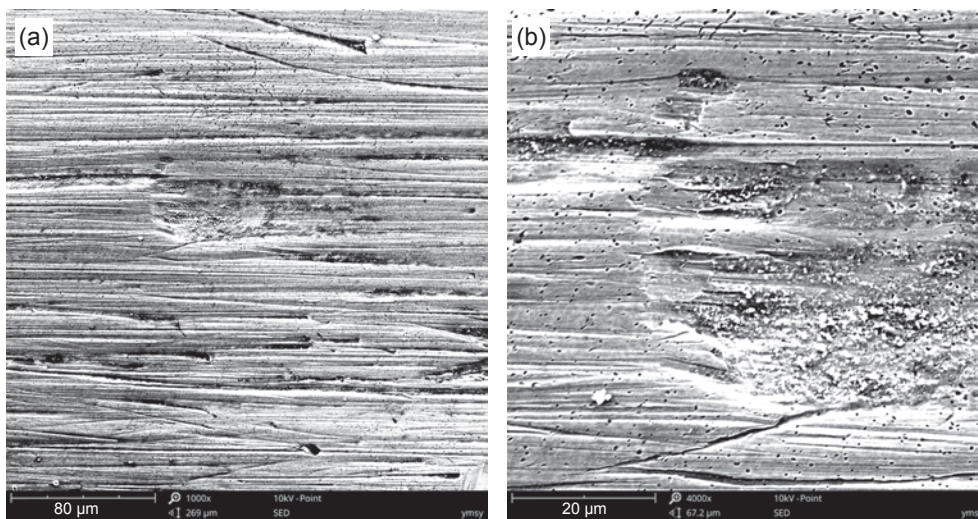
Fig. 8: SEM micrographs of the entrance surface of the ring die hole

Surface morphologies at the entrance of the failed ring die hole are shown in Fig. 8 (a) and (b). It can be seen that, compared with the inner surface of the ring die hole, a certain degree of spalling and a deeper groove are found on the worn surface of the entrance of the ring die, which is related to the greater stress on the entrance surface. This also confirms the result of visual analysis that the most severe wear damage is at the entrance of the ring die hole.

(2) Spraying ceramic coating on the entrance of the ring die hole will effectively improve its resistance to wear and corrosion.

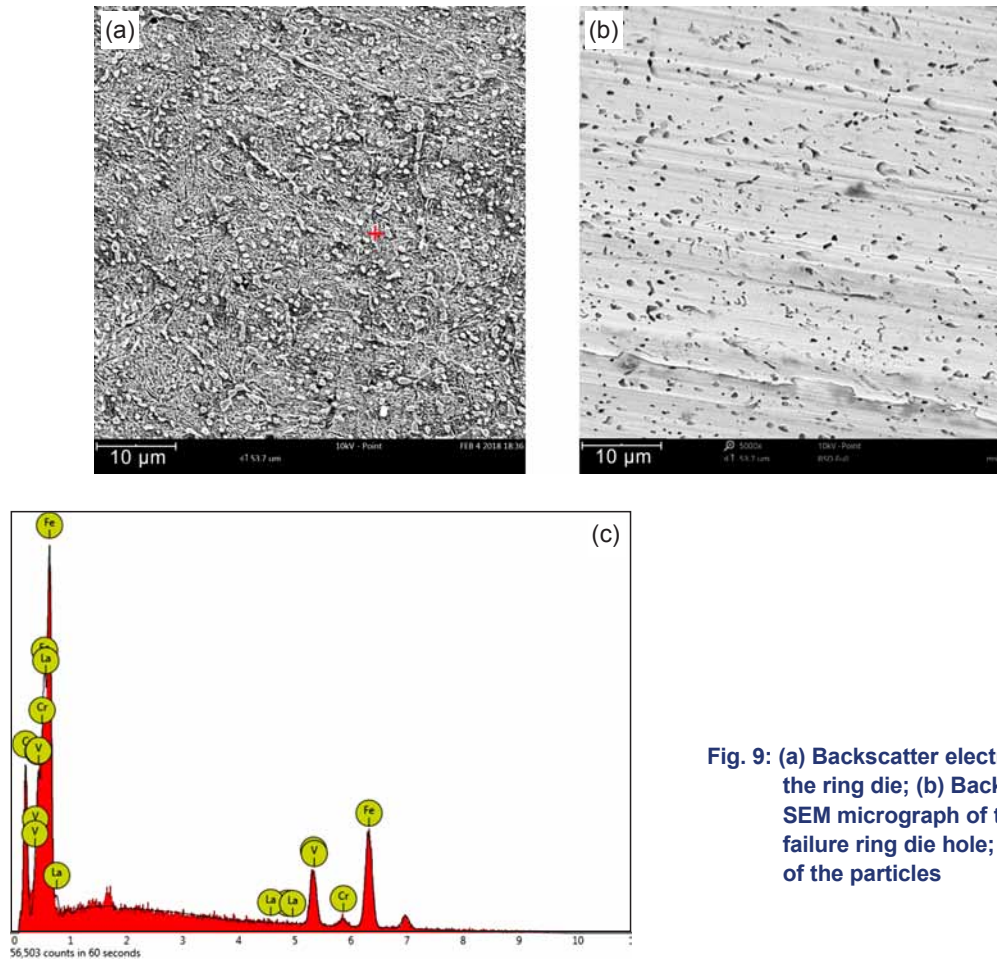
To find the reason causing the small pits, backscatter electron (BSE) and EDS were used for the microscopic morphology analysis of the ring die. As shown in Fig. 9 (a), many particles are found in the microscopic morphologies on the ring die sample. The particles are smaller than $2\ \mu\text{m}$ and diffusively distributed in the material. By means of EDS [Fig. 9 (c)], it is determined that the chemical compositions of these particles marked on Fig. 9 (a) are mainly composed of carbon (C, 1.94wt.%), chromium (Cr, 18.77wt.%) and iron (Fe, 79.29wt.%). Considering that the sample has been thoroughly cleaned with ethanol in the ultrasonic cleaner before the SEM examination, it is affirmed that these particles are carbide particles.

The worn morphology of the entrance of the ring die hole is shown in Fig. 9 (b). Comparing the carbide particles in Fig. 9 (a) with the pits in Fig. 9 (b), it can be seen that the size and shape of the small pits and carbide particles are almost identical.

Fig. 9: (a) Backscatter electron micrograph of the ring die; (b) Backscatter electron SEM micrograph of the entrance of the failure ring die hole; (c) EDS spectrum of the particles

The small pits are not caused by wear, because of the average size of the third-body should be about 5 μm according to the sizes of the furrows, much larger than the small pits (less than 2 μm) [Fig. 9 (d)]. As mentioned above, the small pits are caused by falling off of carbide particles. One hypothesis is that the galvanic cell structure is formed between the metallic matrix and the carbide particles in the hot and moist feed powder environment. Electrochemical corrosion is caused by galvanic cell reaction where carbide particles serve as anode, metallic matrix as cathode and some substances in the feed powder as ion transport medium. The corrosion of the metallic matrix causes the gap between the metallic matrix and the carbides. Furthermore, the continuous mechanical vibration or wear during the operation of the ring die accelerates the falling off of the carbide particles, resulting in small pits [19-22]. The small pits deteriorate the mechanical properties of the material surface, and the peeling off of carbide particles, which are hard particles, also leads to the decrease of wear resistance. Meanwhile, wear promotes the exposure of new material, which corrodes more easily in the electrolyte. The small pits can become a stress concentration point on the surface of the material, which will cause fatigue flaking from this point on. This could perfectly explain the entrance of the ring die hole is severely worn even though its hardness reached 57.6 HRC. Therefore, it can be concluded that the major wear mechanism of the entrance of the ring die hole is a combined effect of third-body abrasive wear, fatigue-exfoliative wear, and electrochemical corrosion.

(1) Properly increase the holding time during the heat treatment of the ring die to fully melt the carbides.
