# Tool wear analysis in milling of locomotives wheels

P. A. P. Pacheco<sup>1</sup>

Received: 3 August 2020 / Accepted: 21 December 2020 / Published online: 6 January 2021

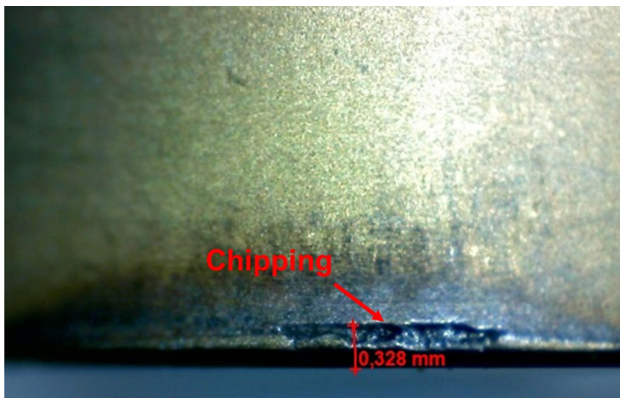
In this analysis, a premature chipping of the insert at position 2 was noticed, as can be seen in Fig. 9. According to Lopes [8], the contact stresses resulting from the mechanical efforts of the wheel against the rail lead to the metal hardening in the wheel surface, which can be defined as its hardening by plastic deformation. This increase in hardness associated with calluses and race-way imperfections may have resulted in increased cut resistance with the consequent chipping of the cutting edge of the tool.

Fig. 9 Chipping in the insert 2 (expanded 100X)

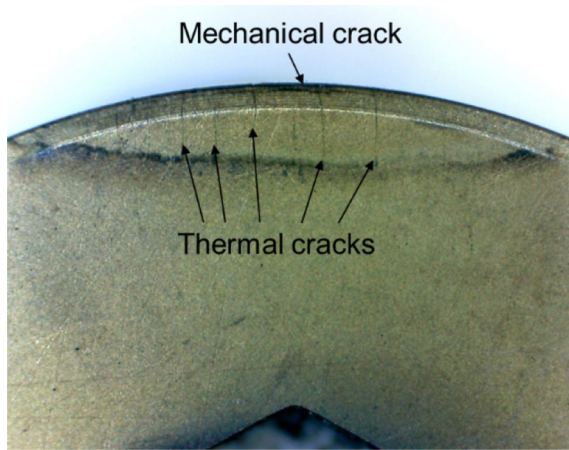
Insert 2 deserves greater attention, given that it presented flank wear, thermal and mechanical cracks, as can be seen in Fig. 11. The practice of not using cutting fluid when milling occurs precisely to reduce the risks of thermal cracks, however the milling process, due to intermittent cutting, can cause these defects in the tools. In this

**Fig. 11** Insert 2 with thermal cracks (expanded 80X)

process, in the first passes, the tool is faced with a material with high hardness due to hardening by hardening the wheel, consequently, the forces needed for cutting are greater, so mechanical cracks were also found.

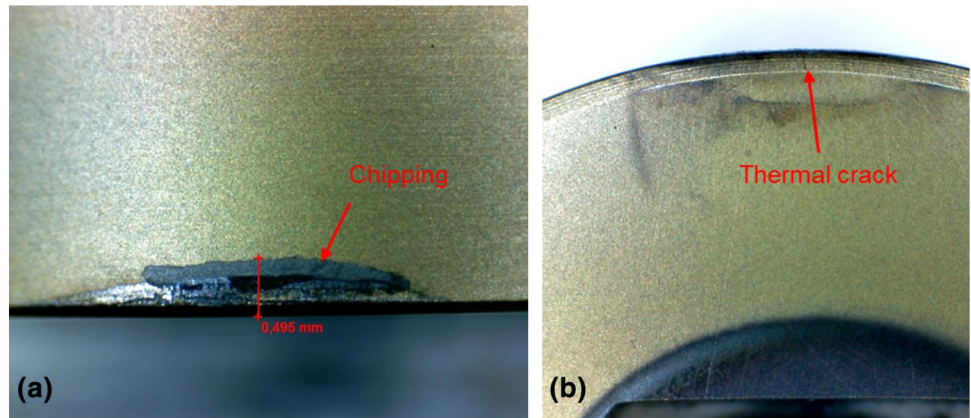
In sample 4, with the exception of the insert in position 7, Fig. 13, which suffered chipping, and inserts 14 and 15, that didn't-wear, all the others showed flank

wear. Near the region that showed chipping, it is possible to notice a crack that appears to be of mechanical origin. Looking at Fig. 13b, which represents the rake surface of the same insert, it is possible to notice a small crack of thermal origin. According to Melo et al. [10], the meeting of the mechanical cracks with the thermal cracks leads to detachment of portions of the cutting edge, accelerating tool wear.

**Fig. 13** Insert 7 for 4 passes (expanded 80X). **a** Chipping and mechanical cracking; **b** Thermal crack

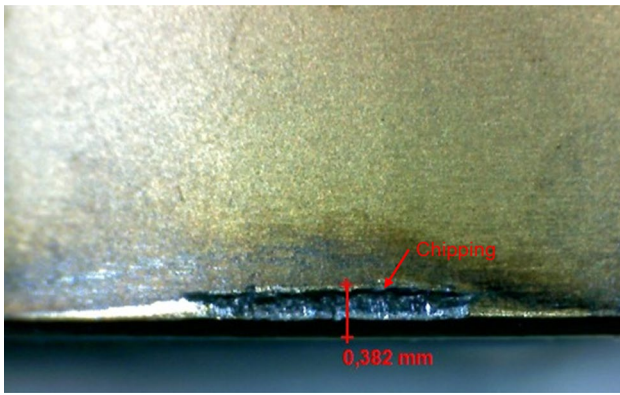
Inserts 14 and 15, due to the geometry of the wheels machined in this stage, did not cut, so they did not show wear. Insert 1 showed chipping, Fig. 16, so wear measurement was not possible.

**Fig. 16** Clearance surface of insert 1 after 7 passes (expanded 100X)

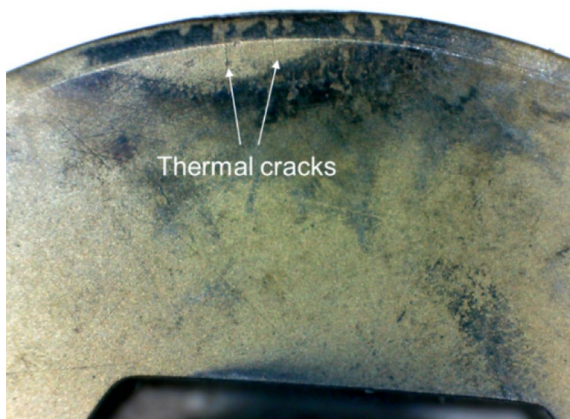
The cause of this chipping may be related to what has already been mentioned, the hardening of the region of the track and the thermal cracks common in the milling process. Figure 17 shows some cracks perpendicular to the cutting edge on the rake surface of this insert, generally identified as thermal cracks.

**Fig. 17** Rake surface of insert 1 after 7 passes (expanded 80X)

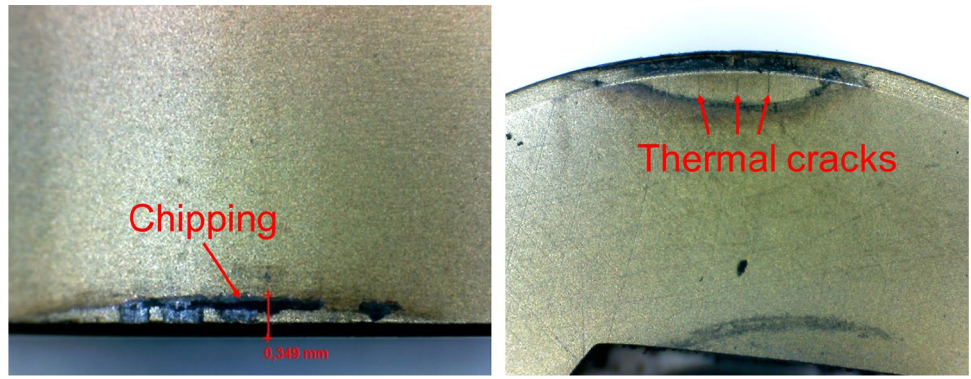
Inserts 3 and 4, Figs. 19 and 20, respectively, did not have wear measurement performed because they showed chipping. The mechanisms described above that involve hardening and cracks may have been influential for this occurrence.

**Fig. 19** Clearance surface and rake to insert 3 after 18 passes (expanded 80x)

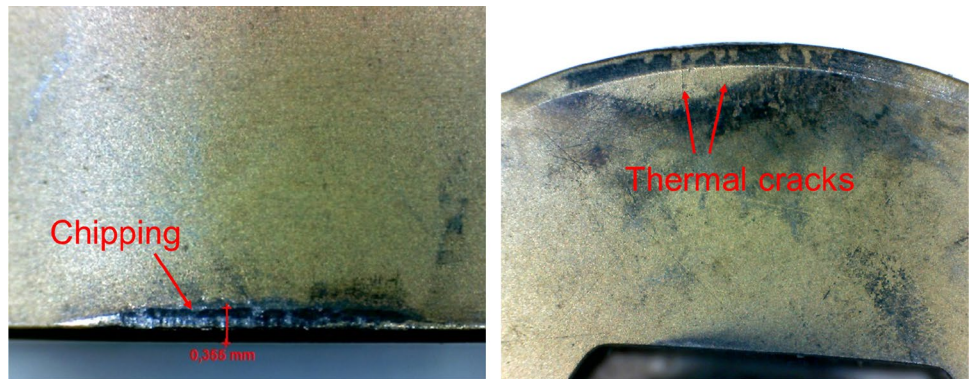
**Fig. 20** Clearance surface and rake to insert 4 after 18 passes (expanded 80x)

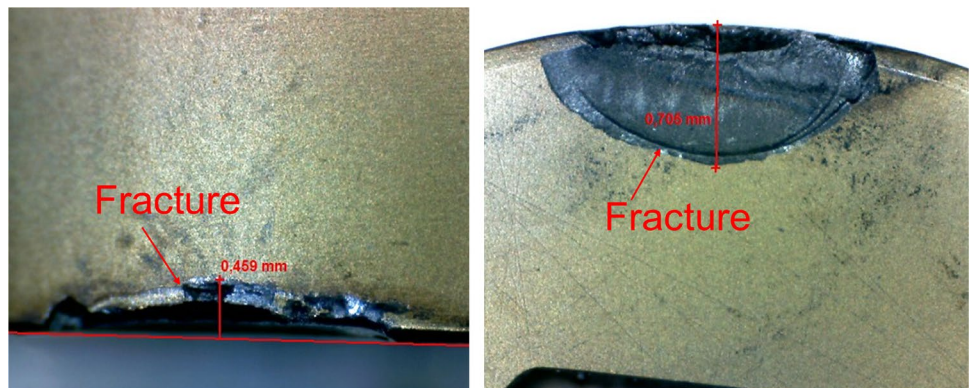
Inserts 5, 8 and 9, Figs. 21, 22 and 23, respectively, had a more protuberant chipping that elongated to the tool's rake surface and originated what can be classified as a fracture. It was also not possible to measure wear. These damages may have occurred by the same mechanisms discussed as well as due to high wear, considering that 18 consecutive passes have already passed. According to

**Fig. 21** Clearance surface and rake to insert 5 after 18 passes (expanded 80x)

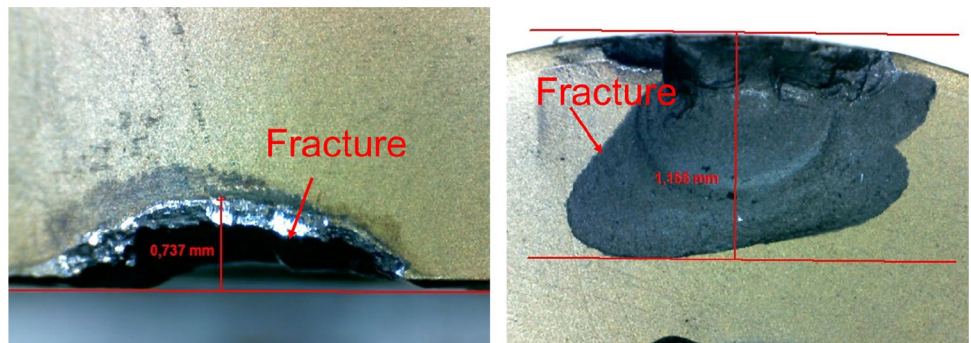
**Fig. 22** Clearance surface and rake to insert 8 after 18 passes (expanded 80x)

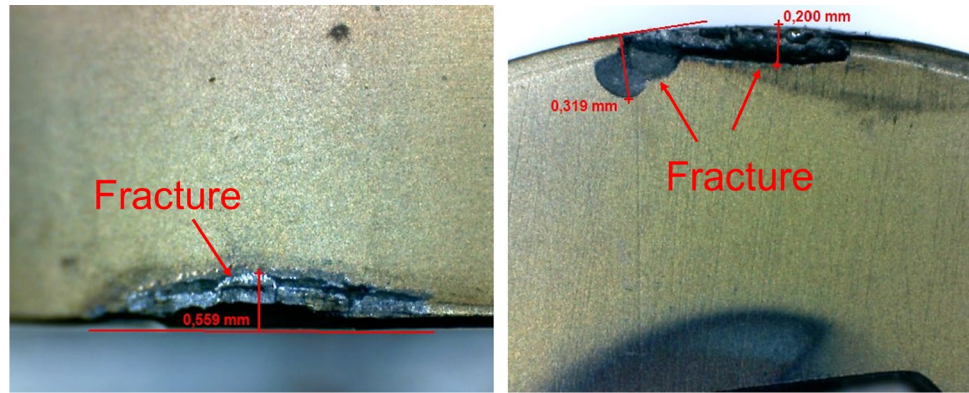
**Fig. 23** Clearance surface and rake to insert 9 after 18 passes (expanded 80x)

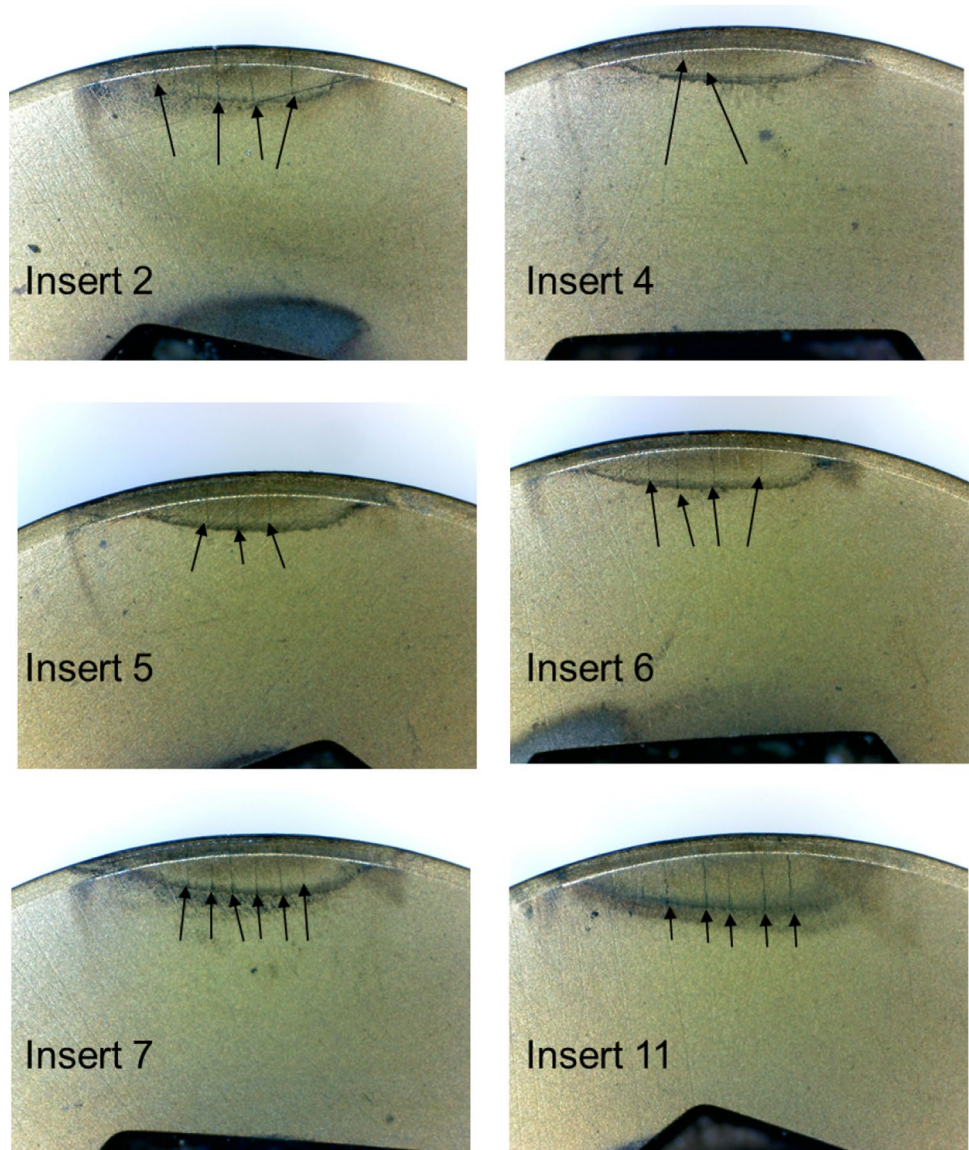
With 34 passes, even some inserts that did not show chipping had thermal cracks clearly visible on the exit surface, as can be seen in Fig. 26. Cracks of thermal origin seem to be the main causes of chipping in the cutting tools.

**Fig. 26** Rake surface of some inserts after 34 passes (expanded 70x)

Therefore, it can be concluded that the inserts in the scroll region suffer wear the most. In addition, a possible solution to the emergence of thermal cracks would be the adoption of inserts with greater resistance to temperature. A suggestion for future work is the evaluation of inserts
